Remediation Summary and Closure Request

**Durango Midstream LLC
12" Cedar Breaks_7/12/21_001_0
Eddy County, New Mexico
Unit Letter "E", Section 8, Township 18 South, Range 31 East
Latitude 32.762764 North, Longitude 103.896954 West
NMOCD Incident # nAPP2121448951**

November 2021

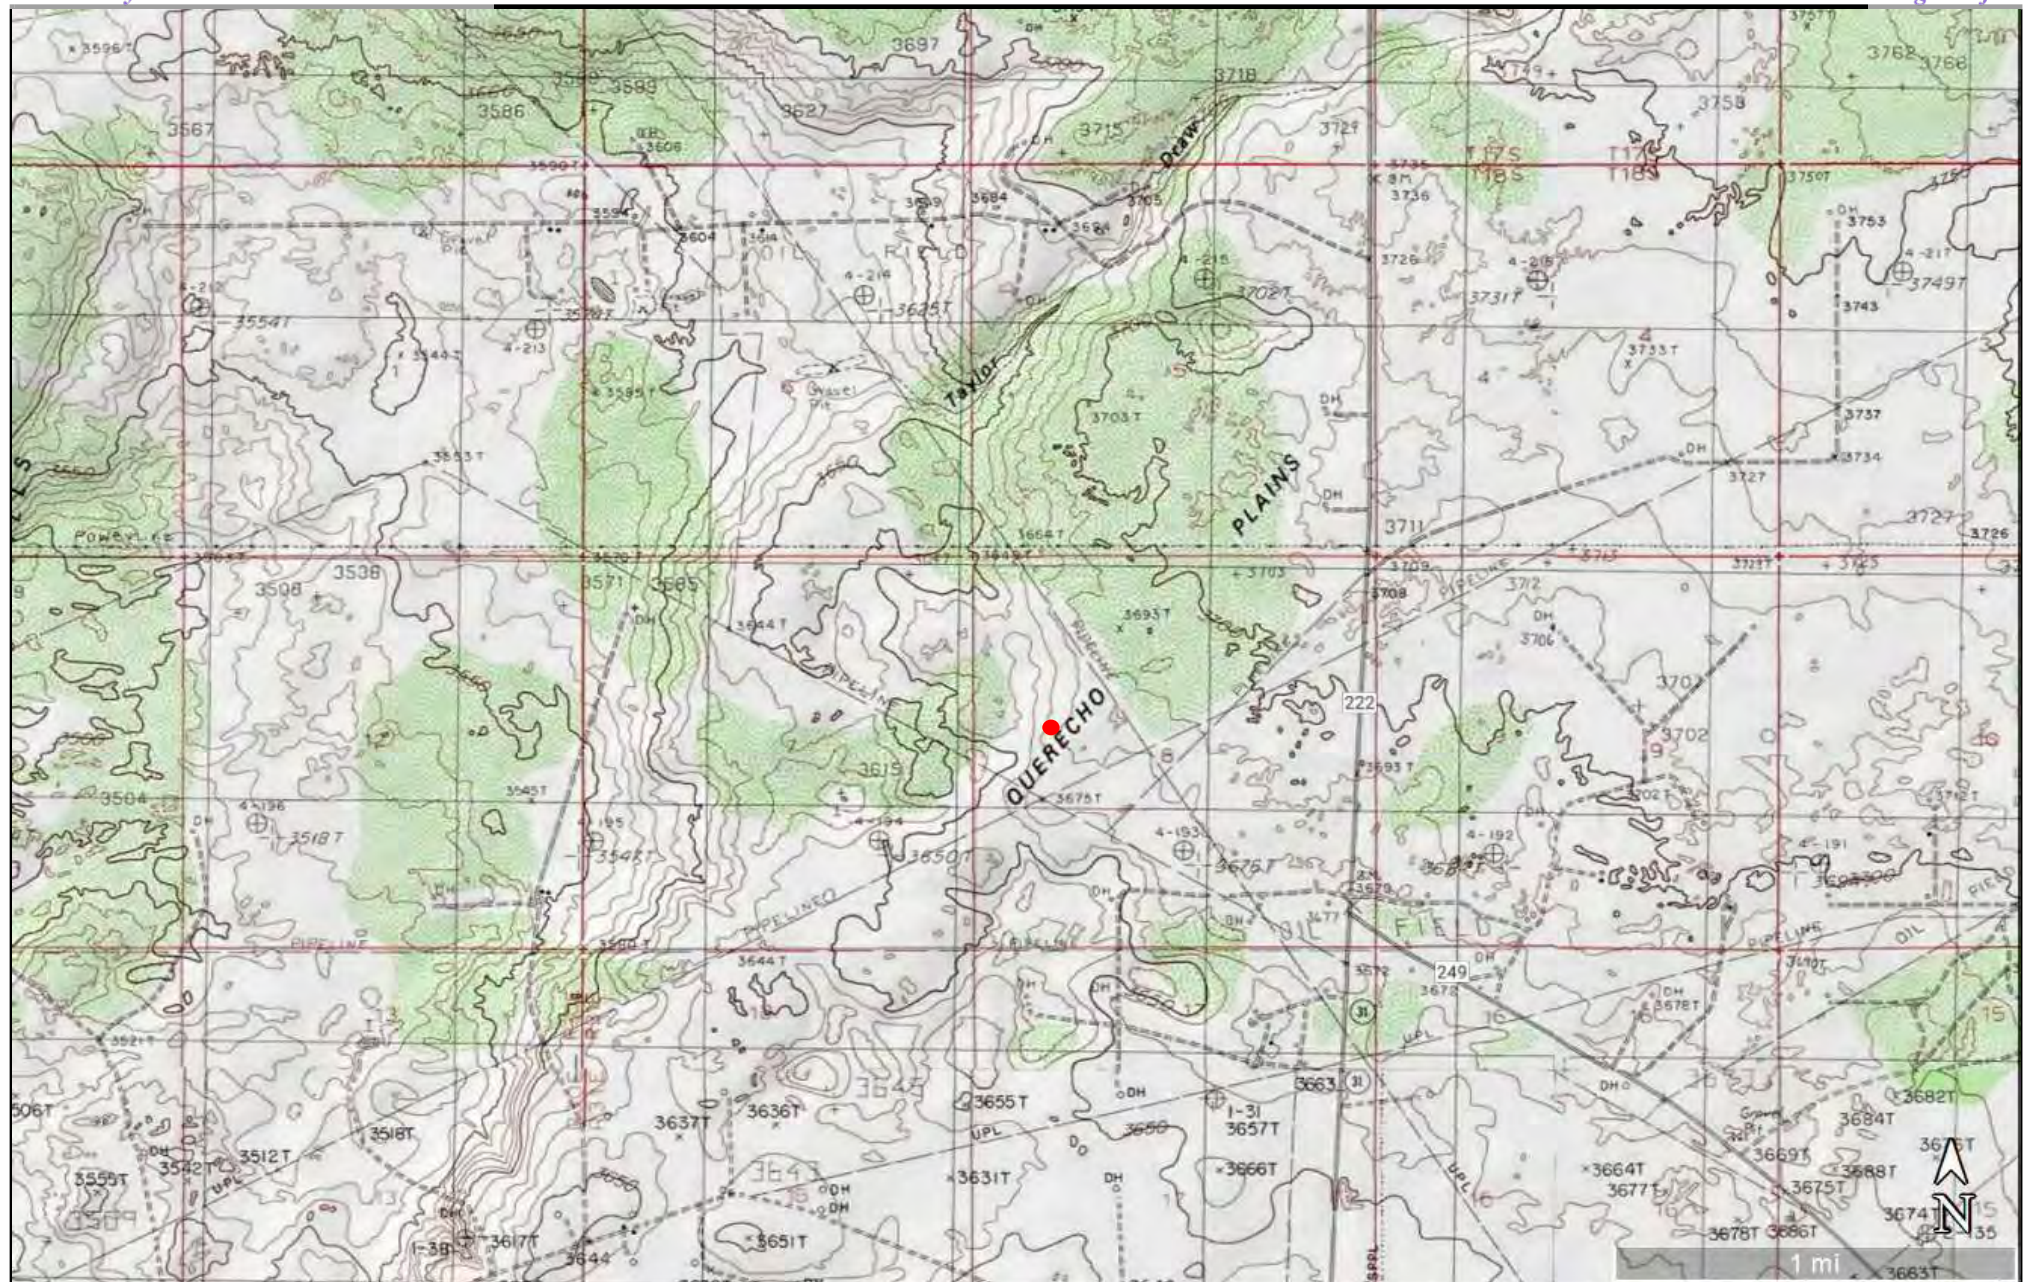
**Figure 1**

Topographic Map

The site is located in Unit Letter E (SW/NW), Section 8, Township 18 South, Range 31 East, approximately 6 miles Southeast of Loco Hills, in Eddy County, New Mexico. The property is Federally owned. Topographic Map, OSE POD Locations Map, and USGS Well Locations Map are included as Figure 1, Figure 2, and Figure 3, respectively.

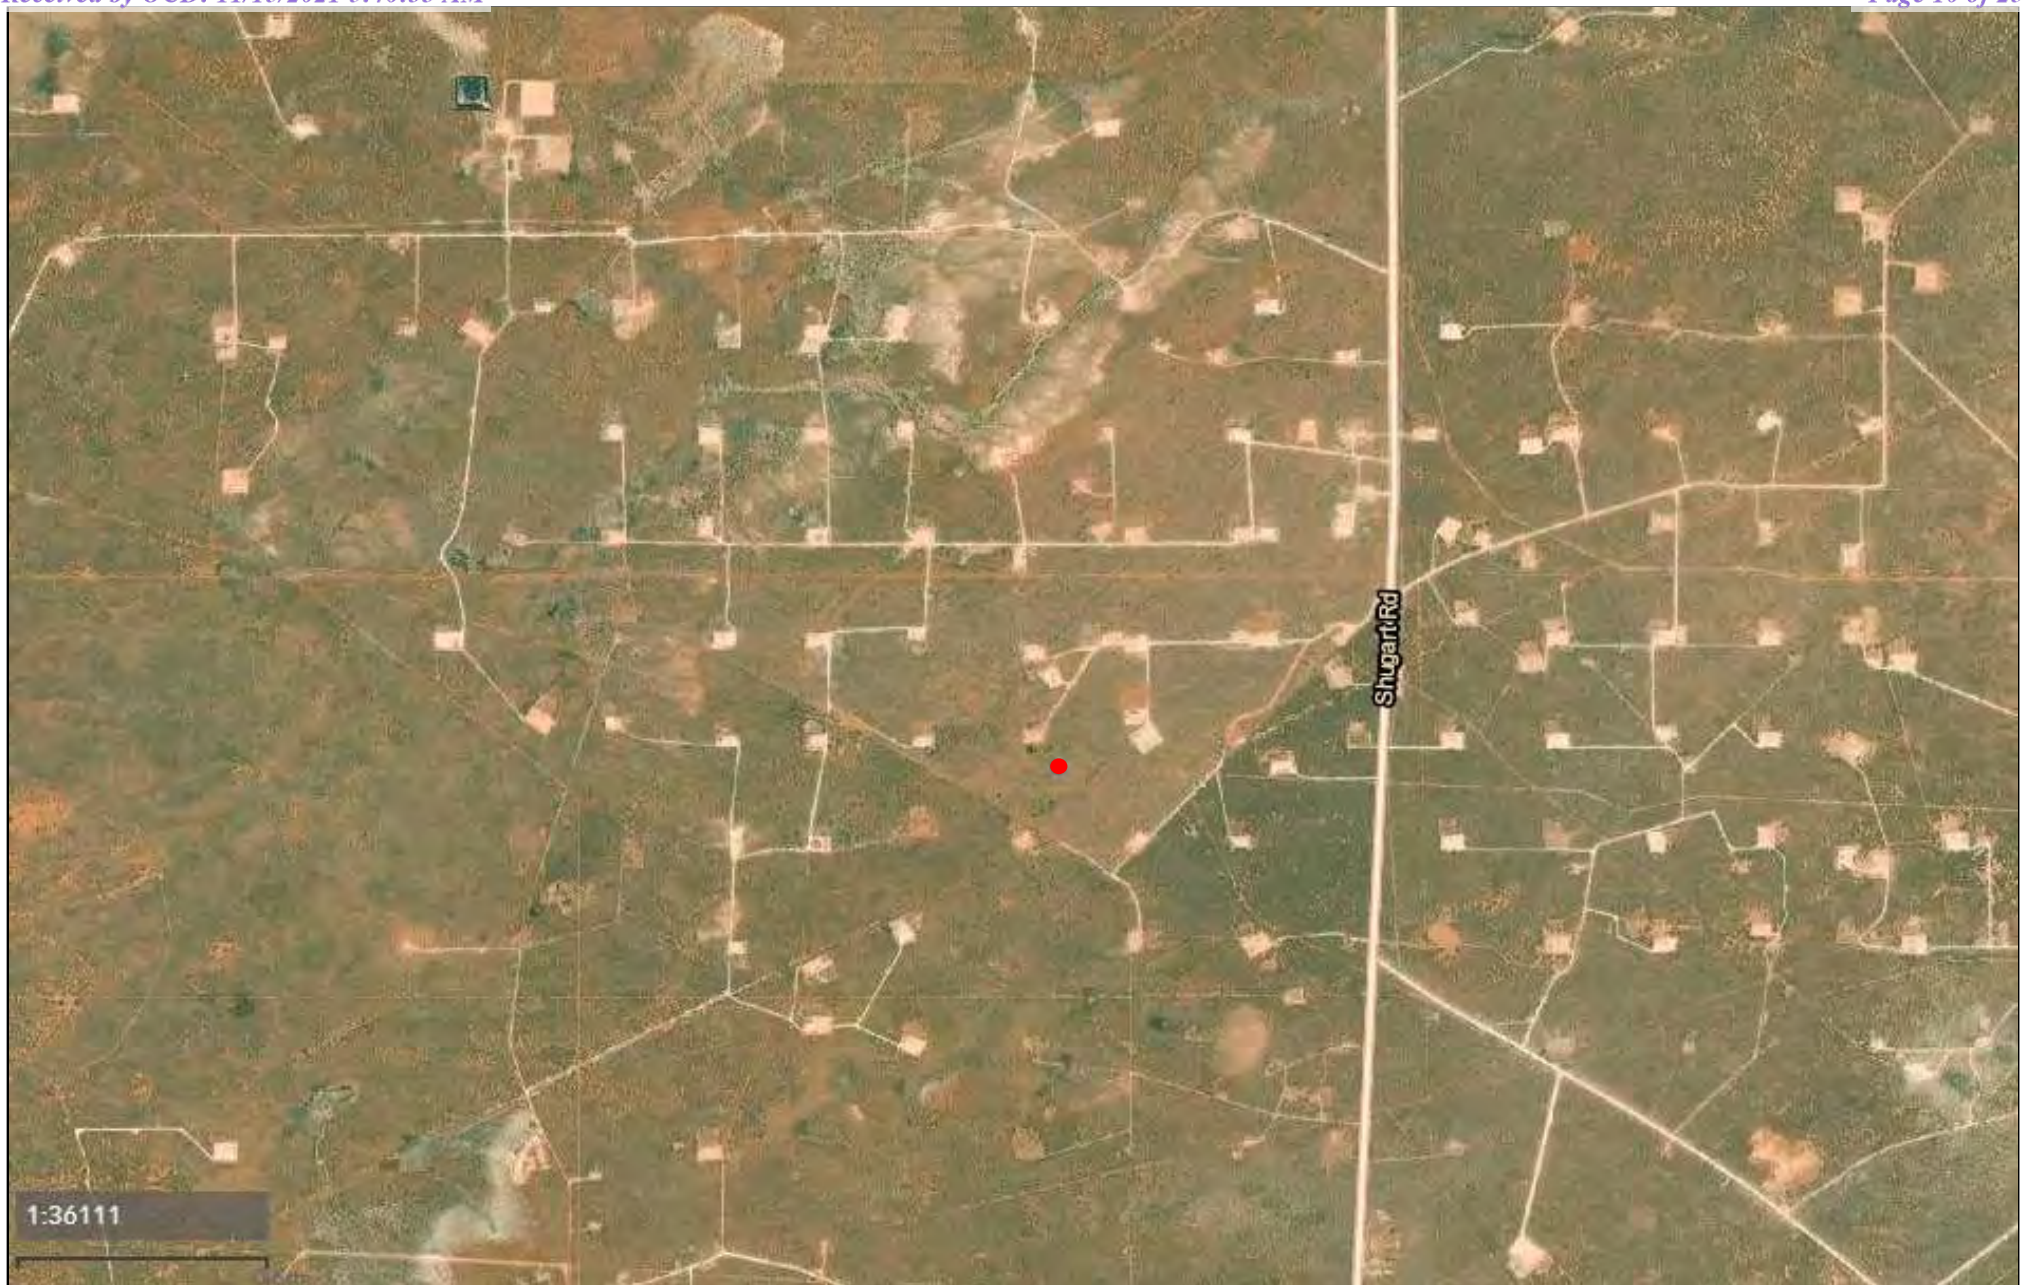
**Figure 2**

A search of the New Mexico Office of the State Engineer (NMOSE) and United States Geological Survey (USGS) groundwater databases was completed in an effort to determine the horizontal distance to known water sources within a half mile radius of the Release Site. Approximate depth to groundwater was determined using maintained and published water well data. Karst mapping indicates the site is not located in a Karst designated area. Depth to groundwater information is provided as Attachment II and the results are depicted on Figures 2 & 3.

No water wells could be located within a half mile of the release area, therefore, depth to water could not be determined. Consequently, the site was delineated and further remediated according to the strictest NMOCD Closure Criteria. Utilizing this information, the NMOCD Closure Criteria for the Site were determined as follows:

OSE POD Locations Map
Durango Midstream
12" Cedar Breaks_7/12/21_001_0
GPS: 32.762764, -103.896954
Eddy County

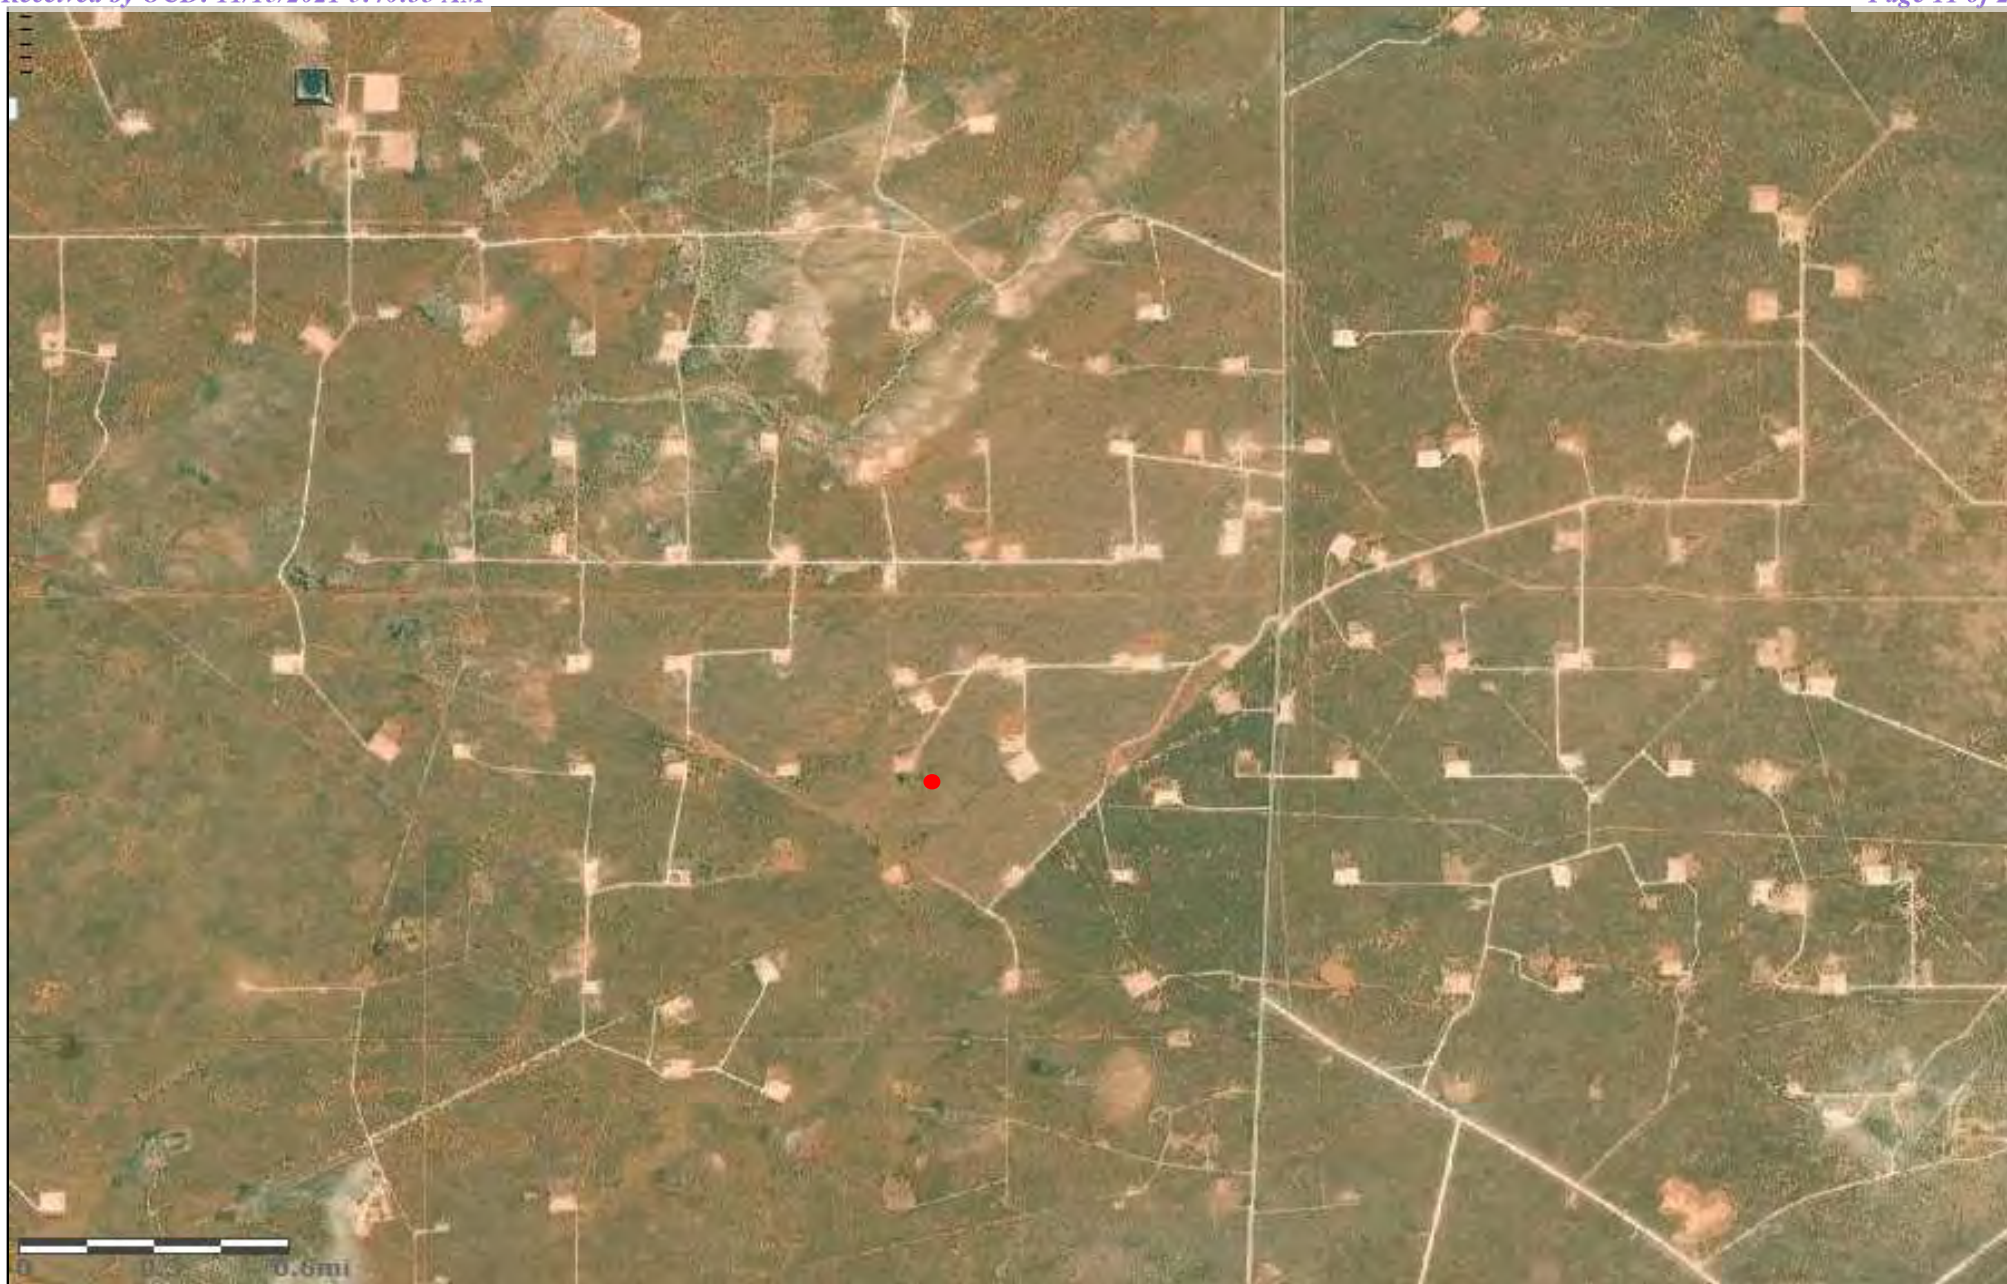
**Figure 3**

USGS Well Locations Map
Durango Midstream
12" Cedar Breaks_7/12/21_001_0
GPS: 32.762764, -103.896954
Eddy County

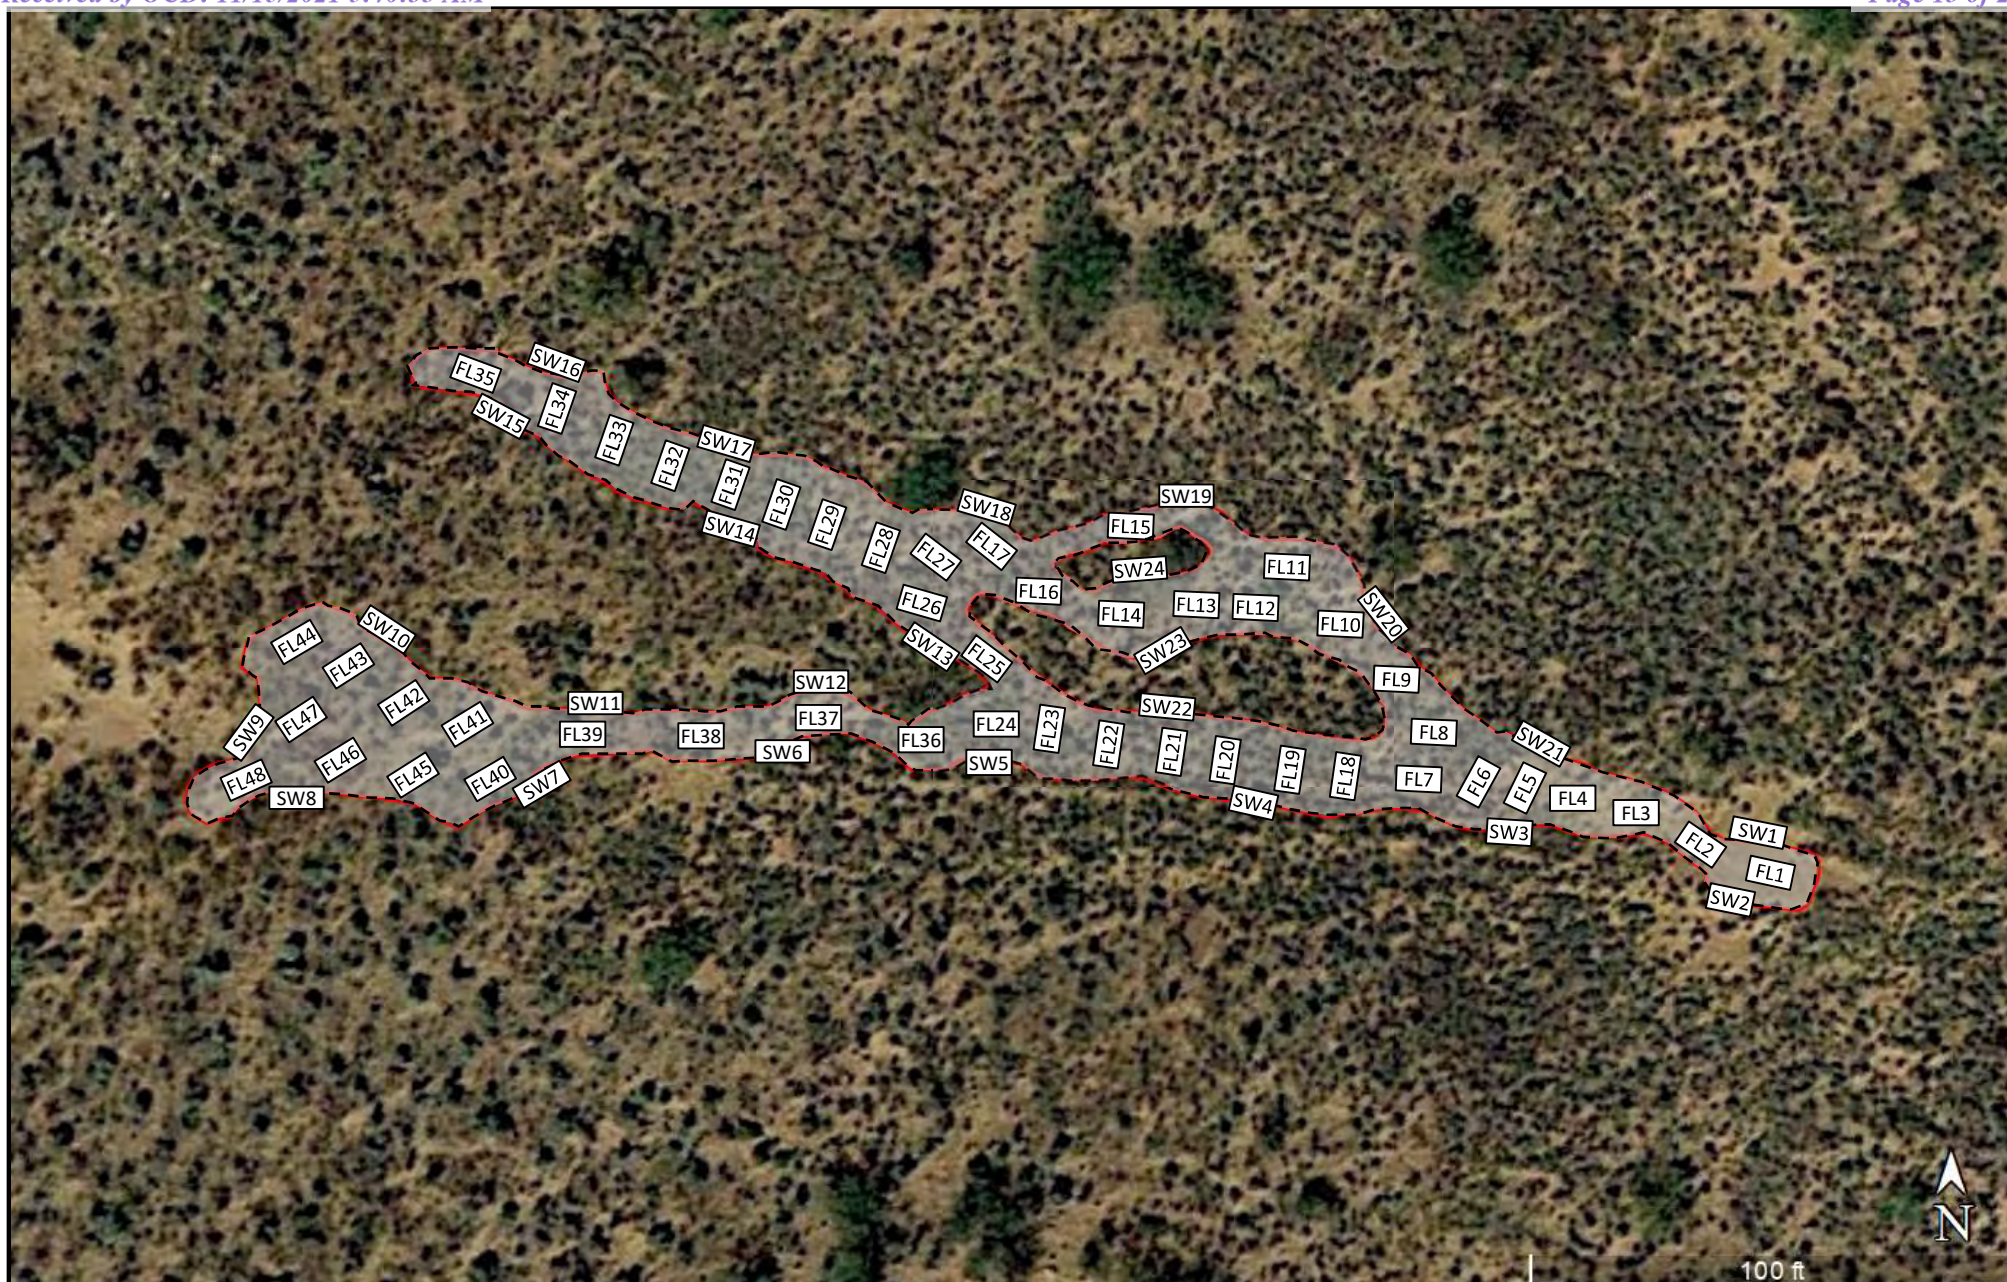
**Figure 5**

From October 13 through 22, 2021, excavation activities commenced on location. The release area was excavated to a depth ranging from approximately two to eight feet bgs. The area characterized by sample location FL1 was excavated an additional one-foot bgs, bringing the total depth to approximately eight feet bgs. The areas characterized by sample locations SP1 through SP10 were excavated to a depth of approximately two feet bgs. The areas characterized by sample locations SW2 and SW4 were excavated laterally approximately one foot bgs. Excavated soil was temporarily stockpiled at a nearby location, atop plastic, then hauled to a state approved facility for disposal.

On October 25, 2021, after excavation activities were complete, seventy-two composite confirmation soil samples were collected from the excavation floor and sidewalls. Soil samples FL1 through FL48 and SW1 through SW24, were submitted to the laboratory for analysis of BTEX, TPH, and chloride. Laboratory analytical results indicated contaminant concentrations were below the NMOCD Closure Criteria in each of the submitted samples.

The excavated area measured approximately three hundred forty feet in length, ten to thirty-five feet in width, and two to eight feet in depth. During remediation activities approximately 750 cubic yards of impacted soil were excavated and hauled to an NMOCD approved disposal facility.

Excavation Sample Map

A Delineation Sample Map and Excavation Sample Map are provided as Figure 4 and Figure 5, respectively. Field data is provided as Attachment III. A Summary of Soil Sample Laboratory Analytical Results is provided as Table 1 and Laboratory Analytical Reports are provided as Attachment IV.
