**SITE CHARACTERIZATION UPDATE AND PROPOSED
REMEDIATION PLAN**

**CROSSROADS AFX FEDERAL #1
UNIT P, SECTION 22, TOWNSHIP 7S, RANGE 35E
ROOSEVELT COUNTY, NEW MEXICO
33.68760, -103.34329
RANGER REFERENCE NO. 5375**

**SITE CHARACTERIZATION UPDATE AND PROPOSED REMEDIATION PLAN
CROSSROADS AFX FEDERAL #1
UNIT P, SECTION 22, TOWNSHIP 7S, RANGE 35E
ROOSEVELT COUNTY, NEW MEXICO
33.68760, -103.34329
RANGER REFERENCE NO. 5375**

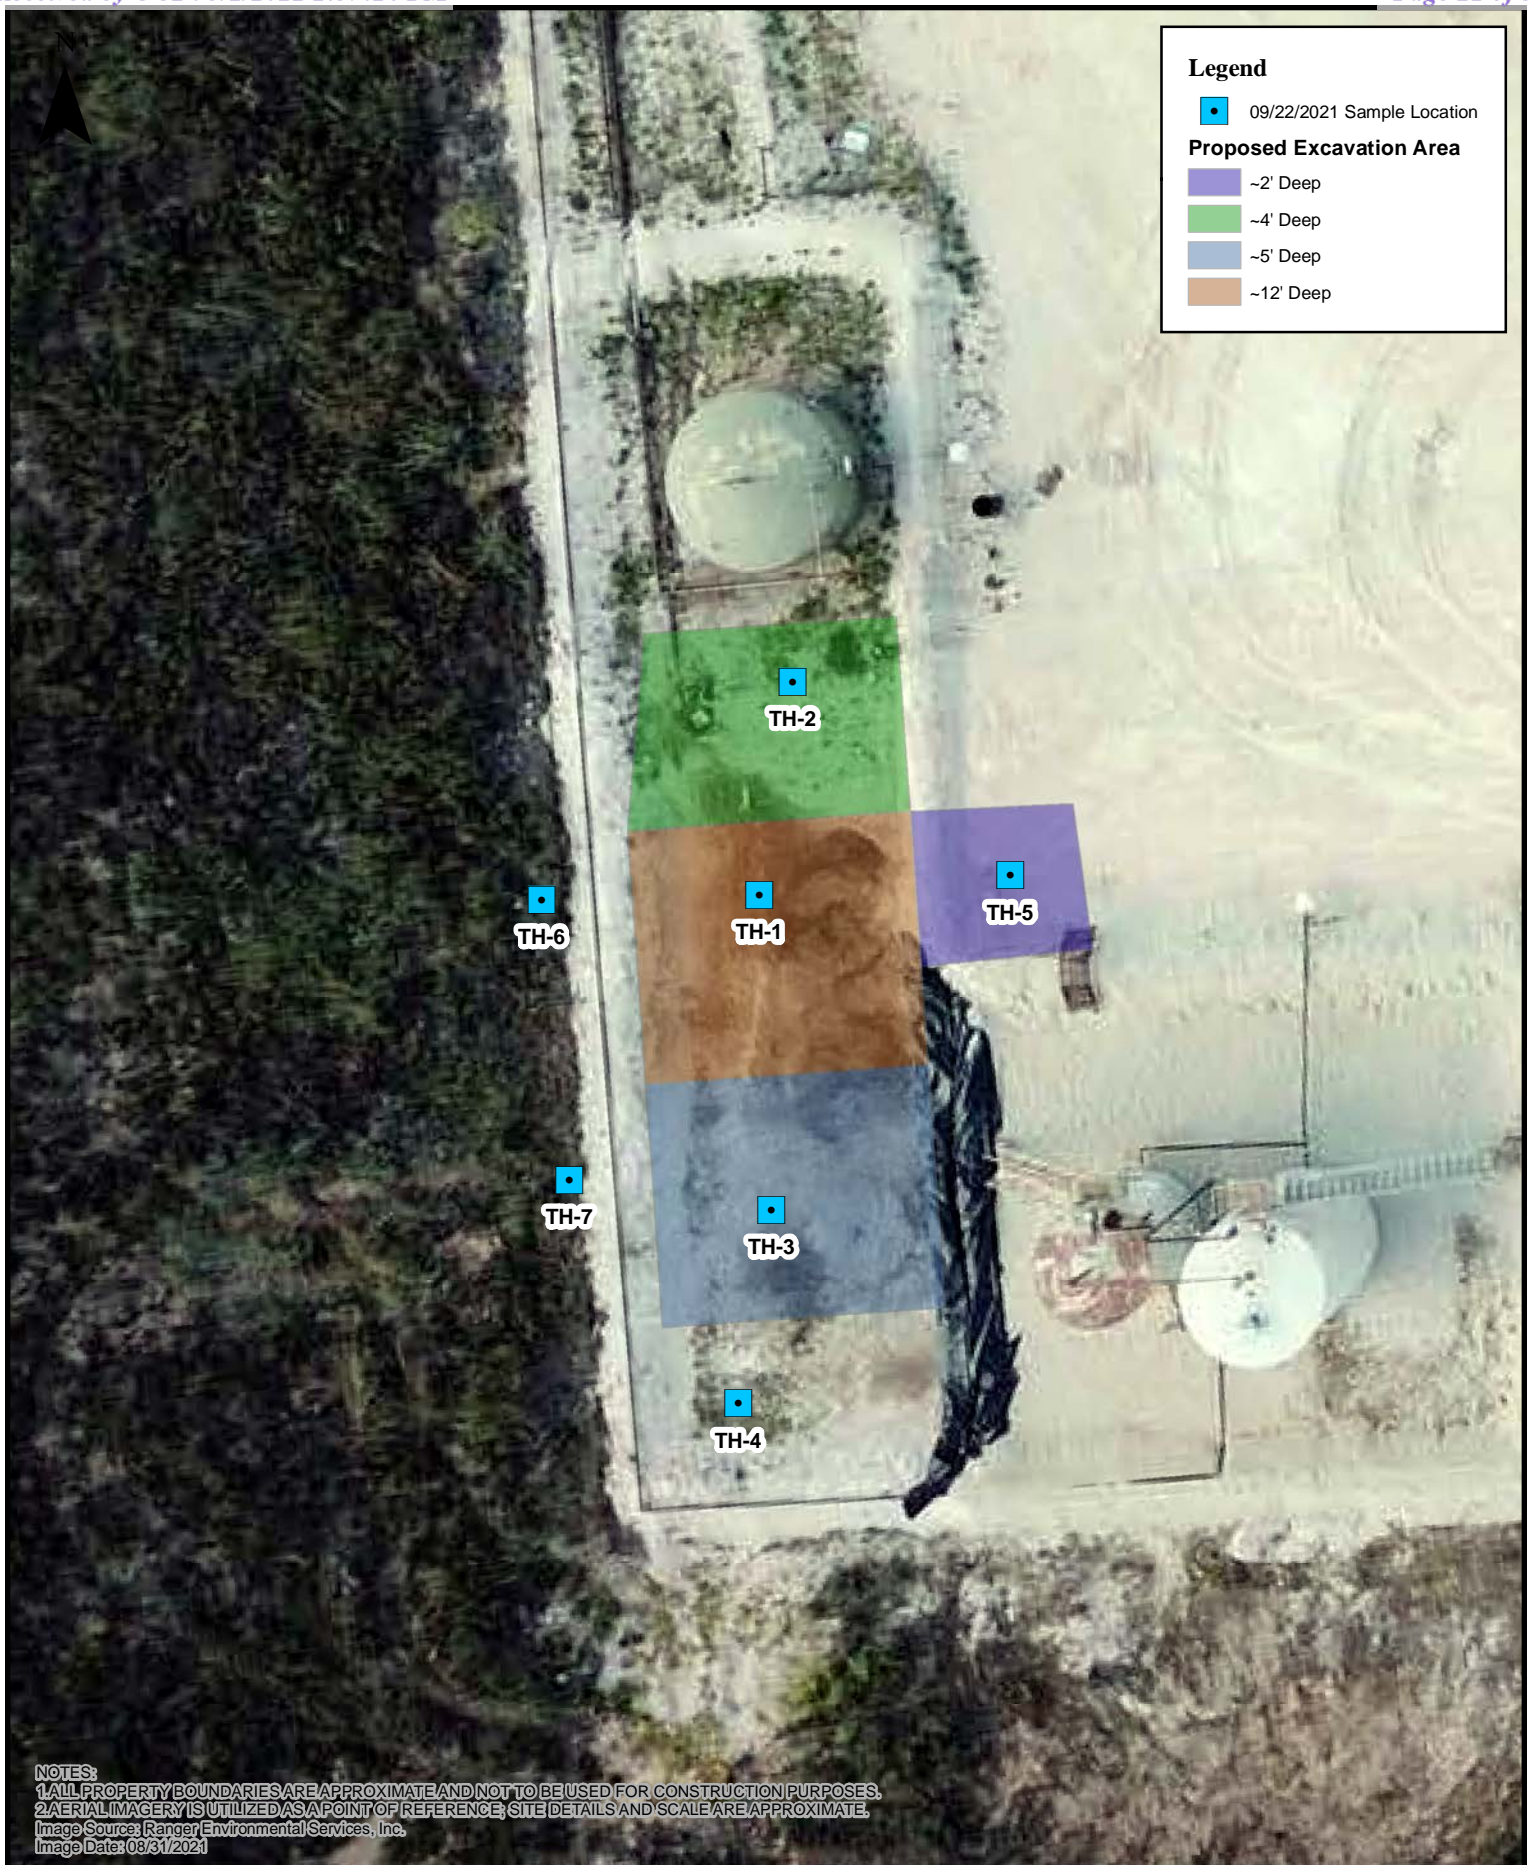
- Proposed Base Area Grab Sample Location
 - Proposed Composite Sample Area (4'-12' bgs)
- Proposed Excavation Area**
- ~2' Deep
 - ~4' Deep
 - ~5' Deep
 - ~12' Deep

To confirm that the excavation base has been completed to appropriate boundaries, discrete grab soil samples are proposed to be collected from the base of each section of the excavated area. A *Proposed Sample Location Map* is attached which depicts the proposed grab cleanup confirmation soil sample locations.

To confirm attainment of the site cleanup criteria in the excavation side walls, the collection of five-part composite cleanup confirmation soil samples are proposed. As illustrated in the attached *Proposed Confirmation Sample Location Map*, the excavation activities will be completed in four sections of varying depths (2', 4', 5' and 12' bgs). To evaluate the side walls of the proposed 2', 4' and 5'-deep excavation areas, the cleanup confirmation soil samples will be collected from the side walls in accordance with NMAC 19.15.29.12(D), as five-part composite samples with each sample representing no more than 200 square feet. The samples will be collected from various locations and depths along the excavation side walls.

To confirm attainment of the site cleanup criteria in the side walls of the proposed 12'-deep excavation area, side wall samples are proposed to be collected using two methods. The first method will confirm that the surface to four-foot-deep interval of the side walls has been brought into attainment of the Restoration, Reclamation and Re-Vegetation criteria. Five-part composite soil samples will be collected from the surface to four-foot bgs depth interval in accordance with NMAC 19.15.29.12(D) with each sample representing no more than 200 square feet. The second proposed side wall cleanup confirmation sampling method will confirm that the 4'-12' bgs portion of the excavation side walls are within the proposed Table 1 19.15.29.12 NMAC (groundwater 51'-100' feet) criteria. The proposed cleanup confirmation sampling methodology for this portion of the side walls will include the collection of one five-part composite sample from the 4'-12' bgs depth interval of each excavation side wall.

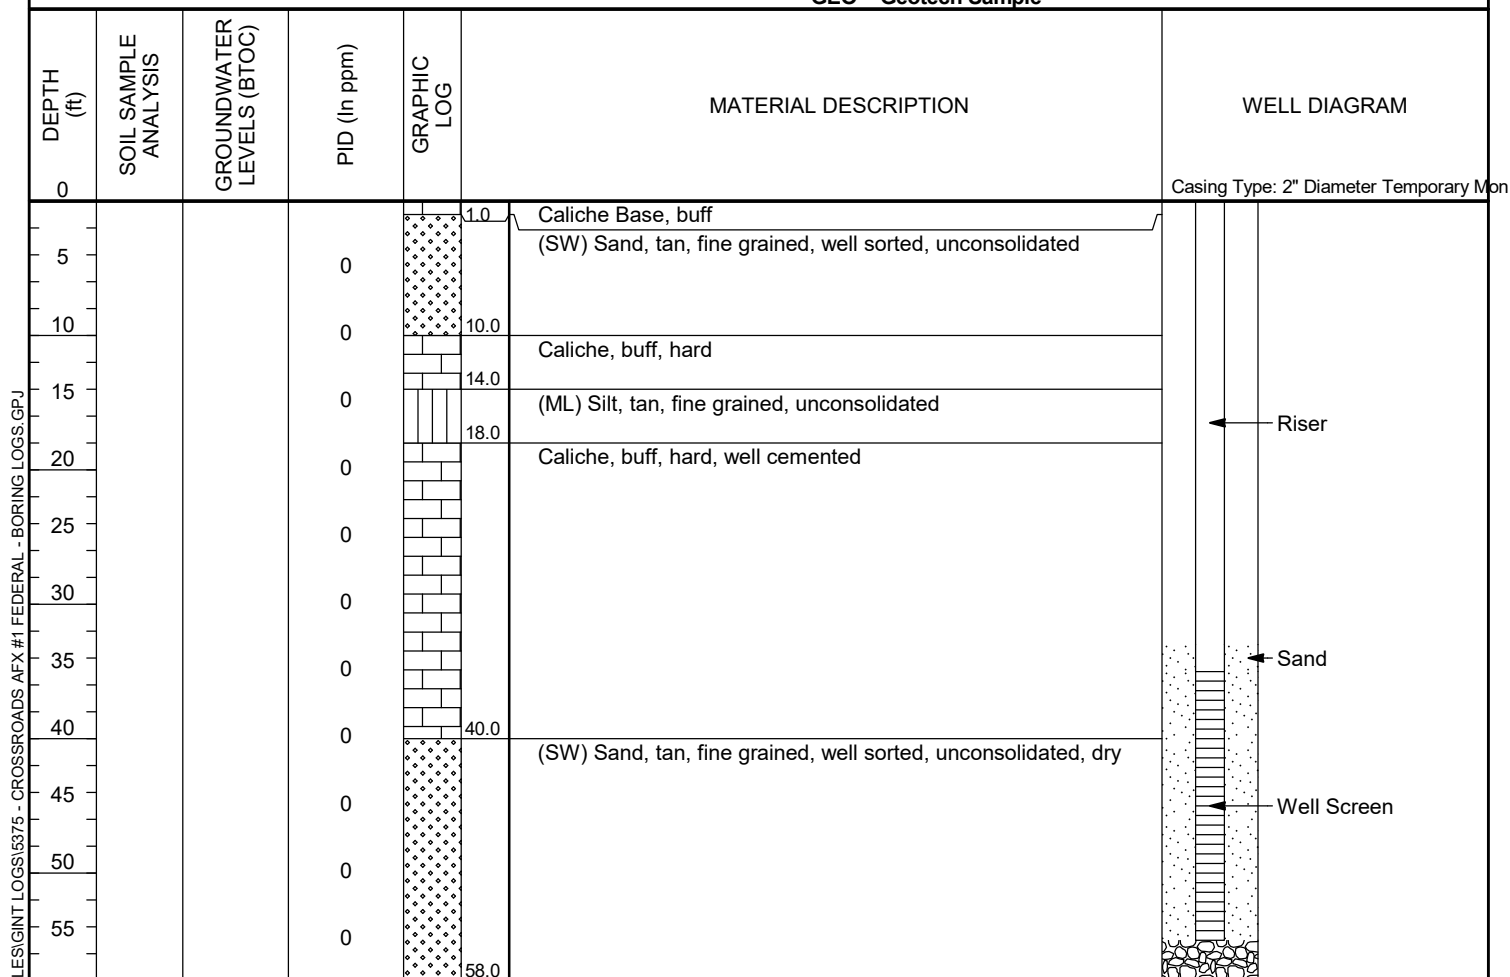
*Note: 72 hours after installation, on February 25, 2022, Ranger personnel utilized a Heron Instruments, Inc. electronic water level meter to evaluate the temporary 2" diameter monitor well for the presence or absence of groundwater. Groundwater was not encountered during the February 25, 2022, assessment activities.

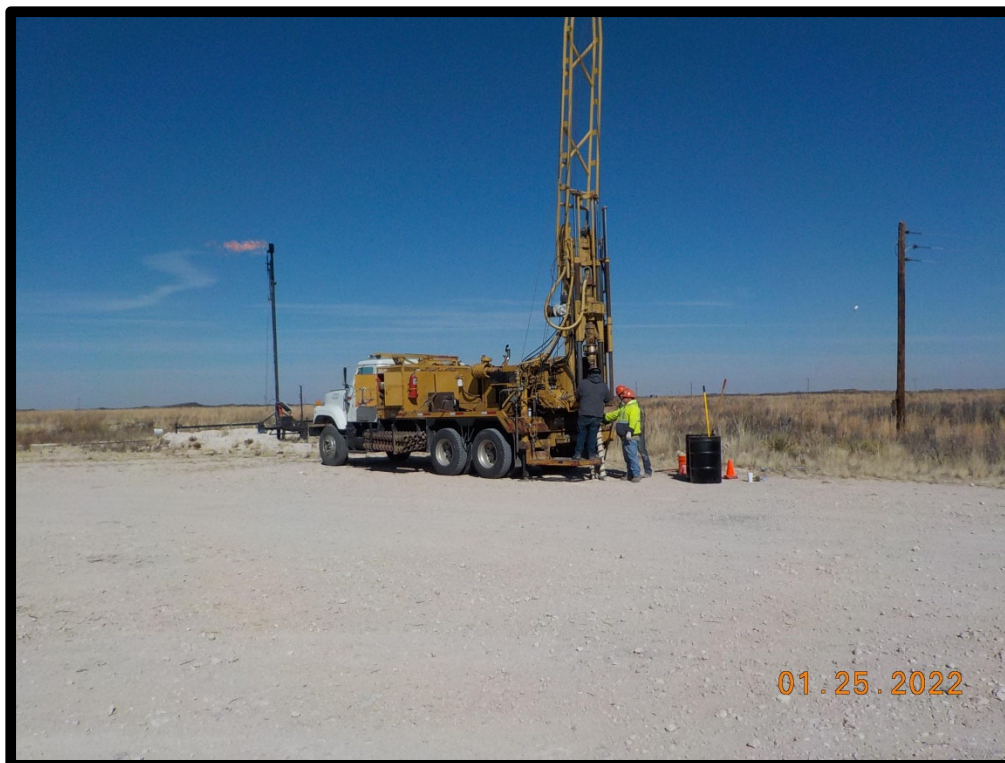
PHOTOGRAPH NO. 1 – A general view of the hollow stem auger soil boring activities on January 25, 2022. The view is towards the northeast.

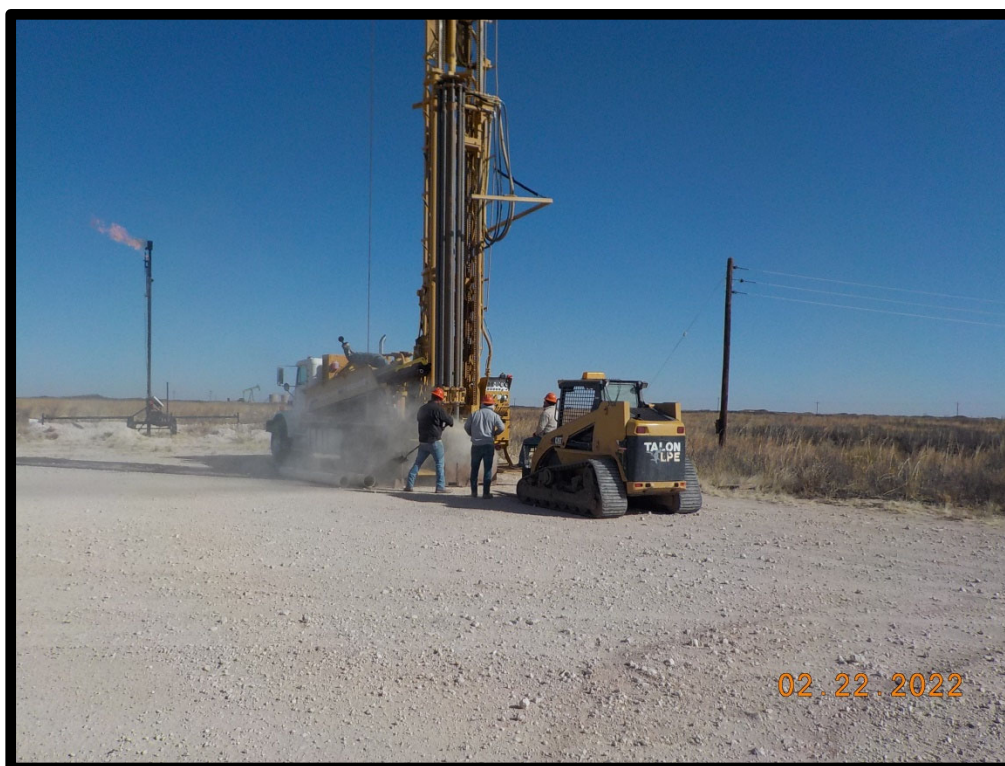
PHOTOGRAPH NO. 2 – A view of the air rotary soil boring activities on February 22, 2022. The view is towards the northeast.

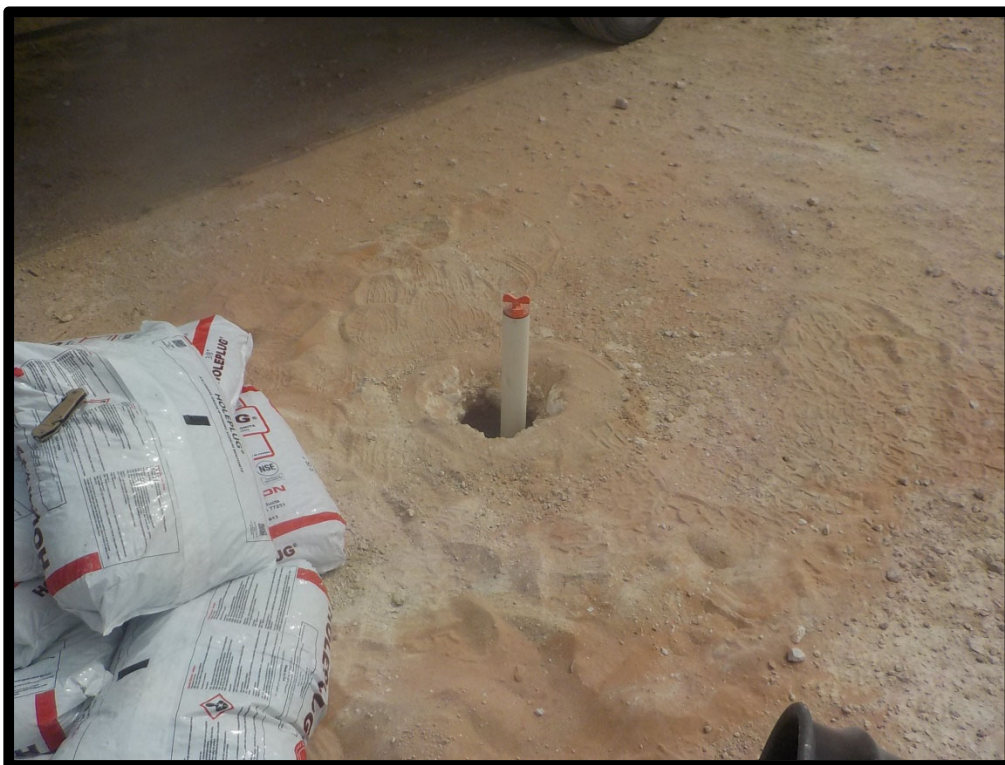
PHOTOGRAPH NO. 3 – A view of the soil boring fitted with PVC casing prior to gauging and plugging and abandonment.
