Release Notification

| Site Name | Warren G Com 26 2 | Site Type | Well |

RE: The release appears to be a historic stain from possible fiberglass tank run over. LOGOS plans to remove the pit, identify any leaks and clean up the stained area at the Warren G Com 26 2 well site. Located in Section 26, Township 25 North, Range 6 West, Rio Arriba, New Mexico.

**LOGOS Operating, LLC
Site Pictures
Warren G Com 26 2
Figure: 1**

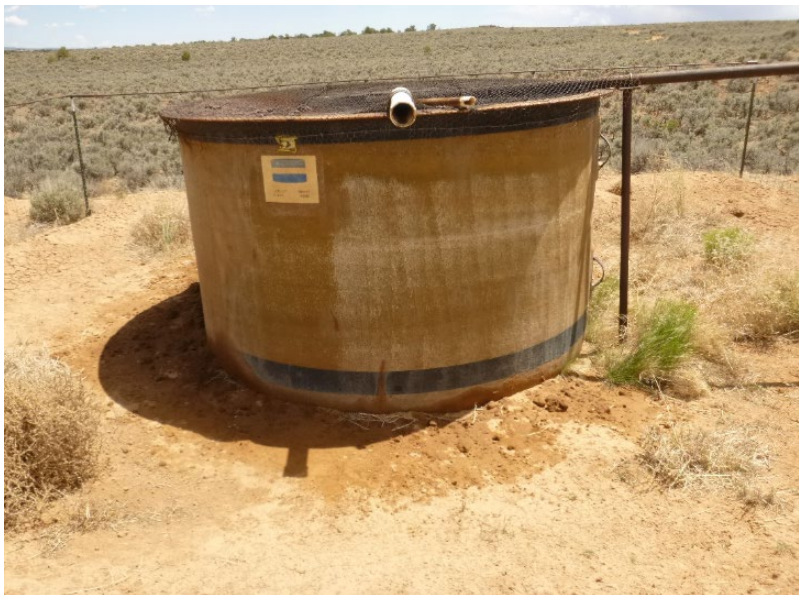
The release appears to be a historic stain from possible fiberglass run over. LOGOS plans to remove the pit, identify any leaks and clean up the stained area. OCD will be notified 48 hours prior to sampling.

Impacted Area

On June 23, 2020, LOGOS removed the berm and the above ground tank. The impacted area was scraped and removed 4" to 6" of the stained soil until no staining was visual.

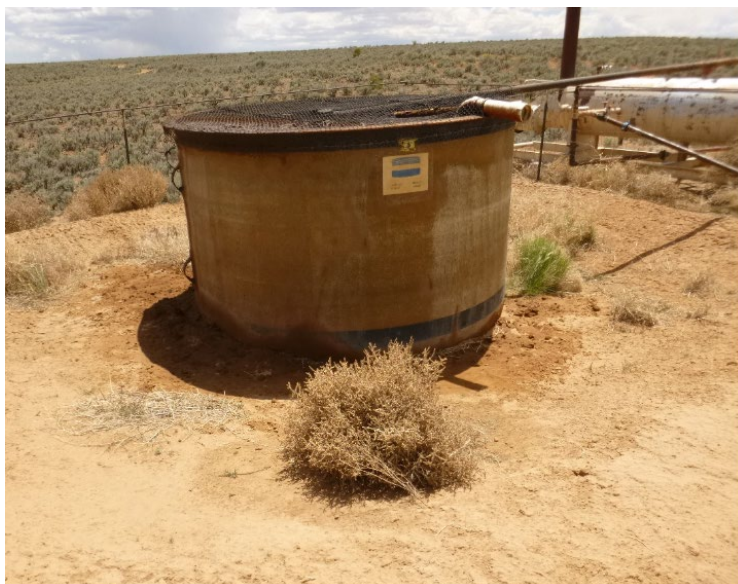
Impacted Area

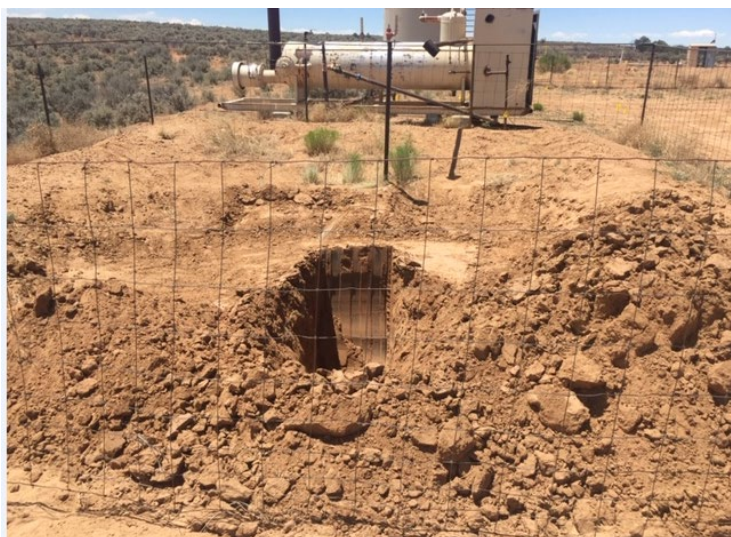
Remediating

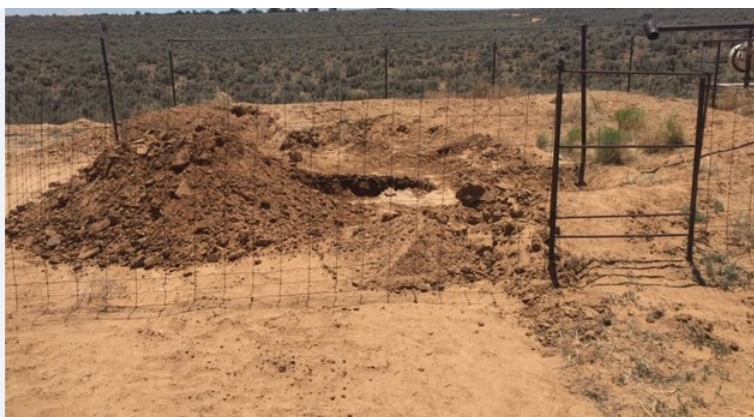
Remediating

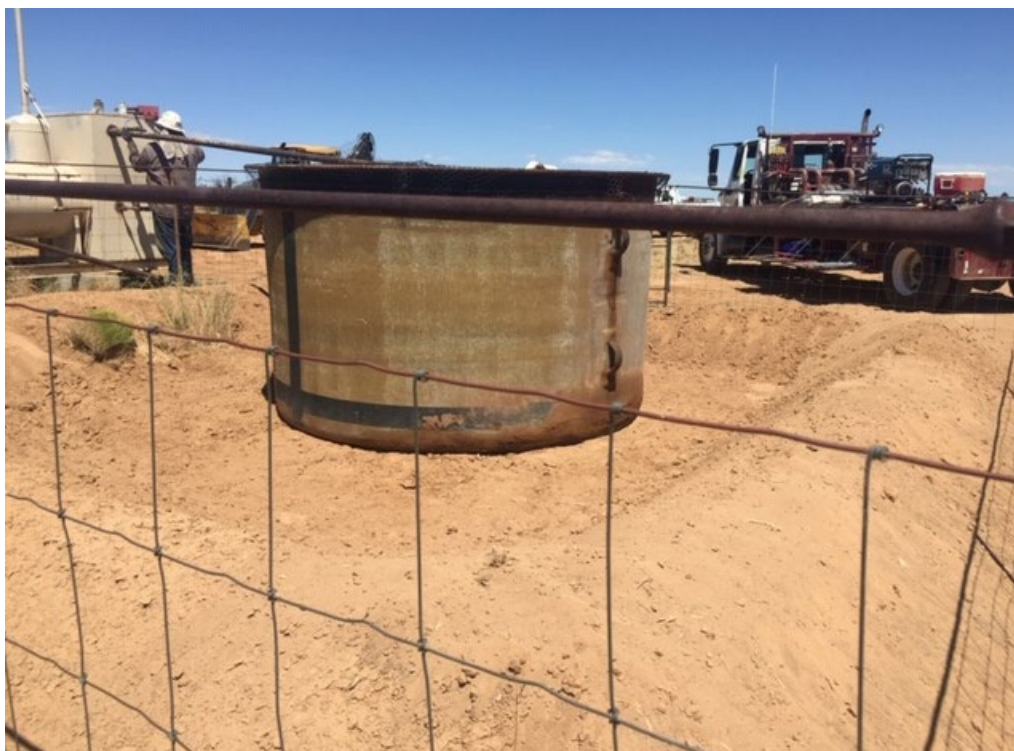
After

On July 7, 2020, after receiving the final sample results, approximately 3yds of stained soil was hauled to the Envirotech Landfarm and the impacted area was replaced with clean location dirt and some of the berm material. Area was filled in, leveled out and the above ground tank was re-set

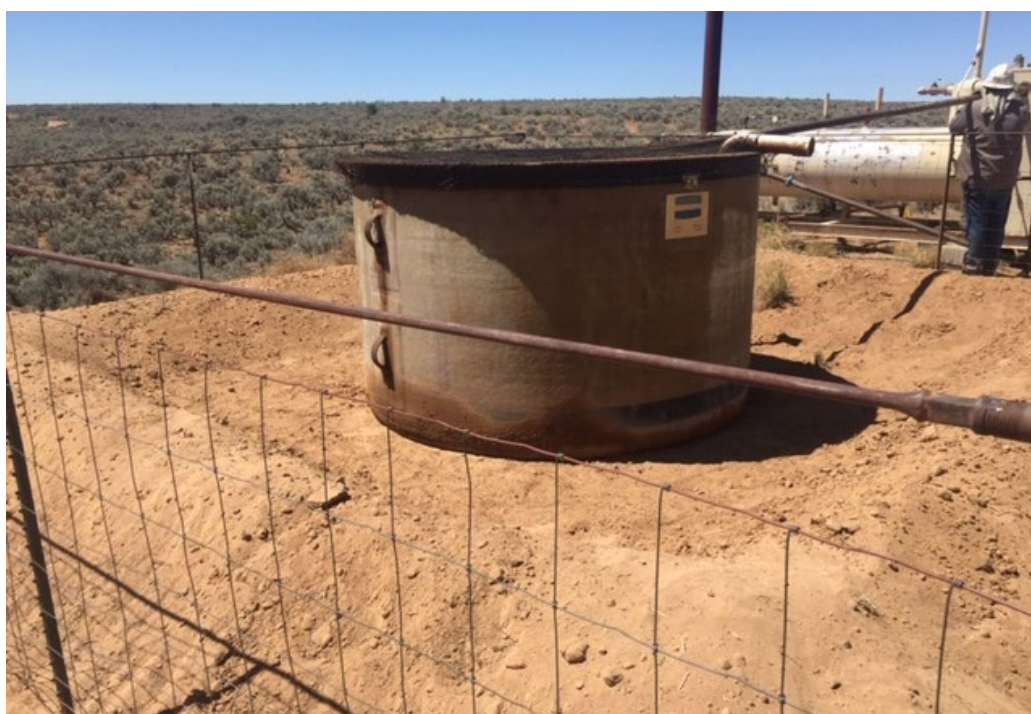
After
