Closure Report

2 RP-3832 & 2RP-4039

Site Name:	Ross Ranch 6 Federal #1H	API: 30-015-36883
Company:	Chevron	
Legal Description:	U/L C, Section 25, T22S, R32E	
County:	Lea County, NM	
GPS Coordinates:	N 32.36740 W -103.63062

Chevron, Ross Ranch 6 Federal #1H

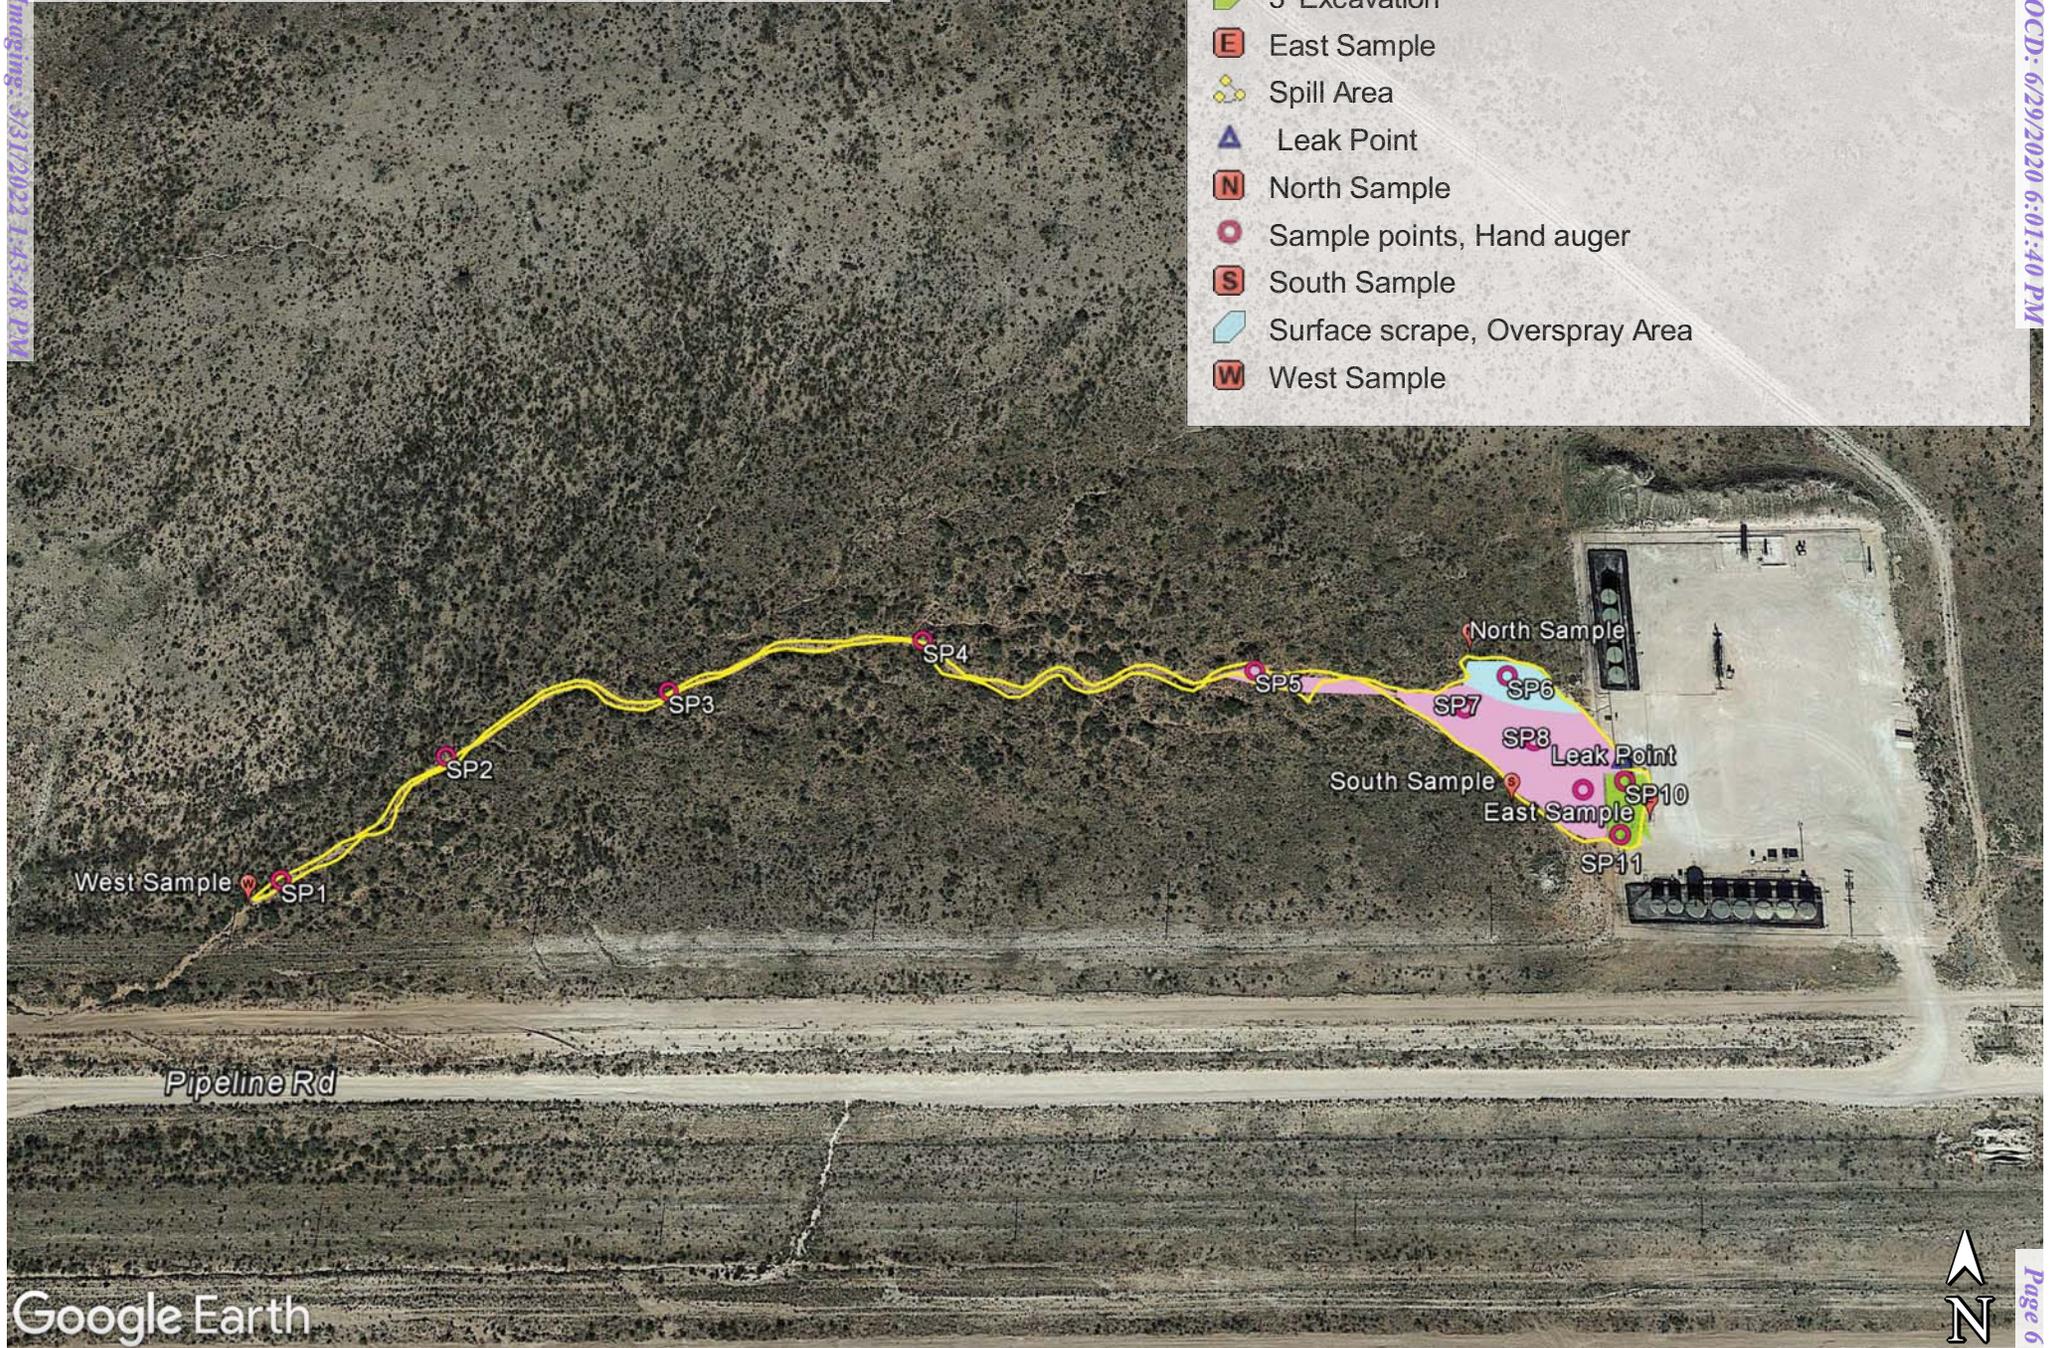
Leak Date: 12/05/2016 2RP-4039, API # 30-015-36883

- 1' Excavation
- 3' Excavation
- East Sample
- Spill Area
- Leak Point
- North Sample
- Sample points, Hand auger
- South Sample
- Surface scrape, Overspray Area
- West Sample

Remediation Parameters:	The first release occurred on 7/30/16 (2RP-3832) and the second release occurred on 12/5/16 (2RP-4039). The spill path was the same for both releases. This report closes both leaks. The leak area was surface scraped near SP6. Excavated leak areas SP5, SP7, SP8, & SP9 to a depth of 1 foot. Areas SP10 & SP11 were excavated to a depth of 3 feet. Zero remediation was required for SP1, SP2, & SP3. The entire leak area was back-filled with clean soil.	
Remediation Activities:	6/08/20 through 6/19/20	
Plan Sent to OCD:	11/6/2017	E-mail from Josie DeLeon to BLM, OCD, & Cliff Brunson
OCD Approval of Plan:	2/22/2018	E-mail from Mike Bratcher to Cliff Brunson
Plan Sent to BLM:	11/6/2017	E-mail from Josie DeLeon to BLM, OCD, & Cliff Brunson
BLM Approval of Plan:	3/29/2018	E-mail from Shelly Tucker to Cliff Brunson
