RE: Closure Request

UL – J, Section 33, Township 18S, Range 32E, County – Lea

Incident # - NGRLL1012338608

**SOIL ASSESSMENT AND DELINEATION  
ACTIVITIES REPORT  
KEEL FEDERAL TANK BATTERY  
RP #2504**

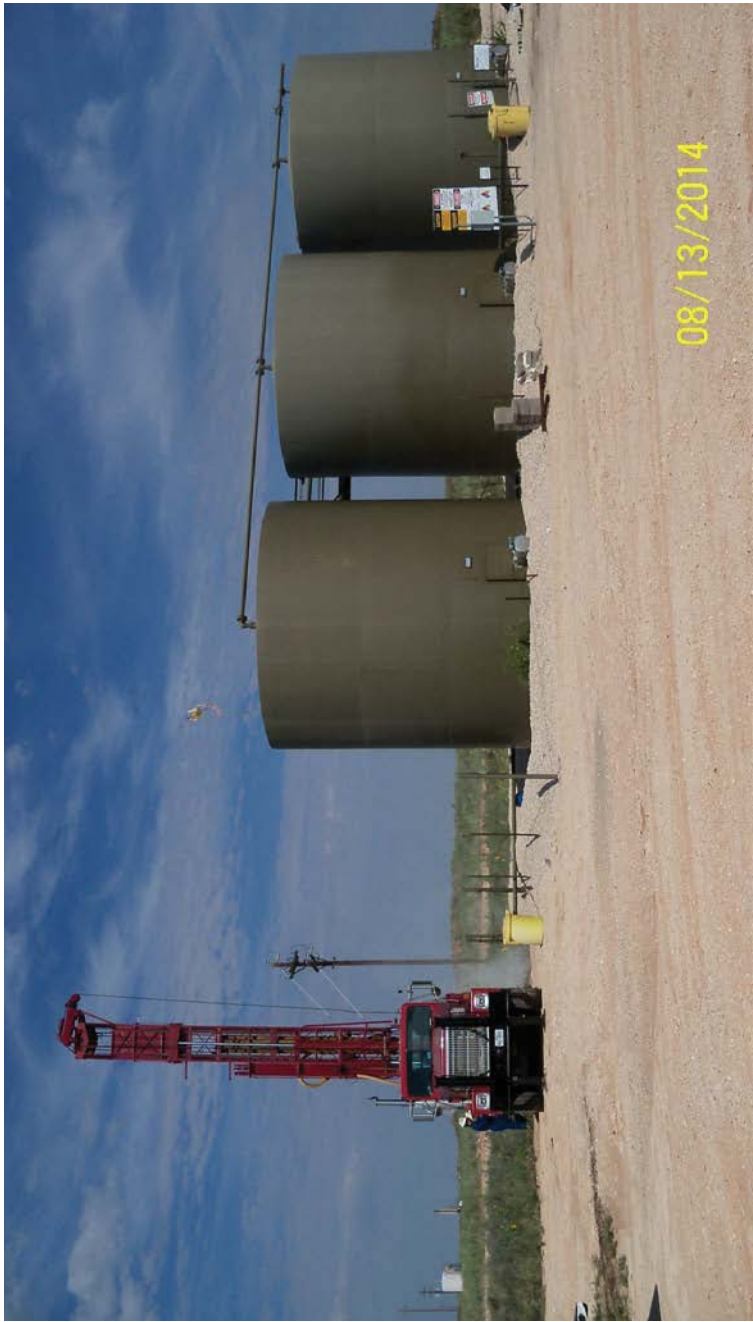
PHOTO 1: View of soil boring (SB-1) installation activities facing north west

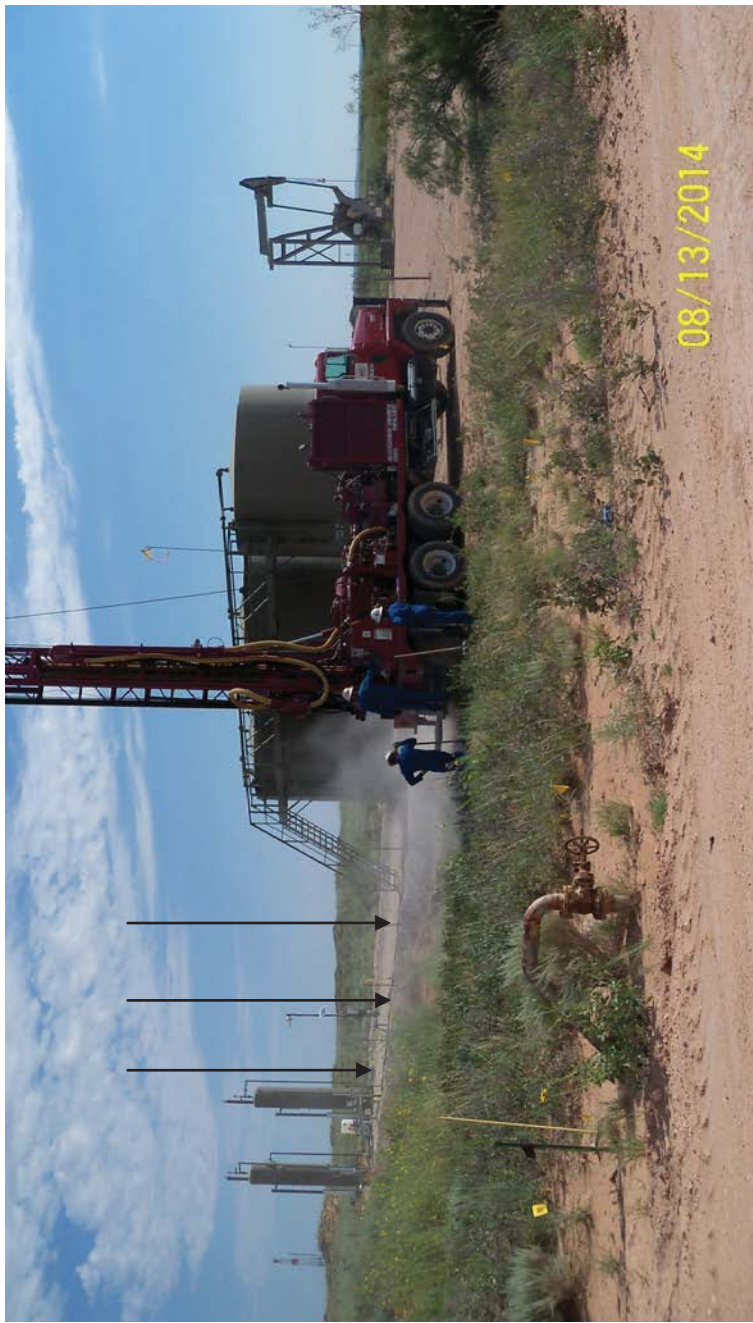
PHOTO 2: View of soil boring (SB-1) installation activities and hand auger (HA-1, HA-2, and HA-3) locations facing north east
