Closure Report

Site Name:	Lovington Paddock Unit
Company:	Chevron
Legal Description:	U/L P, Section 1, T17S, R36E
County:	Lea County, NM
GPS Coordinates:	N 32.85846° W-103.30103°

Date of Release:	12/25/2016
Type of Release:	Produced water
Source of Release:	Steel line leak
Volume of Release:	16.36 bbls
Volume Recovered:	13 bbls

Chevron, Loving Paddock Unit

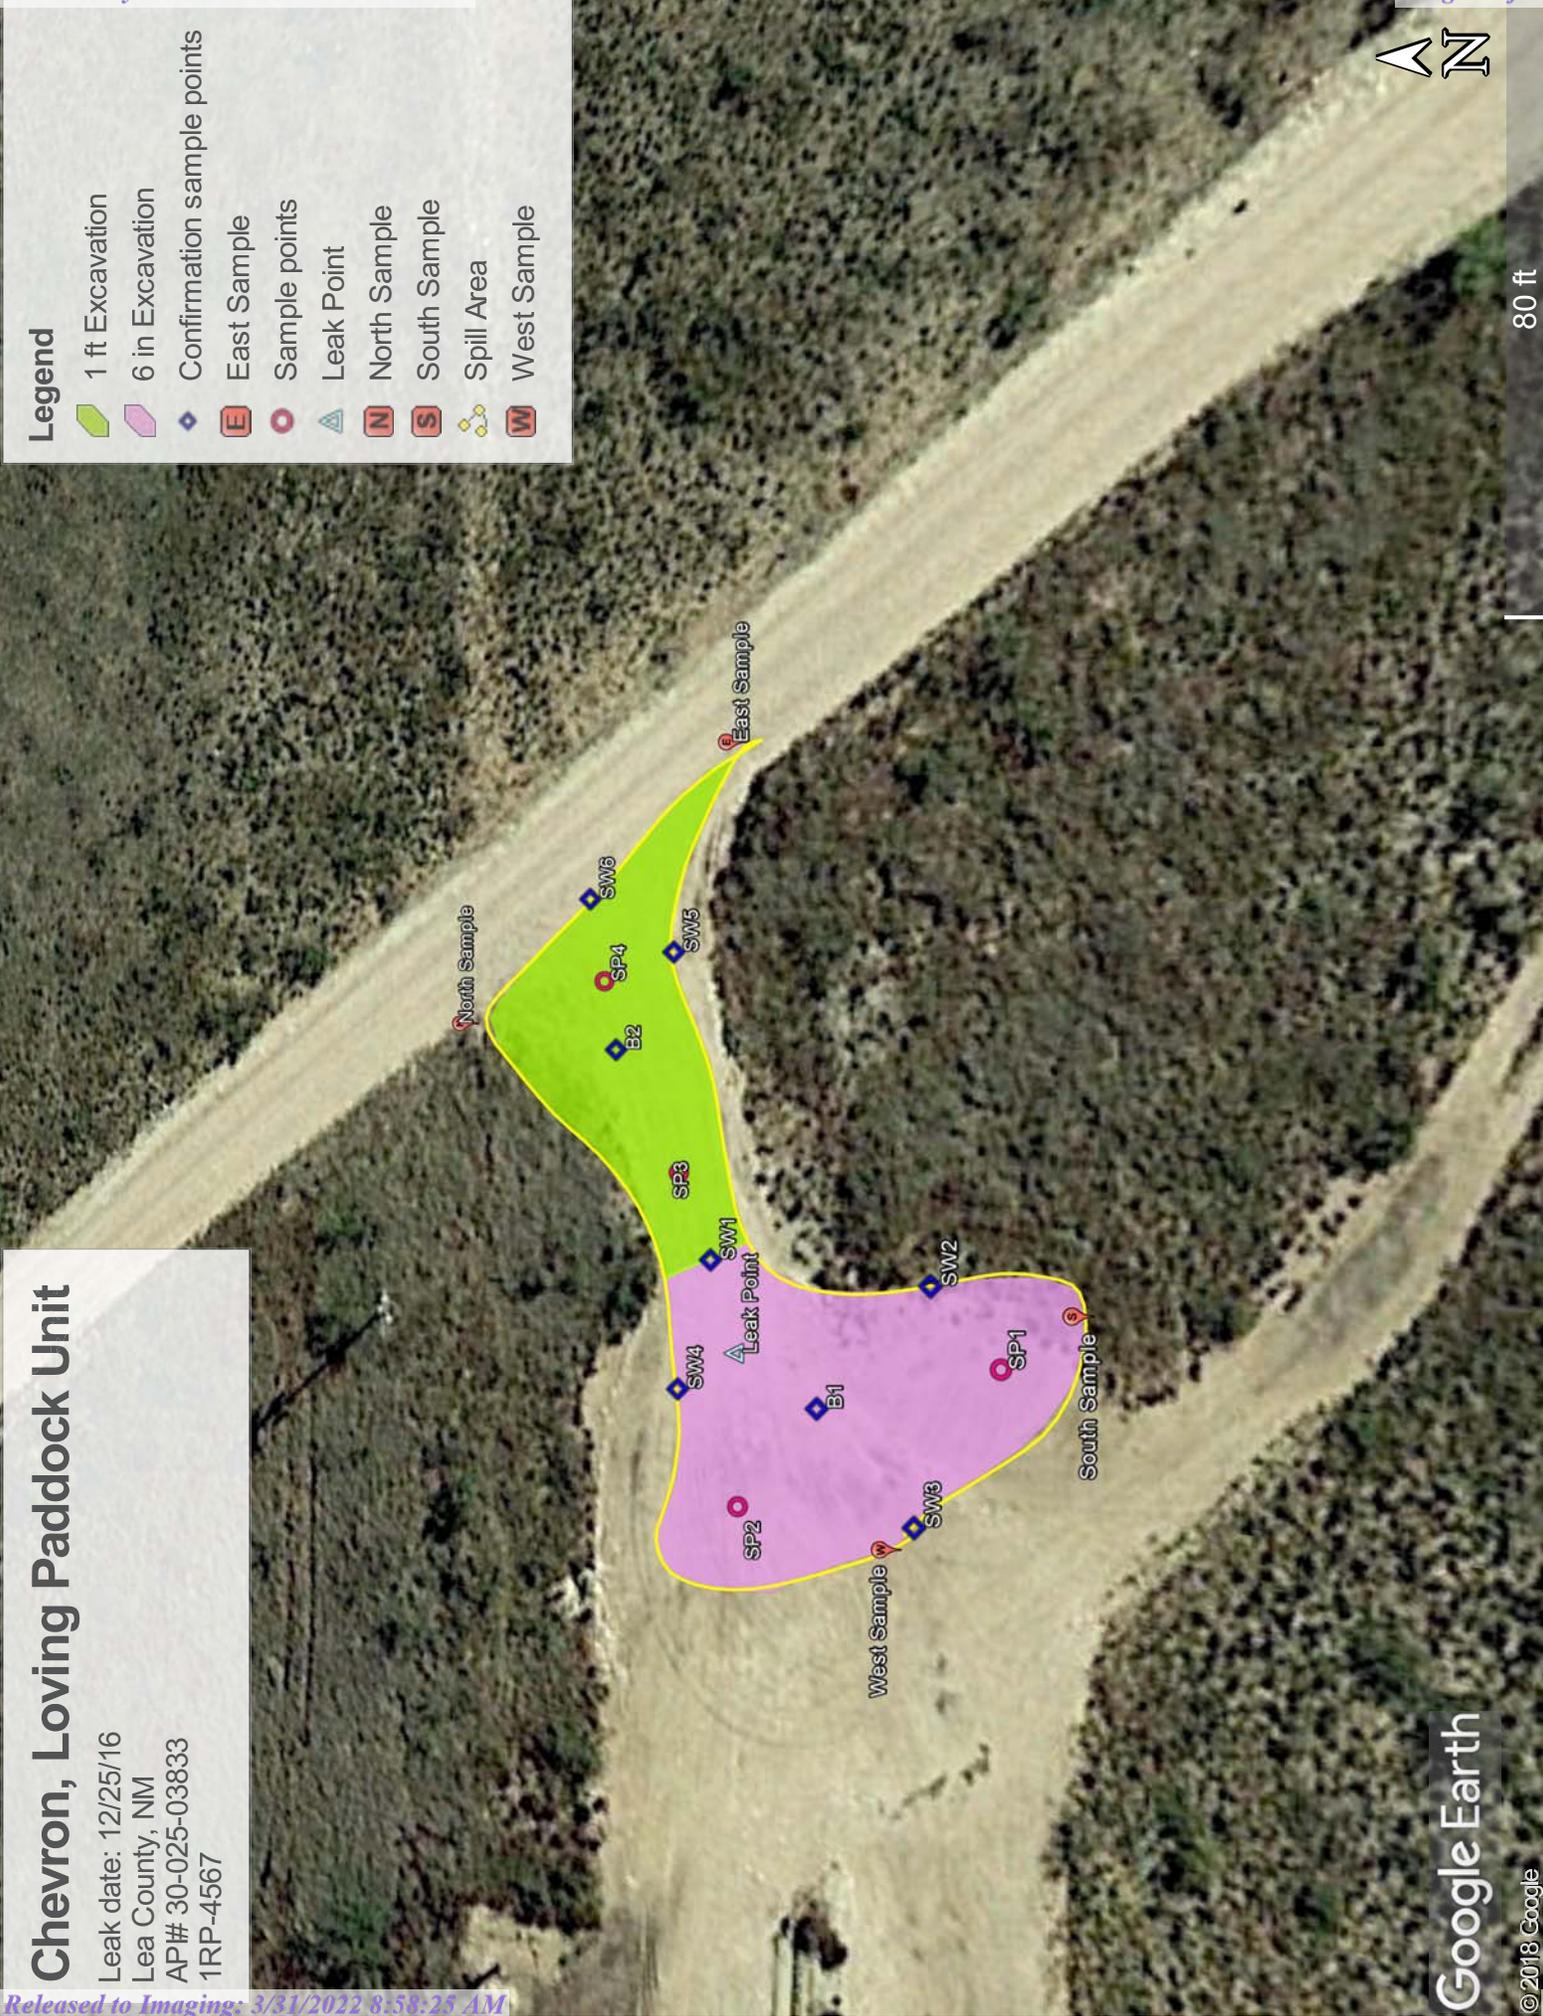
Leak date: 12/25/16
Lea County, NM
API# 30-025-03833
1RP-4567

1 ft Excavation
-

6 in Excavation
-

Confirmation sample points
-

Leak Point
-

Spill Area
-

Remediation Parameters:	Excavate the areas of SP1 and SP2 to a depth of 6 inches. Excavate the areas of SP3 and SP4 to a depth of 1 foot. Obtain bottom and sidewall confirmation samples. Backfill the site with clean soil.	
Remediation Activities:	03/22/2018 to 03/29/2018	
Plan Sent to OCD:	01/26/2018	Email from Cliff Brunson to Olivia Yu
OCD Approval of Plan:	02/01/2018	Email from Olivia Yu to Cliff Brunson
Plan Sent to BLM:	n/a	n/a
BLM Approval of Plan:	n/a	n/a
