SITE CHARACTERIZATION REPORT AND REMEDIATION PLAN

Pump Canyon Compressor Station (8/28/2019)
SW 1/4, S24 T30N R9W
San Juan County, New Mexico

February 21, 2020 (Updated June 15, 2020)
Ensolum Project No. 05A1226070

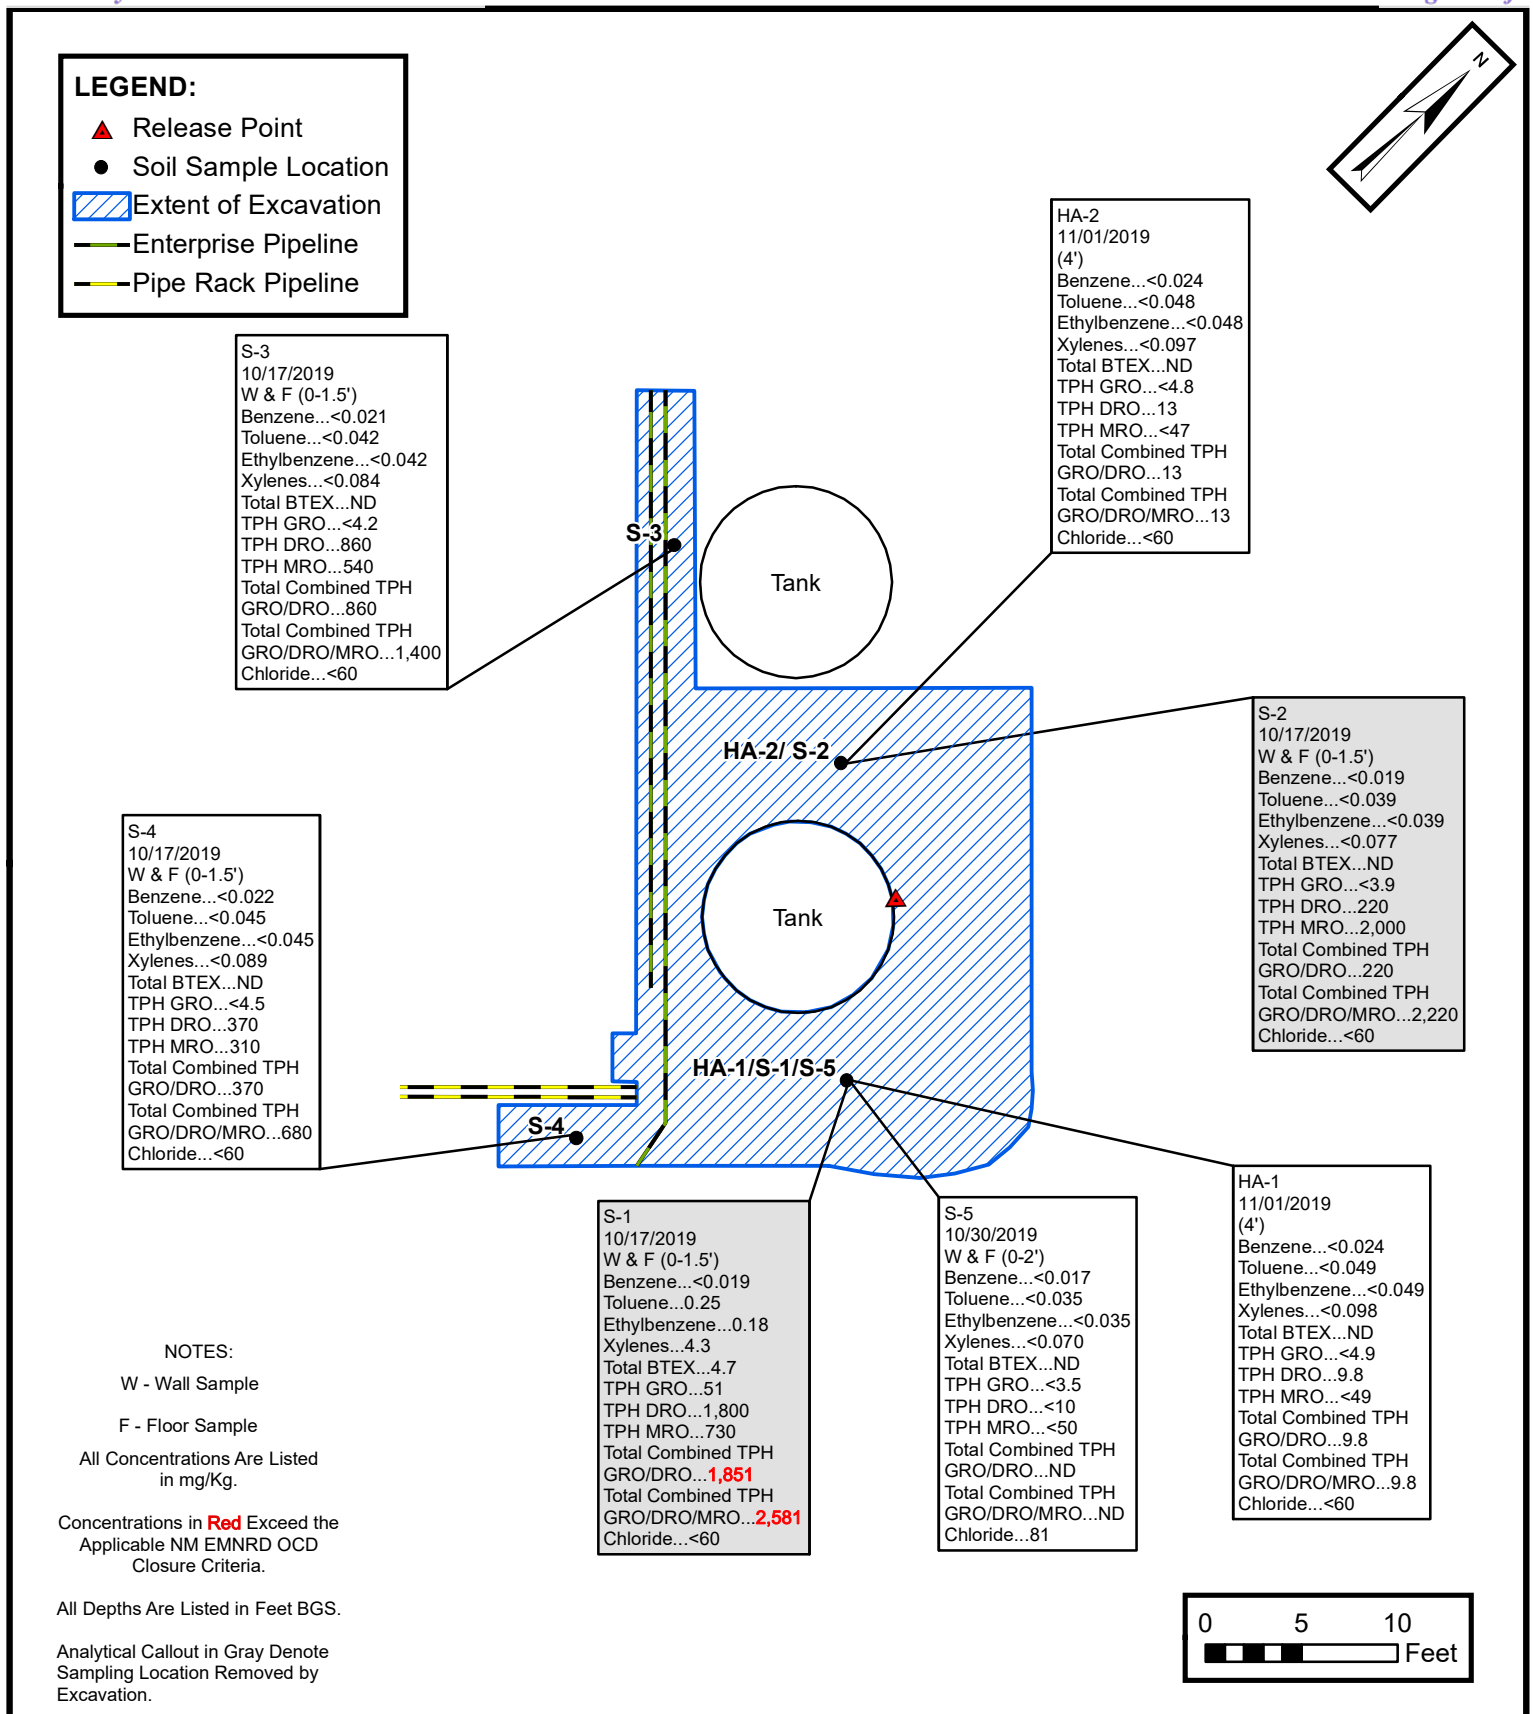
Figure 3 is a map that identifies approximate soil sample locations and depicts the approximate dimensions of the excavation with respect to the storage tank (**Appendix A**). Photographic documentation of the field activities is included in **Appendix D**.

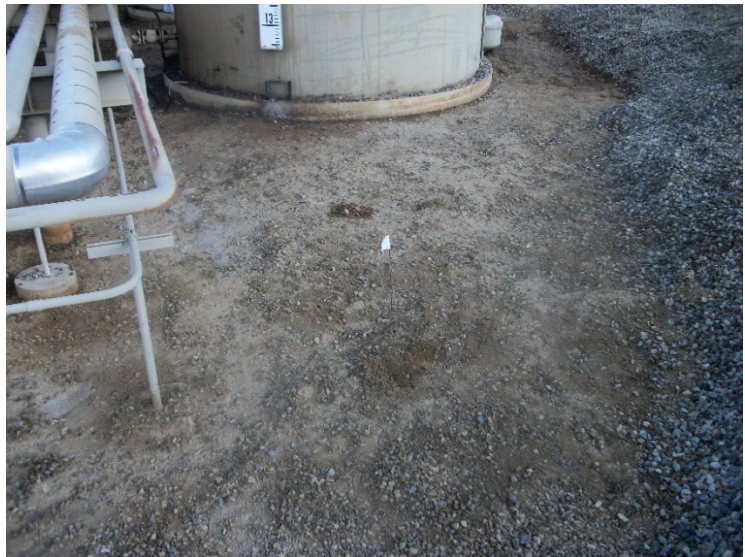
**Photograph 1**

Photograph Description: View of the initial release area.

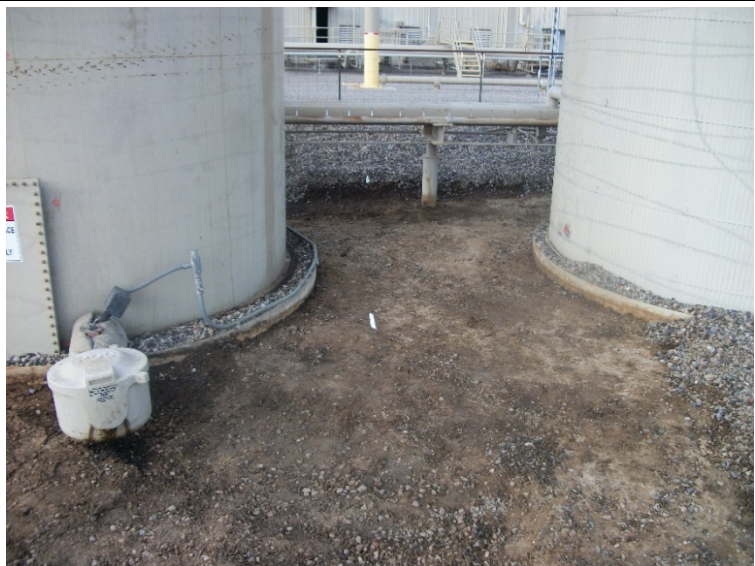
**Photograph 2**

Photograph Description: View of the initial release area.

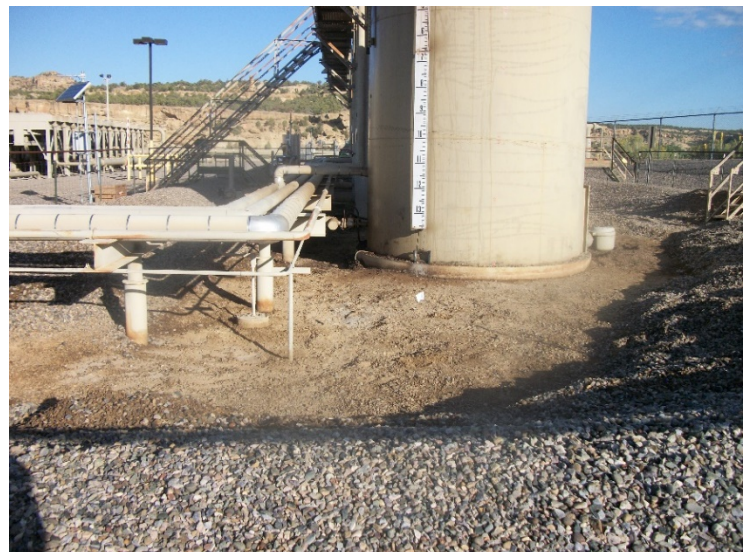
**Photograph 3**

Photograph Description: View of the excavation.

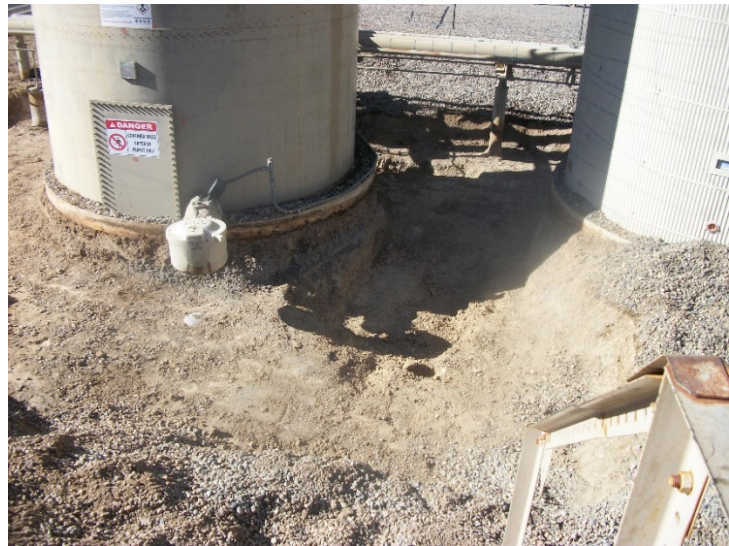
**Photograph 4**

Photograph Description: View of the excavation.

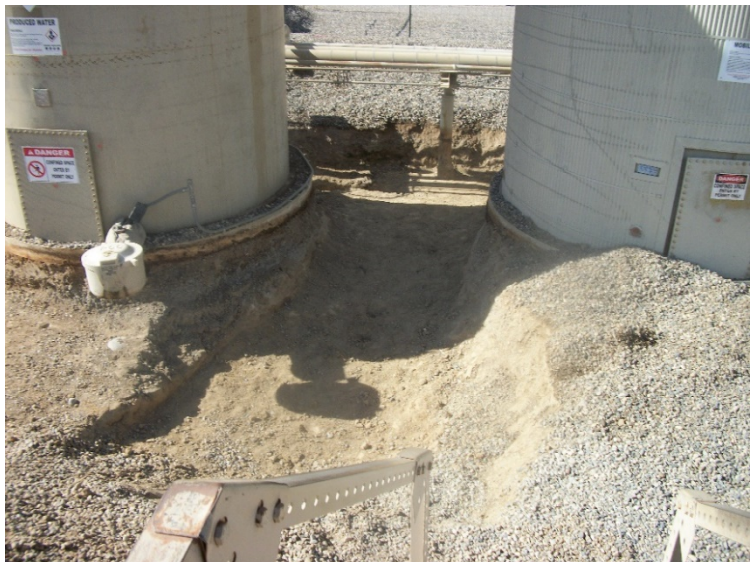
**Photograph 5**

The final excavation measured approximately 40 feet long and 22 feet wide at the maximum extents. The maximum depth of the excavation measured approximately two (2) feet bgs. It is believed that deeper excavation in the area at this time would risk undermining the integrity of the storage tank foundations.

Photograph Description: View of the final excavation.

A total of approximately 104 cubic yards of petroleum hydrocarbon affected soils were transported to the Envirotech, Inc. (Envirotech) landfarm near Hilltop, New Mexico for disposal/remediation. The executed C-138 solid waste acceptance forms are provided in **Appendix C**. The excavation was backfilled with imported fill, and the secondary containment was repaired.

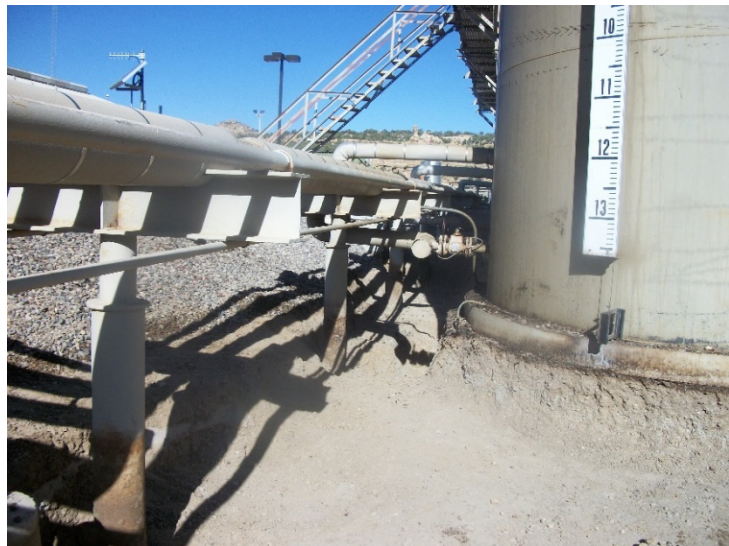
**Photograph 6**

Photograph Description: View of the final excavation.

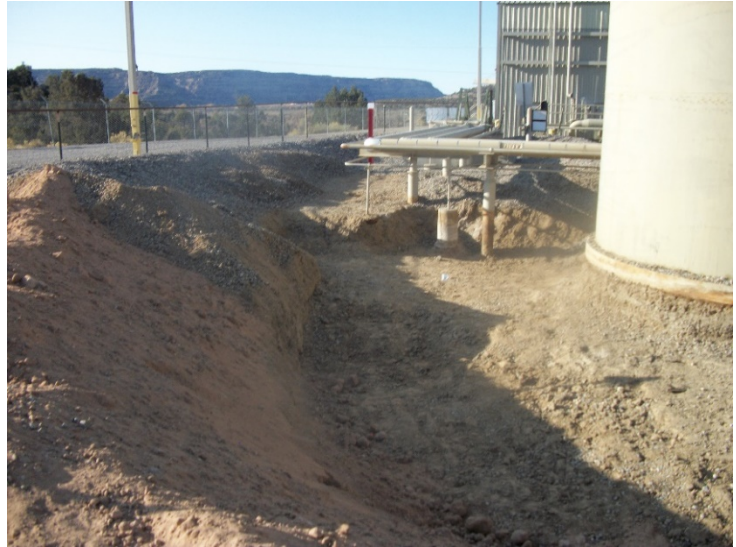
Photograph 7

Photograph Description: View of the final excavation.
