## **SITE REMEDIATION AND CLOSURE REPORT**

**AMOLE AMM STATE #2  
UNIT K, SECTION 16, TOWNSHIP 19S, RANGE 25E  
EDDY COUNTY, NEW MEXICO  
32.658273, -104.491577  
RANGER REFERENCE NO. 5375**

**JUNE 8, 2022**

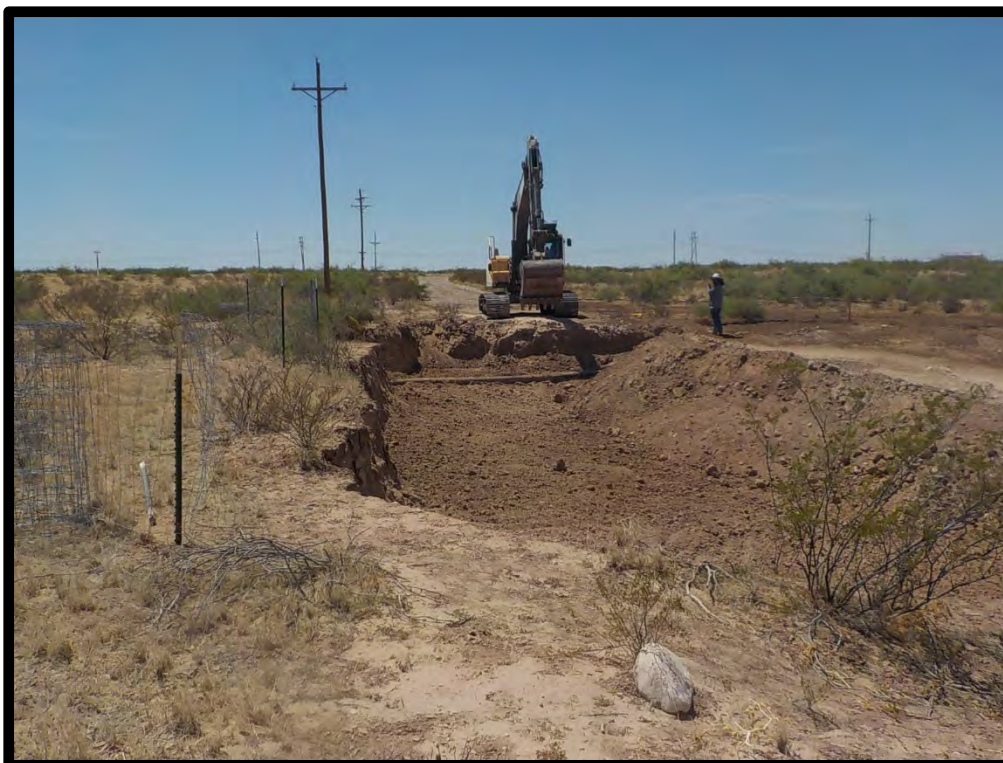
**PHOTOGRAPH NO. 1 – A view of the eastern portion of the excavation/remediation area upon completion. The view is towards the south.**

Upon receipt of the soil analytical data, which confirmed that the eastern excavation area had achieved the approved closure criteria, the area was backfilled with clean fill material.

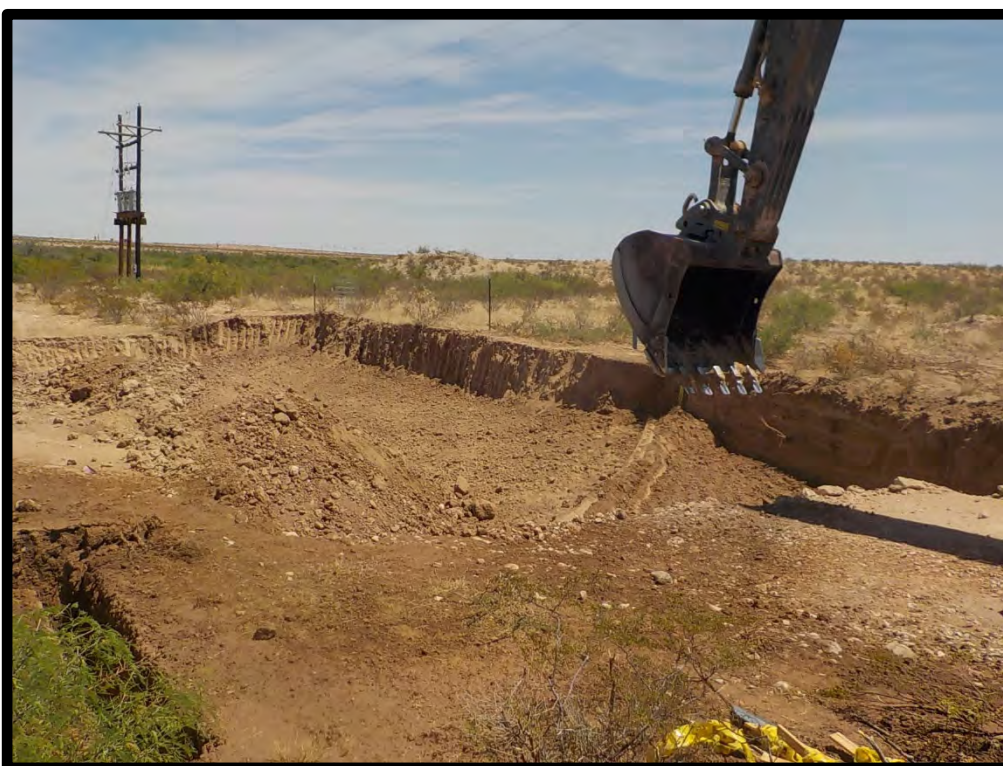
**PHOTOGRAPH NO. 2 – An additional view of the eastern portion of the excavation/remediation area at the Site. The view is towards the northeast.**

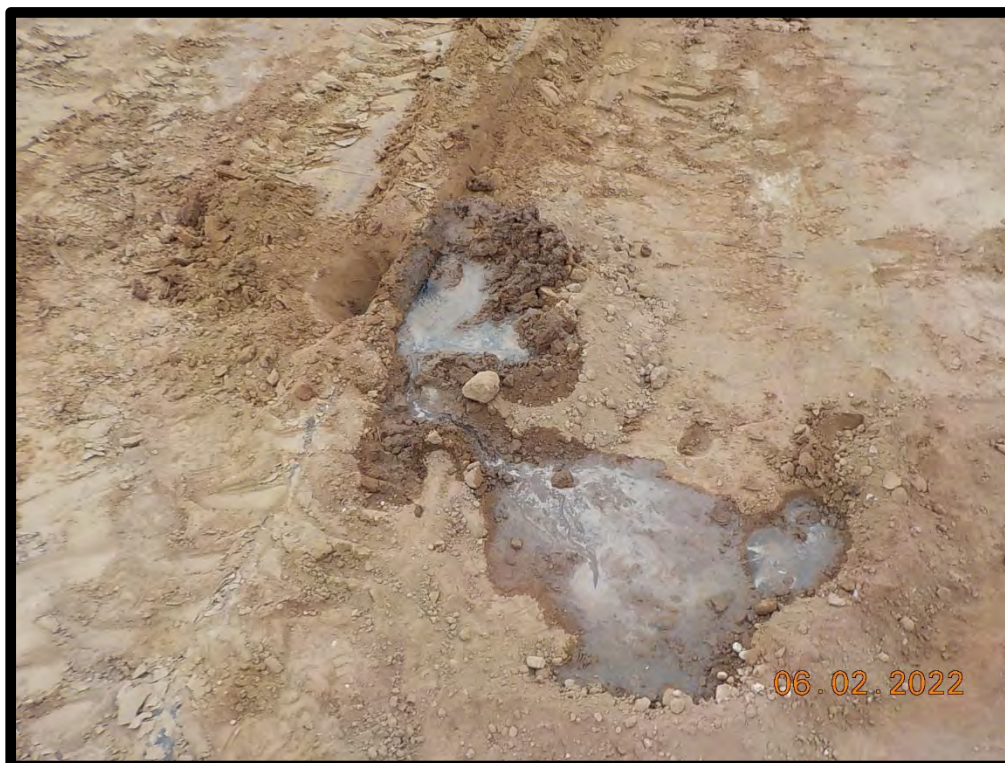
**PHOTOGRAPH NO. 3 – A view of the maximum extent of impacts associated with the discovered release originating from the out-of-service flowline. The view is towards the south. (Approximate GPS: 32.658301, -104.491567)**

During the excavation process, a release was observed along the out-of-service flowline in the southern portion of the excavation area. Residual fluids were observed to be draining out of the bottom of the flowline. Immediate efforts to halt the release of fluids and contain the impacts from the released fluids were taken. It is estimated that less than one barrel of fluid was released from the out-of-service flowline. Recovery efforts were successful in capturing approximately 17 gallons of the released fluids. Upon abatement of the release, the removal of all wet and discolored soils in the release area were immediately completed. Upon completion, the over-excavated area had maximum dimensions of approximately eight (8) feet by 11 feet by approximately 6.5 feet deep.

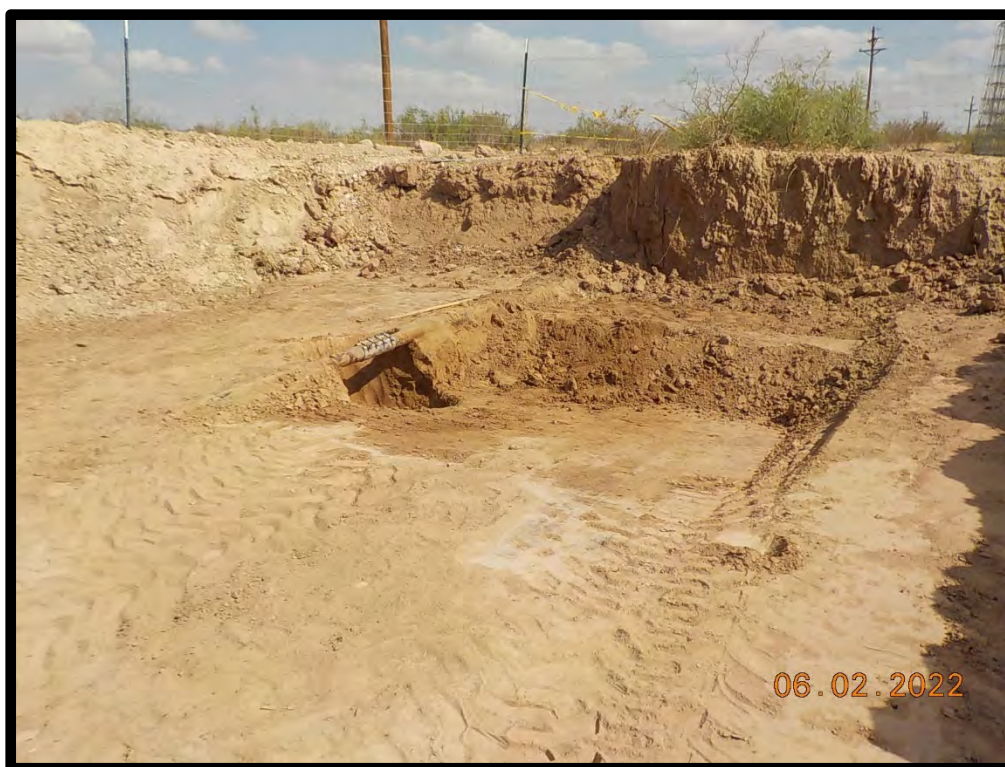
**PHOTOGRAPH NO. 4 – A view over-excavated area in the vicinity of the discovered release location. The view is towards the southeast. (Approximate GPS: 32.658329, -104.491573)**

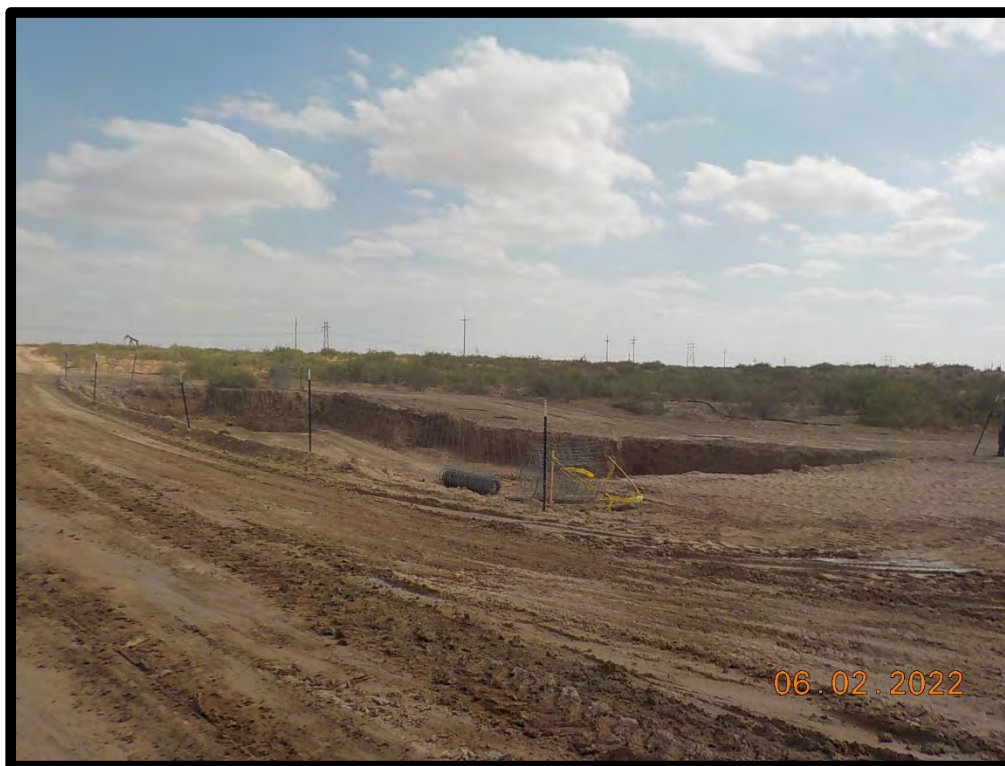
**PHOTOGRAPH NO. 5 – A view western excavation/remediation area upon completion. The view is to the southwest.** (Approximate GPS: 32.658531, -104.491475)

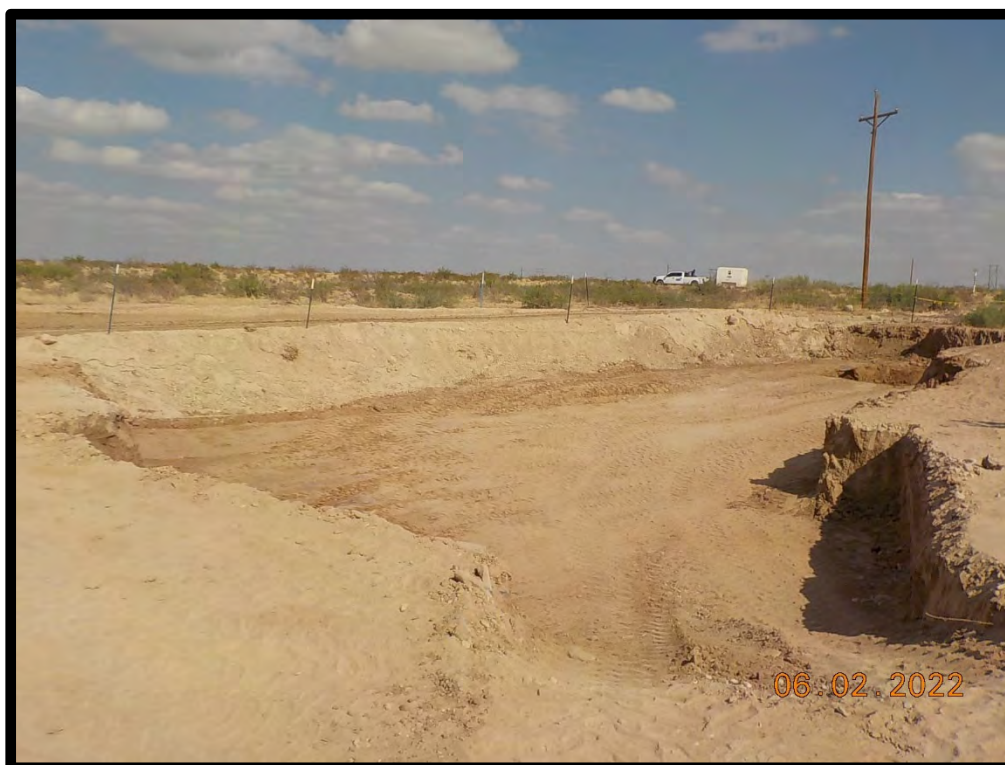
**PHOTOGRAPH NO. 6 – An additional view of the western portion of the excavation/remediation area at the Site. The view is towards the southeast.** (Approximate GPS: 32.658511, -104.491690)
