Release Notification

Site Name: Trunk R – Lowrey Sales Tank	Site Type: Battery
Date Release Discovered: 2/17/2022	API# (if applicable)

**Re: Closure Request
Lowery Tank Battery
Incident Number NAPP2205975241
Rio Arriba County, New Mexico**

Photographic Log
Harvest Midstream
Lowery Tank Battery

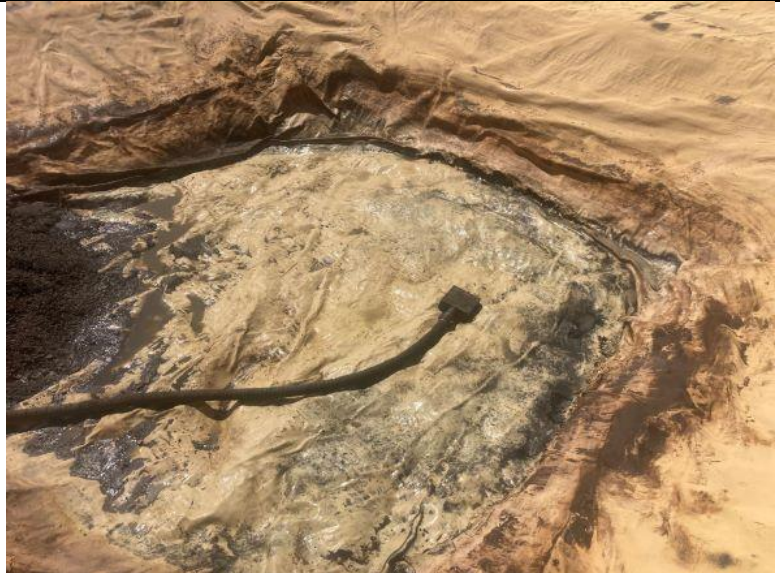
Photograph 1

On February 17, 2022, a valve on the produced water tank froze and broke, resulting in the release of approximately 50 barrels (bbls) of produced water into a lined secondary containment. A vacuum truck was immediately dispatched to the Site to recover the 50 bbls of free-standing fluids, and the broken valve was replaced. Harvest reported the release to the NMOCD via email on February 17, 2022, and on a Release Notification Form C-141 (Form C-141) on February 28, 2022. The release was assigned Incident Number NAPP2205975241.

View of liquids removal.

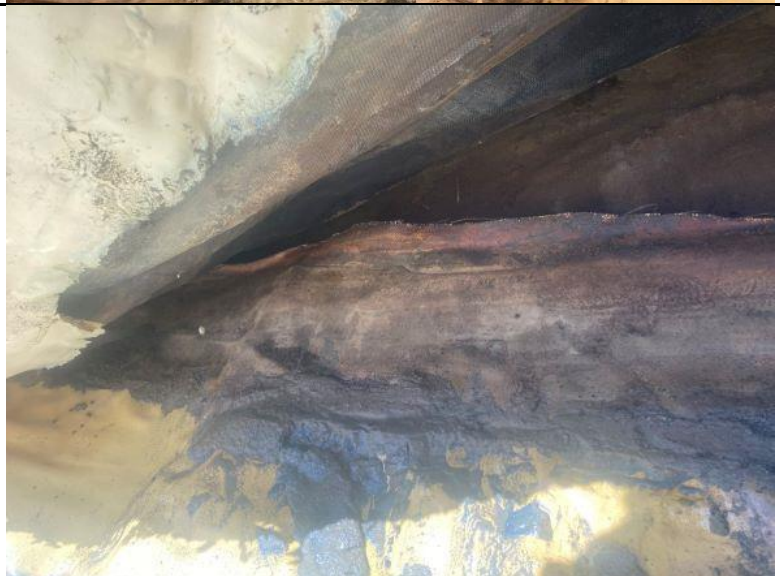
Photograph 2

Harvest notified the New Mexico Oil and Gas Conservation Commission (NMOCD) of a liner inspection on April 18, 2022. A copy of the notification is included as Appendix A. During the inspection on April 20, 2022, Harvest observed a tear in the liner, and collected a surface soil sample from directly below the tear (sample ID: Bottom). Photographic documentation was completed during the Site visit and a photographic log is included in Appendix B. Concentrations of total TPH exceeded the Table 1 Closure Criteria in sample Bottom, so Harvest removed part of the liner to conduct additional investigation and potential remediation. Harvest removed *de minimis* stained soil that was observed directly below the liner tear.

View of tear in liner.

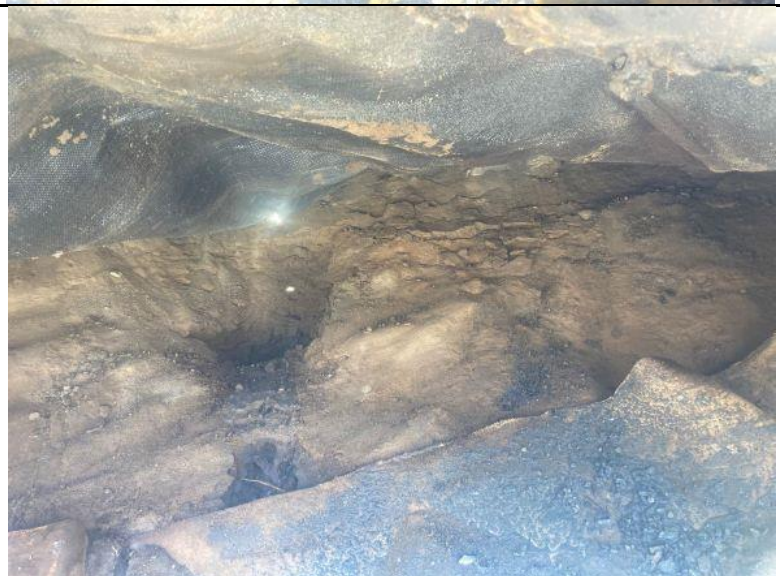
Photograph 3

View of initial sample collected by Harvest below the tear.

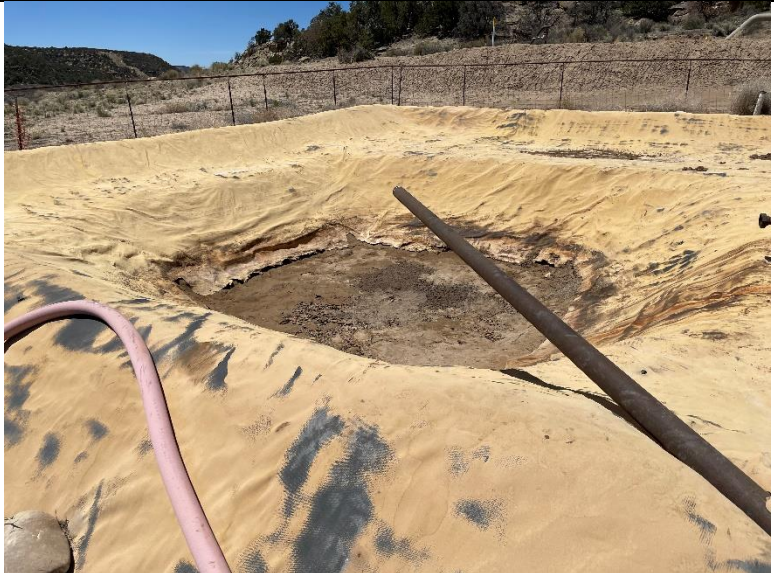
Photograph 4

View of area where liner was removed.

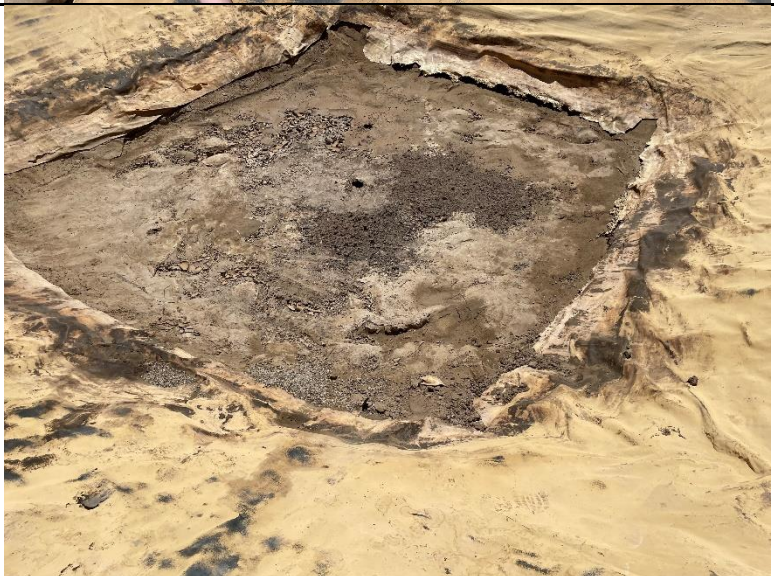
**Photograph 5**

Laboratory analytical results for soil samples BH01 @ 0-0.5', and BH01 @ 7.5' collected from the source area, indicated that benzene, BTEX, TPH, and chloride concentrations were compliant with the Closure Criteria. Laboratory analytical results are summarized in Table 1 and laboratory analytical reports are included as Appendix C.

View of Borehole 01, where samples BH01 @ 0-0.5' and BH01 @ 7.5' were collected.
