**CLOSURE REPORT**

**Lateral 2C-6 (3/2/22)  
Unit Letter P, S31 T26N R7W  
Rio Arriba County, New Mexico**

**New Mexico EMNRD OCD Incident ID No. NAPP2206337228**

May 23, 2022  
Ensolum Project No. 05A1226186

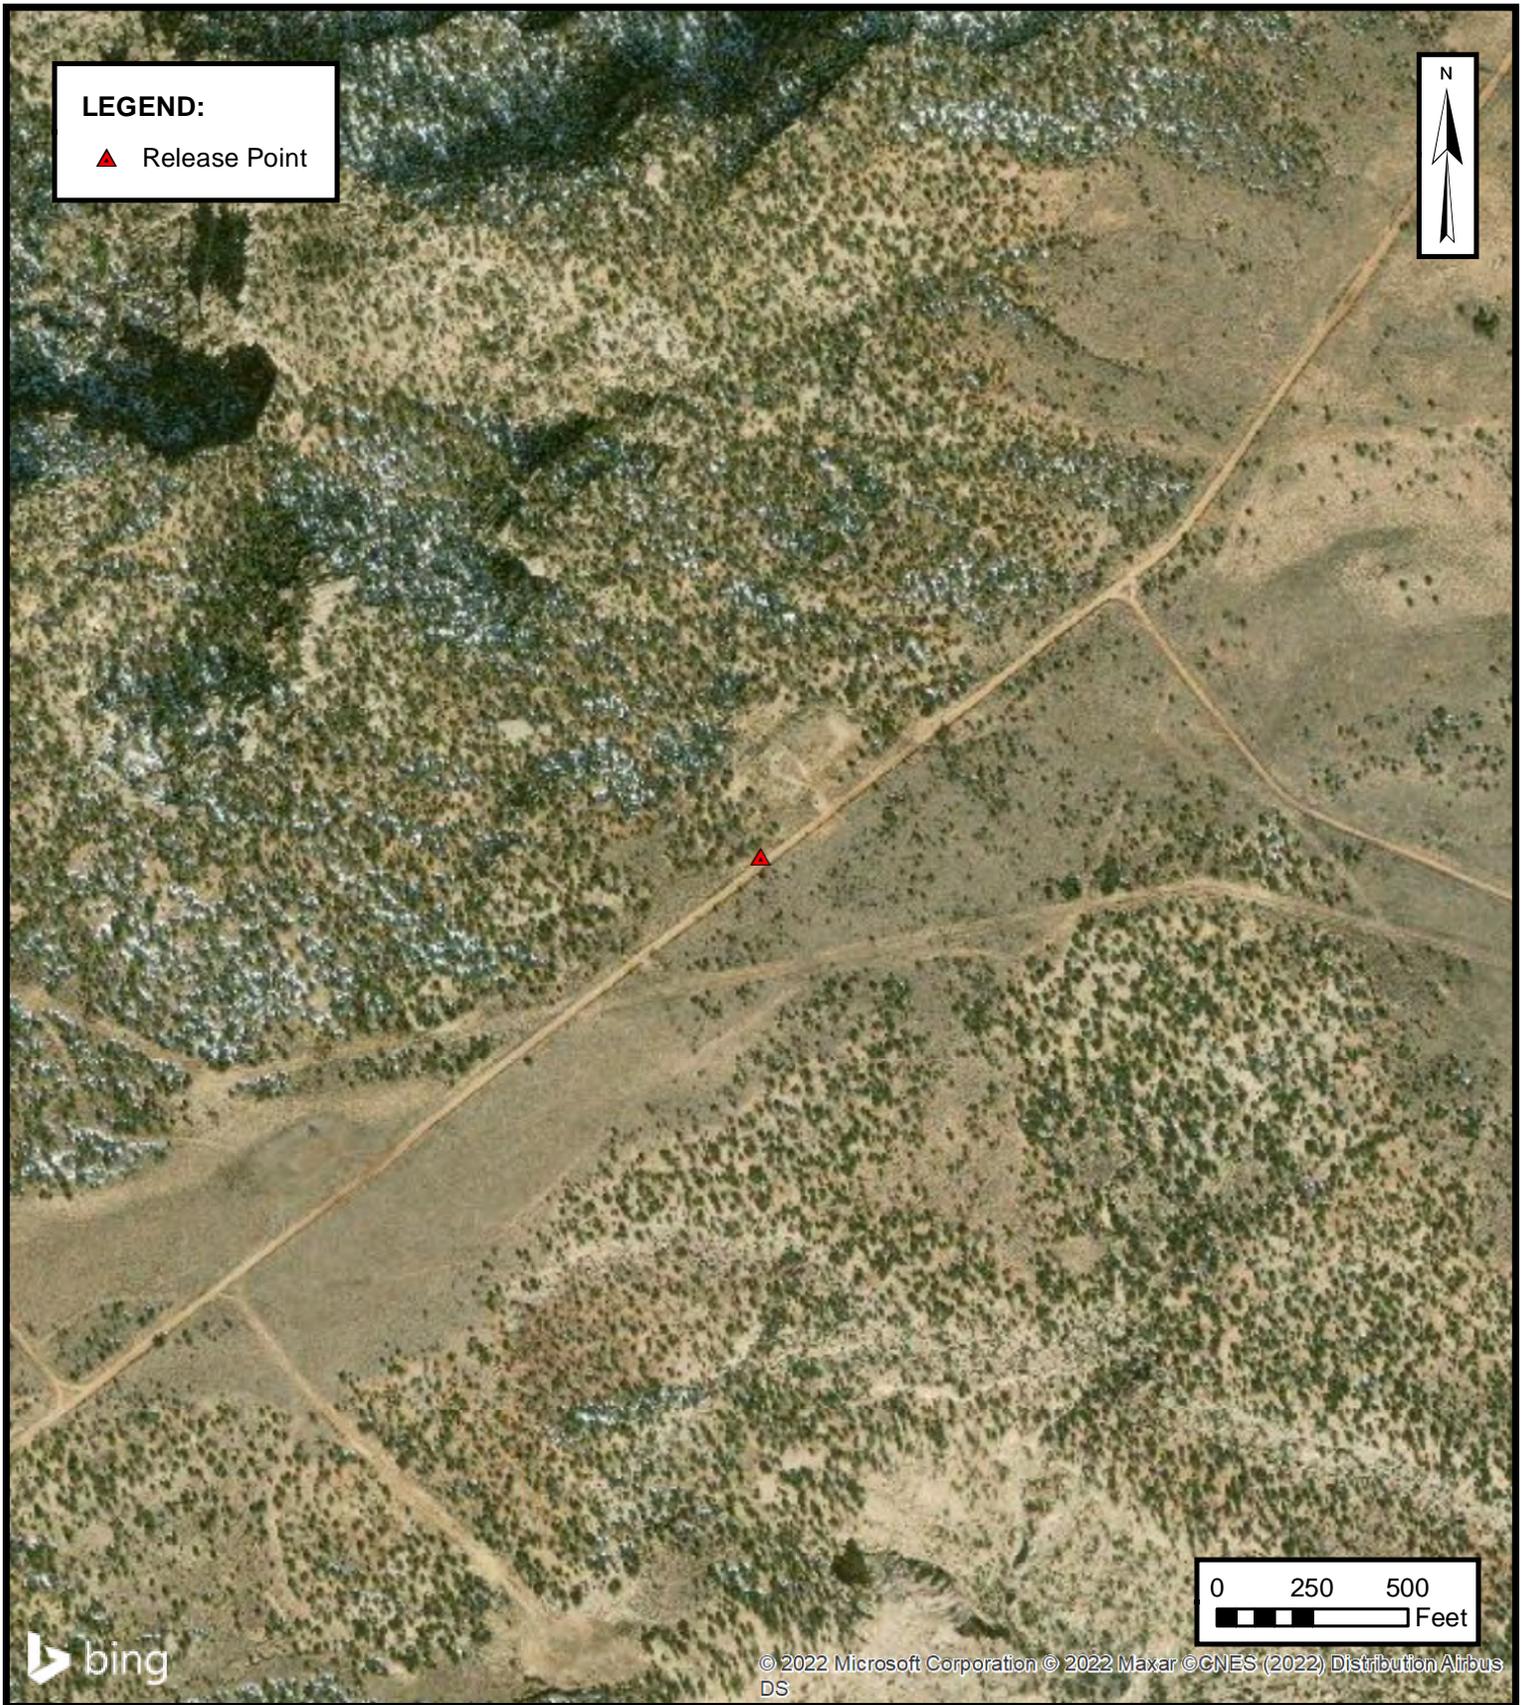
**FIGURE**  
**2**

**SITE VICINITY MAP**  
ENTERPRISE FIELD SERVICES, LLC  
LATERAL 2C-6 (3/2/22)  
Unit Letter P, S31 T26N R7W, Rio Arriba County, New Mexico  
36.438720° N, 107.611543° W  
PROJECT NUMBER: 05A1226186

A **Topographic Map** depicting the location of the Site is included as **Figure 1**, and a **Site Vicinity Map** is included as **Figure 2** in **Appendix A**.

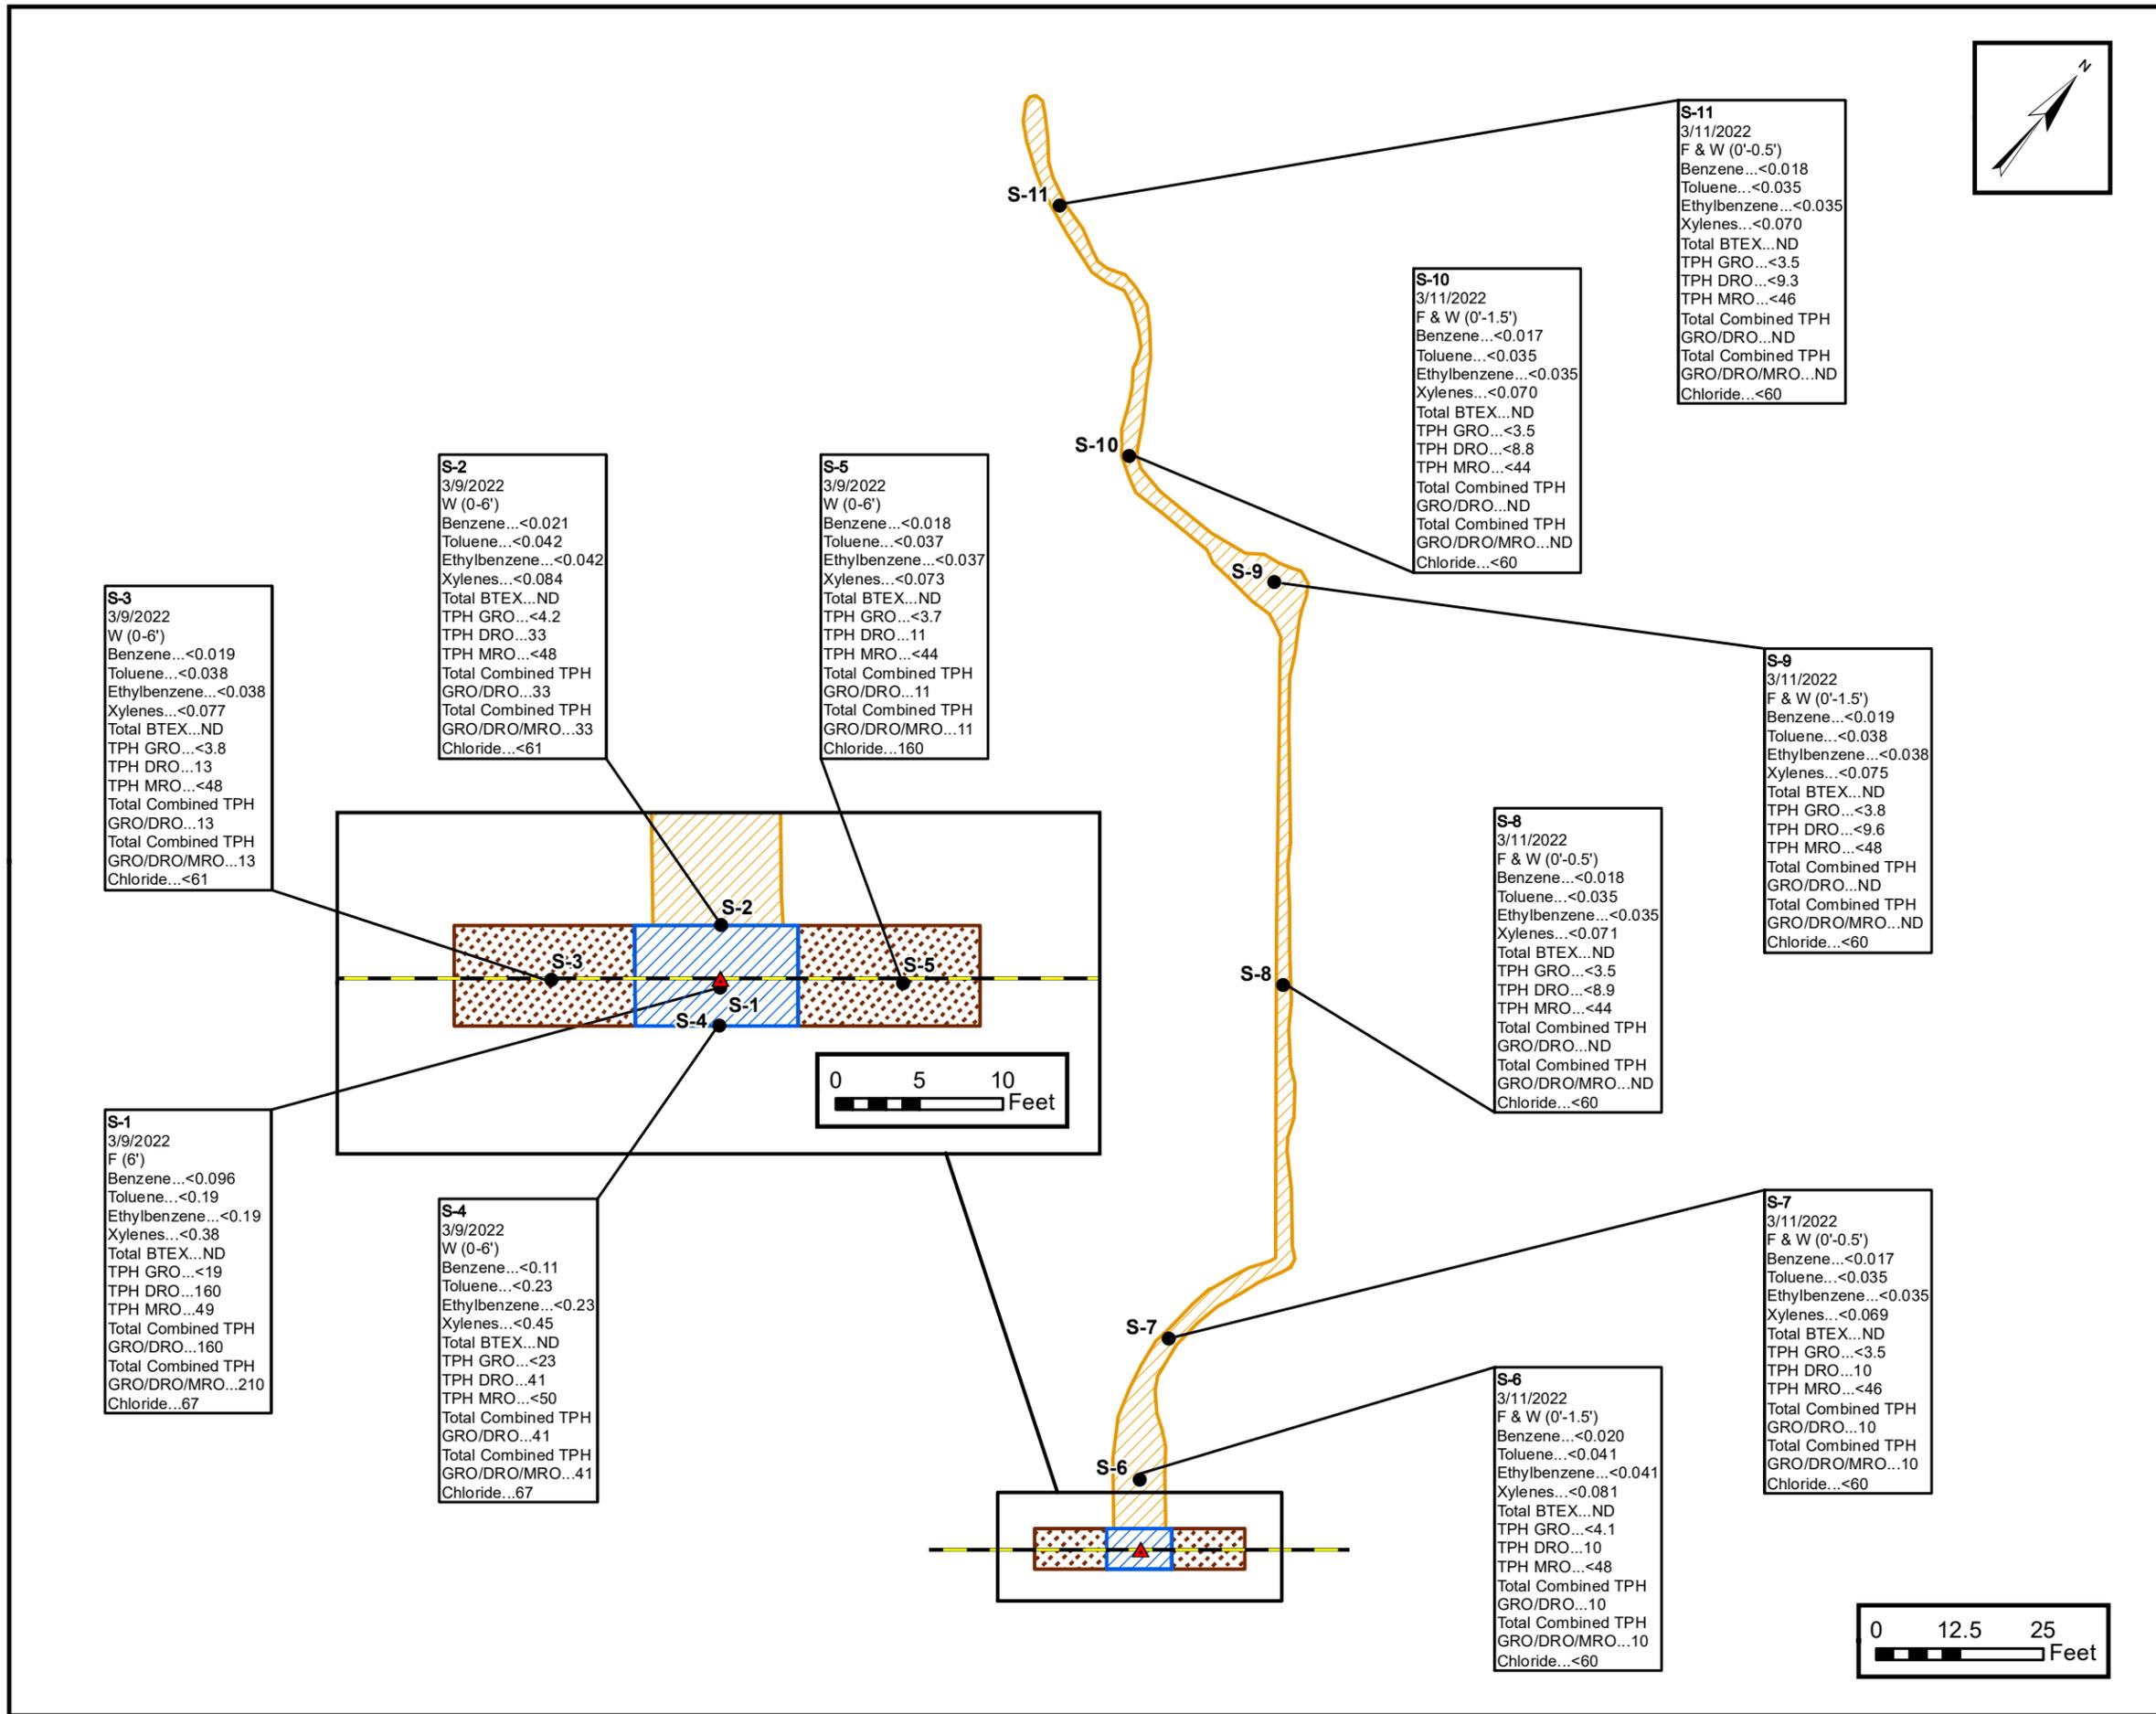
- ▲ Release Point
- Composite Soil Sample Location
- Extent of Excavation
- Sloped Sidewall
- Extent of Flowpath
- Approximate Lateral 2C-6 Pipeline Location

**Figure 3** is a map that identifies approximate soil sample locations and depicts the approximate dimensions of the pipeline and flow path excavation with respect to the pipeline (**Appendix A**). Photographic documentation of the field activities is included in **Appendix D**.

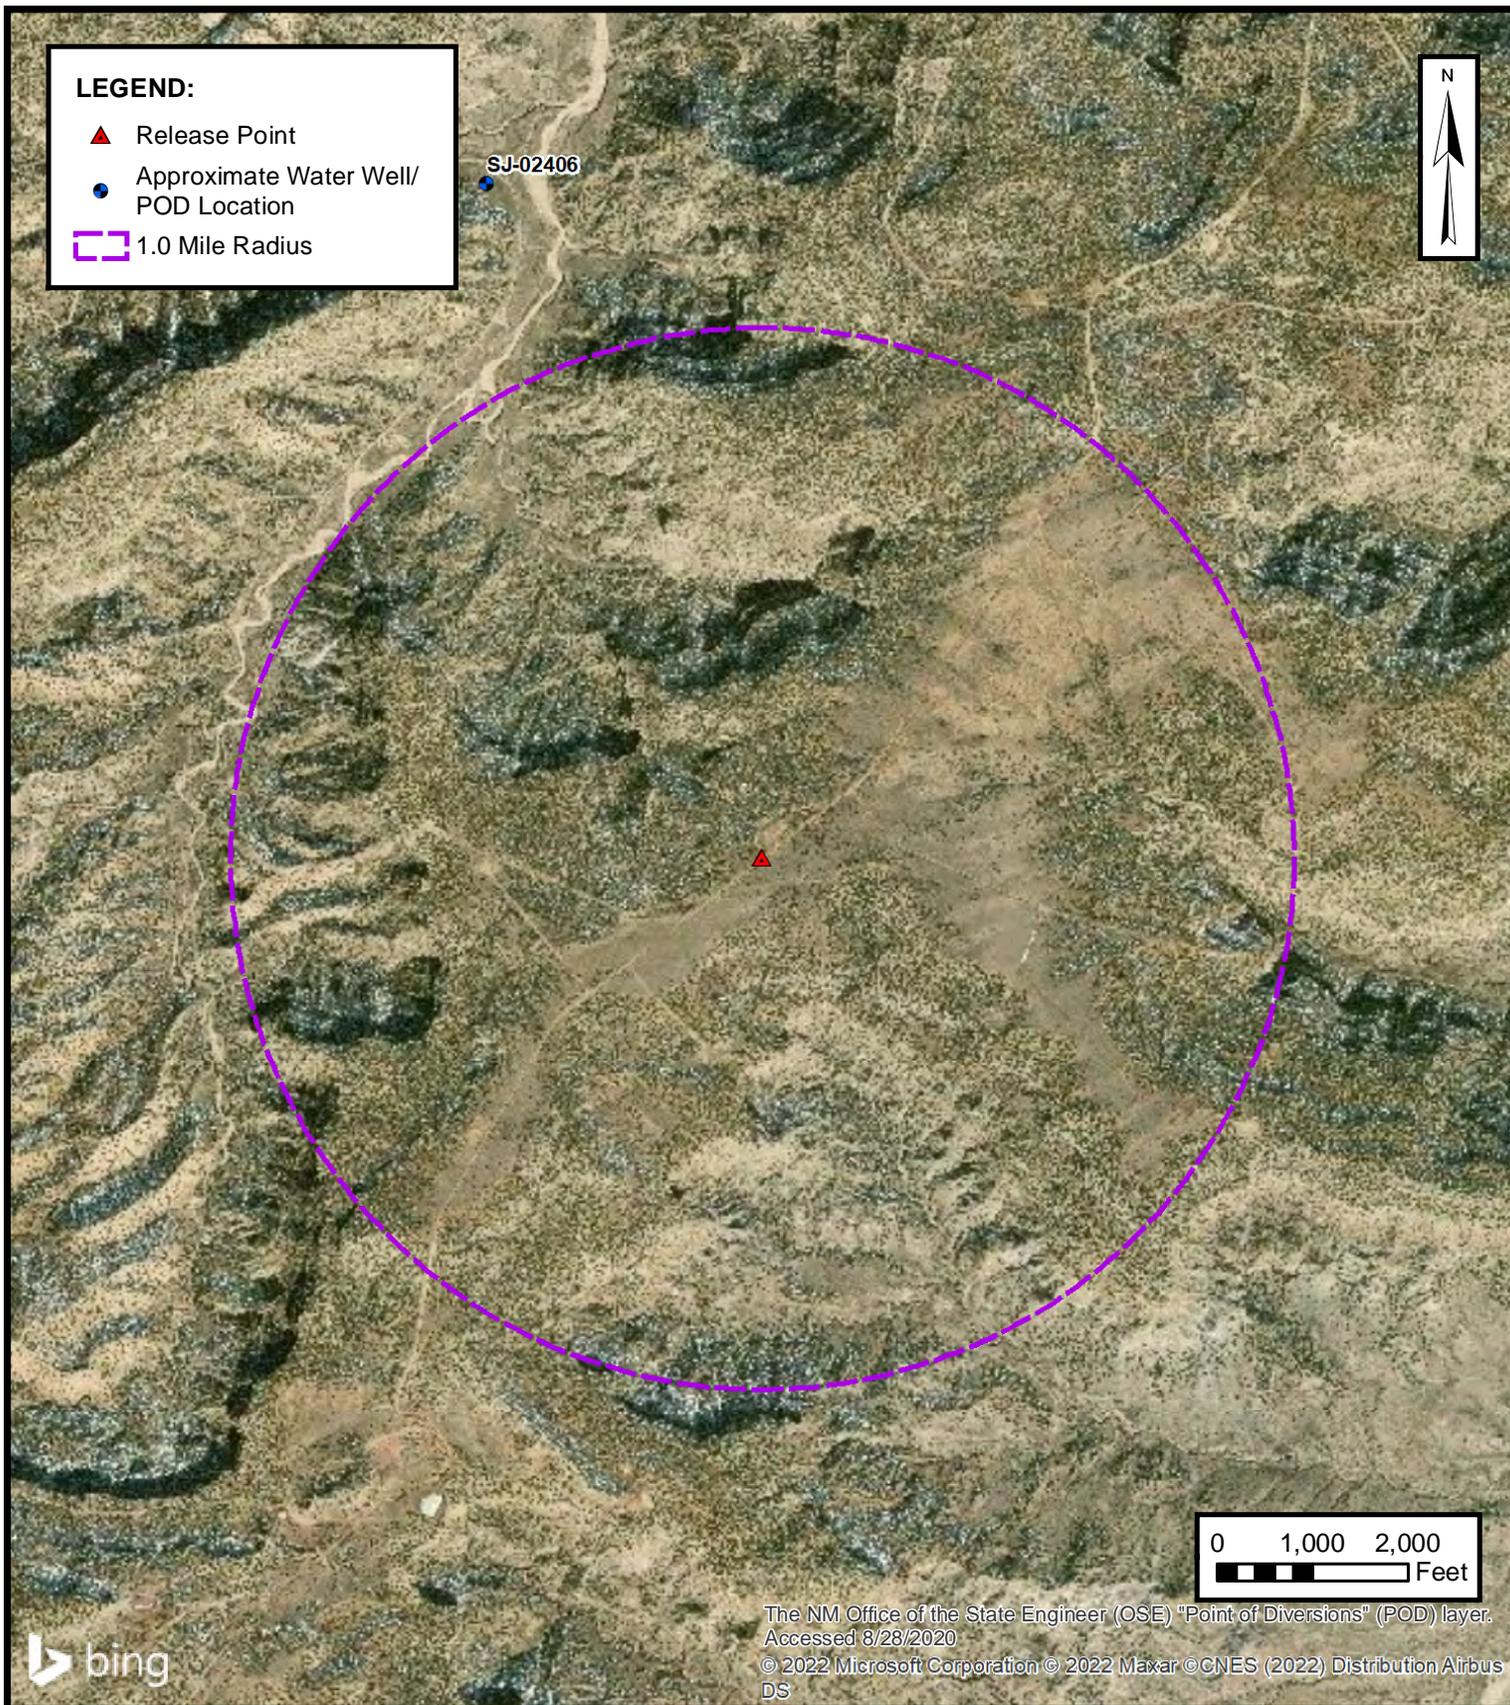
**FIGURE**  
**A**

**1.0 MILE RADIUS WATER WELL/ POD LOCATION MAP**

- The OSE tracks the usage and assignment of water rights and water well installations and records this information in the Water Rights Reporting System (WRRS) database. Water wells and other points of diversion (PODs) are each assigned POD numbers in the database (which is searchable and includes an interactive map). No PODs were identified in the same Public Land Survey System (PLSS) section as the Site. One POD (SJ-02406) was identified in an adjacent section. POD SJ-02406 is located approximately 1.4 miles northwest of the Site and is approximately 664 feet lower in elevation than the Site. The records for POD SJ-02406 indicate a depth to water of 180 feet below grade surface (bgs) (**Figure A, Appendix B**).

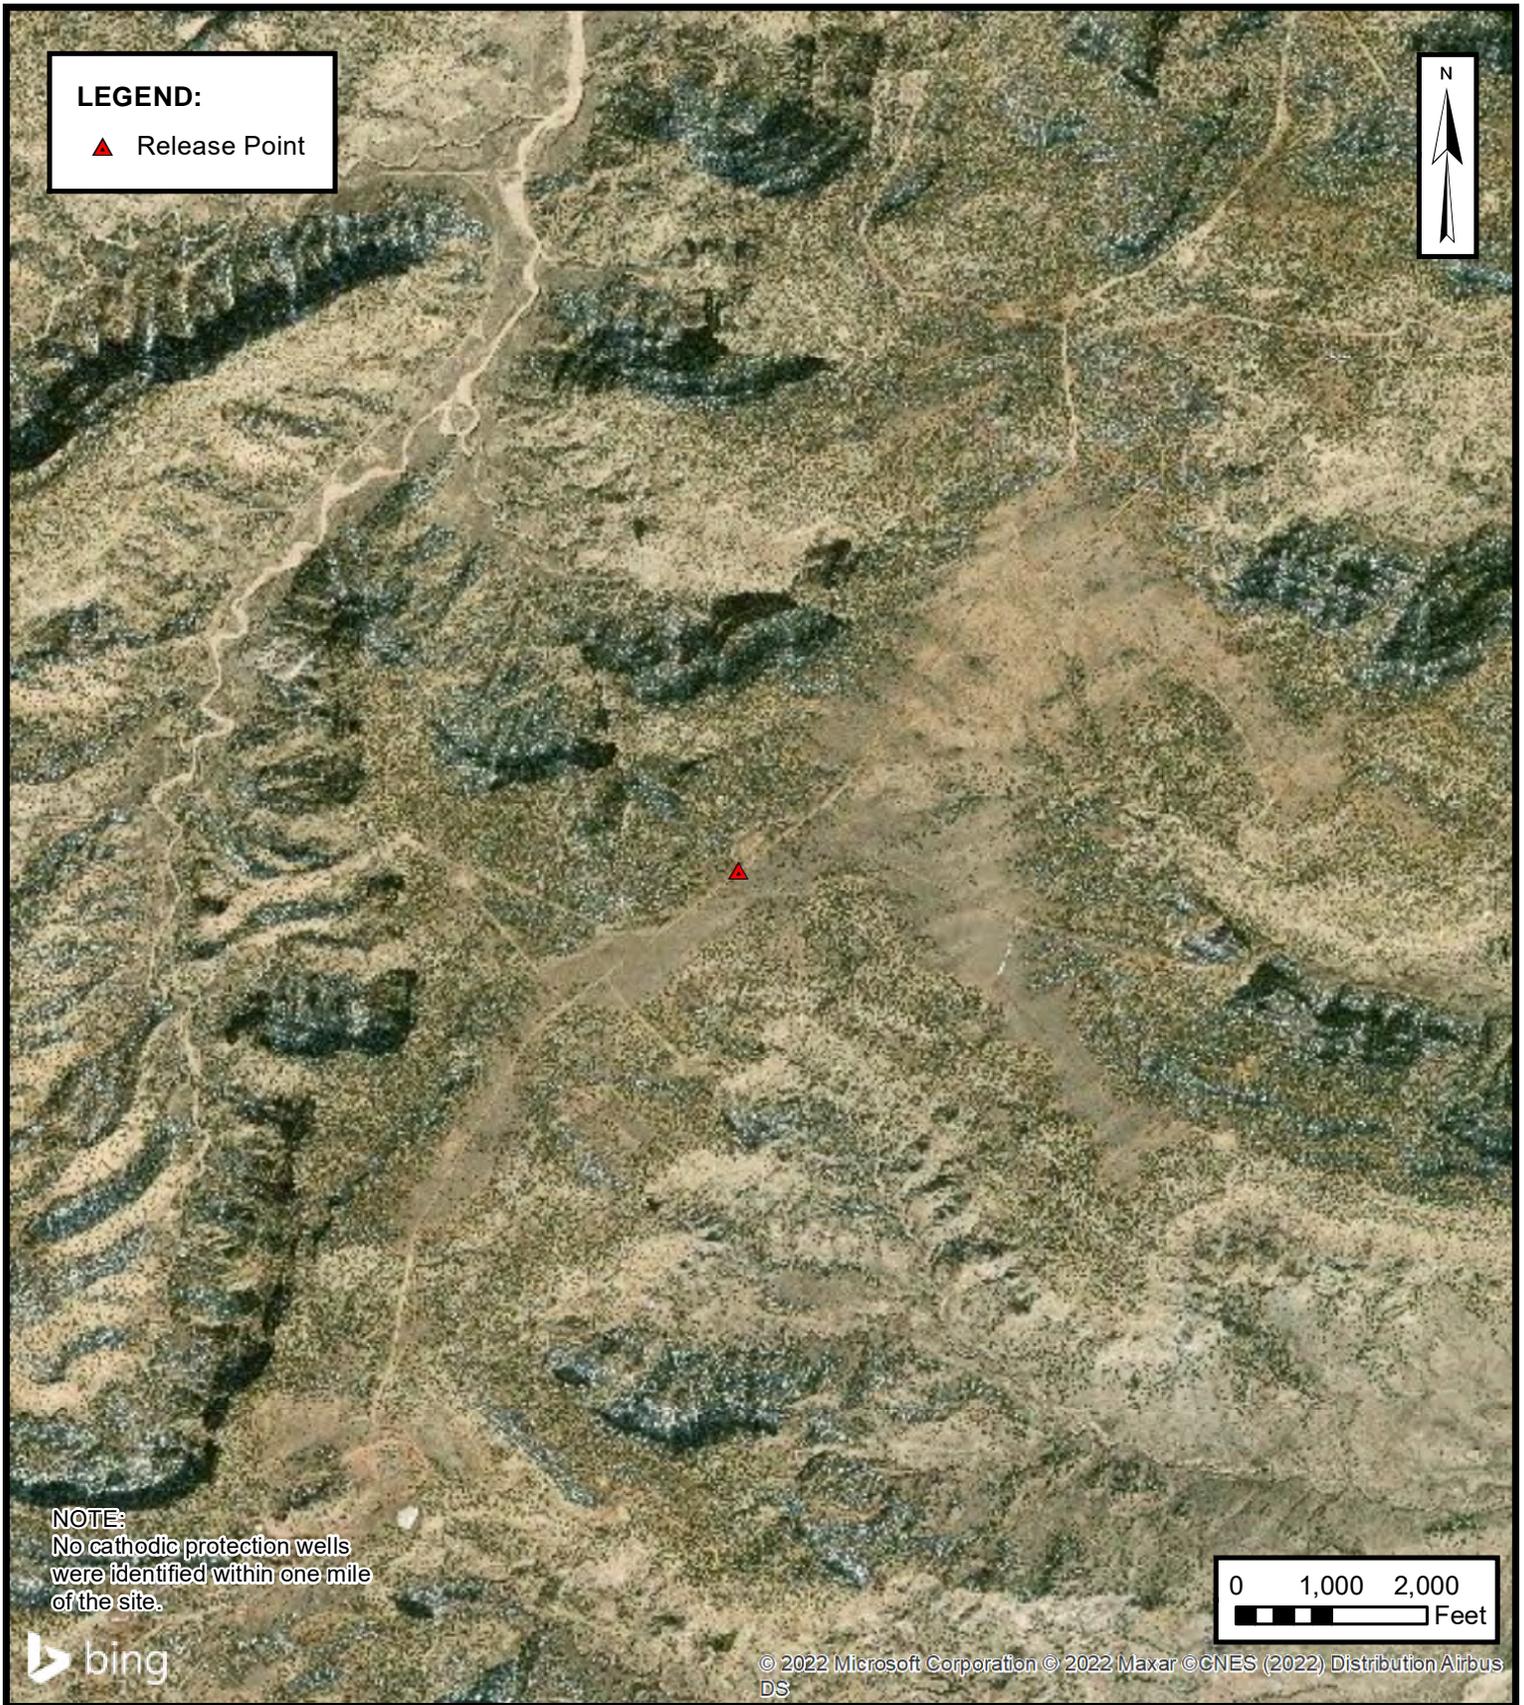
**FIGURE  
 B**

**CATHODIC PROTECTION WELL RECORDED  
 DEPTH TO WATER**  
 ENTERPRISE FIELD SERVICES, LLC  
 LATERAL 2C-6 (3/2/22)  
 Unit Letter P, S31 T26N R7W, Rio Arriba County, New Mexico  
 36.438720° N, 107.611543° W  
 PROJECT NUMBER: 05A1226186

- No cathodic protection wells (CPWs) were identified in the same or adjacent PLSS sections in the NM EMNRD OCD imaging database (**Figure B, Appendix B**).

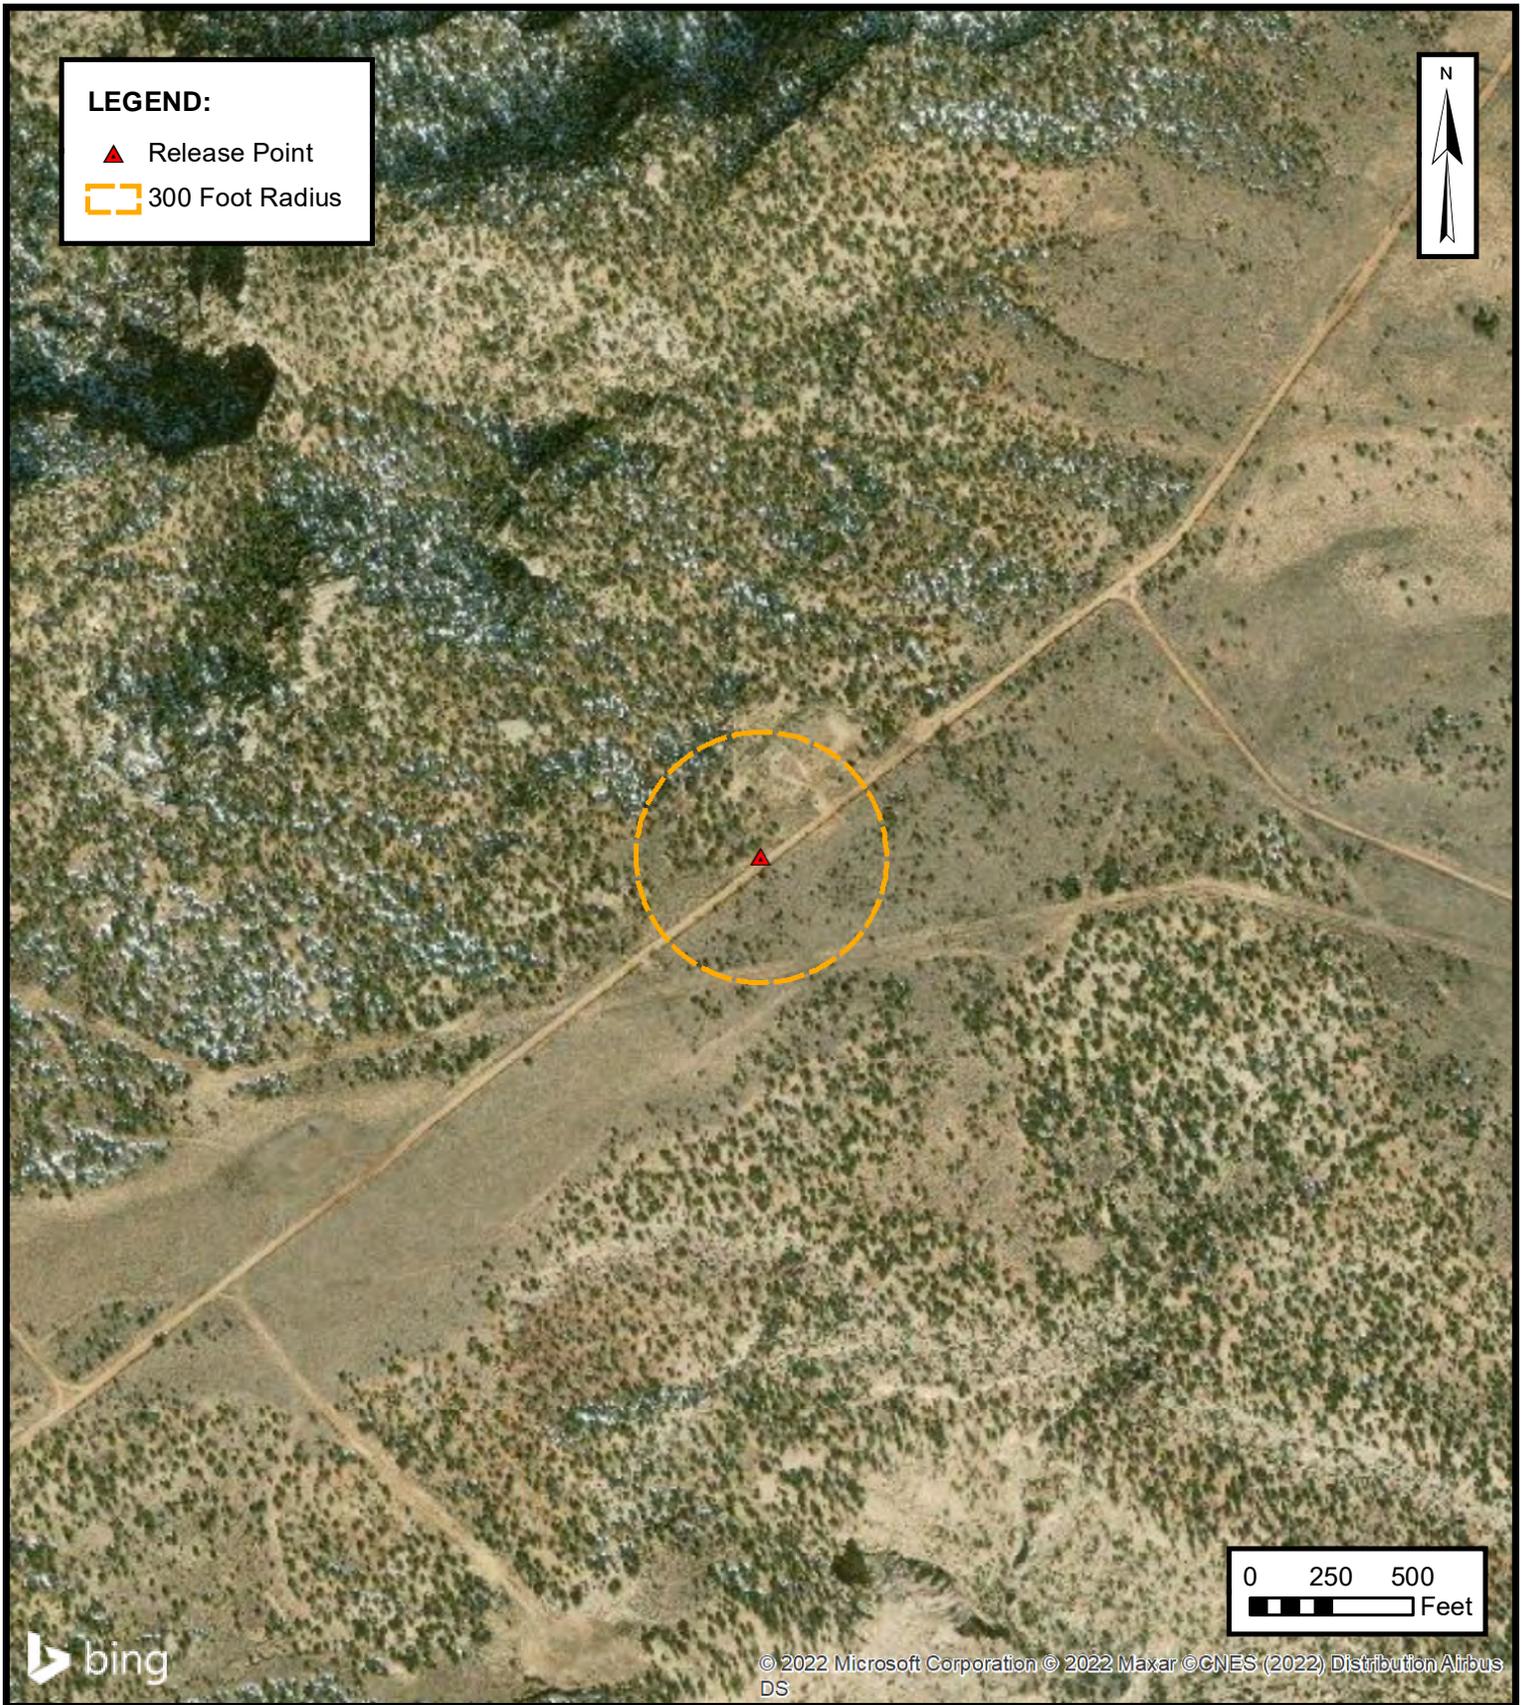
**FIGURE  
C**

**300 FOOT RADIUS  
WATERCOURSE AND DRAINAGE IDENTIFICATION**  
 ENTERPRISE FIELD SERVICES, LLC  
 LATERAL 2C-6 (3/2/22)  
 Unit Letter P, S31 T26N R7W, Rio Arriba County, New Mexico  
 36.438720° N, 107.611543° W  
 PROJECT NUMBER: 05A1226186

- The Site is not located within 300 feet of a NM EMNRD OCD-defined continuously flowing watercourse or significant watercourse (**Figure C, Appendix B**).

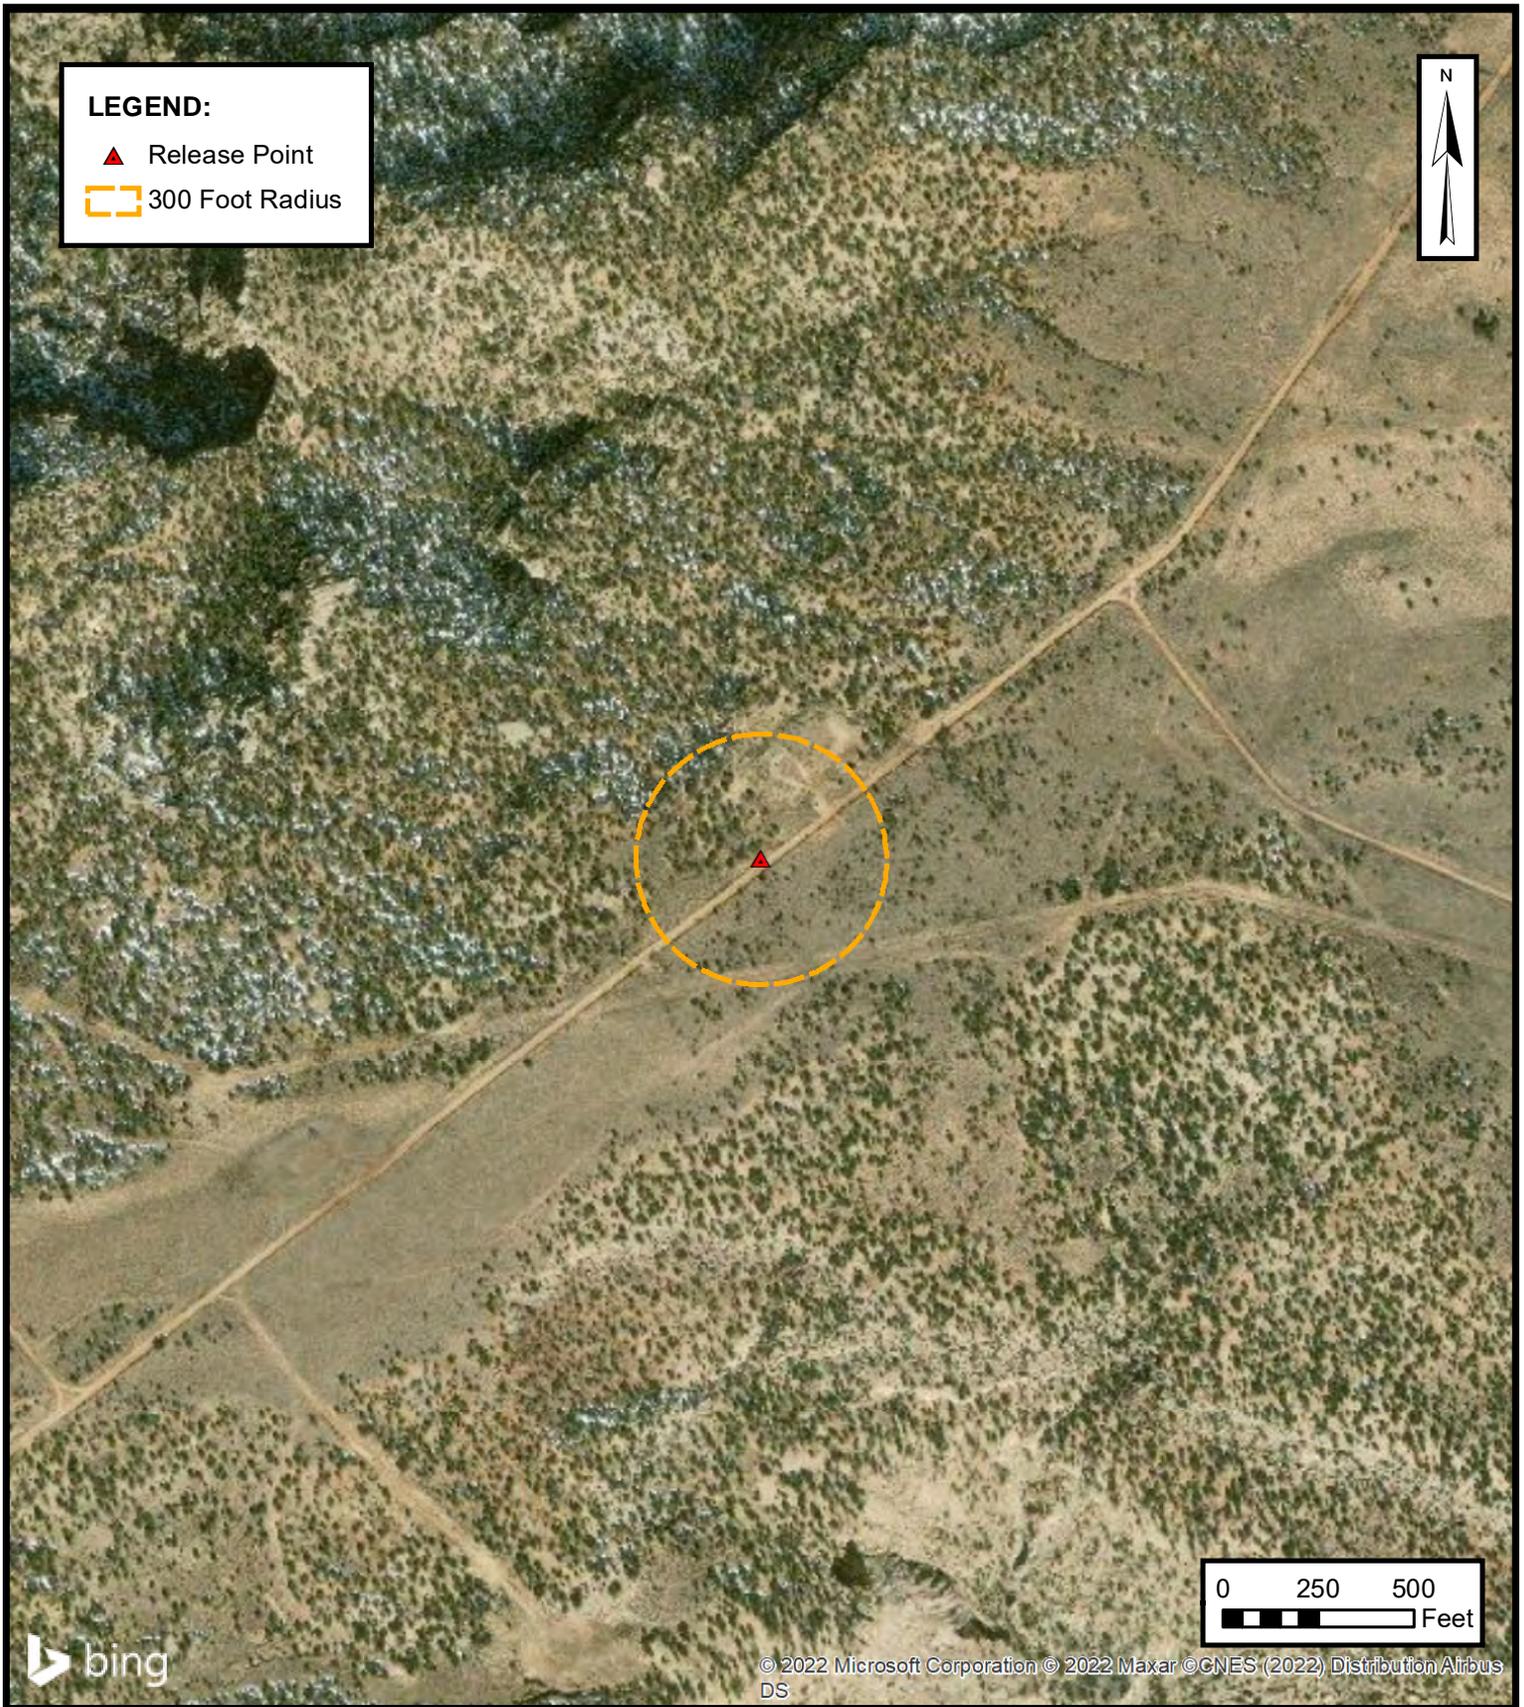
**FIGURE  
D**

**300 FOOT RADIUS  
OCCUPIED STRUCTURE IDENTIFICATION**  
ENTERPRISE FIELD SERVICES, LLC  
LATERAL 2C-6 (3/2/22)  
Unit Letter P, S31 T26N R7W, Rio Arriba County, New Mexico  
36.438720° N, 107.611543° W  
PROJECT NUMBER: 05A1226186

- The Site is not located within 200 feet of a lakebed, sinkhole, or playa lake.
- The Site is not located within 300 feet of a permanent residence, school, hospital, institution, or church (**Figure D, Appendix B**).

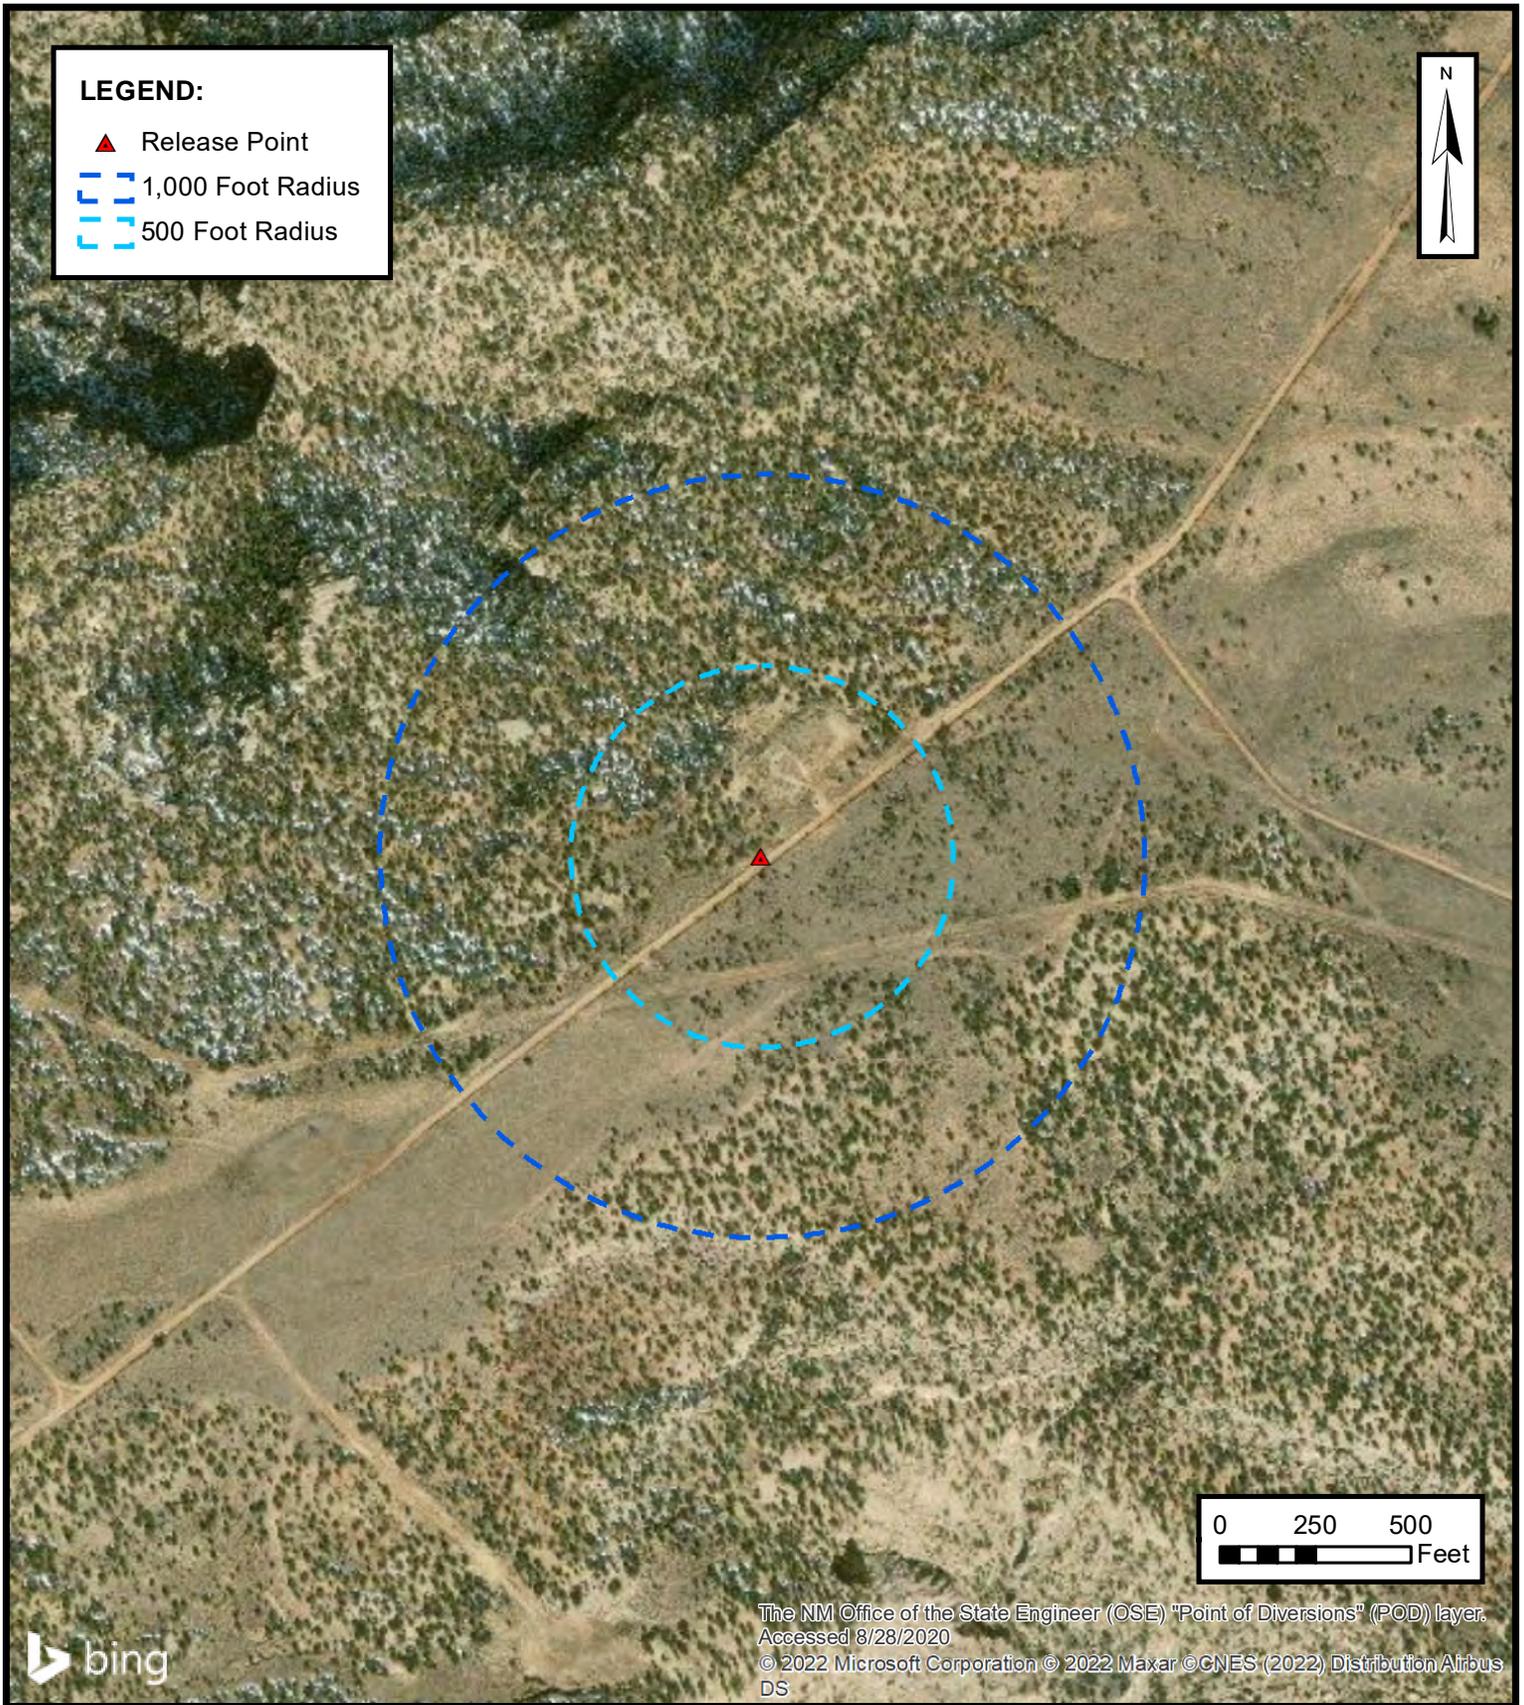
**FIGURE**  
**E**

**WATER WELL AND NATURAL SPRING LOCATION**

- No springs, or private domestic fresh water wells used by less than five households for domestic or stock watering purposes were identified within 500 feet of the Site (**Figure E, Appendix B**).

- No fresh water wells or springs were identified within 1,000 feet of the Site (**Figure E, Appendix B**).
- The Site is not located within incorporated municipal boundaries or within a defined municipal fresh water well field covered under a municipal ordinance adopted pursuant to New Mexico Statutes Annotated (NMSA) 1978, Section 3-27-3.

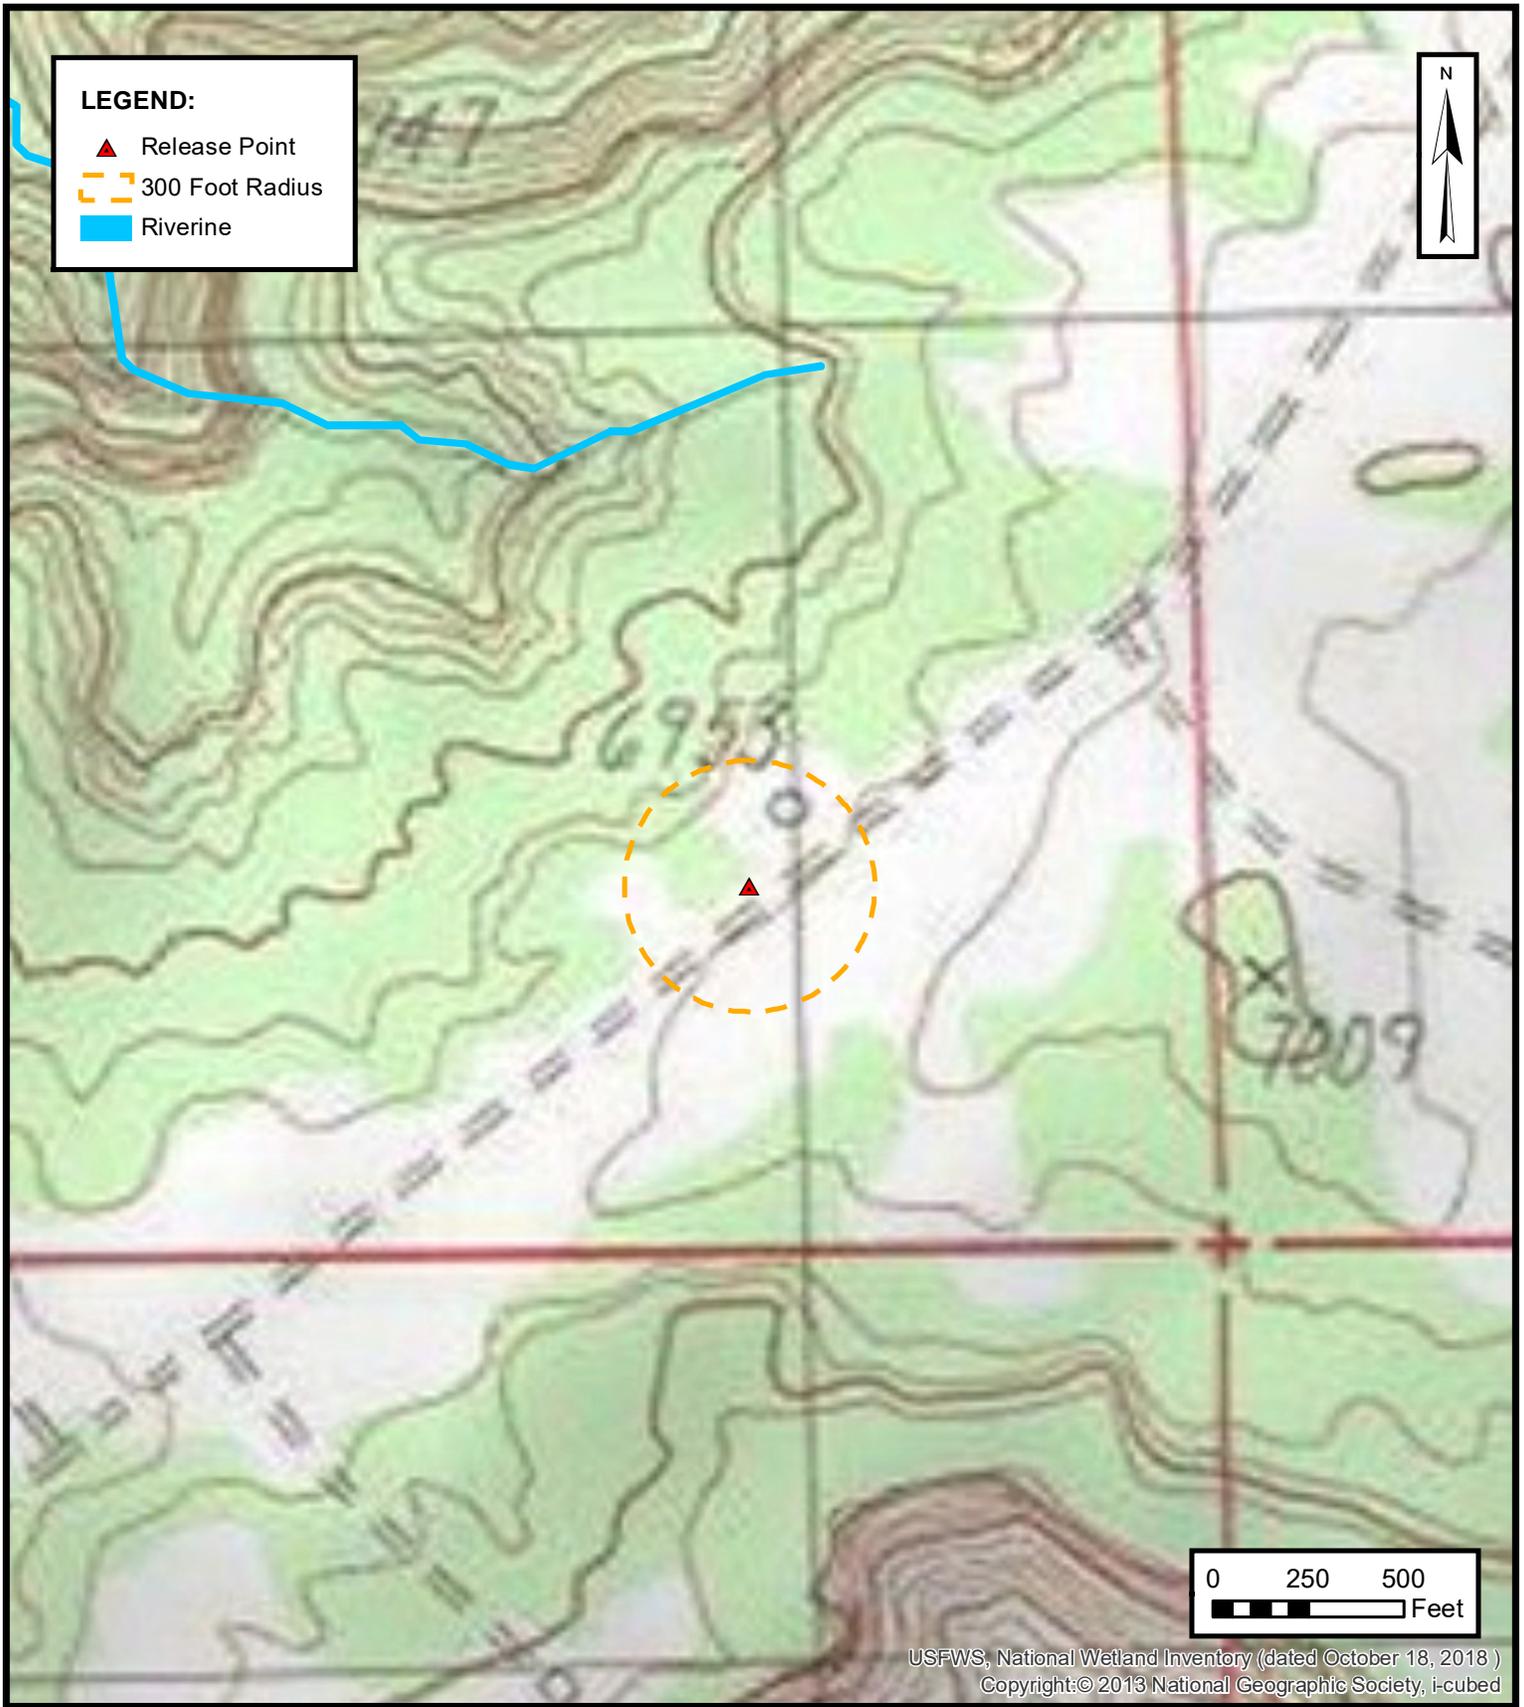
**F**

**WETLANDS**

- Based on information identified in the U.S. Fish & Wildlife Service National Wetlands Inventory Wetlands Mapper, the Site is not within 300 feet of a wetland (**Figure F, Appendix B**).
