**CLOSURE REPORT**

**Lateral 2C-6 (3/2/22)  
Unit Letter P, S31 T26N R7W  
Rio Arriba County, New Mexico**

**New Mexico EMNRD OCD Incident ID No. NAPP2206337228**

May 23, 2022  
Ensolum Project No. 05A1226186

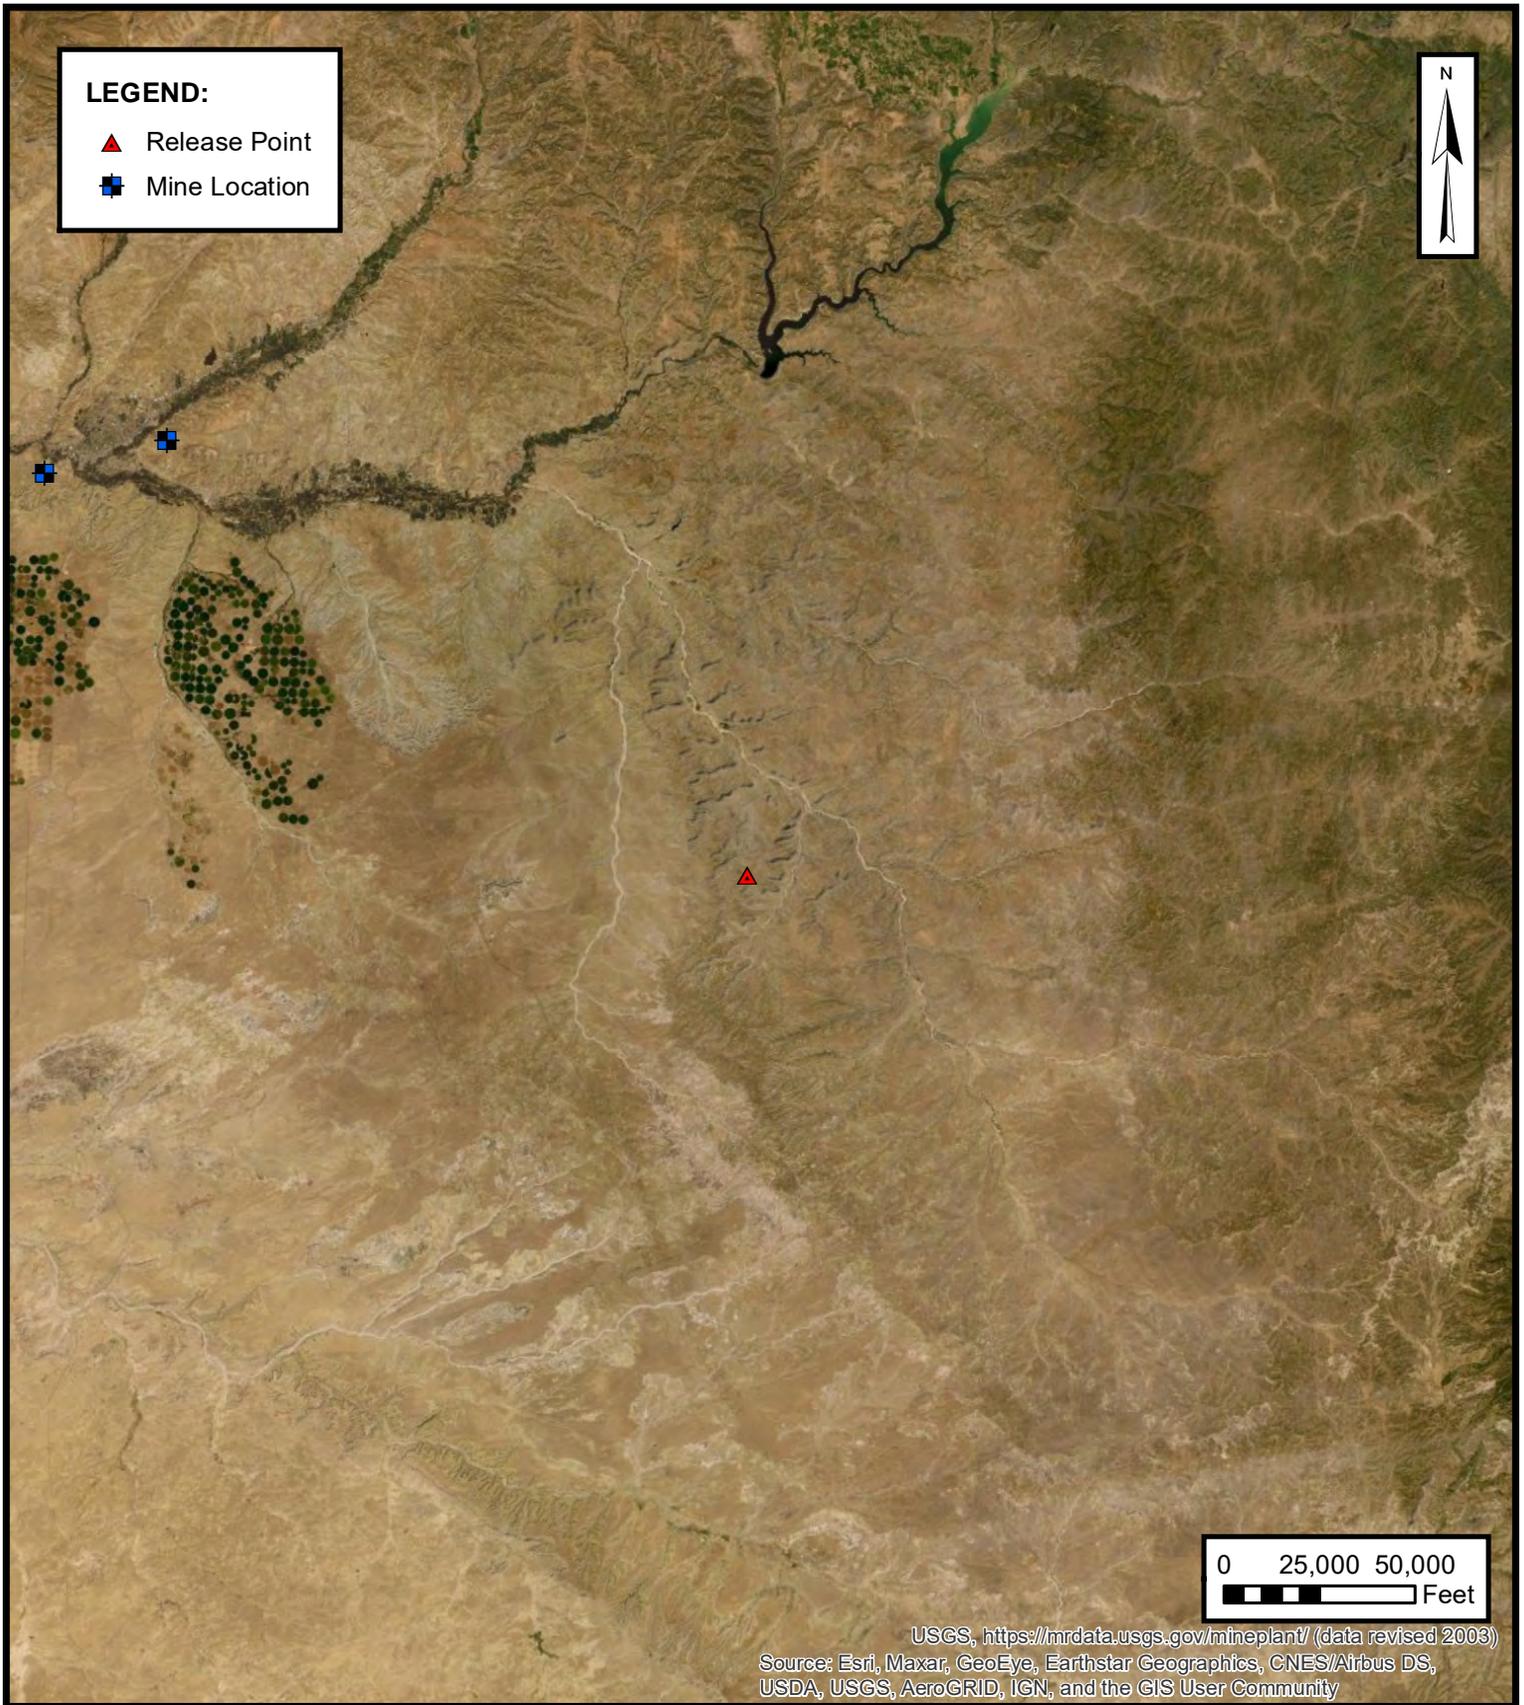
**G**

**MINES, MILLS AND QUARRIES**

- Based on information identified in the NM Mining and Minerals Division's Geographic Information System (GIS) Maps and Mine Data database, the Site is not within an area overlying a subsurface mine (**Figure G, Appendix B**).

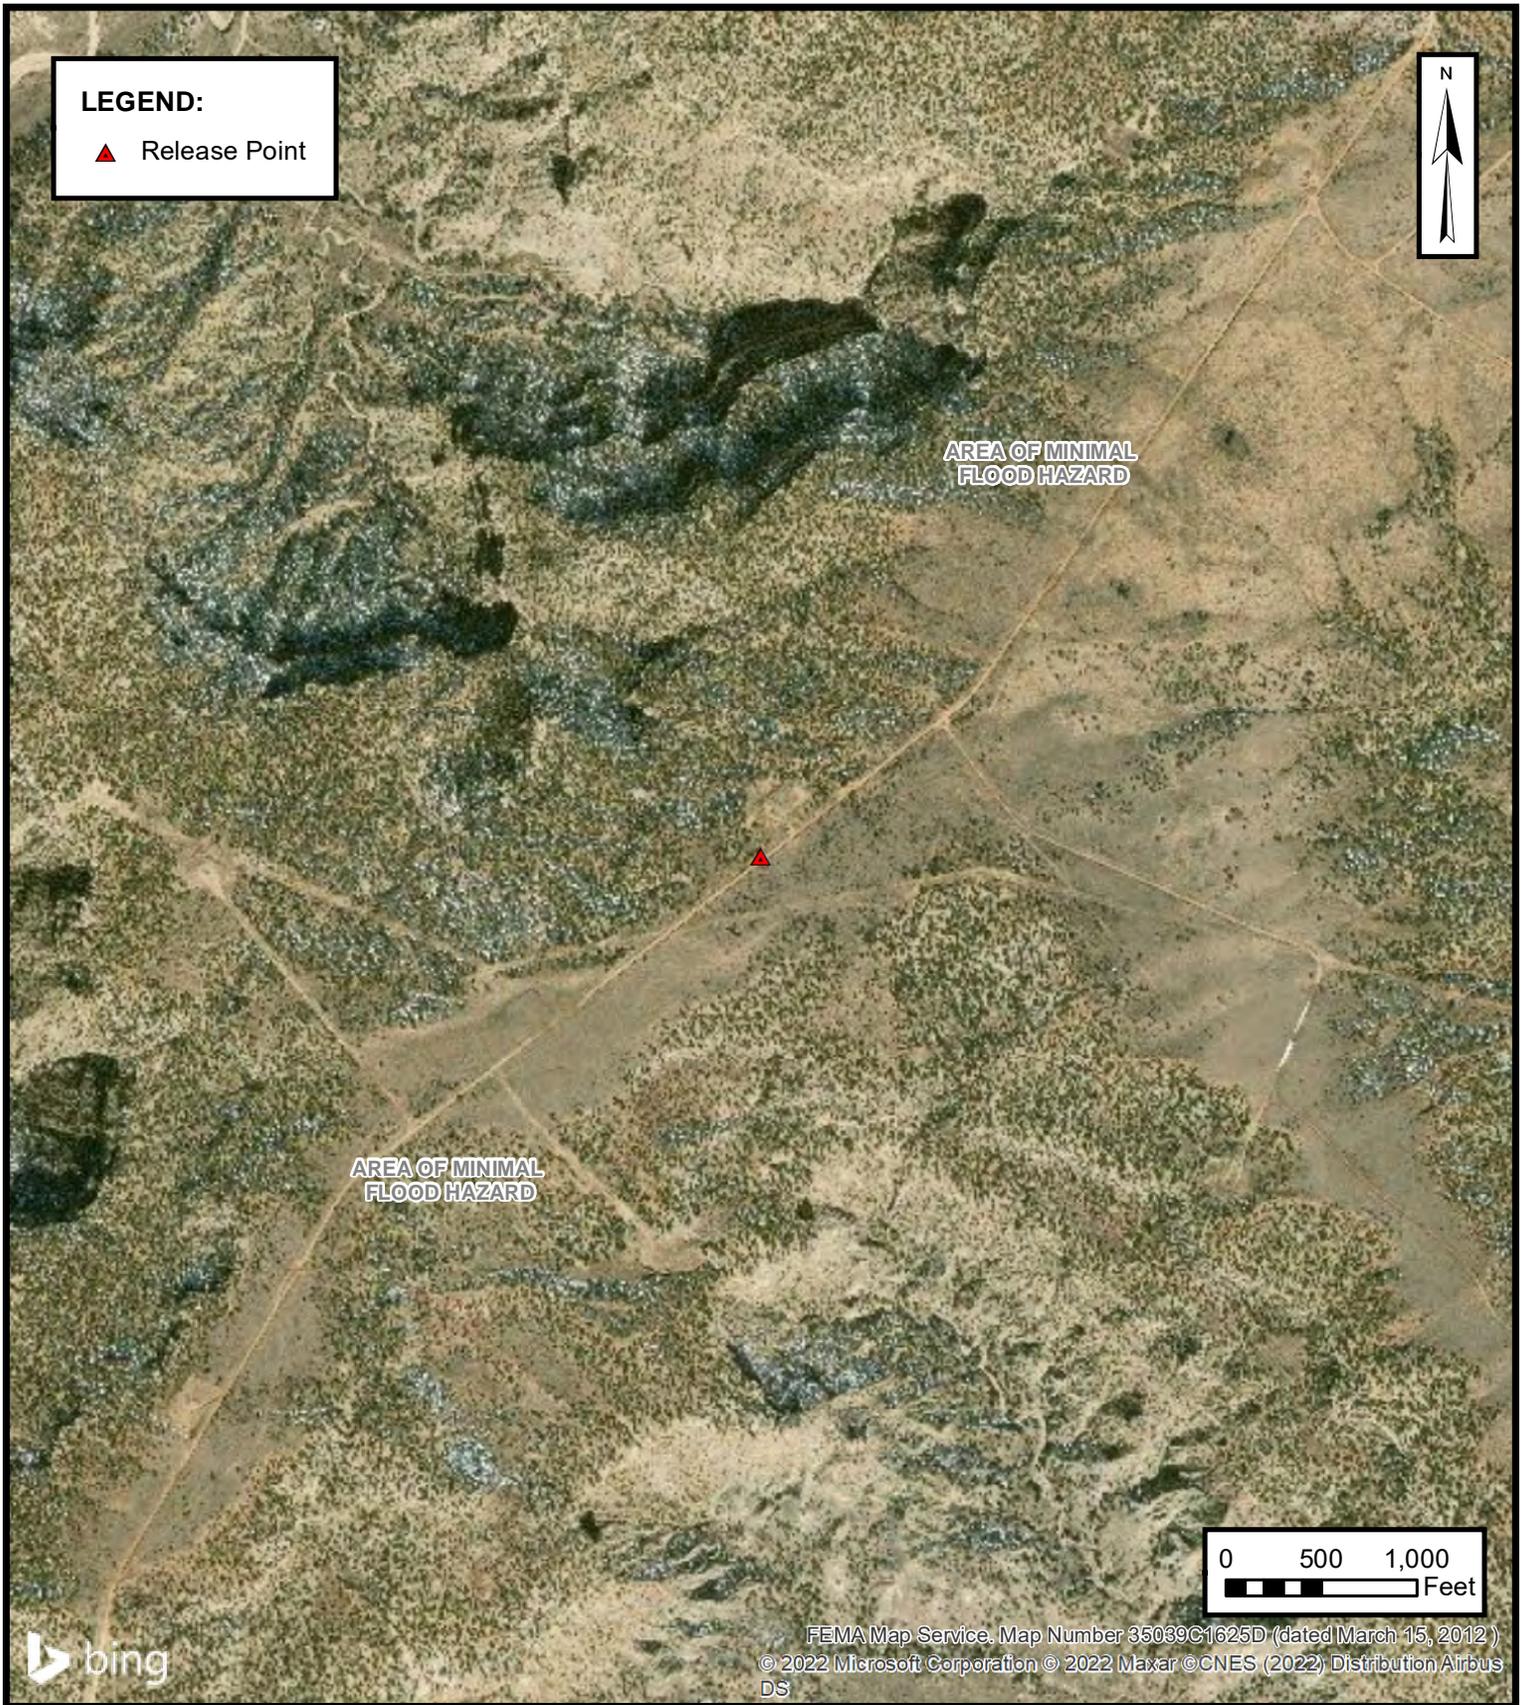
**100-YEAR FLOOD PLAIN MAP**

- The Site is not located within an unstable area.
- Based on information provided by the Federal Emergency Management Agency (FEMA) National Flood Hazard Layer (NFHL) geospatial database, the Site is not within a 100-year floodplain (**Figure H, Appendix B**).

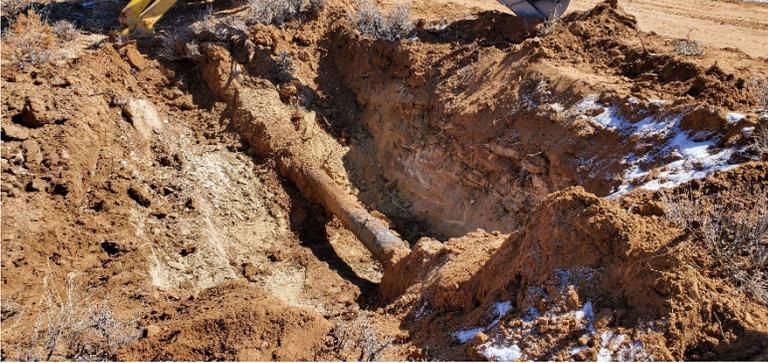
<p><b>Photograph 1</b></p> <p>Photograph Description: View of the in-process excavation activities.</p>

The final primary excavation measured approximately 32 feet long and 6 feet wide at the maximum extents. The maximum depth of the excavation measured approximately 6 feet bgs. The flow path excavation measured approximately 224 feet long and 8 feet wide at the maximum extents. The maximum depth of the flow path excavation measured approximately 1.5 feet bgs. The lithology encountered during the completion of remediation activities consisted primarily of sandy silt underlain by sandstone.

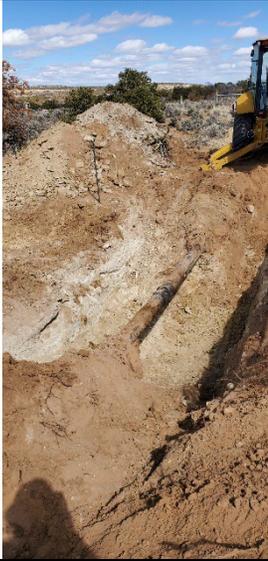
A photograph showing an active excavation site. A large, dark pipe is being laid into a deep, reddish-brown soil trench. A yellow excavator is visible at the top left of the frame.
<p><b>Photograph 2</b></p> <p>Photograph Description: View of the final excavation.</p>

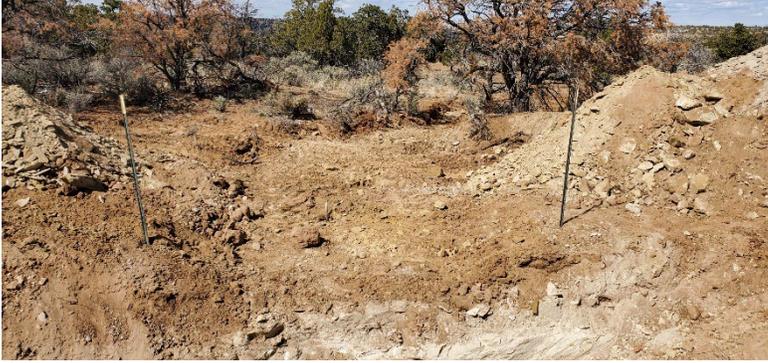
A vertical photograph showing a completed excavation. A dark pipe is visible, partially buried in the soil. A yellow excavator is positioned at the top right of the excavation.
<p><b>Photograph 3</b></p> <p>Photograph Description: View of the final flow path excavation.</p>

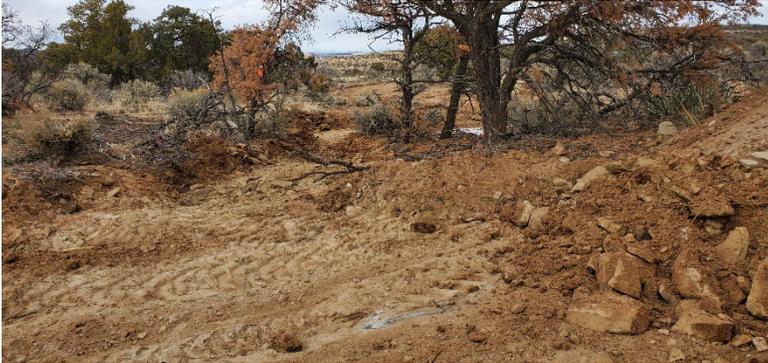
<p><b>Photograph 4</b></p> <p>Photograph Description: View of the final flow path excavation.</p>

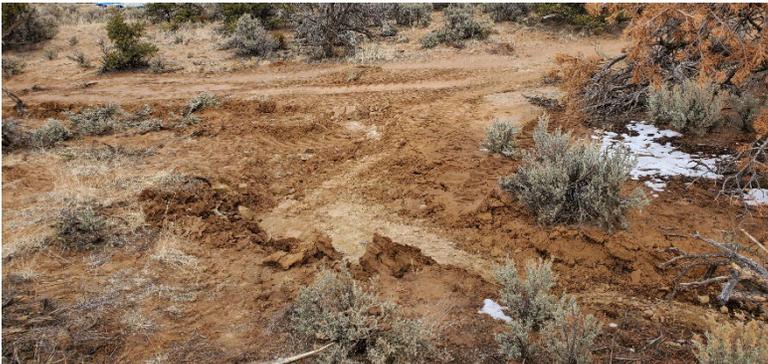
A photograph showing a wide, shallow excavation of reddish-brown soil. The ground is uneven with some rocks and sparse vegetation. In the background, there are several trees and a clear sky.
<p><b>Photograph 5</b></p> <p>Photograph Description: View of the final flow path excavation.</p>

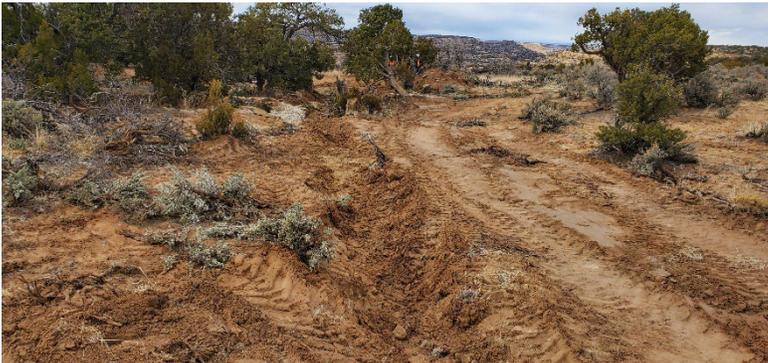
A photograph showing a view of the final flow path excavation. The ground is reddish-brown soil with some sparse vegetation and a small puddle of water on the right side. The background shows a clear sky and some trees.
<p><b>Photograph 6</b></p> <p>Photograph Description: View of the final flow path excavation.</p>

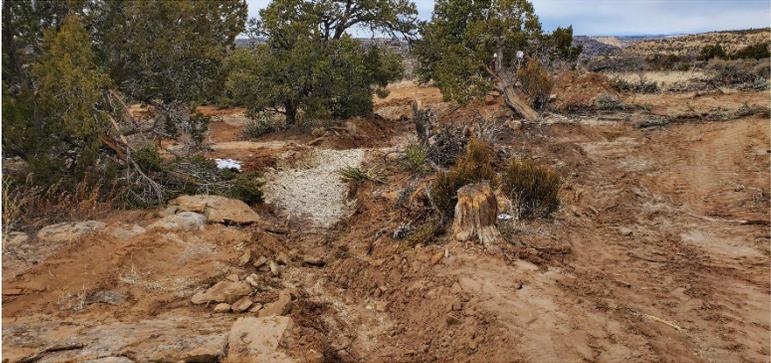
<p><b>Photograph 7</b></p> <p>Photograph Description: View of the final flow path excavation.</p>

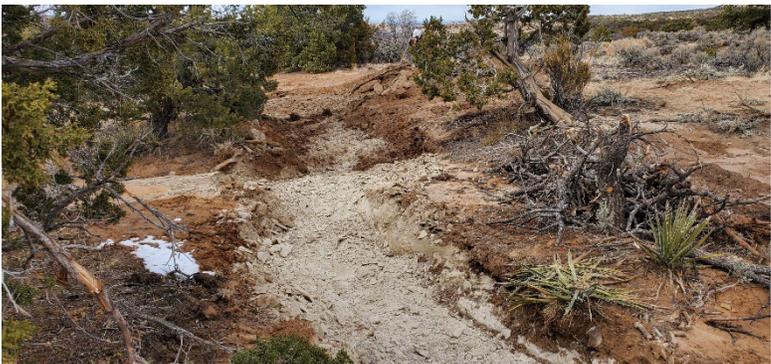
A photograph showing a dirt and rock excavation path in a dry, brushy landscape. The path is reddish-brown and appears to be a channel for water flow. There are some trees and shrubs on either side.
<p><b>Photograph 8</b></p> <p>Photograph Description: View of the final flow path excavation.</p>

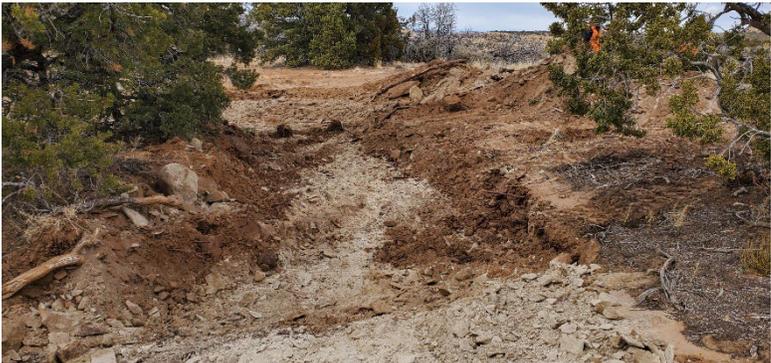
A photograph showing a dirt and rock excavation path in a dry, brushy landscape. The path is reddish-brown and appears to be a channel for water flow. There are some trees and shrubs on either side.
<p><b>Photograph 9</b></p> <p>Photograph Description: View of the final flow path excavation.</p>

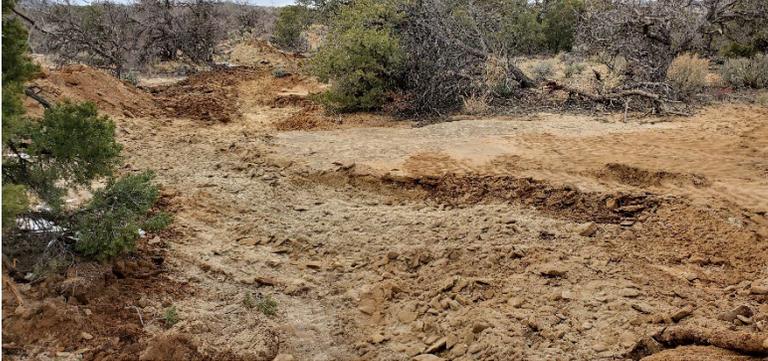
<p><b>Photograph 10</b></p> <p>Photograph Description: View of the final flow path excavation.</p>

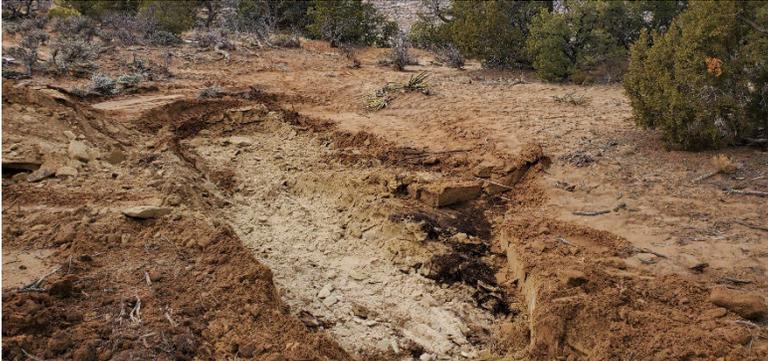
A photograph showing a wide, shallow excavation of reddish-brown soil. The ground is uneven with some small rocks and sparse, dry vegetation. The background shows a line of trees under a clear sky.
<p><b>Photograph 11</b></p> <p>Photograph Description: View of the final flow path excavation.</p>

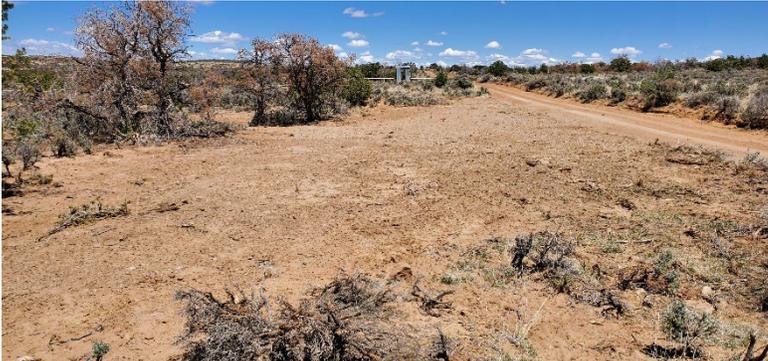
A photograph showing a similar view to Photograph 10, but from a slightly different angle. It shows a deep, narrow channel of reddish-brown soil with some exposed roots and rocks. The surrounding area is dry and rocky.
<p><b>Photograph 12</b></p> <p>Photograph Description: View of the site after initial restoration.</p>

The excavation was backfilled with clean imported fill and then contoured to the surrounding topography.
