## **Remediation and Closure Report**

Hawk 9 F Federal #7 Transfer line  
API #30-015-33182 \* 2RP-4909

Subject: **Remediation and Closure Report**  
Hawk 9 F Federal #7 Transfer Line  
API #30-015-33182 \* 2RP-4909

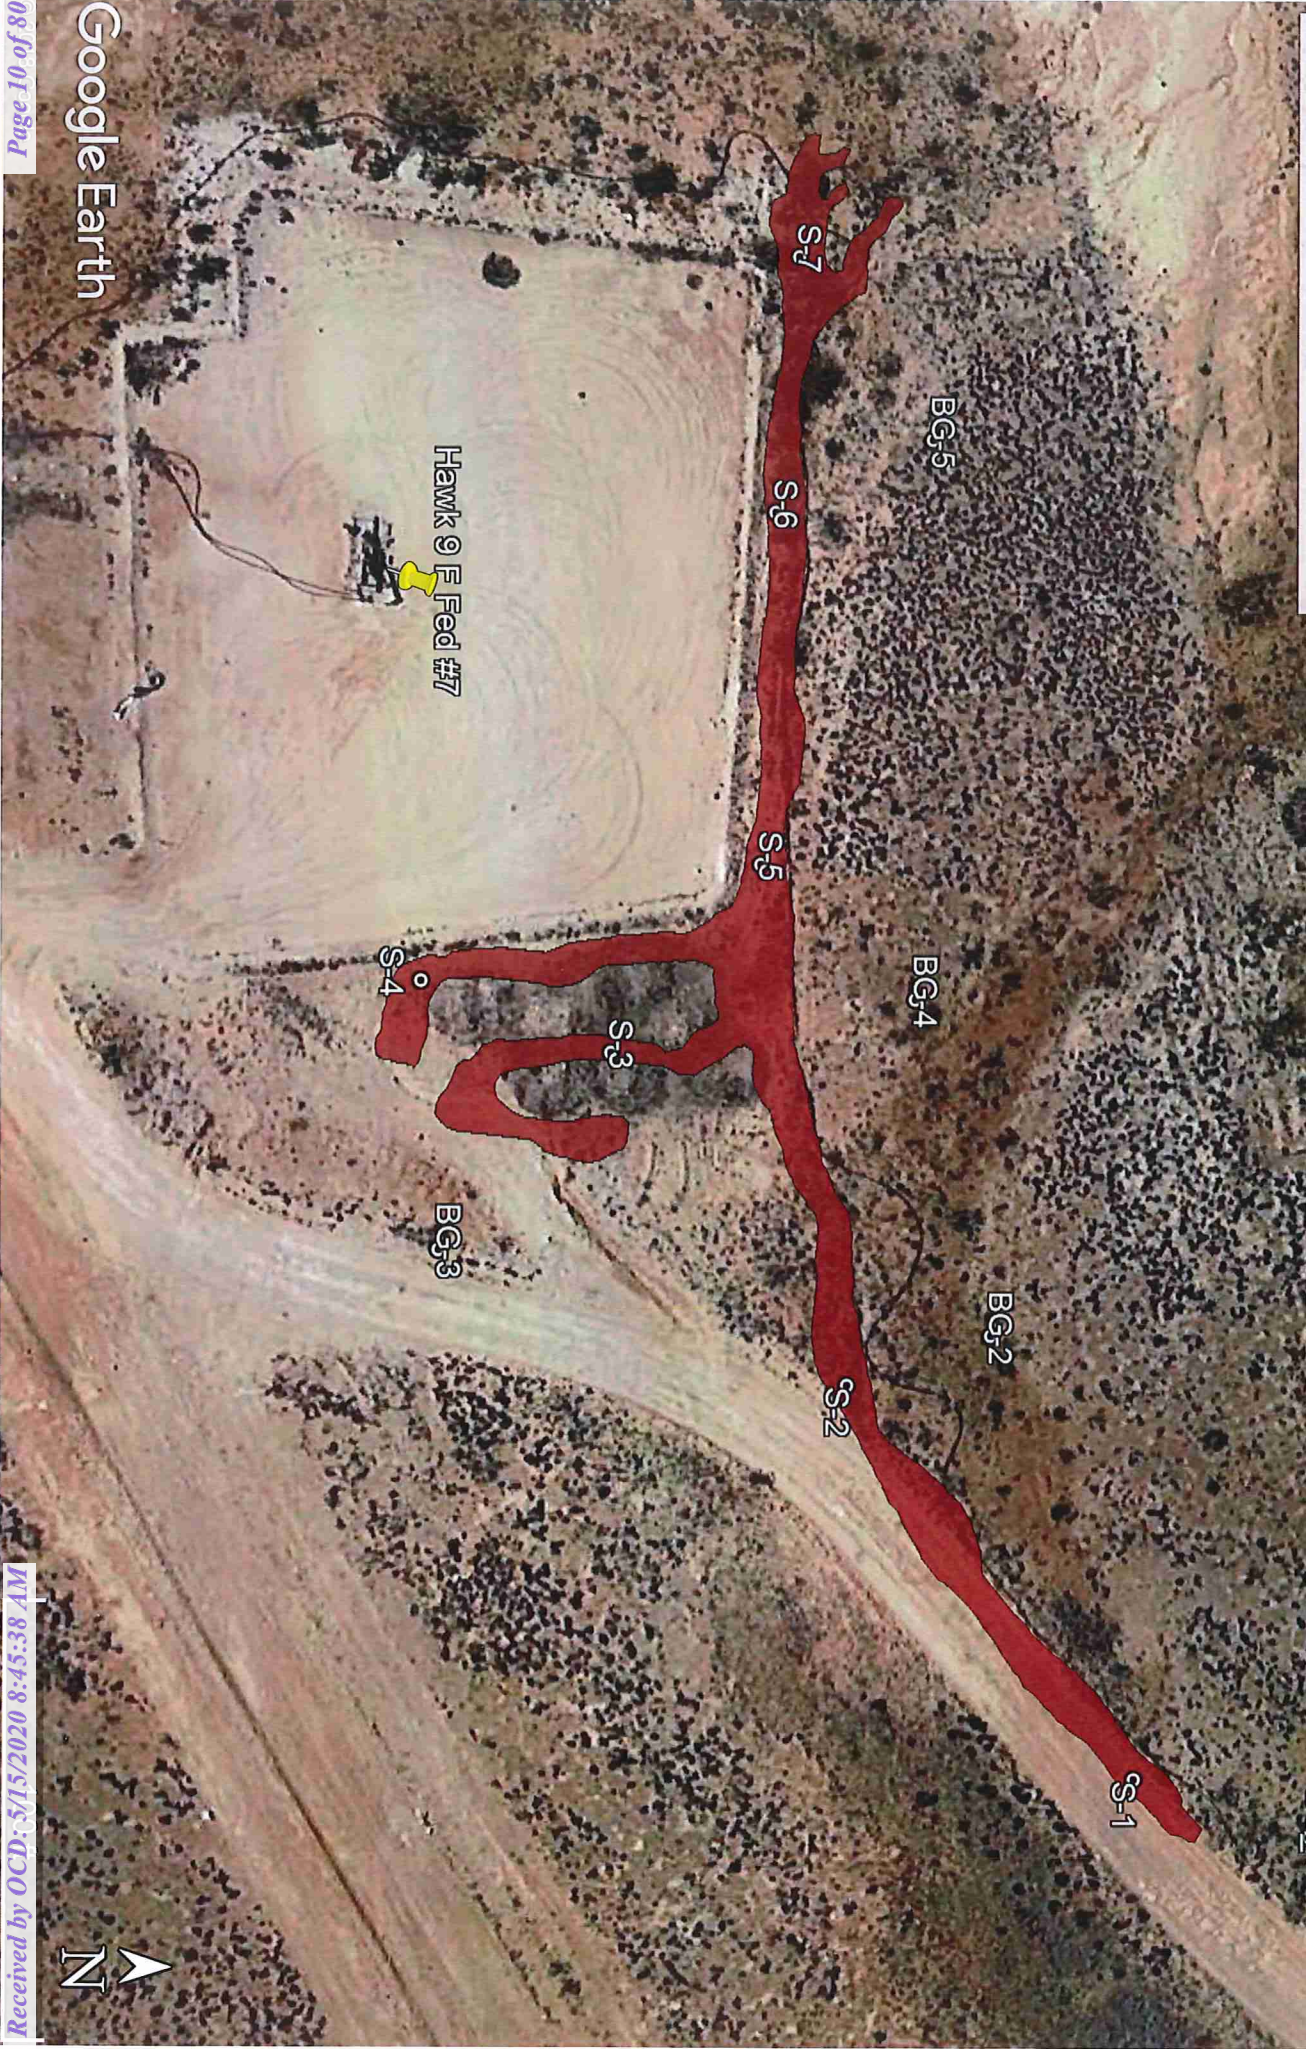
Samples

Spill Path

Google Earth

On July 23, 2018, the poly transfer line from the Hawk 9 battery ruptured resulting in the release of 35 barrels of produced water along the lease road pooling on the north and east sides of the Hawk 9 #7 location. The transfer line was isolated, repairs were made. No fluids were recovered. A site plan is presented in [Appendix I](#).

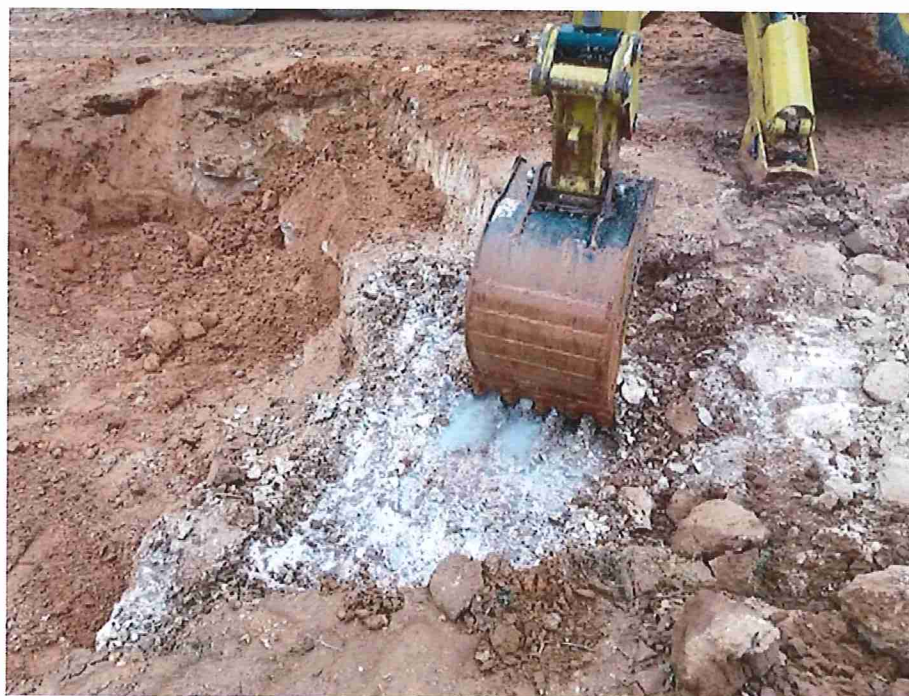
## PHOTOGRAPHS

## Refusal

- The impacted area in the vicinity of S-1 and S-2 along the lease road was excavated to a depth of 2.0 feet deep.
- The impacted area in the vicinity of S-3 and S-4 pooling areas were excavated to a depth of 1.5 to 2.0-feet.

- The impacted area in the vicinity of S-5 to S-6 was excavated to a depth of 2.0 feet deep.
- The impacted area in the vicinity of S-7 was excavated to a depth of 4.0 feet deep until the excavation was met with hard rock refusal with a backhoe.

- Unfortunately, excavation depths were met with hard rock refusal throughout the remediation process. Therefore excavation was completed to maximum depths possible. [Appendix IV](#) provides photographic documentation of this process.
