Release Notification

Site Name SPAU Injection Line	Site Type Flow Line - Injection
Date Release Discovered 9/15/2021	API# (if applicable) NA

Cause of Release The release is attributed to the failure of a fiberglass trunk line.

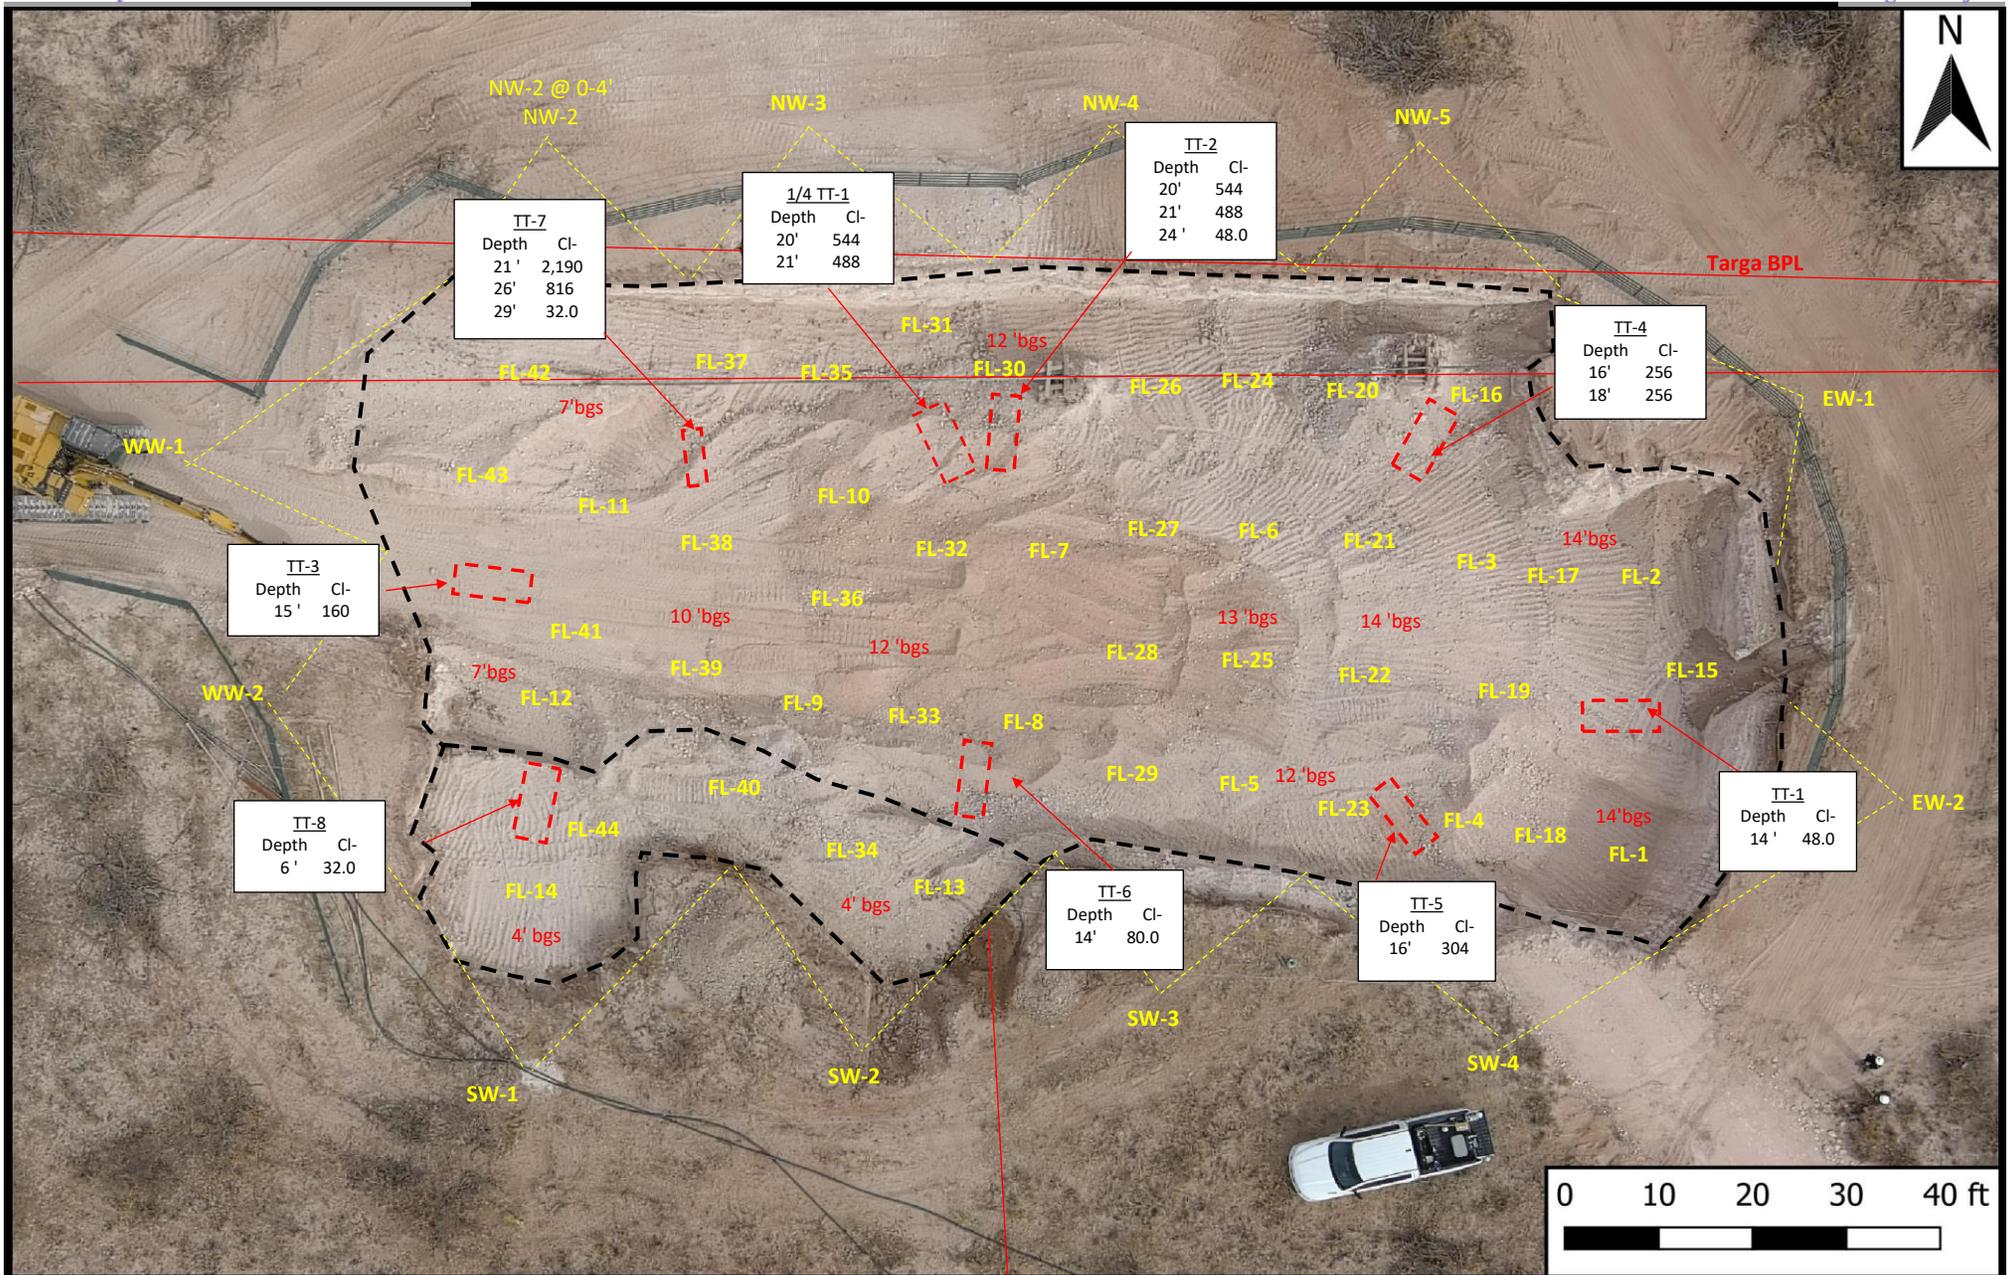
Figure 3

Site and Sample Location Map

TT-7	
Depth	Cl-
21'	2,190
26'	816
29'	32.0

1/4 TT-1	
Depth	Cl-
20'	544
21'	488

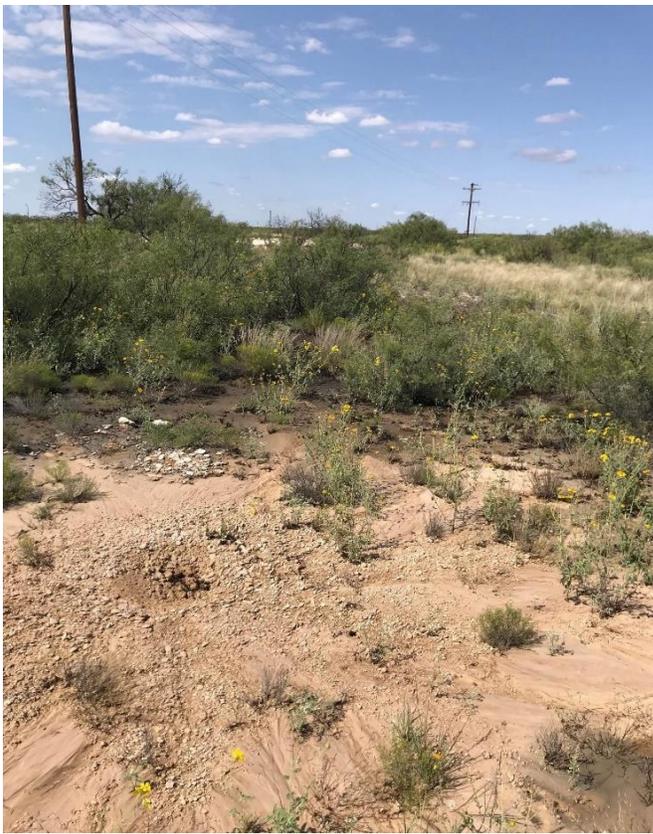
Photo Number: 1

Photo Direction: South	
Photo Description: View of impacted area.

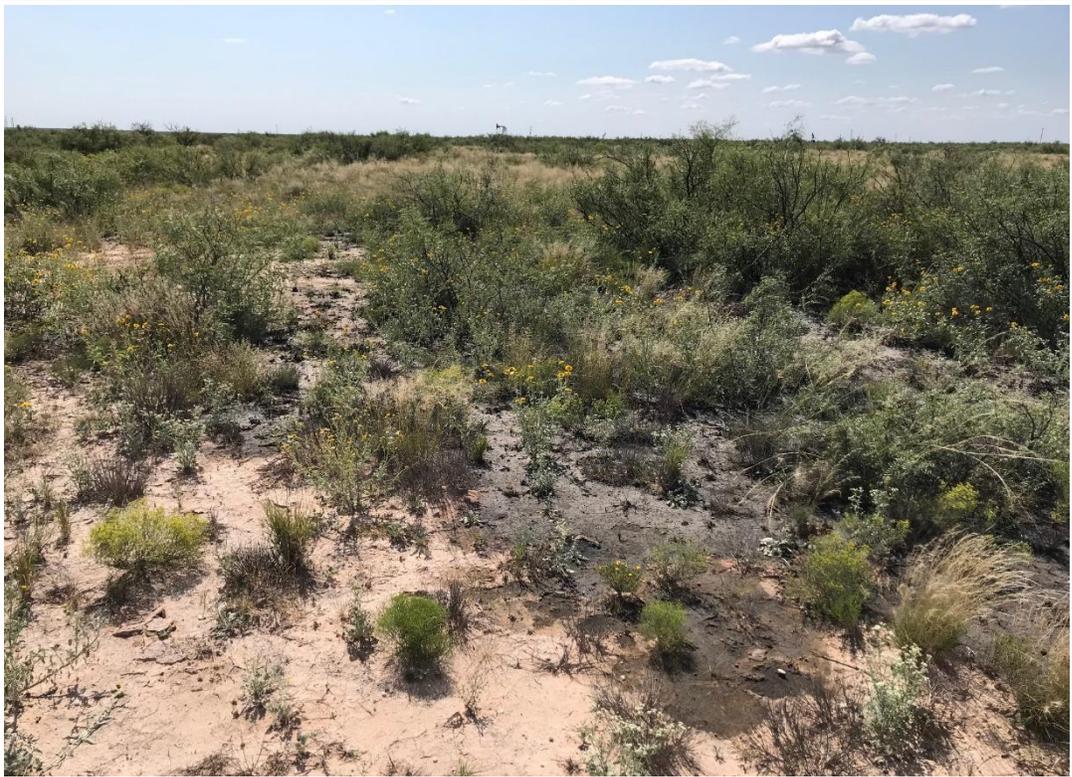
Photo Number: 2

Photo Direction: South	
Photo Description: View of impacted area.

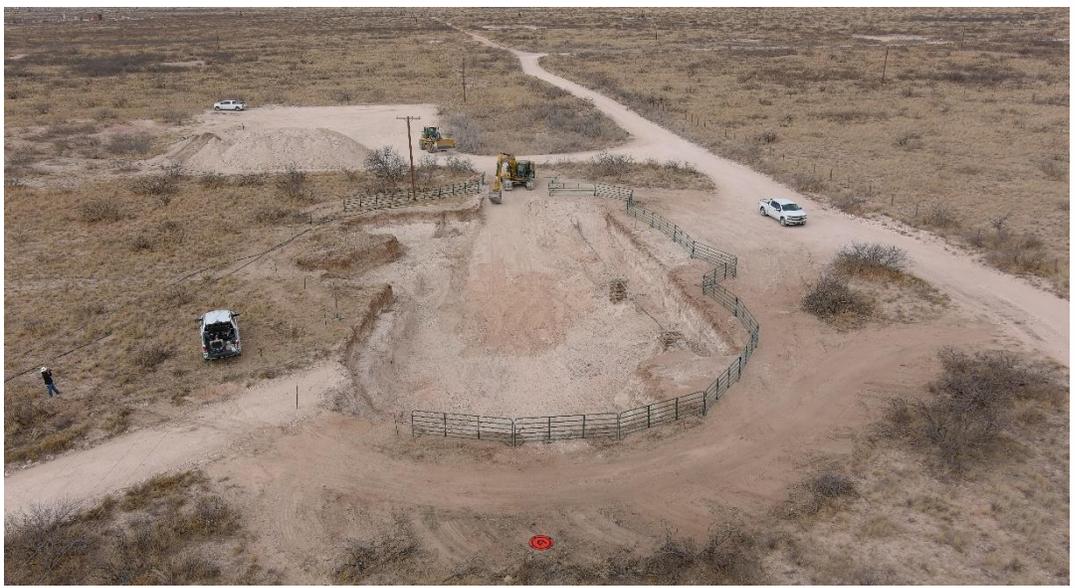
Photo Number: 3

Photo Direction: Top-Down	
Photo Description: Aerial view of excavation.

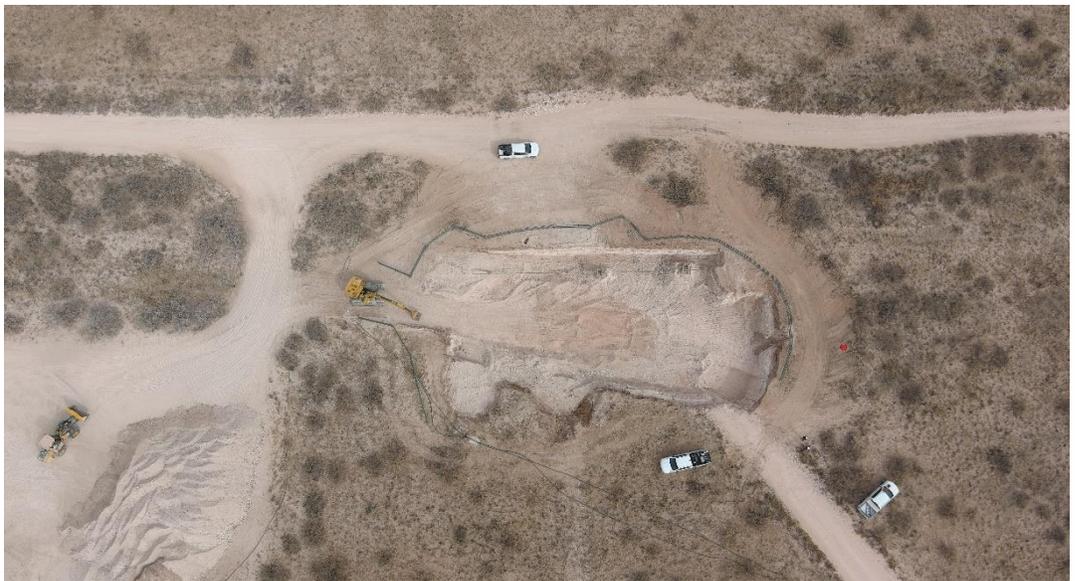
Photo Number: 4

Photo Direction: Top-Down	
Photo Description: Aerial view of excavation.

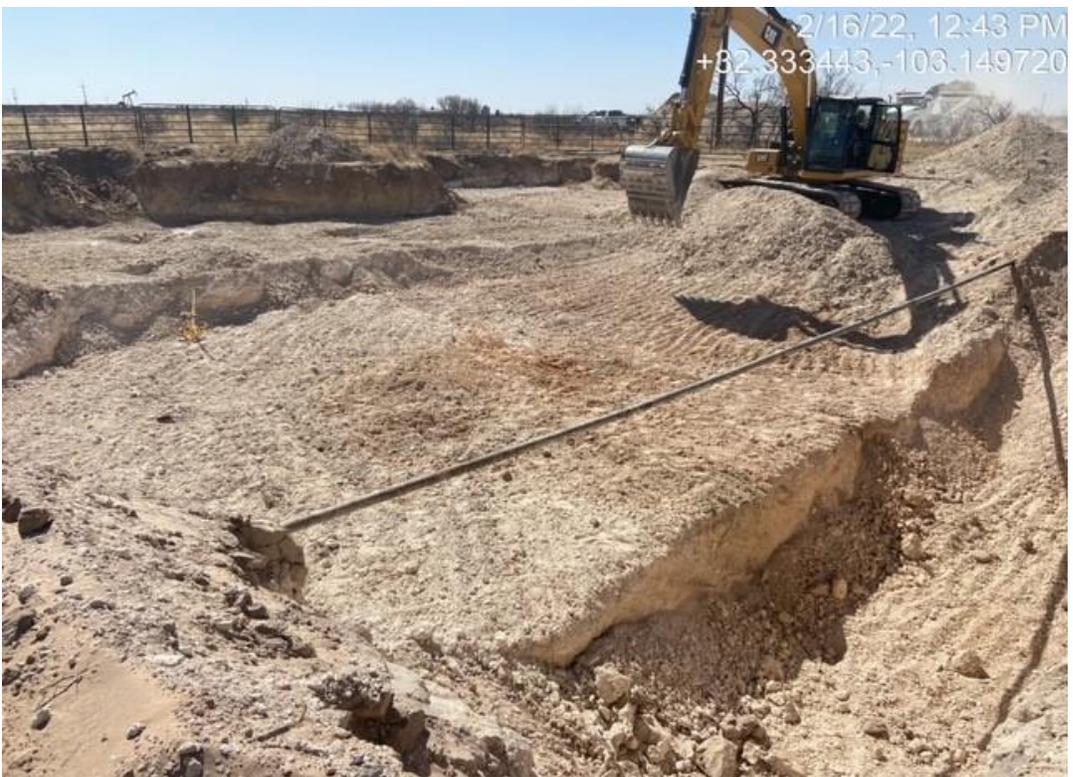
Photo Number: 5

<p>2/16/22, 12:43 PM +82.333443,-103.149720</p> <p>View of excavated area.</p>
Photo Direction: Southwest	
Photo Description:

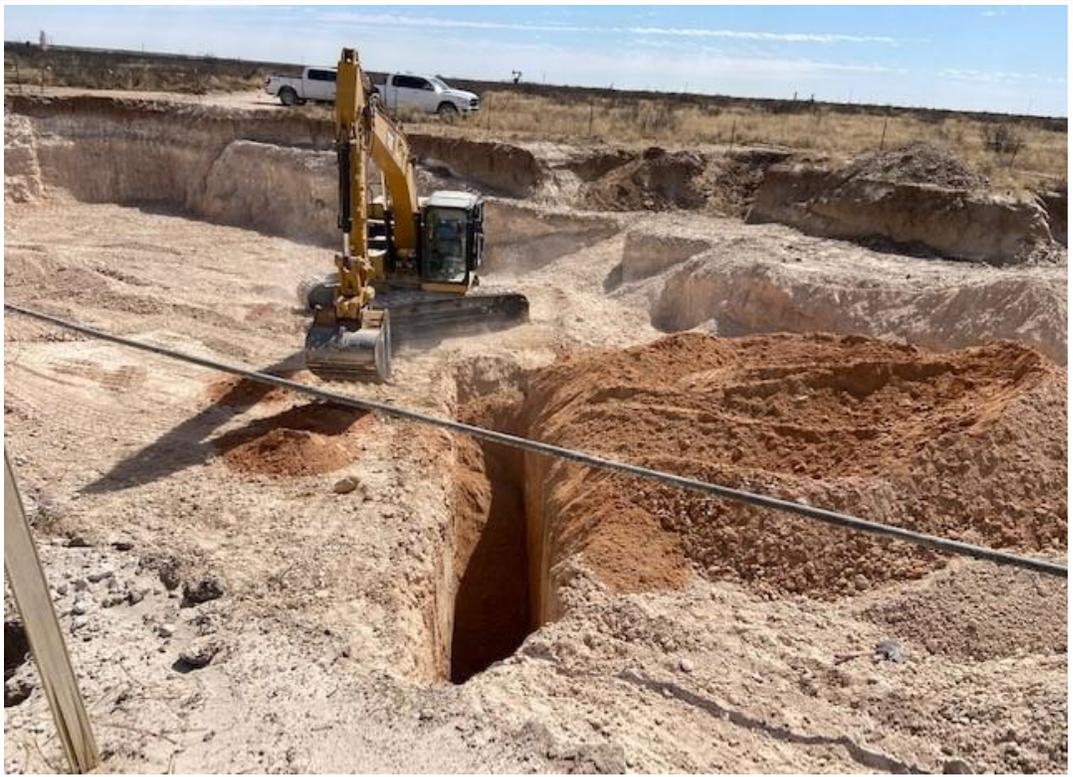
Photo Number: 6

<p>View of excavated area.</p>
Photo Direction: South	
Photo Description:

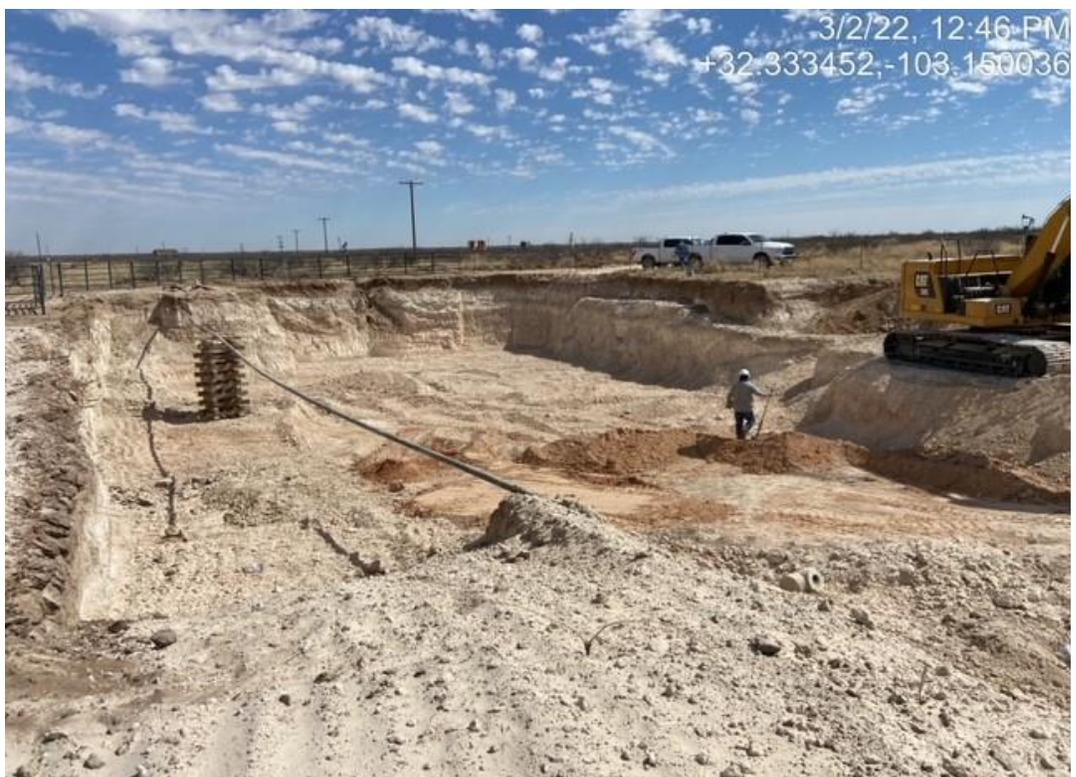
Photo Number: 7

<p>3/2/22, 12:46 PM +32.333452,-103.150036</p>
Photo Direction: Southeast	
Photo Description: View of excavated area.

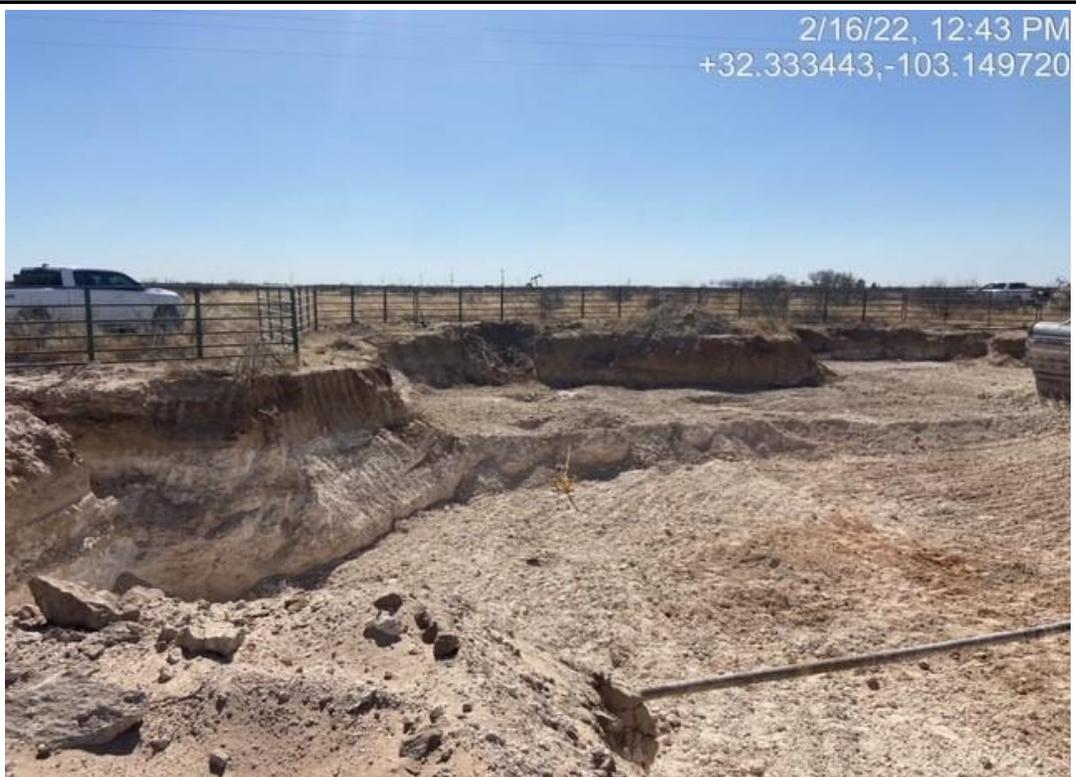
Photo Number: 8

<p>2/16/22, 12:43 PM +32.333443,-103.149720</p>
Photo Direction: South	
Photo Description: View of excavated area.
