July 29, 2022

**Re: Release Characterization, Remediation and Closure Report
ConocoPhillips
Fez Fee #011H Line Release
Unit Letter D, Section 9, Township 25 South, Range 35 East
Lea County, New Mexico
Incident ID NAPP2207444703**

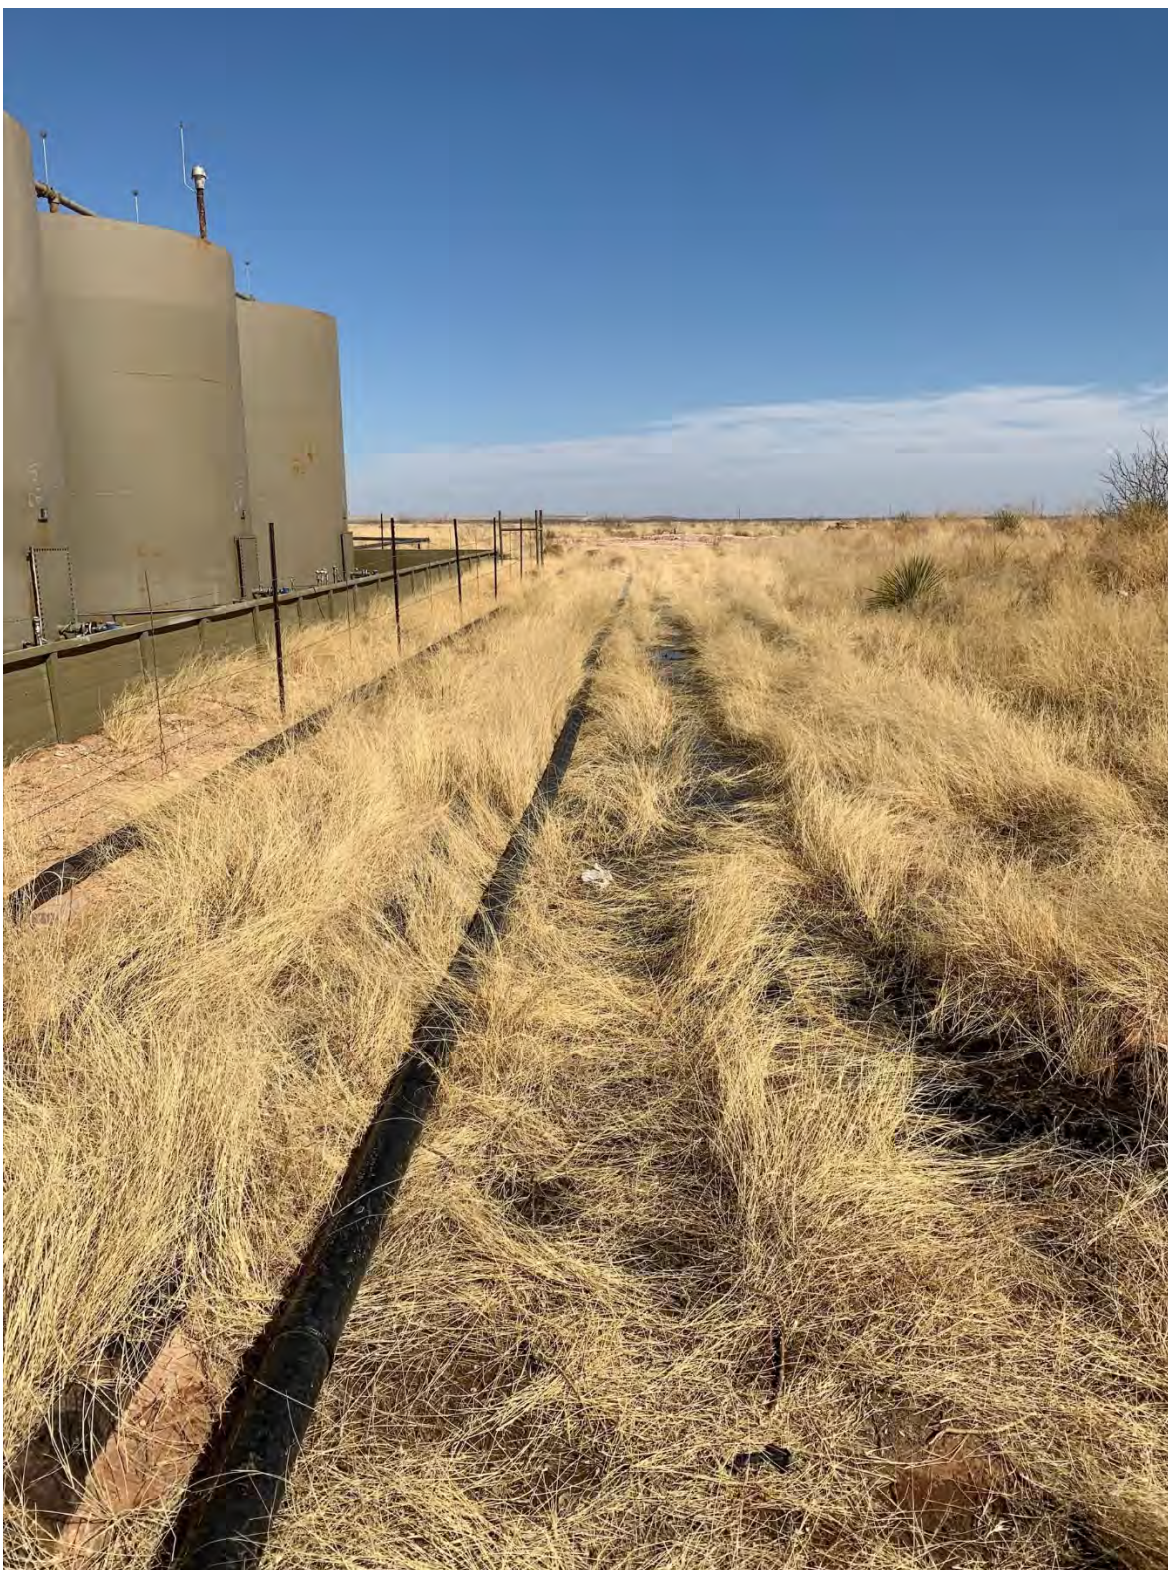
TETRA TECH, INC. PROJECT NO. 212C-MD-02712	DESCRIPTION	View east. Release extent.	1
	SITE NAME	Fez Fee #011H Line Release	3/2022

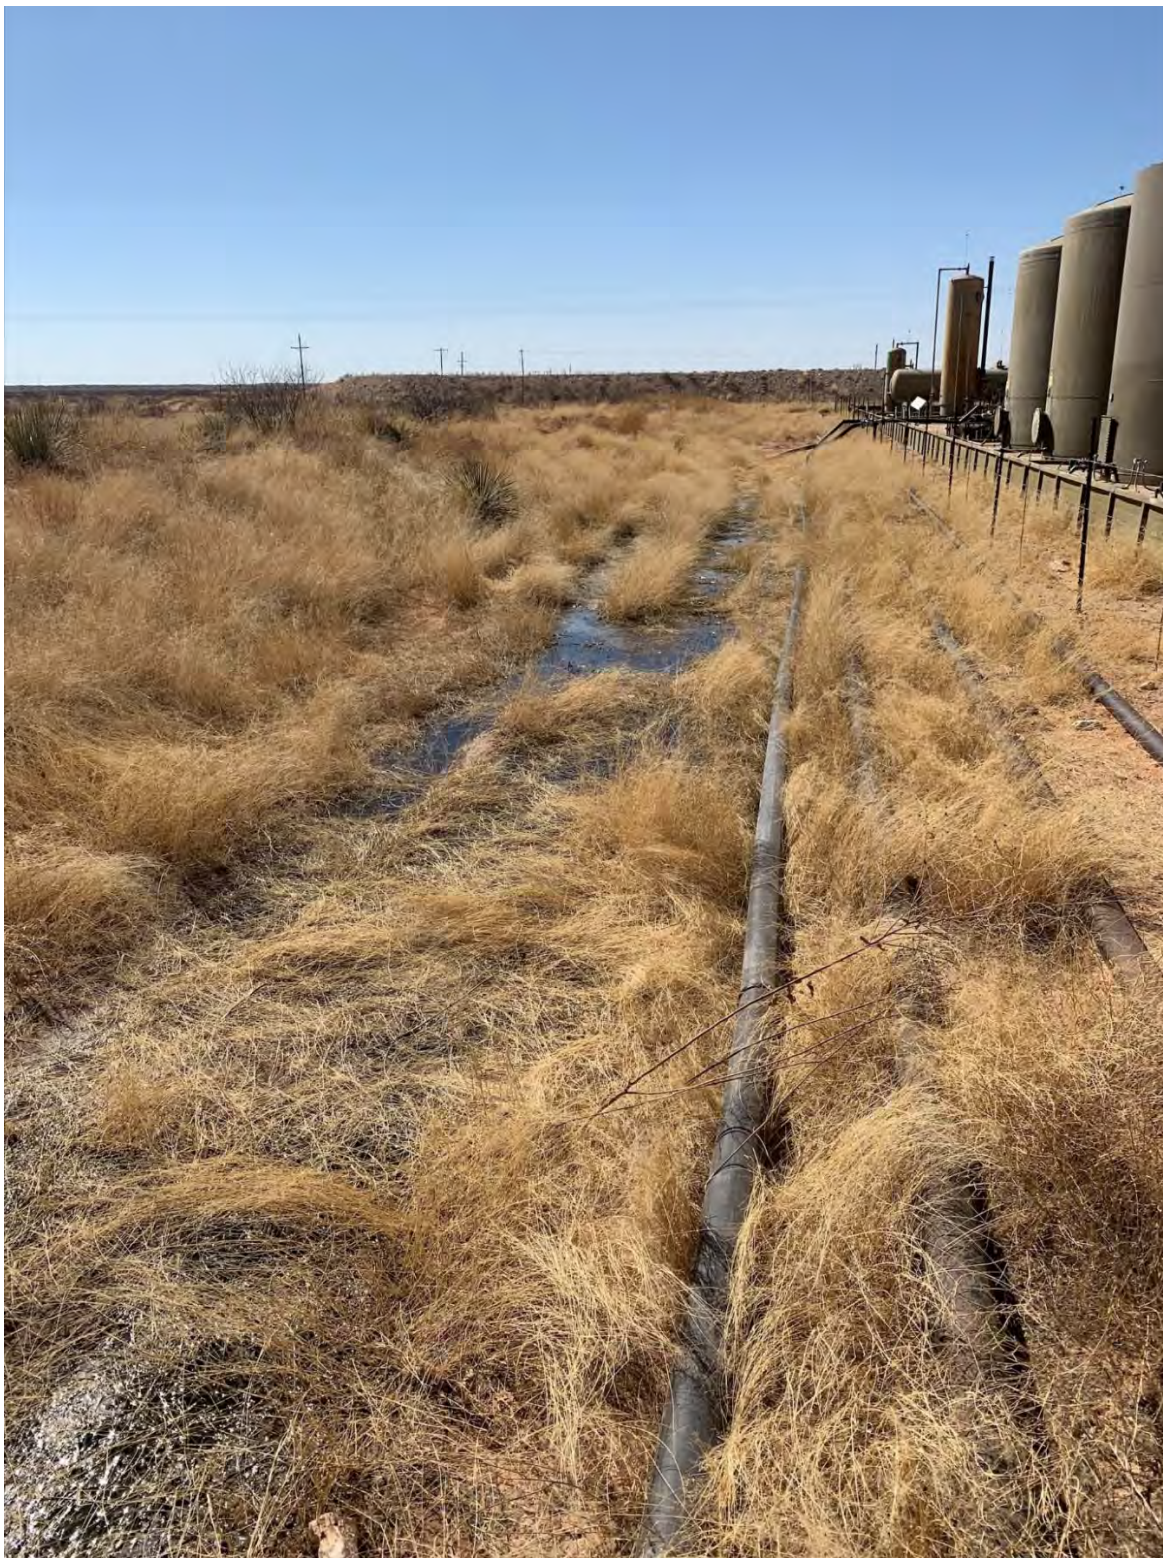
TETRA TECH, INC. PROJECT NO. 212C-MD-02712	DESCRIPTION	View west. Release area on the southern side of the tank battery.	2
	SITE NAME	Fez Fee #011H Line Release	3/2022

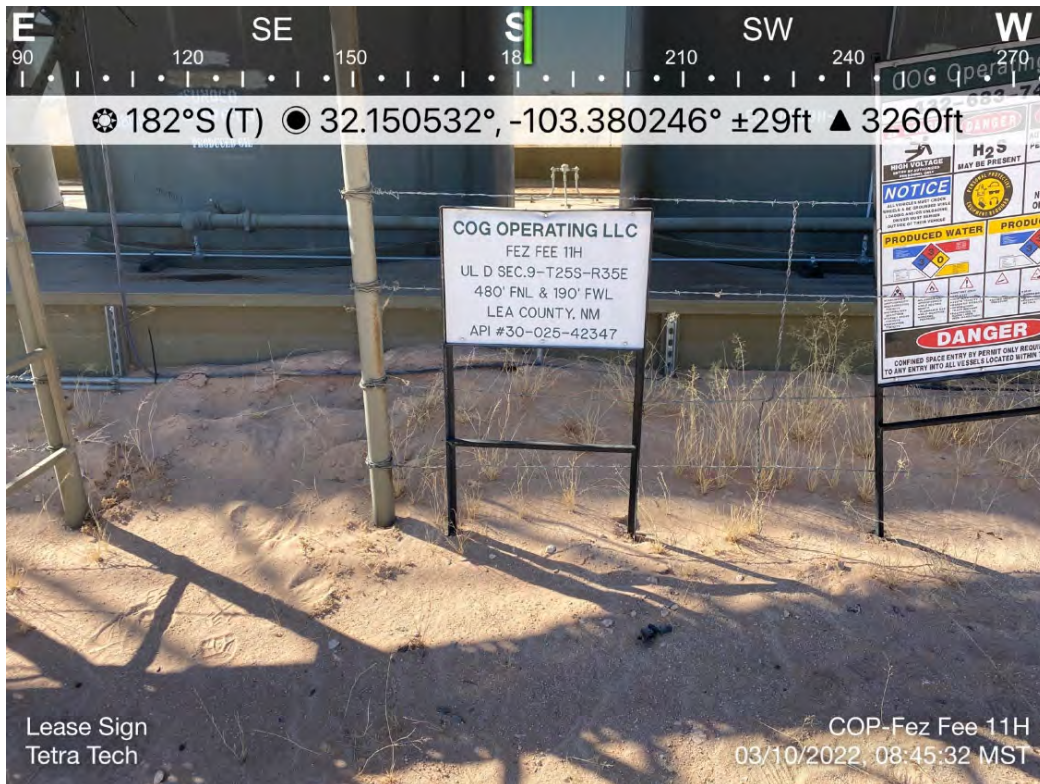
TETRA TECH, INC. PROJECT NO. 212C-MD-02712	DESCRIPTION	View south. Site signage.	3
	SITE NAME	Fez Fee #011H Line Release	3/10/2022

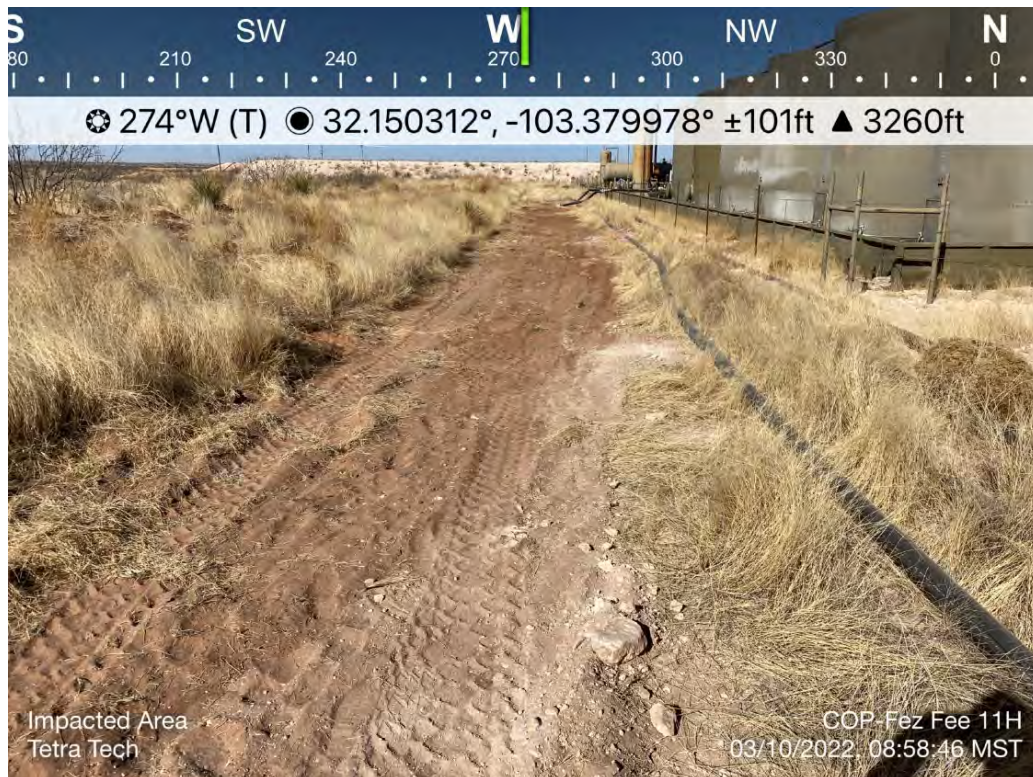
TETRA TECH, INC. PROJECT NO. 212C-MD-02712	DESCRIPTION	View west. Initial response footprint.	4
	SITE NAME	Fez Fee #011H Line Release	3/10/2022

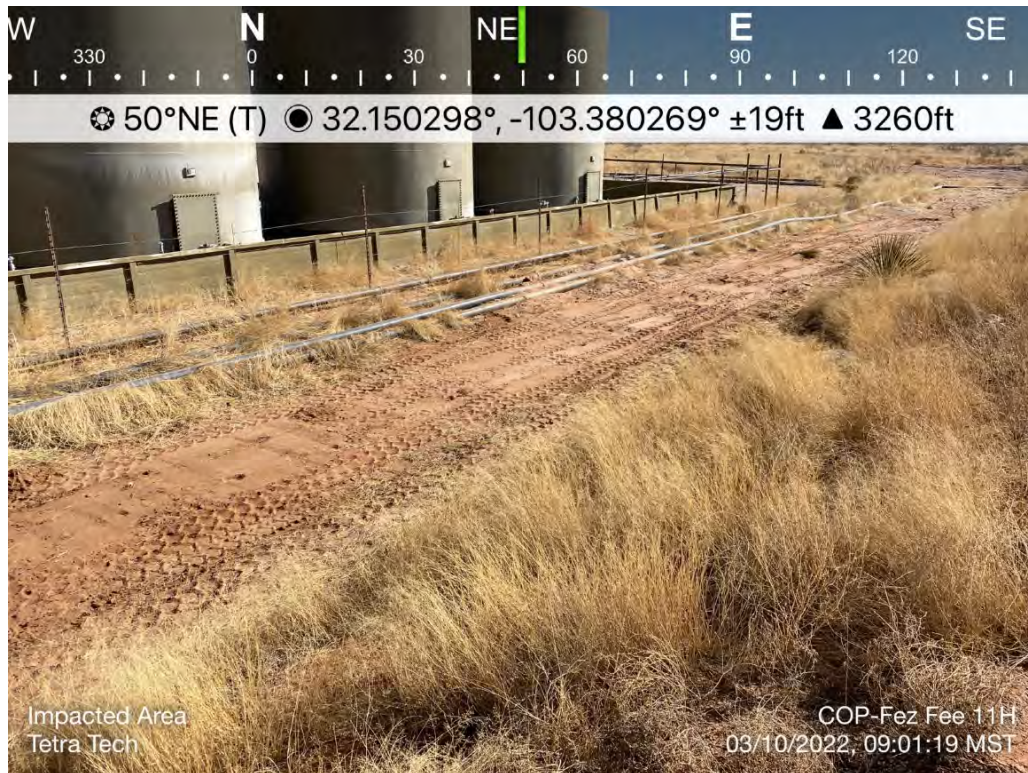
TETRA TECH, INC. PROJECT NO. 212C-MD-02712	DESCRIPTION	View east. Initial response footprint.	5
	SITE NAME	Fez Fee #011H Line Release	3/10/2022

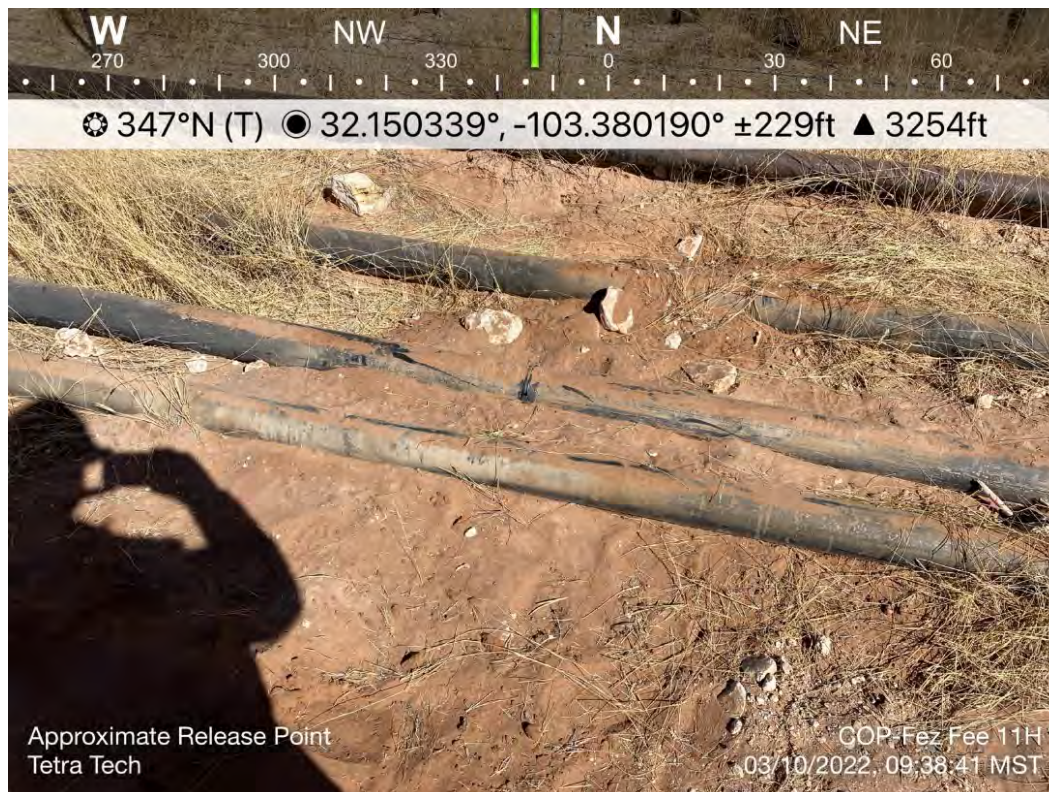
TETRA TECH, INC. PROJECT NO. 212C-MD-02712	DESCRIPTION	View north. Approximate release location.	6
	SITE NAME	Fez Fee #011H Line Release	3/10/2022

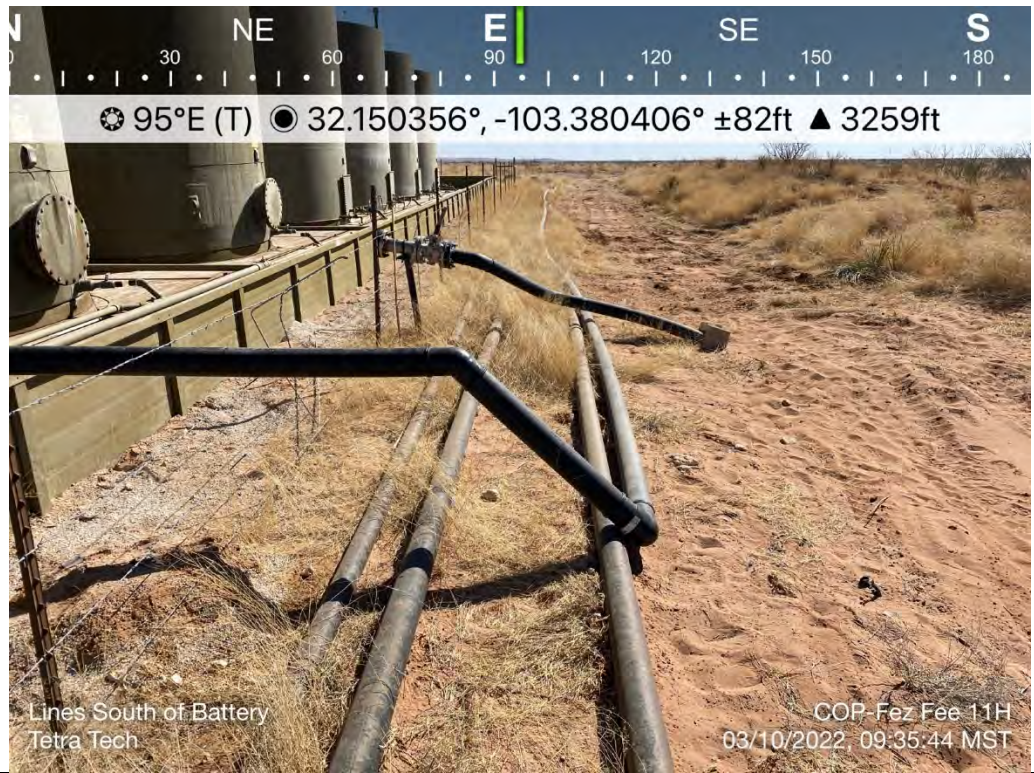
TETRA TECH, INC. PROJECT NO. 212C-MD-02712	DESCRIPTION	View east. Facility lines located west of release area.	8
	SITE NAME	Fez Fee #011H Line Release	3/10/2022

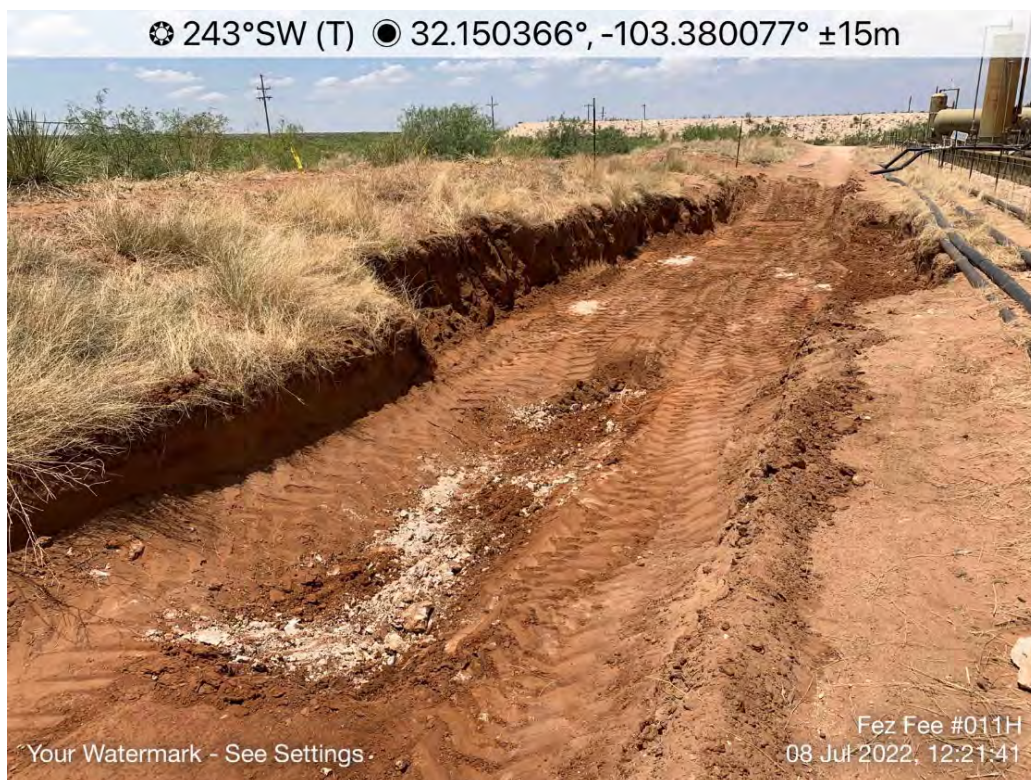
TETRA TECH, INC. PROJECT NO. 212C-MD-02712	DESCRIPTION	View west-southwest. Remediated area south of tank battery.	9
	SITE NAME	Fez Fee #011H Line Release	7/8/2022

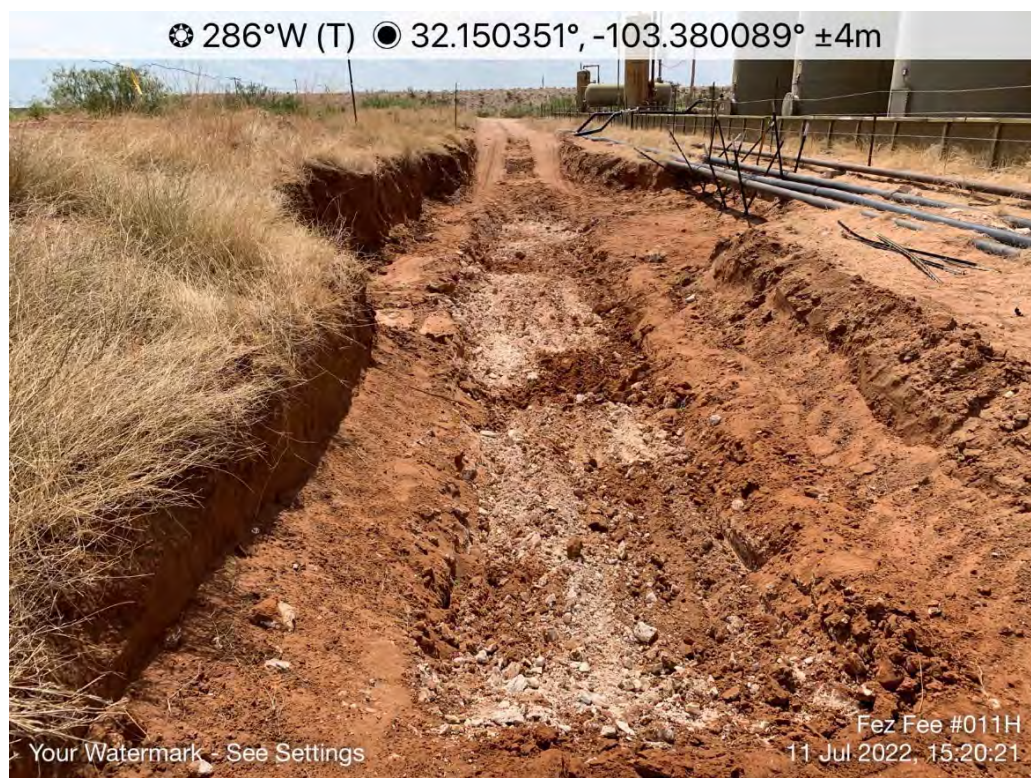
TETRA TECH, INC. PROJECT NO. 212C-MD-02712	DESCRIPTION	View west. Remediated area south of tank battery.	10
	SITE NAME	Fez Fee #011H Line Release	7/11/2022

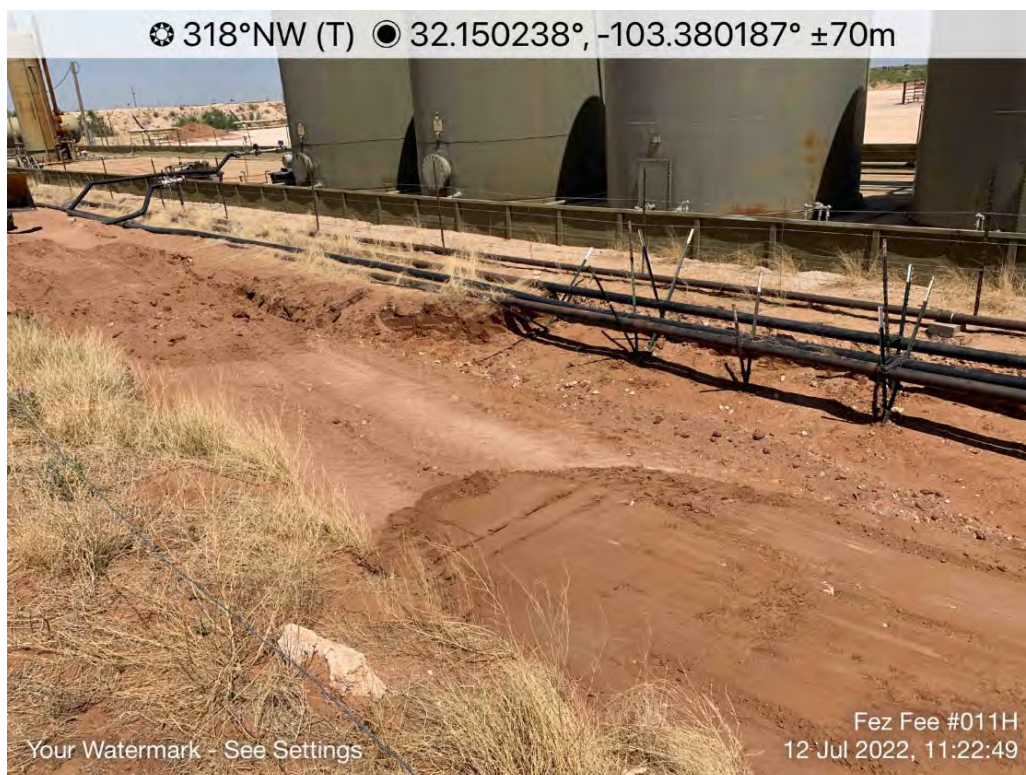
TETRA TECH, INC. PROJECT NO. 212C-MD-02712	DESCRIPTION	View northwest. Backfilling of remediated area.	11
	SITE NAME	Fez Fee #011H Line Release	7/12/2022

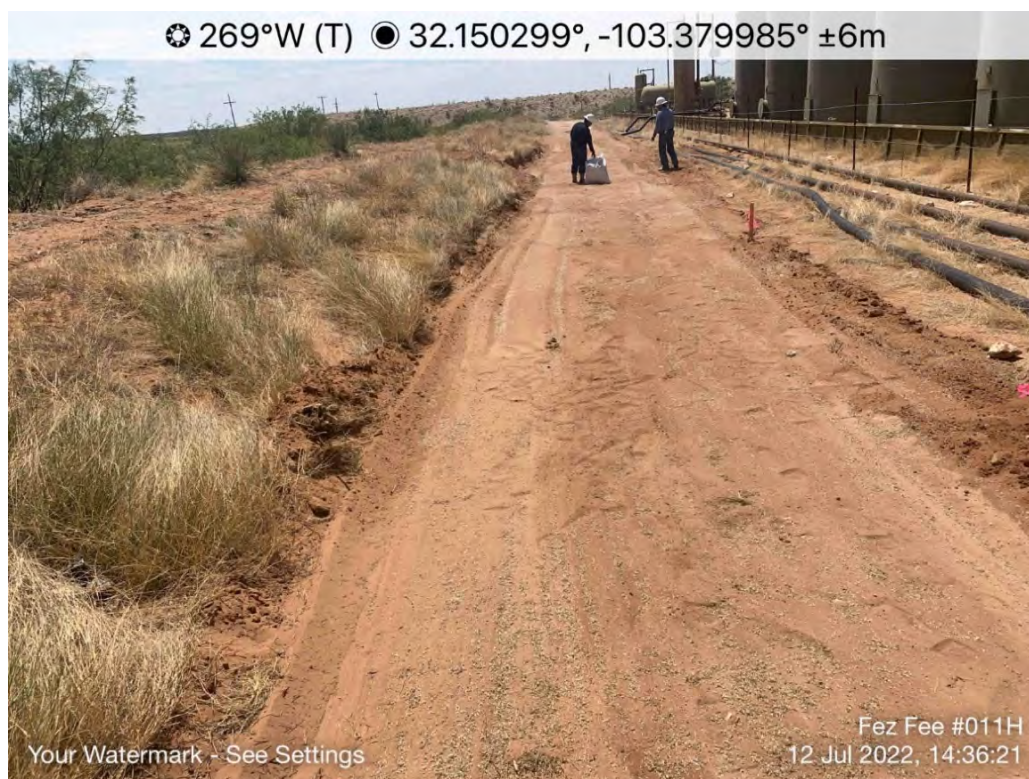
TETRA TECH, INC. PROJECT NO. 212C-MD-02712	DESCRIPTION	View west. Seeding of remediated and backfilled area.	12
	SITE NAME	Fez Fee #011H Line Release	7/12/2022
