Pima Environmental Services
5614 N. Lovington Highway
Hobbs, NM 88240
575-964-7740

May 19, 2022

Re: Site Assessment, Remediation, and Closure Report
South Boyd Federal Com #018H
API No. 30-015-44685
GPS: Latitude 32.623037 Longitude -104.468331
ULSTR - B-34-T19S-R25E
Eddy County, NM
NMOCD Ref. No. NAPP2211547100

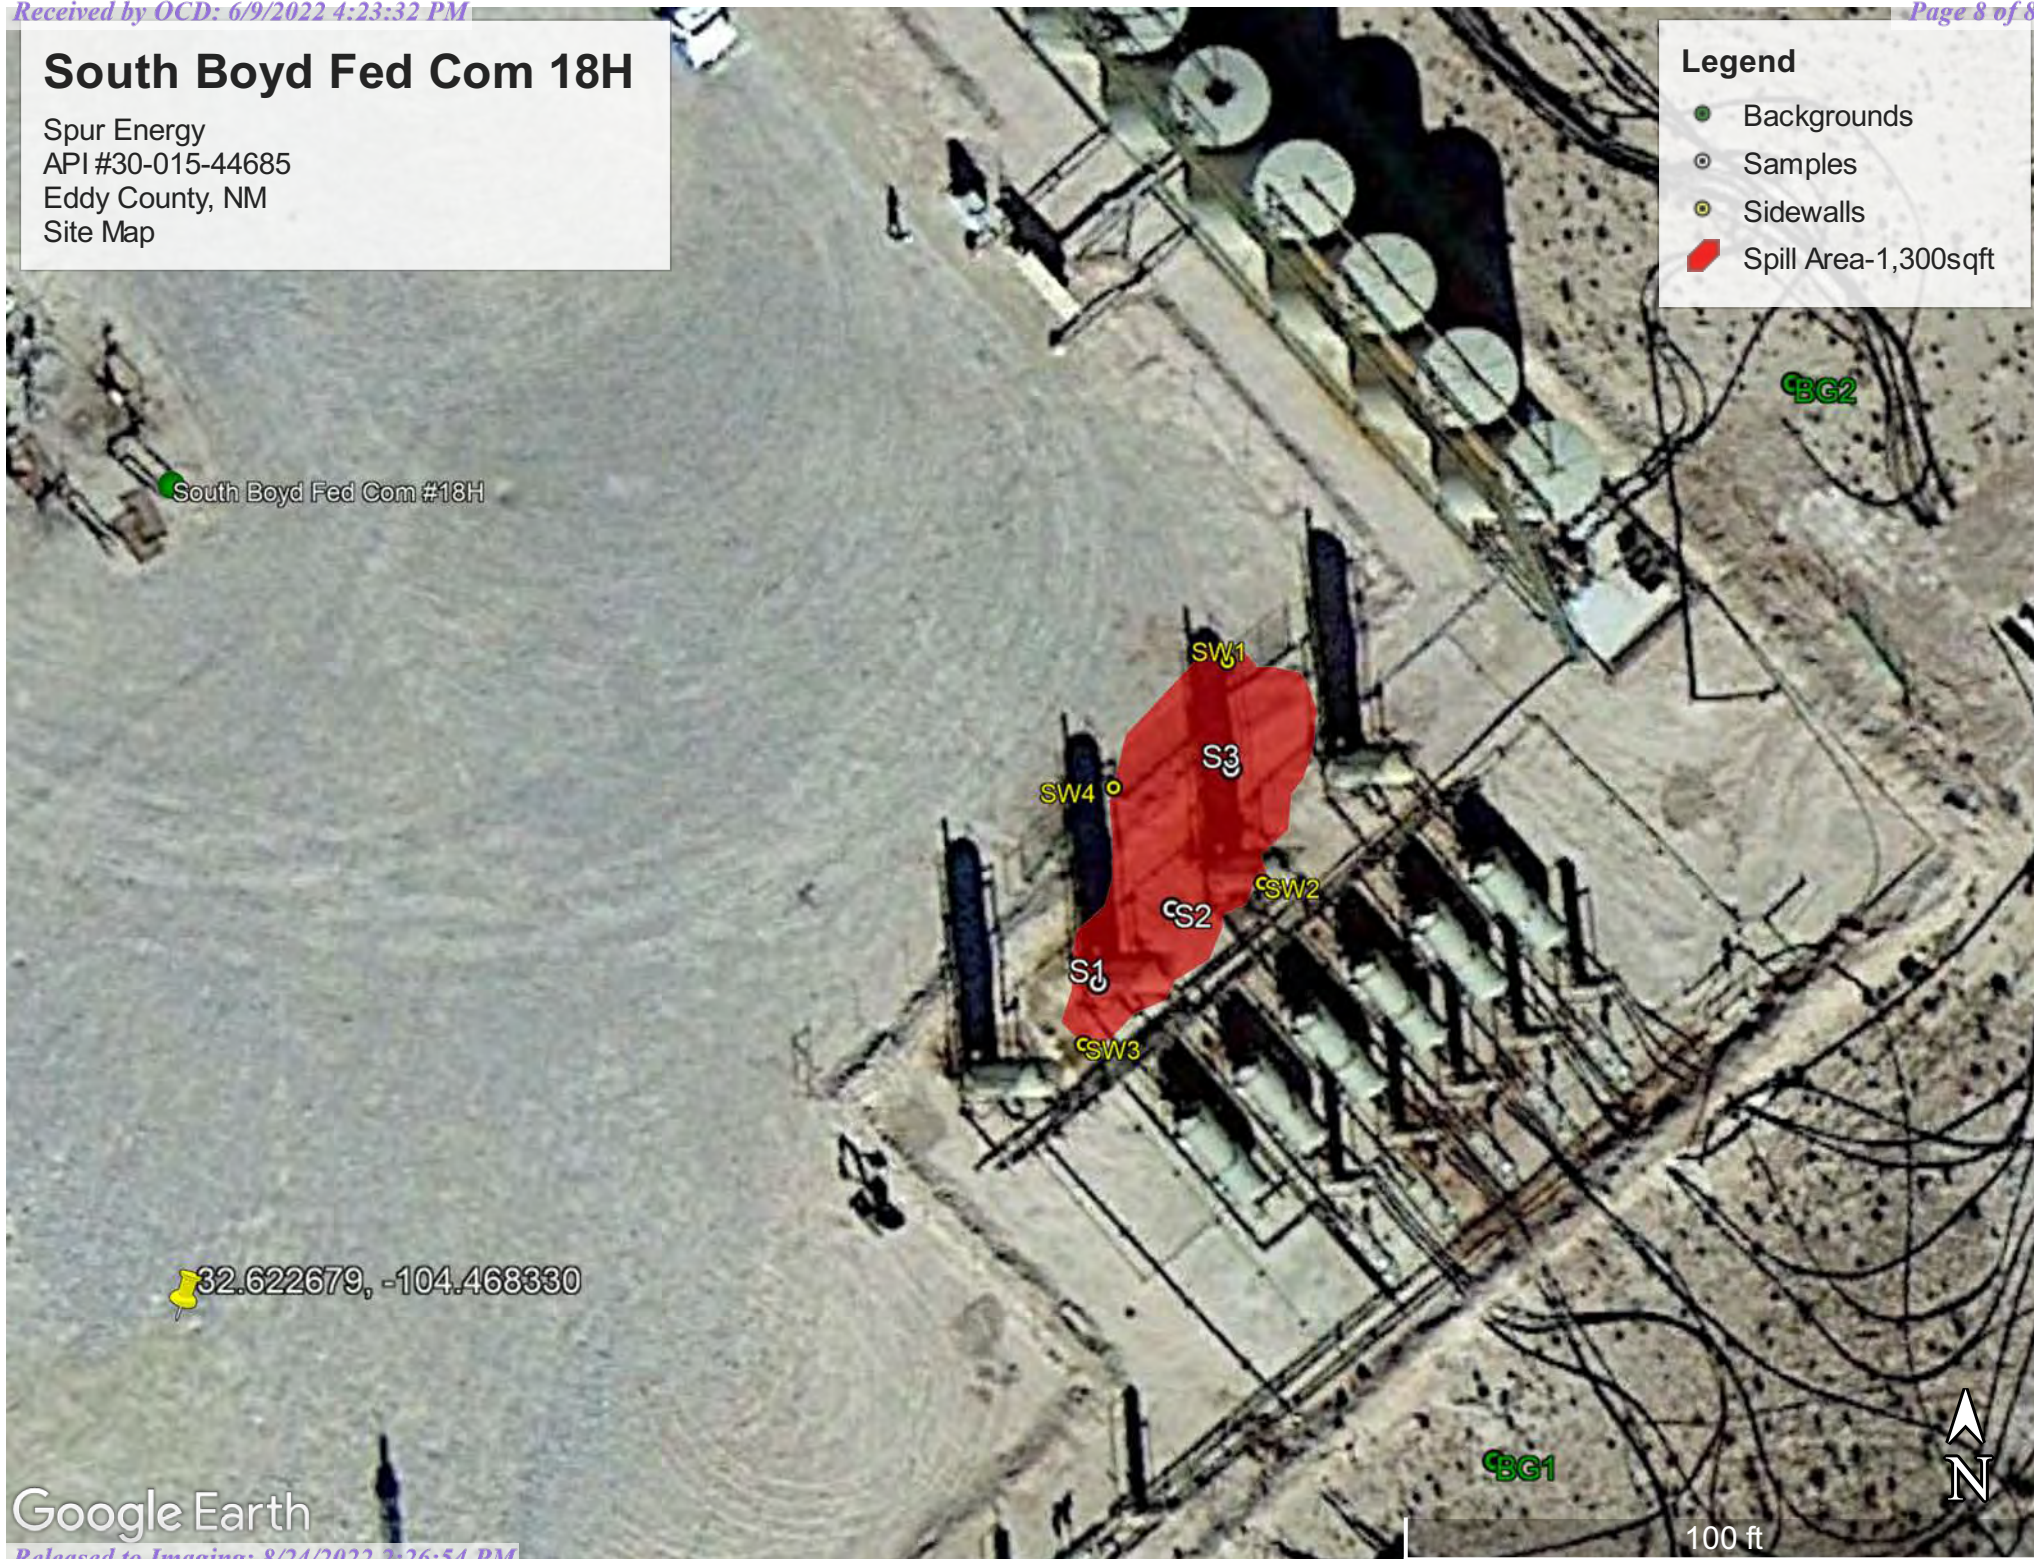
Spur Energy
API #30-015-44685
Eddy County, NM
Site Map

On April 26, 2022, Pima mobilized personnel to the site to assess the area. We sampled the impacted area. Laboratory results of this sampling event can be found in the following data table. A Site Map can be found in Figure 4.

- Backgrounds
- Samples
- Sidewalls
- Spill Area-1,300sqft

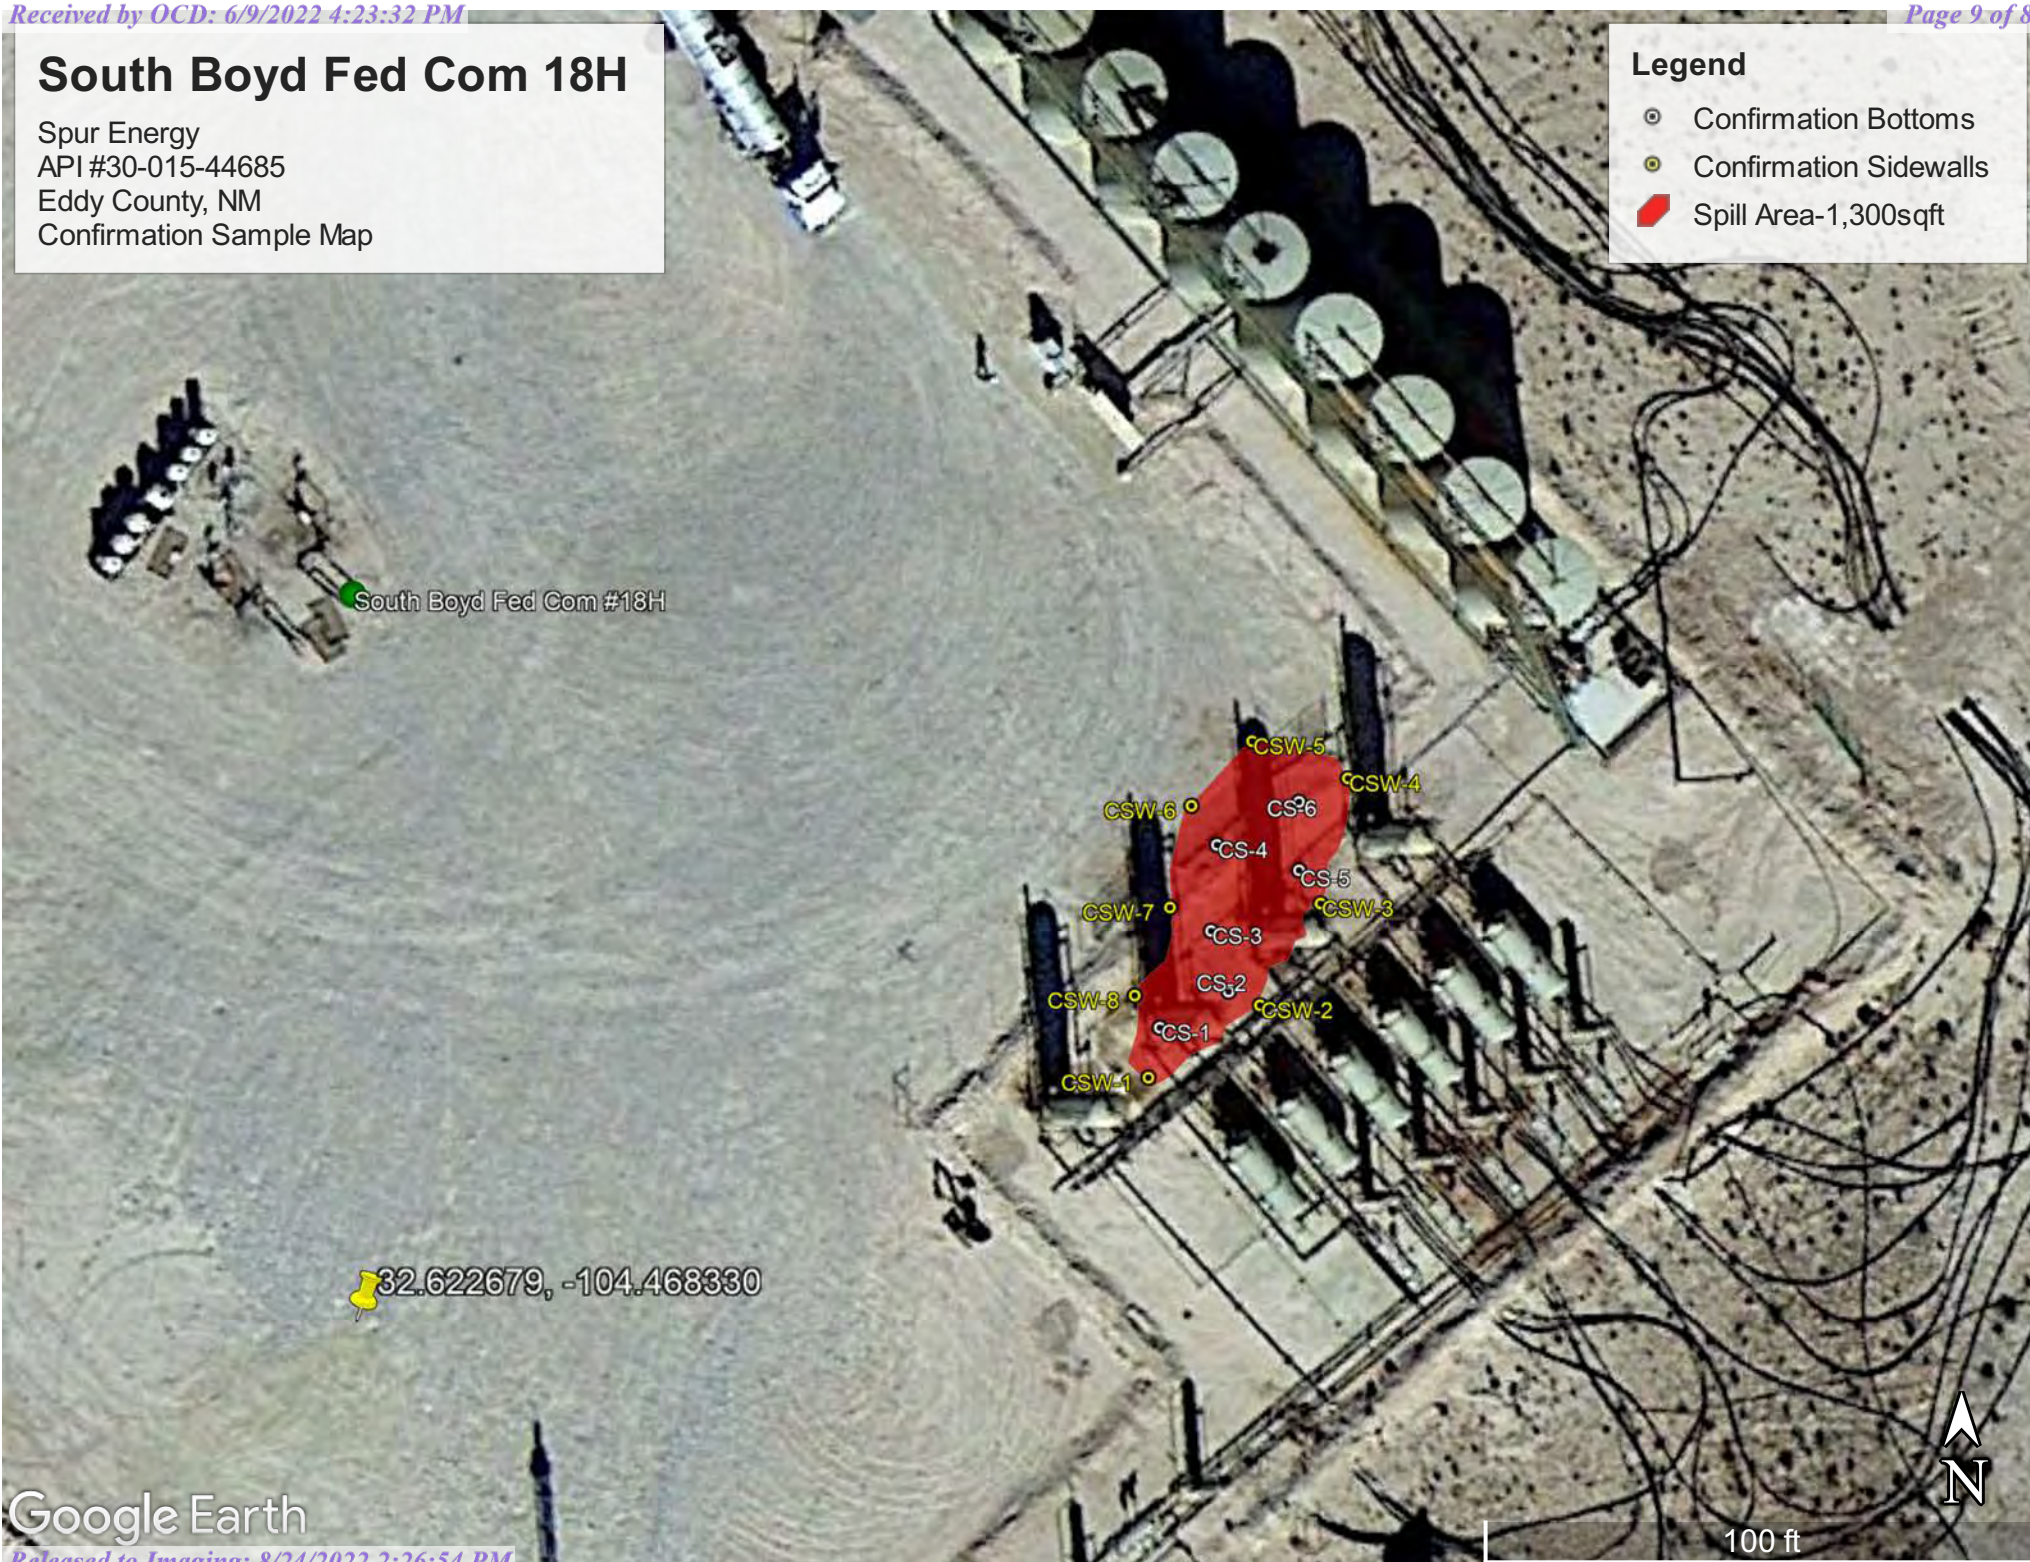
Spur Energy
API #30-015-44685
Eddy County, NM
Confirmation Sample Map

On May 21, 2022, after sending a 48-hour notification, Pima returned to collect confirmation samples of the excavated area. The laboratory results of this sampling event can be found in the following table. A Confirmation Sample Map can be found in Figure 5.

- Confirmation Bottoms
- Confirmation Sidewalls
- Spill Area-1,300sqft

Based on the sample results, the bottom and sidewalls were below NMOCD Closure Criteria 19.15.29 NMAC. The contaminated material was transported to Lea Land, a NMOCD approved disposal site. The excavation was then backfilled with clean like material, machine compacted and contoured to match the surrounding terrain.

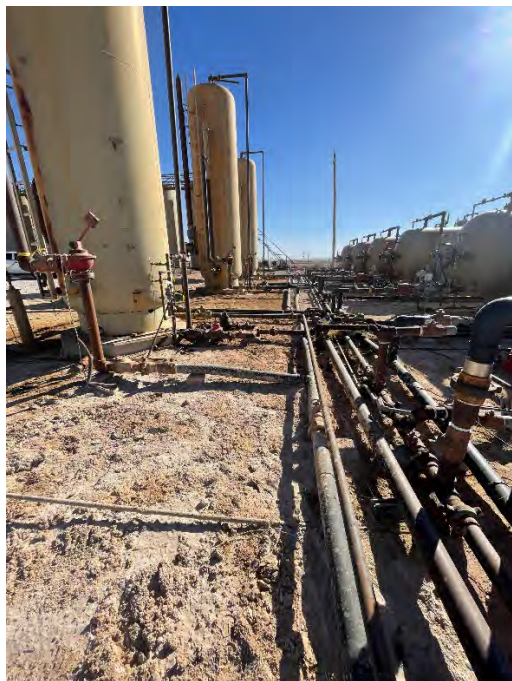
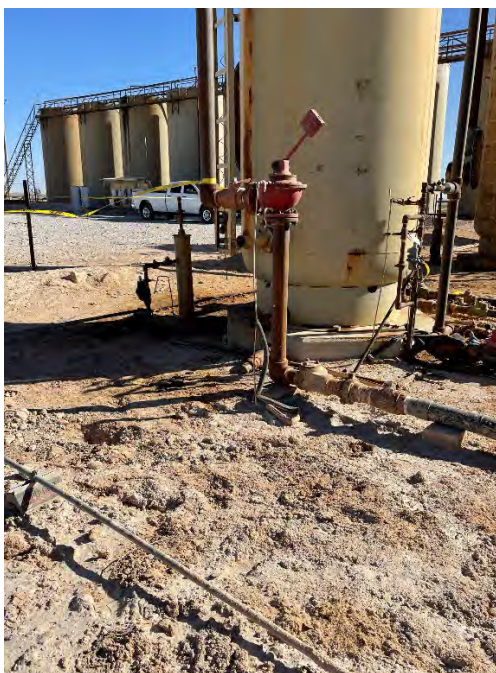
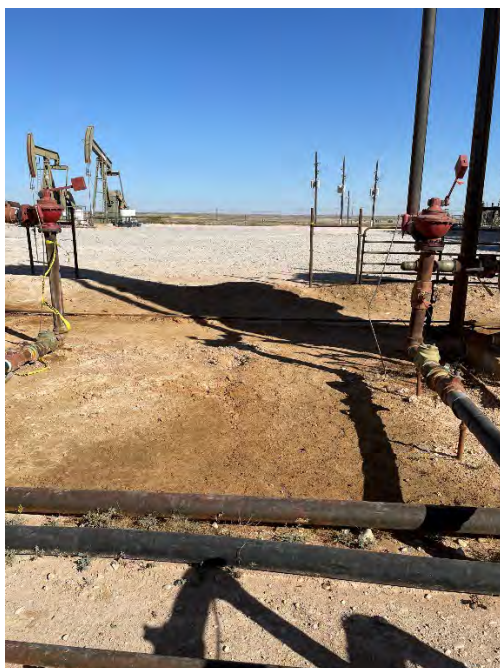
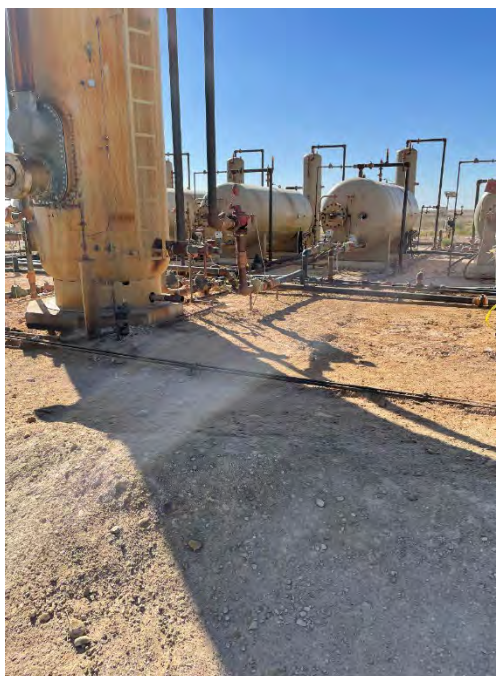
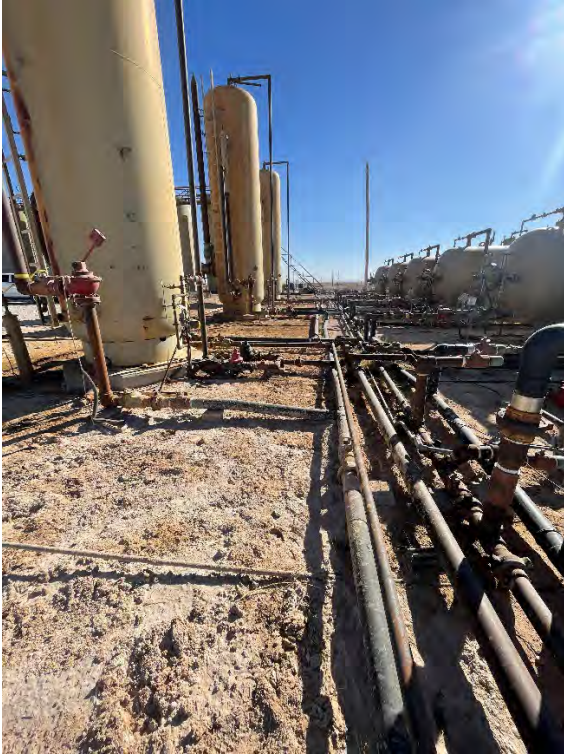
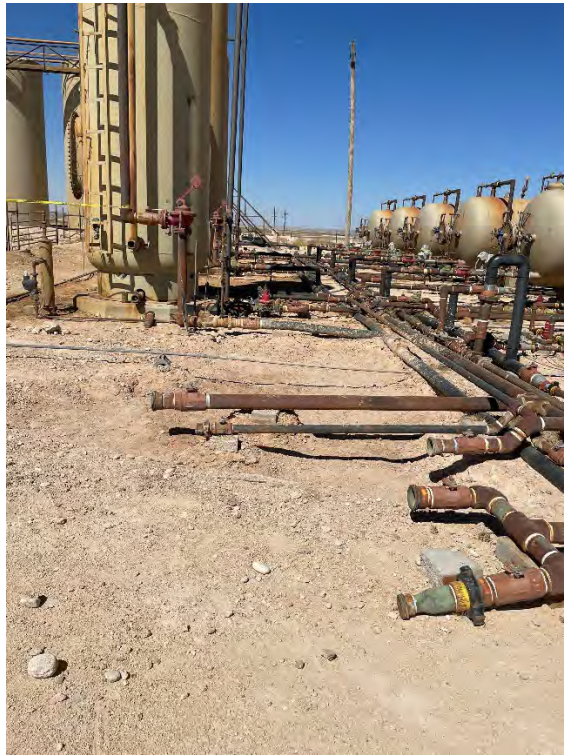
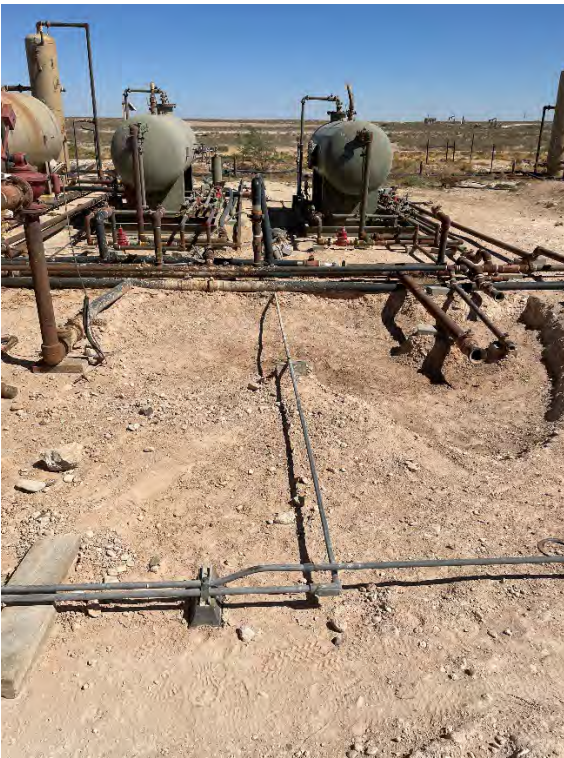
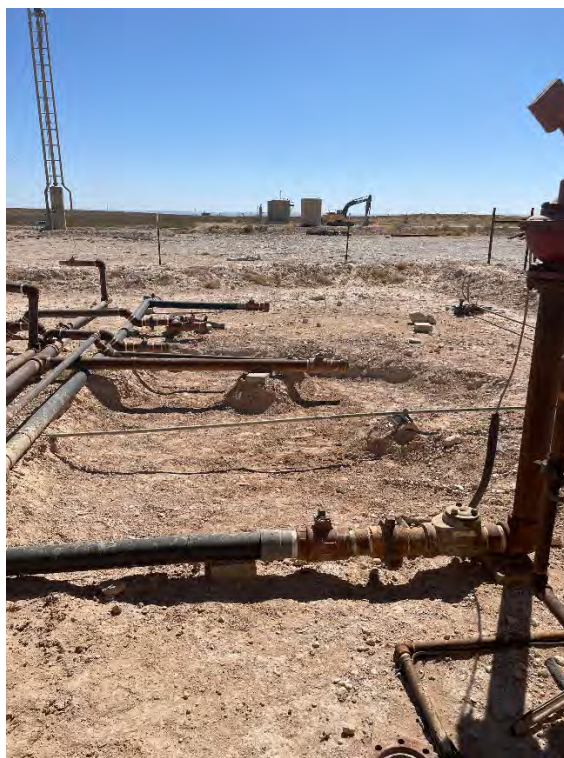
Pre-Treatment

NAPP2211547100: On April 4, 2022, A Heater Treater fire tube leak on the South Boyd Federal Com #018H. The volume of the release was calculated to be approximately 4 barrels (bbls) of produced water and approximately 4 barrels (bbls) of Crude Oil. A vacuum truck was able to recover approximately 6 bbls of total fluid.

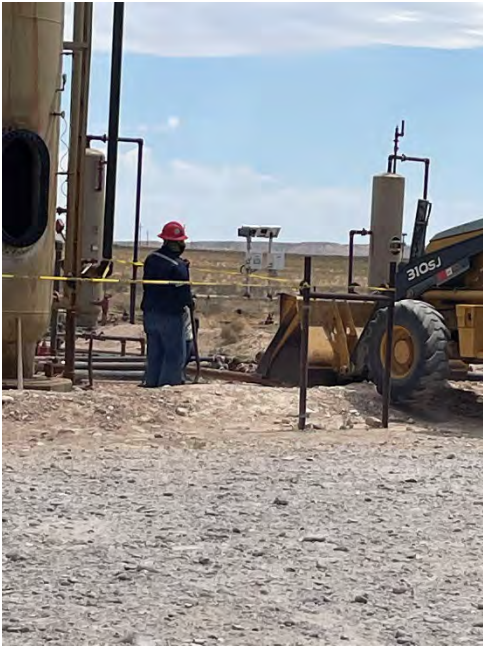
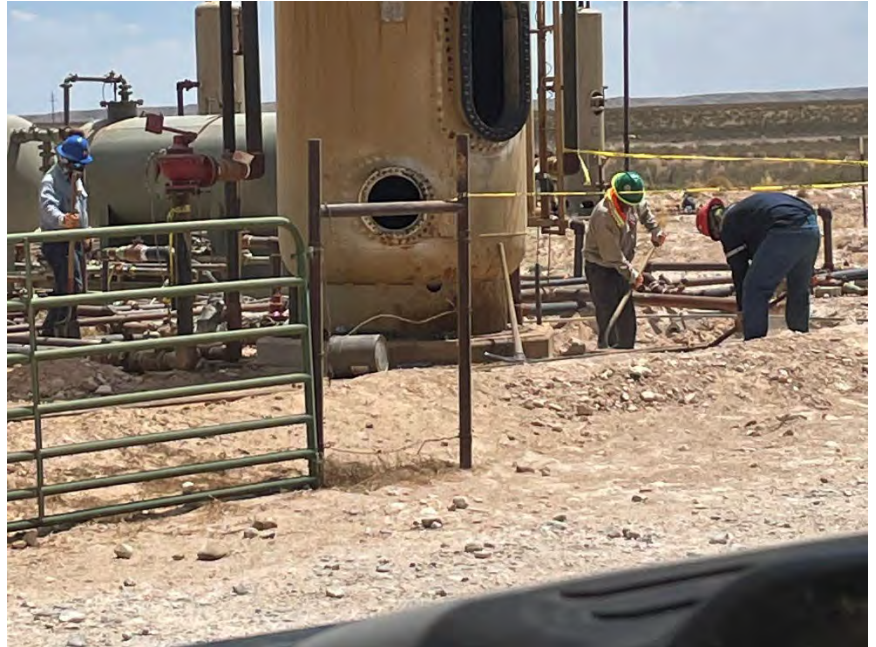
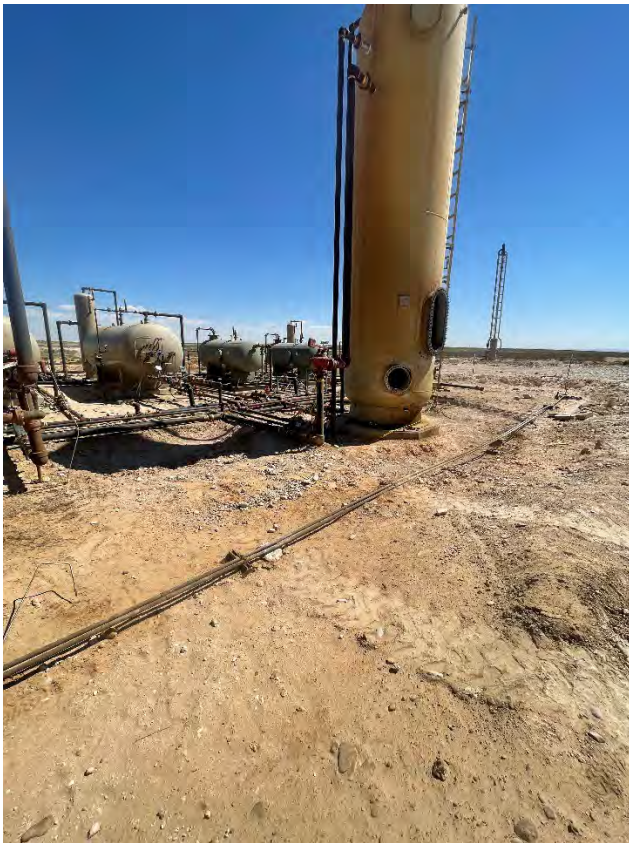
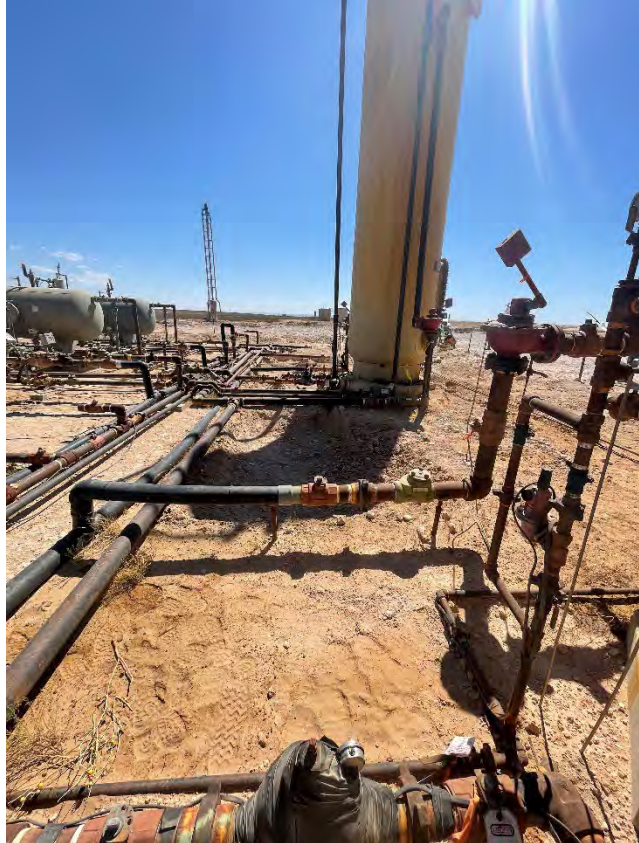
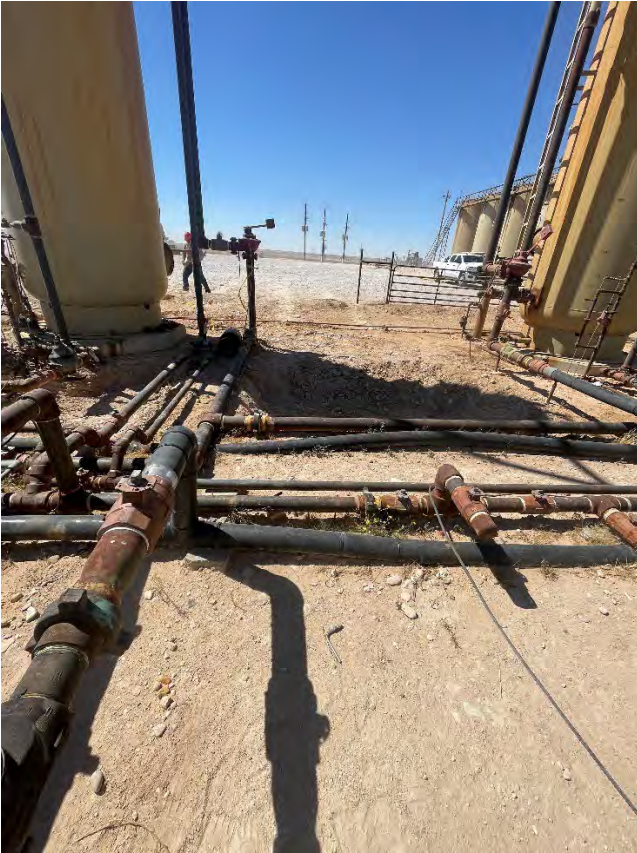
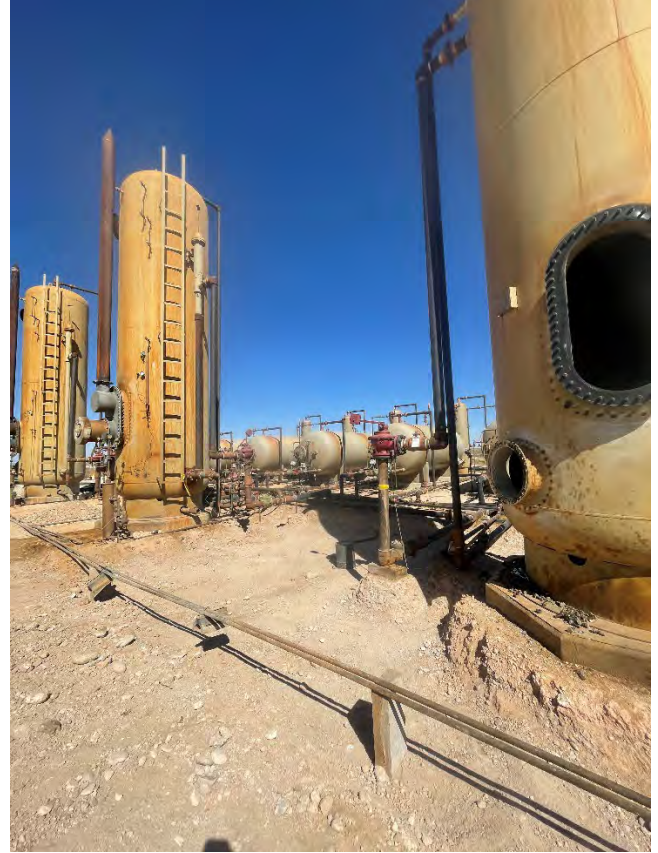
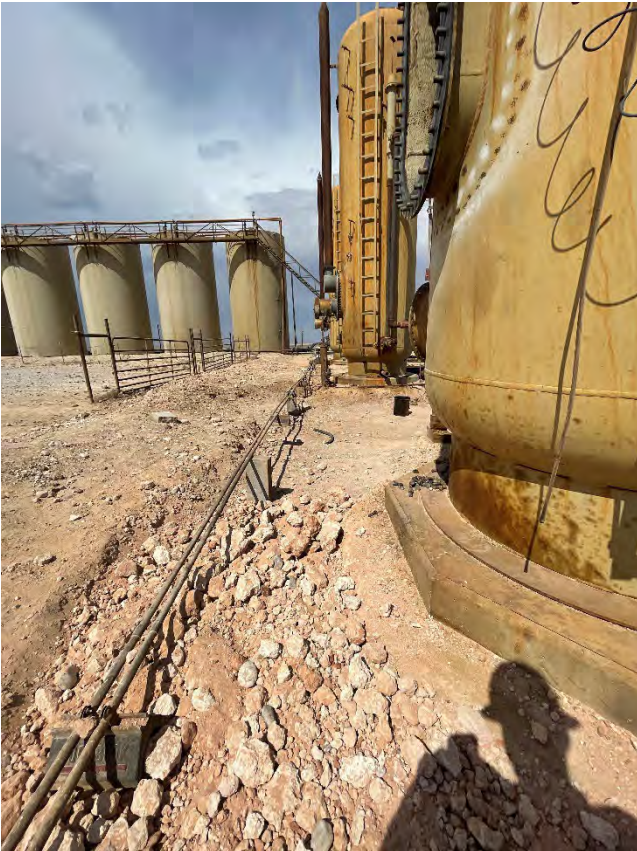
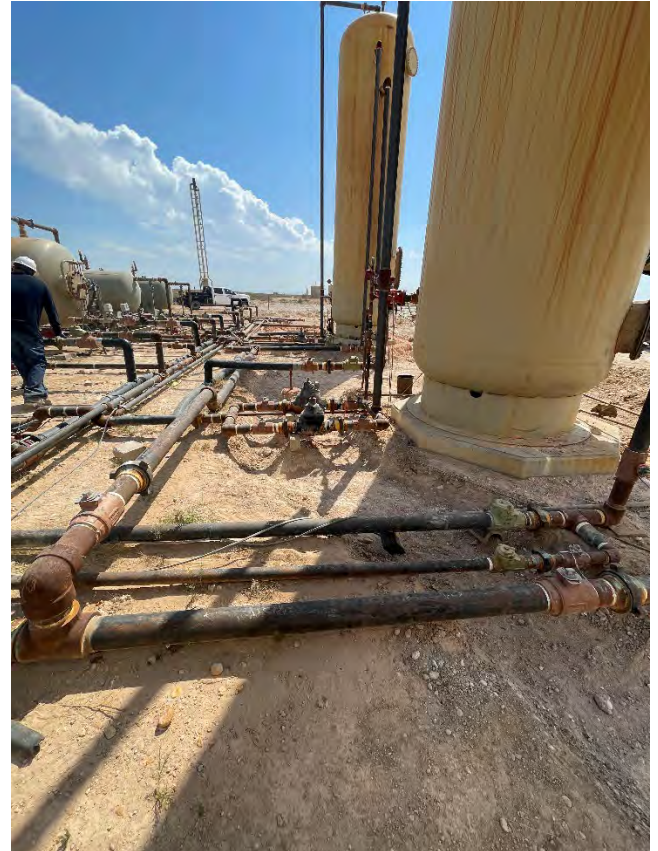
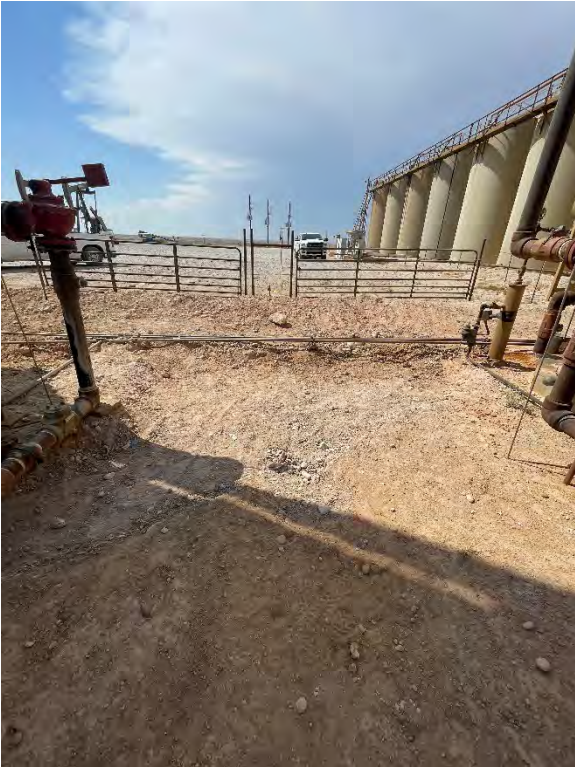
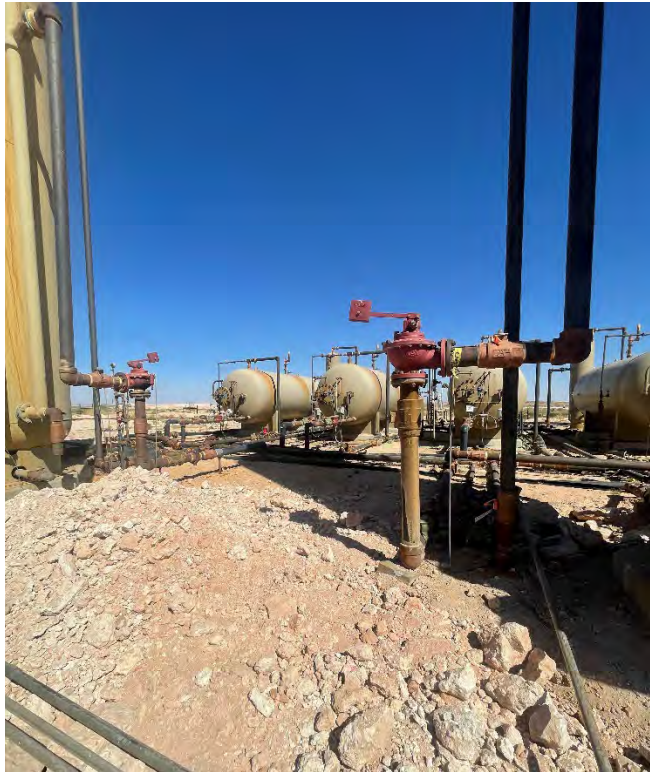
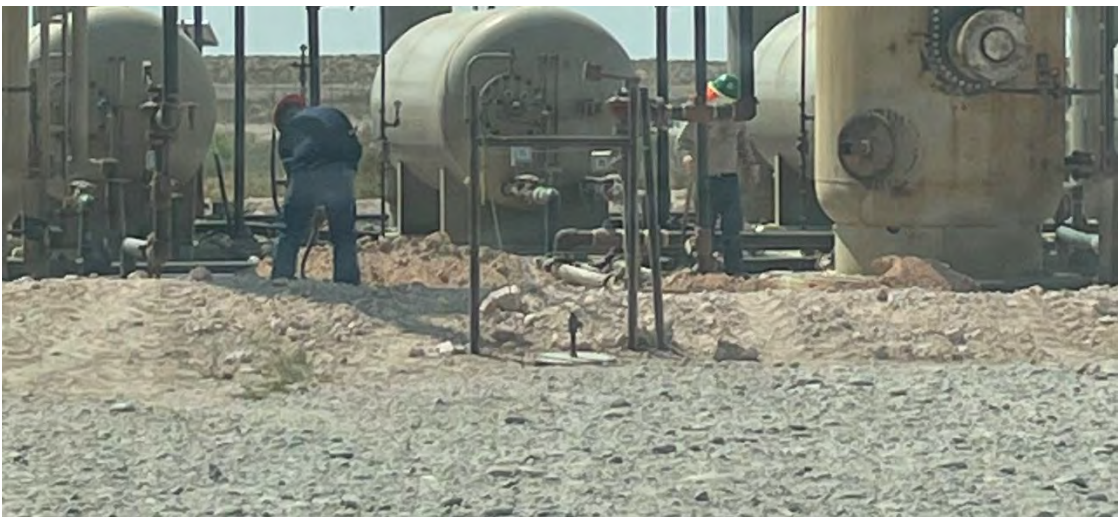
Remediation

On May 9, 2022, Pima returned to the site to remediate the area by excavating the contaminated soil. A total of approximately 65 cubic yards of contaminated material was removed by hands with hand tools. See Appendix D for Photographic Documentation.
