**RE: Closure Request  
Ross Draw Unit 57  
Incident Number nAB1710735309  
Eddy County, New Mexico**

WSP USA Inc. (WSP), on behalf of WPX Energy, Inc. (WPX), is pleased to present the following Closure Request detailing site assessment, soil sampling, and excavation activities at the Ross Draw Unit 57 (Site) in Unit K, Section 27, Township 26 South, Range 30 East, in Eddy County, New Mexico (Figure 1). The purpose of the site assessment, soil sampling, and excavation activities was to address impacts to soil following a release of produced water and oil at the Site. Based on the excavation activities and results of the soil sampling events, WPX is submitting this Closure Request, describing remediation that has occurred and requesting no further action (NFA) for Incident Number nAB1710735309.

**FIGURE 2**  
**DELINEATION SOIL SAMPLE LOCATIONS**  
 ROSS DRAW UNIT 57  
 UNIT K SEC 27 T26S R30E  
 EDDY COUNTY, NEW MEXICO  
 WPX ENERGY PERMIAN, LLC.

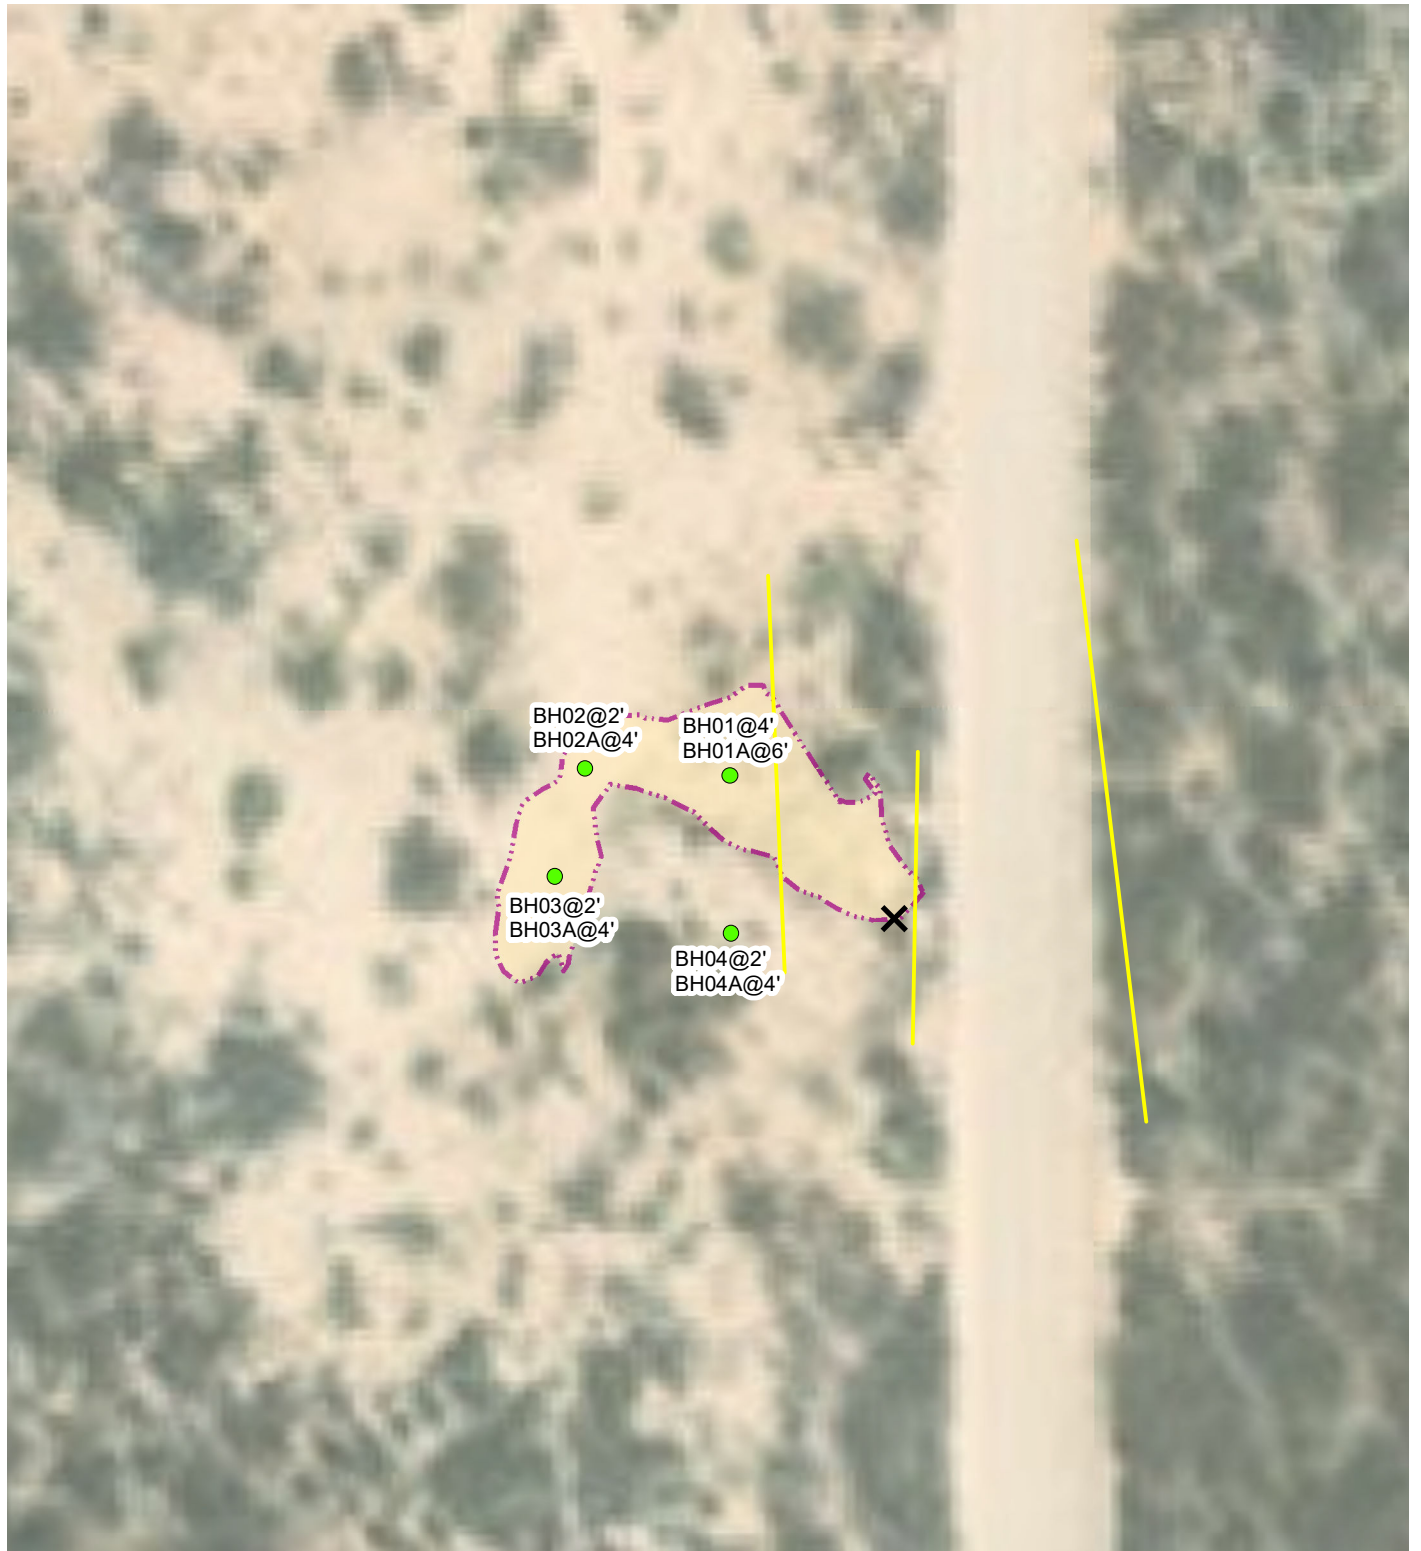
DELINEATION SOIL SAMPLE IN COMPLIANCE  
WITH APPLICABLE CLOSURE CRITERIA

RELEASE EXTENT

NOTE: INCIDENT NUMBER nAB1710735309  
SAMPLE ID@DEPTH BELOW GROUND SURFACE (FEET)

On June 26, 2019, WSP personnel advanced four delineation boreholes via hand auger within and around the release extent in order to define the extent of vertical and lateral impacts. Borehole BH01 was advanced in the current excavation to depths ranging from 3 feet to 6 feet bgs. WSP collected two discrete soil samples from the BH01 location; one at 4 feet bgs in accordance with the vertical clean boundary and the other at the borehole terminus, located at 6 feet bgs. Boreholes BH02 through BH04 were advanced in other areas within and around the release extent to verify the presence or absence of impacted soil. WSP collected two discrete soil samples from the other borehole locations; one at 2 feet bgs in accordance with the highest field screening the other at 4 feet bgs at the borehole terminus. Soil from the boreholes was field screened for volatile aromatic hydrocarbons and chloride utilizing PID and Hach® chloride QuanTab® test strips, respectively. The delineation soil samples were placed directly into a pre-cleaned glass jars, labeled with the location, date, time, sampler name, method of analysis, and immediately placed on ice. The soil samples were transported at or below 4 degrees Celsius (°C), under strict chain-of-custody (COC) procedures, to Eurofins, LLC. (Eurofins) in Carlsbad, New Mexico, for analysis of BTEX following United States Environmental Protection Agency EPA Method 8021B; TPH following EPA Method 8015M/D; and chloride following EPA Method 300.0. Field screening results and observations for the potholes were logged on lithologic/soil sampling logs, which are included in Attachment 3. The delineation soil sample locations are depicted on Figure 2.

Laboratory analytical results for all delineation samples indicated concentrations of benzene, BTEX, TPH-GRO/TPH-DRO, TPH, and chloride are compliant with reclamation and/or Closure Criteria. A minimum removal of 4 feet of soil was required in the pasture area in the vicinity of borehole BH01. Lateral delineation was achieved based on analytical results associated with BH01 through BH04.

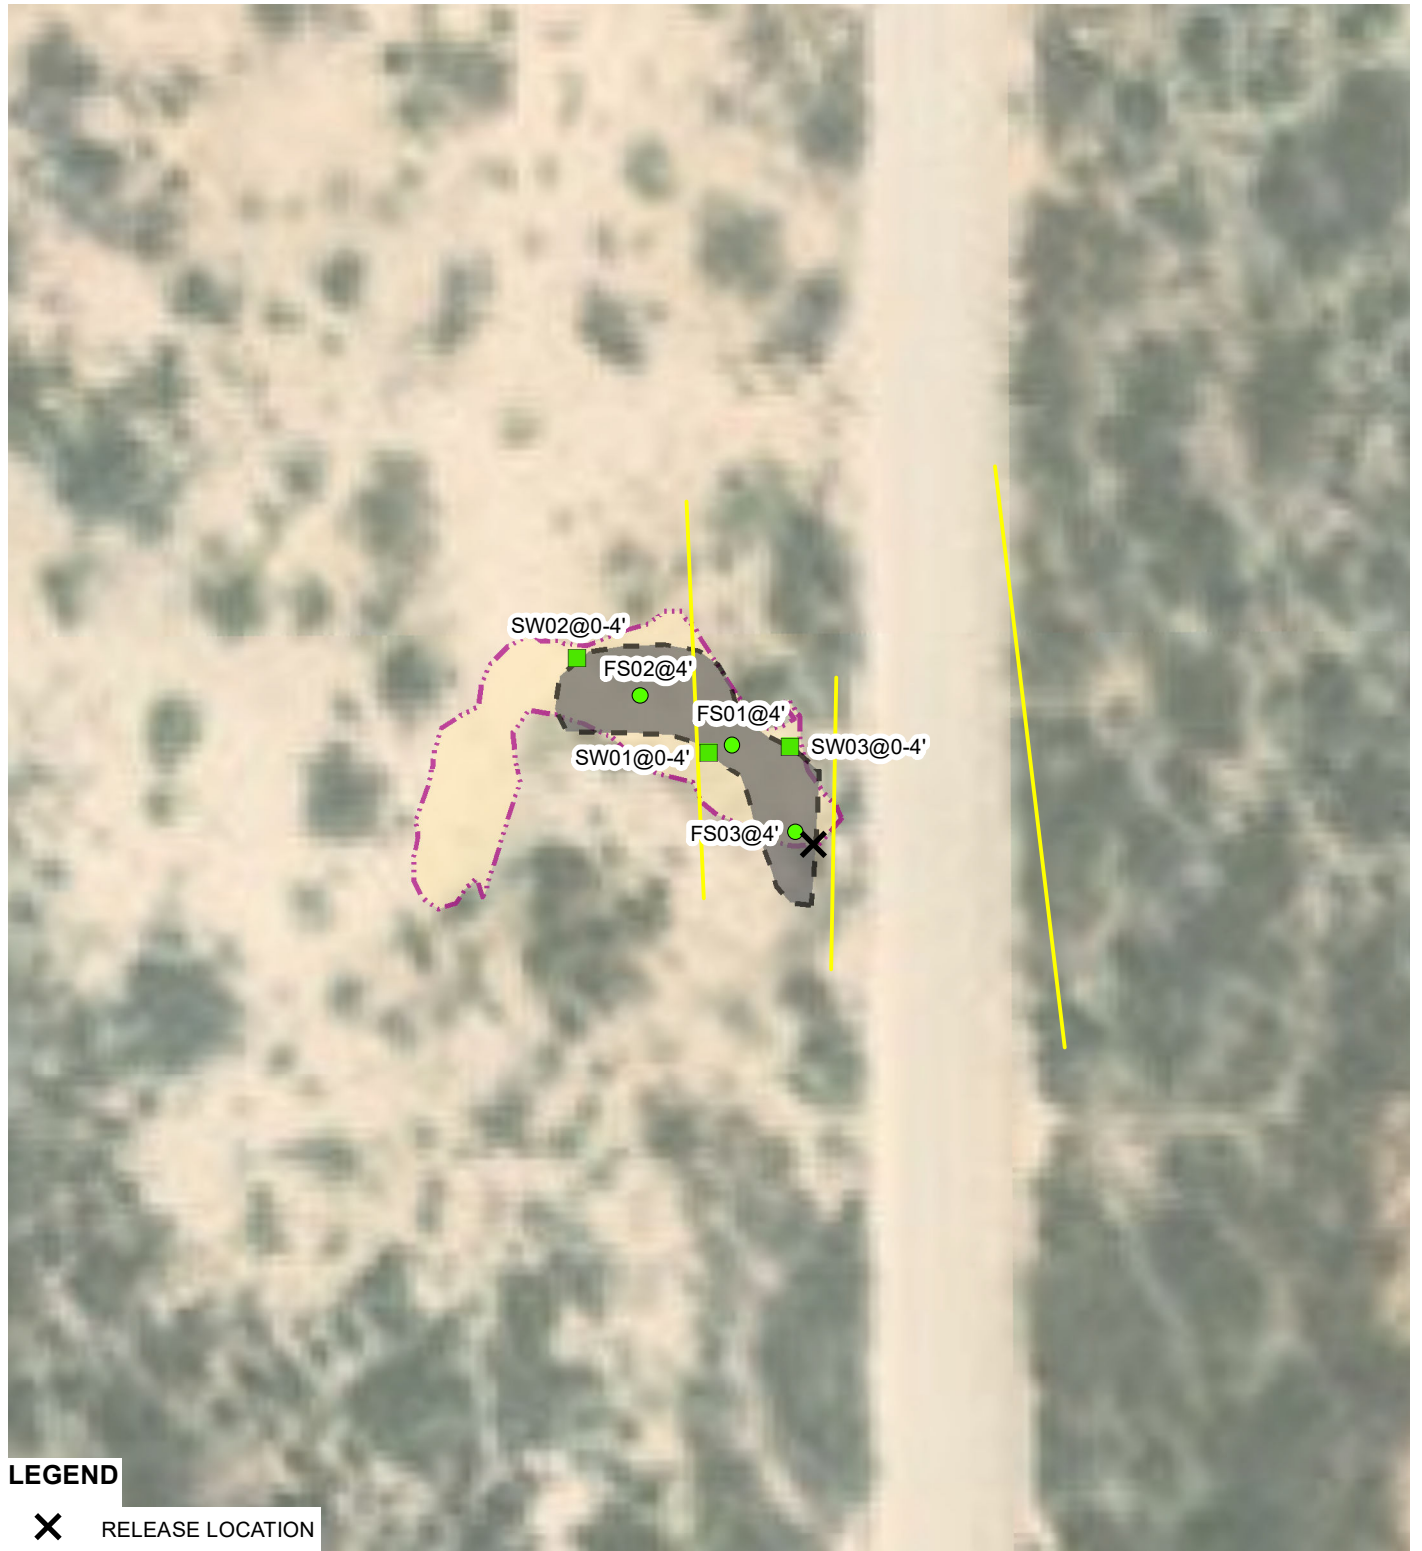
**FIGURE 3**  
**EXCAVATION SOIL SAMPLE LOCATIONS**  
 ROSS DRAW UNIT 57  
 UNIT K SEC 27 T26S R30E  
 EDDY COUNTY, NEW MEXICO  
 WPX ENERGY PERMIAN, LLC.

FLOOR SAMPLE IN COMPLIANCE  
WITH APPLICABLE CLOSURE CRITERIA

SIDEWALL SAMPLE IN COMPLIANCE  
WITH APPLICABLE CLOSURE CRITERIA

EXCAVATION EXTENT

Following removal of impacted soil, WSP collected 5-point composite soil samples to represent at most 200 square feet from the floor and sidewalls of the excavation. The 5-point composite samples were collected by placing five equivalent aliquots of soil into a 1-gallon, resealable plastic bag and homogenizing the samples by thoroughly mixing. Composite soil samples SW01 through SW03 were collected from the sidewalls of the excavation at depths ranging from the ground surface to 4 feet bgs. Composite soil samples FS01 through FS03 were collected from the floor of the excavation at 4 feet bgs. The excavation soil samples were collected, handled, and analyzed following the same procedures as described above. The excavation extent and excavation soil sample locations are presented on Figure 3. Photographic documentation is included in Attachment 2.

The excavation area totaled approximately 600 square feet. A total of approximately 100 cubic yards of impacted soil was removed during the excavation activities. The impacted soil was transported and properly disposed of at the R360 Facility in Orla, Texas under WPX approved

Laboratory analytical results for excavation sidewall samples SW01 through SW03, and floor samples FS01 through FS03 yielded concentrations of benzene, BTEX, TPH-GRO/TPH-DRO, TPH, and chloride compliant with the reclamation and/or Closure Criteria. Laboratory analytical results are summarized in Table 1 and laboratory analytical reports are included as Attachment 4. Based on laboratory analytical results, residual impacts have been excavated.

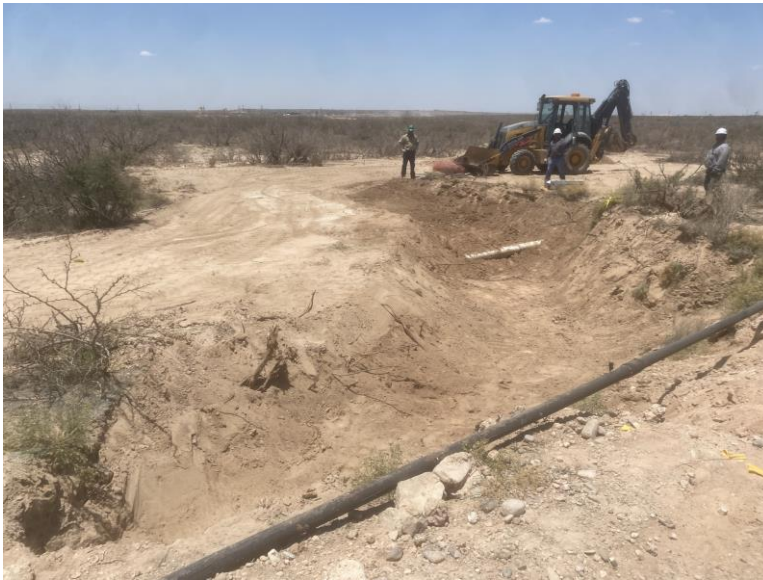
Photo No.	Date	
4	June 15, 2021	
Northwestern view of excavation extent

A photograph showing a large, deep excavation in a dry, sandy area. A yellow excavator is working in the center of the excavation. Several people are standing around the excavation. A large black pipe is visible in the foreground. The ground is uneven and sandy, with some sparse vegetation. The sky is blue with some clouds.
