Closure Report

Site Name:	Roo 22 State #8
Company:	Oxy USA Inc.
Legal Description:	U/L C, Section 22, T17S, R28E
County:	Eddy County, NM
GPS Coordinates:	N 32.82593 W-104.16714

Date of Release:	5/17/17
Type of Release:	Oil and produced water
Source of Release:	Stuffing box packing
Volume of Release:	1 bbl oil, 9 bbls produced water
Volume Recovered:	5 bbls

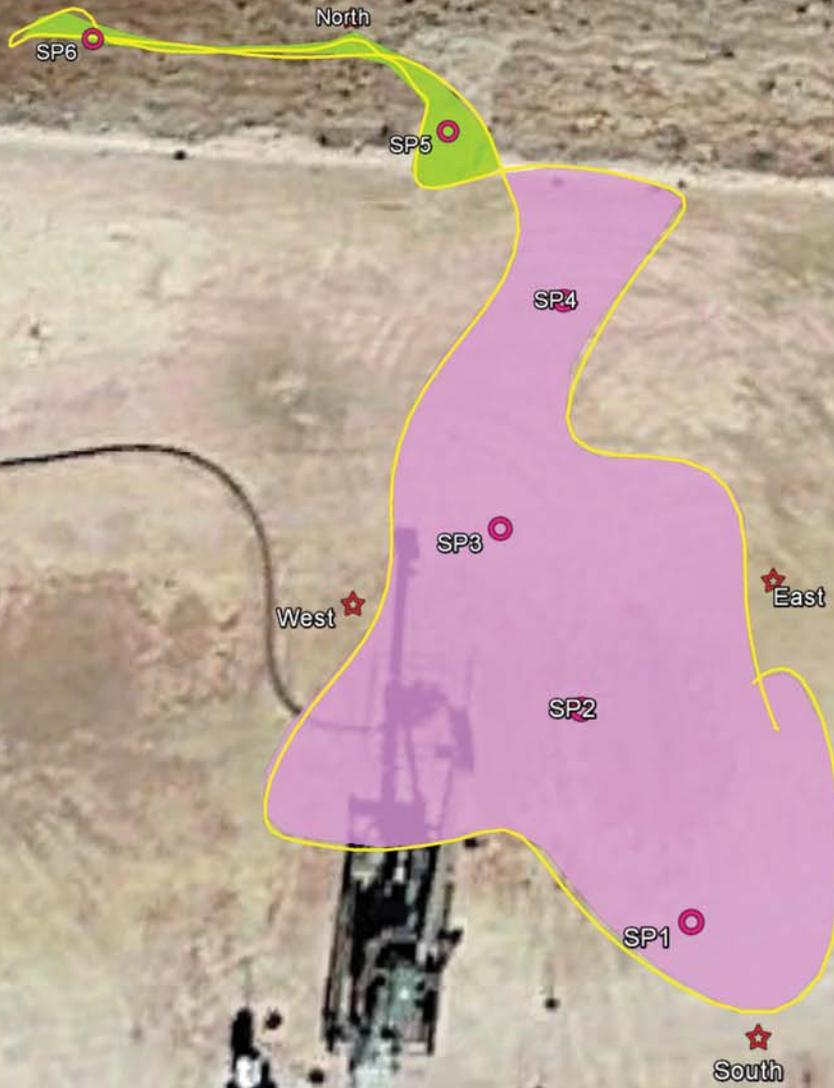
Leak date: 05/17/2017
Eddy County, NM
API# 30-015-39654
2RP-4270

- 1 ft Excavation
- 6 inch Excavation
- Cardinal sample points
- Sample points
- Leak area

Remediation Parameters:	The leak near SP1-SP4 was excavated to a depth of 6 inches. The leak area near SP5 and SP6 was excavated to a depth of 1 foot. The site was backfilled with clean soil.	
Remediation Activities:	06/27/2018 to 06/29/2018	
Plan Sent to OCD:	11/25/2017	Email from Cliff Brunson to Mike Bratcher
OCD Approval of Plan:	03/05/2018	Email from Mike Bratcher to Cliff Brunson
Plan Sent to BLM:	n/a	n/a
BLM Approval of Plan:	n/a	n/a
