Re: Remediation Report and Closure Request

JF Bell #2
San Juan County, New Mexico
Hilcorp Energy Company
NMOCD Incident No: nAPP2212552070

Ensolum, LLC (Ensolum), on behalf of Hilcorp Energy Company (Hilcorp), presents this *Remediation Report and Closure Request* for a historical release at the JF Bell #2 (Site). The Site is located on federal land managed by the Bureau of Land Management (BLM) in rural San Juan County, New Mexico (Figure 1). The work described in this document was performed in order to remediate petroleum hydrocarbon impacted soil originating from a historical release discovered during the removal of the on-site below grade tank (BGT). The Site is located in Unit B, Section 3, Township 30 North, Range 13 West, in San Juan County, New Mexico. Based on the performed remediation activities and laboratory analytical results, Hilcorp is requesting closure and no further action for Incident Number nAPP2212552070.

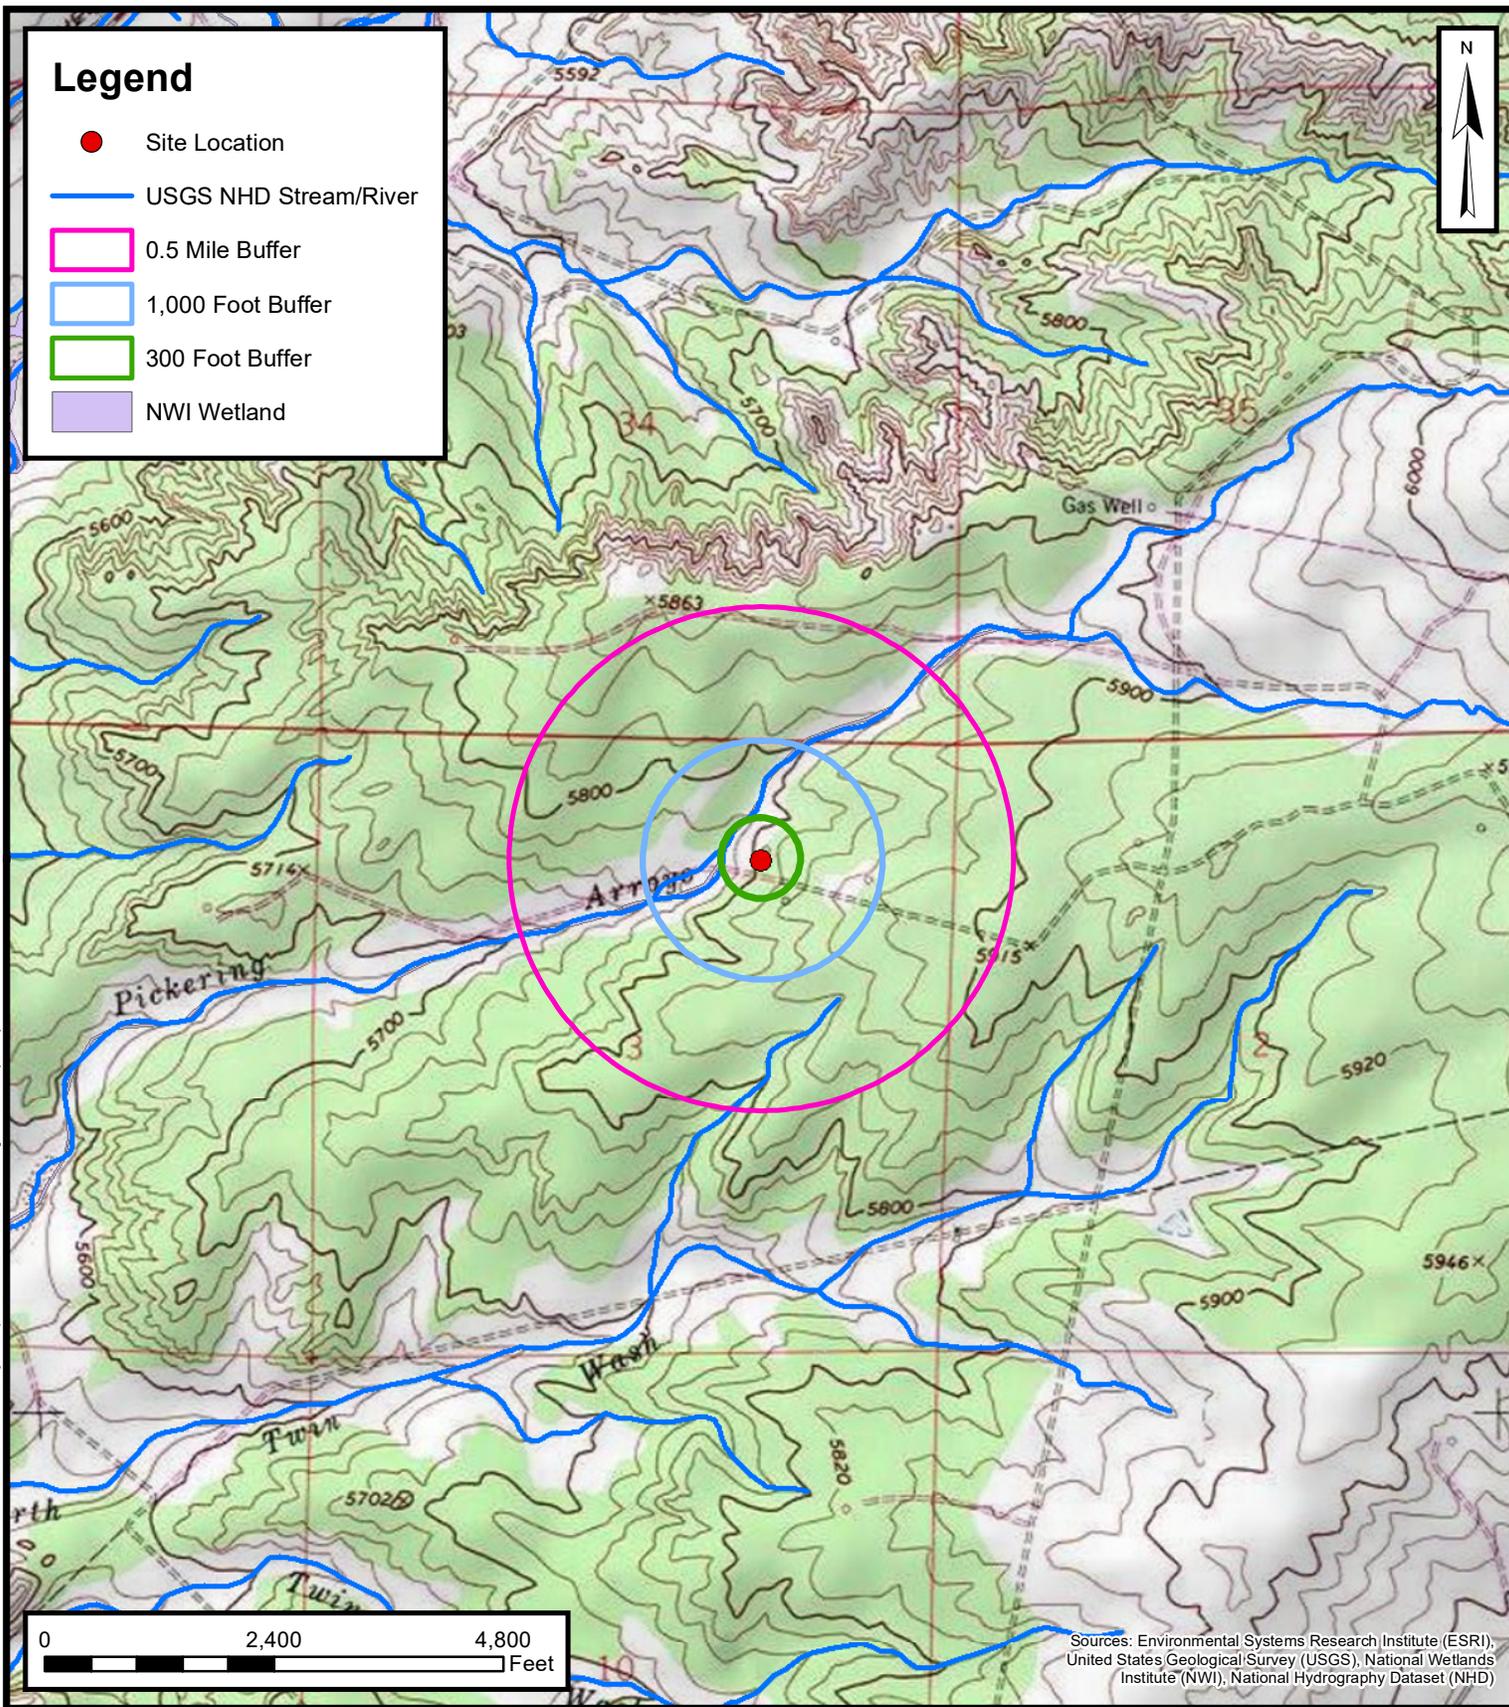
FIGURE
2

Site Receptor Map

The nearest significant watercourse is Pickering Arroyo located 200 feet to the west of the Site. The Site is greater than 200 feet from any lakebed, sinkhole, or playa lake, and greater than 300 feet from any wetland (Figure 2). The nearest fresh-water well is NMOSE permitted well SJ-03751 (Appendix A), located approximately 3,700 feet west of the Site. The recorded depth to water on the NMOSE database is 80 feet below ground surface (bgs). No wellhead protection areas, springs, or domestic/stock wells are located within a ½-mile from the Site. The Site is not within a 100-year floodplain, overlying a subsurface mine, or located within an area underlain by unstable geology (area designated as low potential karst by the BLM). Schools, hospitals, institutions, churches, and/or other occupied permanent residence or structures are not located within 300 feet of the Site.

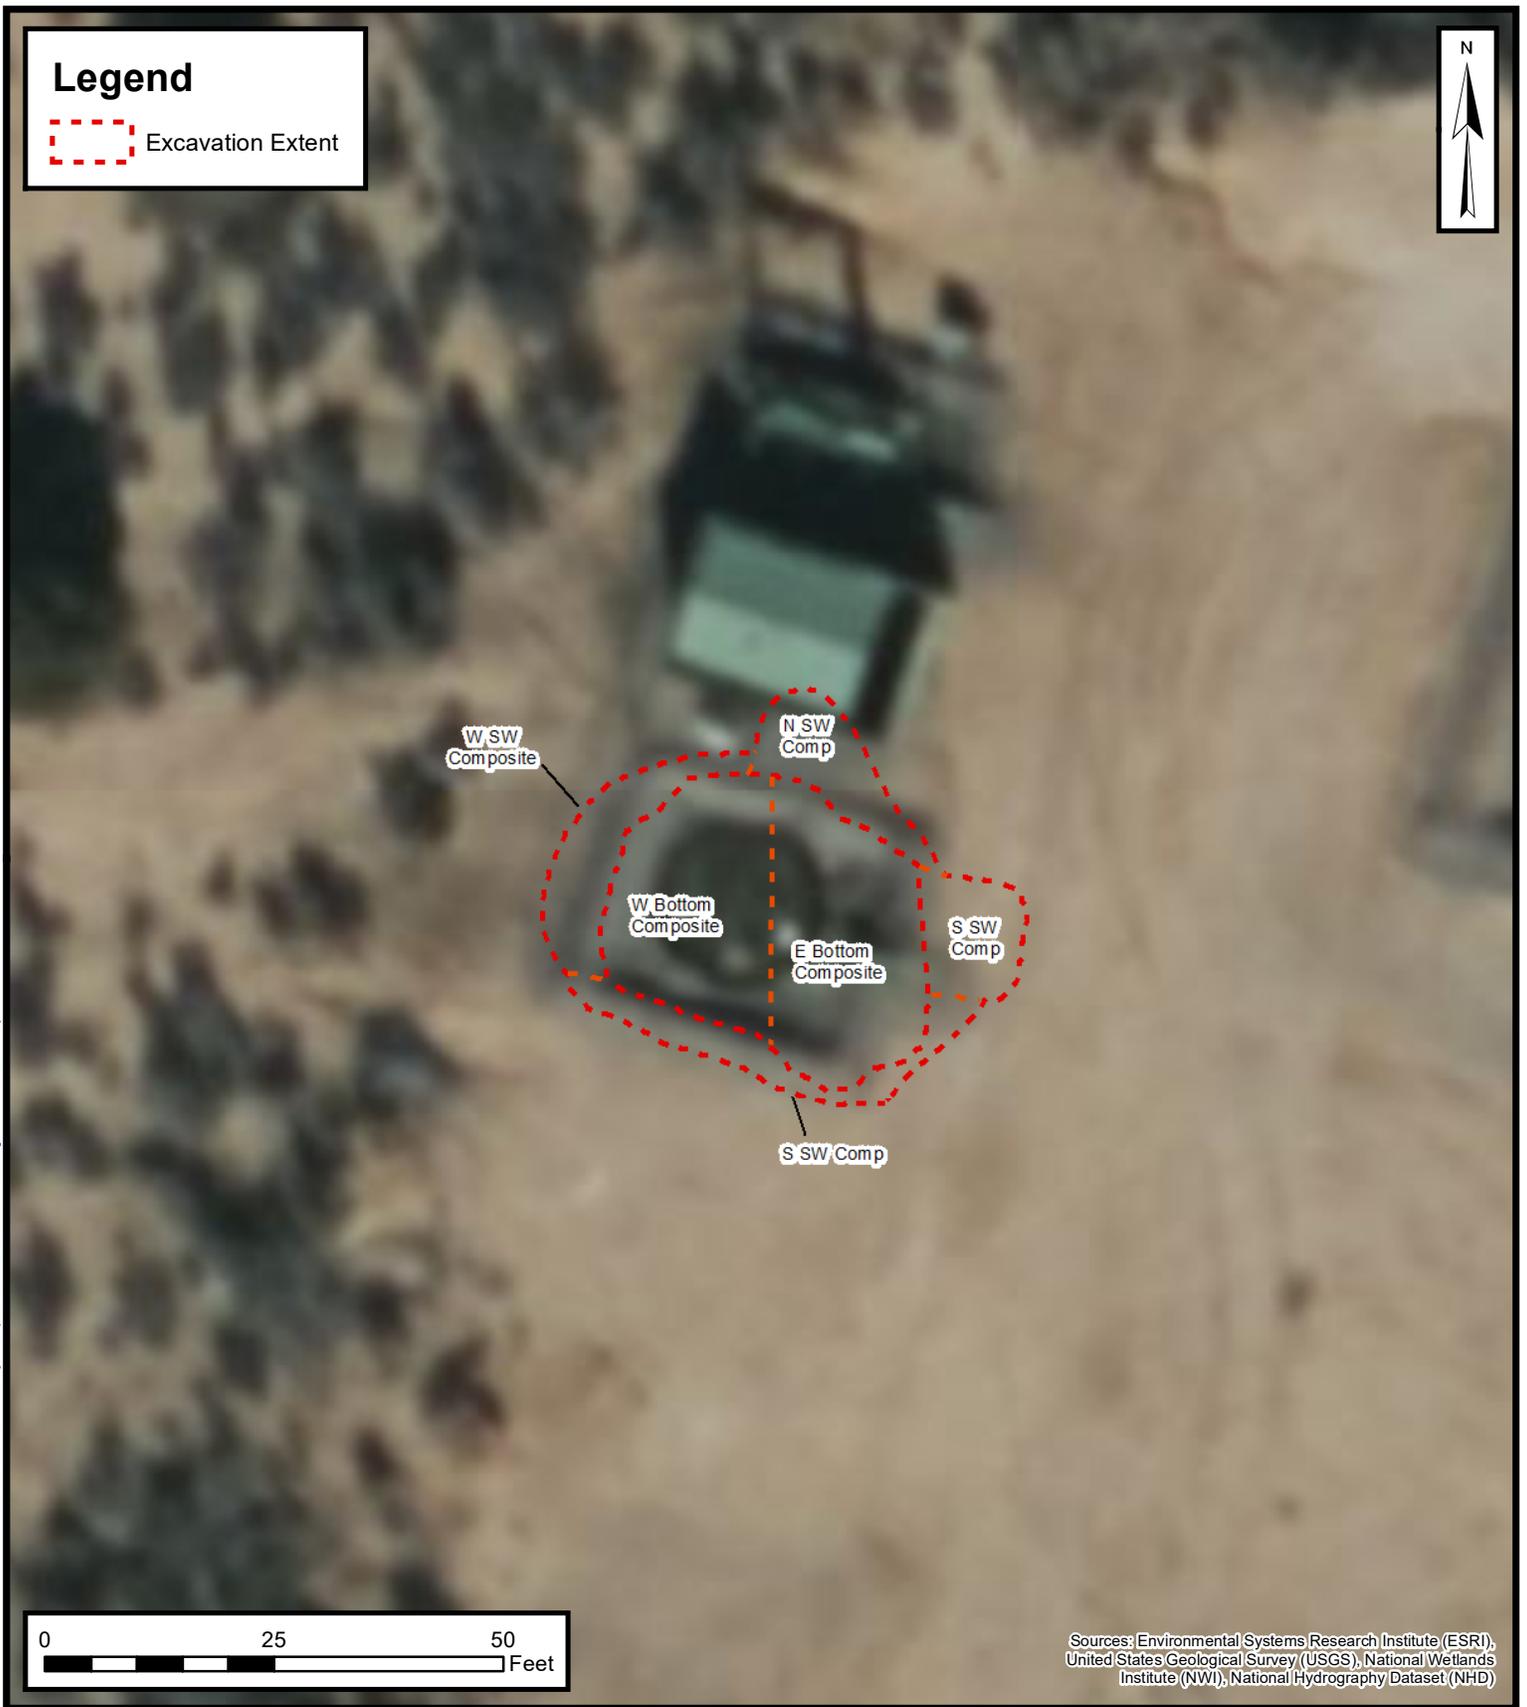
FIGURE
3

Excavation Site Map
 JF Bell #2
 Hilcorp Energy Company
 36.8459015, -108.188446
 San Juan County, NM
 PROJECT NUMBER: 07A1988032

with the location, date, time, sampler name, method of analysis, and immediately placed on ice. The soil samples were transported at or below 4 degrees Celsius (°C) under strict chain-of-custody (COC) procedures to Hall Environmental Analysis Laboratory (Hall) in Albuquerque, New Mexico, for analysis of BTEX following United States Environmental Protection Agency (EPA) Method 8021B; TPH-GRO, TPH-DRO, and TPH-ORO following EPA Method 8015M/D; and chloride following EPA Method 300.0. In total, two floor samples and four sidewall samples were collected on June 2, 2022, as presented on Figure 3.

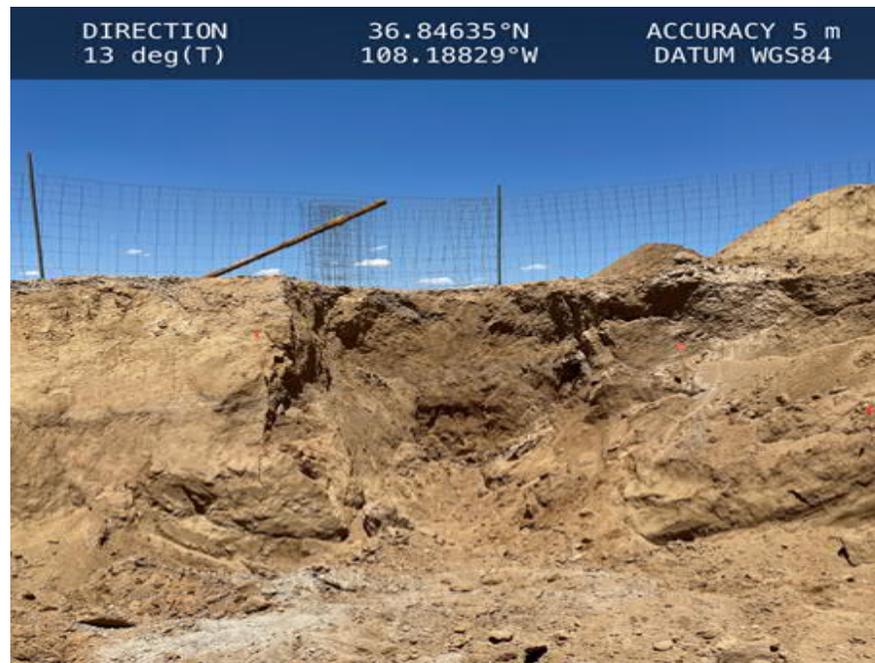
Photograph 1 (dated 6/2/2022) – View of Soil Sample Identification N SW Comp 8'.

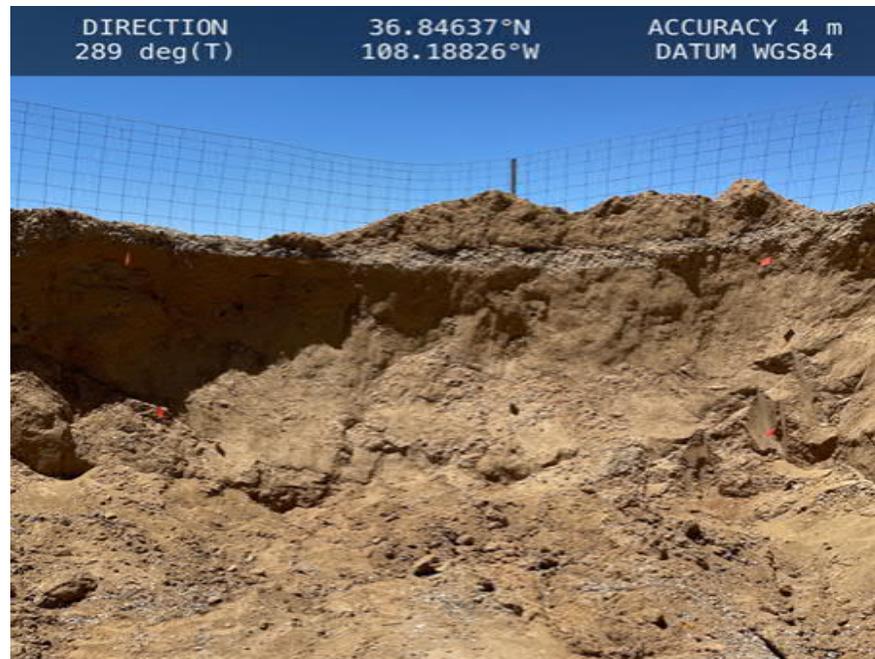
Photograph 2 (dated 6/2/2022) – View of Soil Sample Identification W SW Comp 8'.

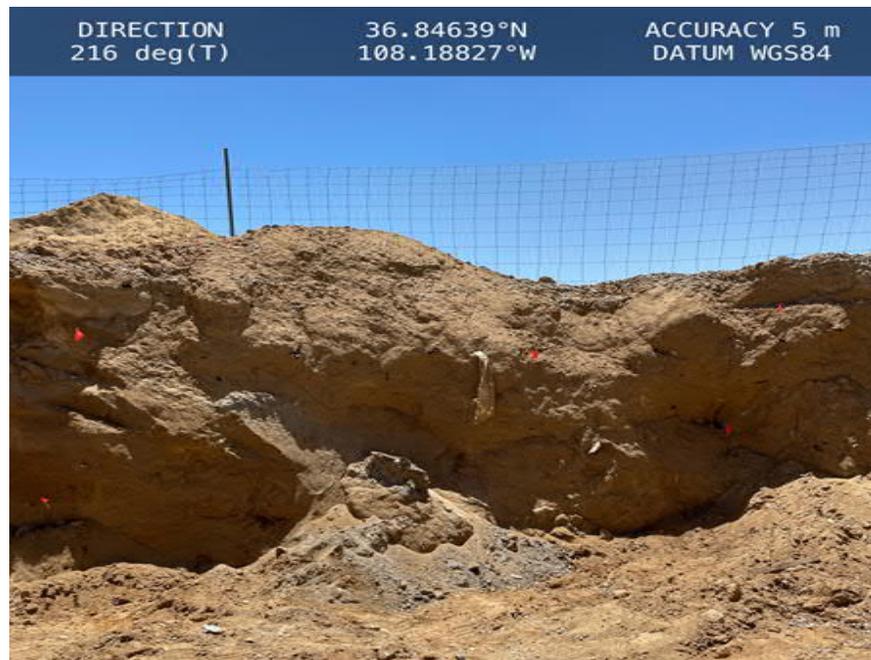
Photograph 3 (dated 6/2/22) – View of Soil Sample Identification S SW Comp 8'.

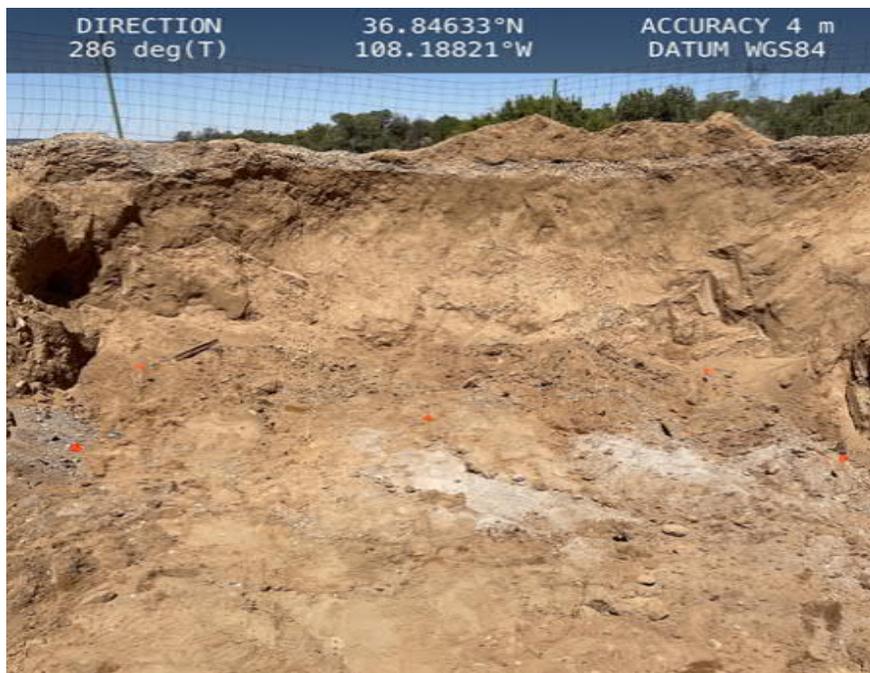
Based on the analytical results, all confirmation samples were in compliance with NMOCD Table I Closure Criteria, with the exception of “W Bottom Comp” collected from the floor on the west half of the excavation. The TPH result from this sample was 160 mg/kg, slightly exceeding the Closure Criteria of 100 mg/kg. Analytical results are summarized in Table 1 with complete laboratory reports included as Appendix C. Photographs from the excavation work taken by Hilcorp are included in Appendix D.

Photograph 5 (dated 6/2/2022) – View of Soil Sample Identification W Bottom Comp 8’.

Based on the single exceedance of TPH in the excavation floor sample, Hilcorp requested approval from the NMOCD of an alternative remediation approach. Specifically, Hilcorp requested the application of Micro-Blaze Emergency Liquid Spill Control (Micro-Blaze™) amendment (see Appendix E) to the “W Bottom Comp” sampling area (approved by the NMOCD on June 21, 2022, Appendix B). Micro-Blaze™ is a liquid amendment designed to enhance bioremediation of residual hydrocarbons in soil and groundwater. Micro-Blaze™ can be used as an *in-situ* treatment method and was applied per the manufacturers specification directly to the “W Bottom Comp” sampling area within the excavation on June 30, 2022. Due to weather conditions and delays in re-sampling at the Site, Hilcorp requested an extension of the original report deadline to September 6, 2022 (NMOCD approval attached in Appendix E).

After allowing the Micro-Blaze™ to degrade the residual TPH concentrations in the soil, Hilcorp notified the NMOCD on August 8, 2022 (Appendix B) and re-collected one 5-point composite soil sample from the “W Bottom Comp” sampling area on August 10, 2022. Based on the analytical results from the June 2, 2022 sampling, Hilcorp requested that the analyte list for final confirmation sampling be reduced to include only TPH analysis by EPA Method 8015 M/D. This request was subsequently approved by the NMOCD on July 13, 2022 (Appendix B). Results from the resampling event indicated that TPH concentrations had been reduced from 160 mg/kg on June 2, 2022 to 128 mg/kg on August 10, 2022. Although decreasing, TPH concentrations in floor area “W Bottom Comp” remain slightly above the NMOCD Table I Closure Criteria of 100 mg/kg. Analytical results are also included in Table 1 with complete laboratory reports in Appendix C.

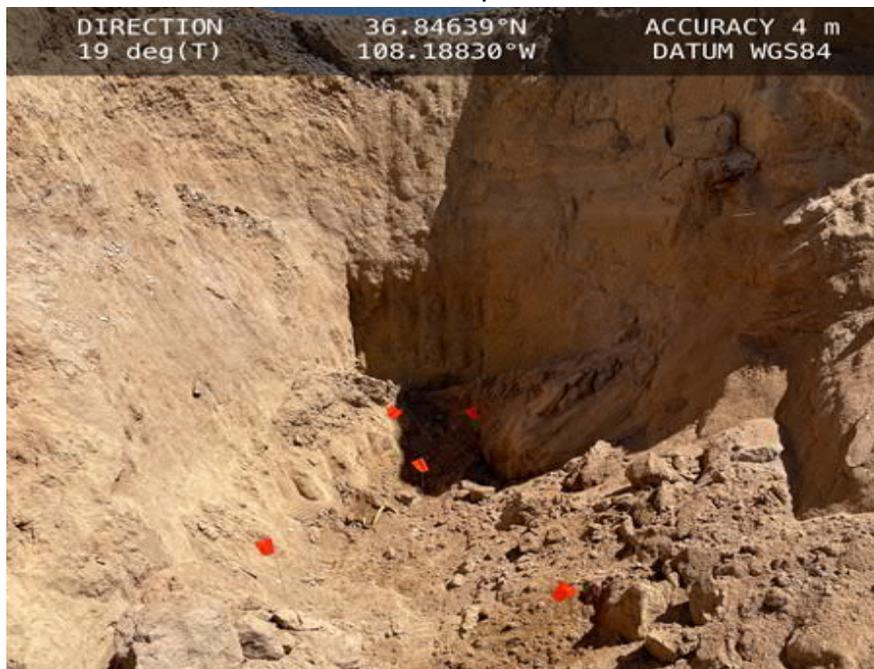
Photograph 6 (dated 6/2/2022) – View of Soil Sample Identification E Bottom Comp 8’.

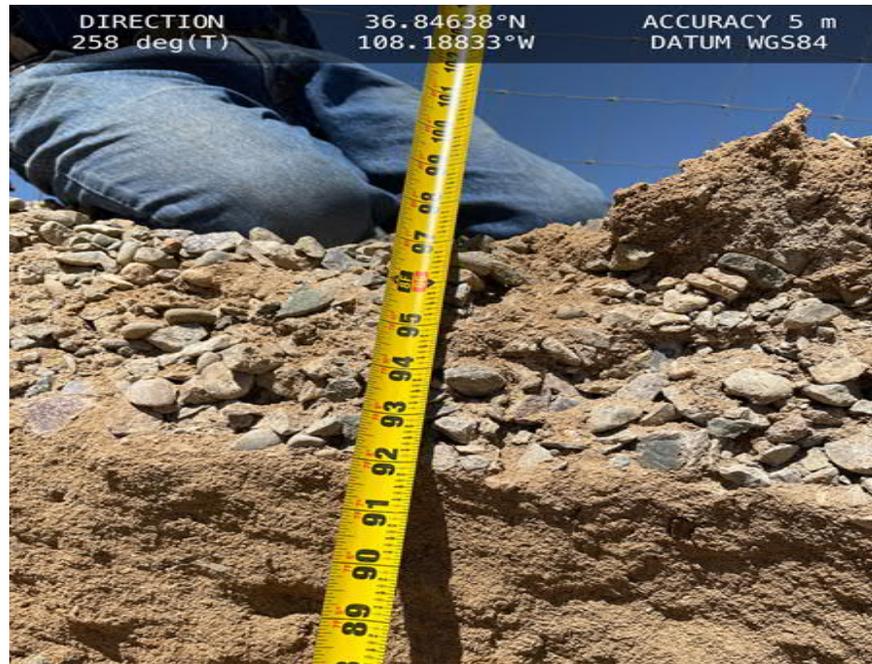
Photograph 7 (dated 6/2/2022) – Close-up view of measuring tape indicating depth of excavation.

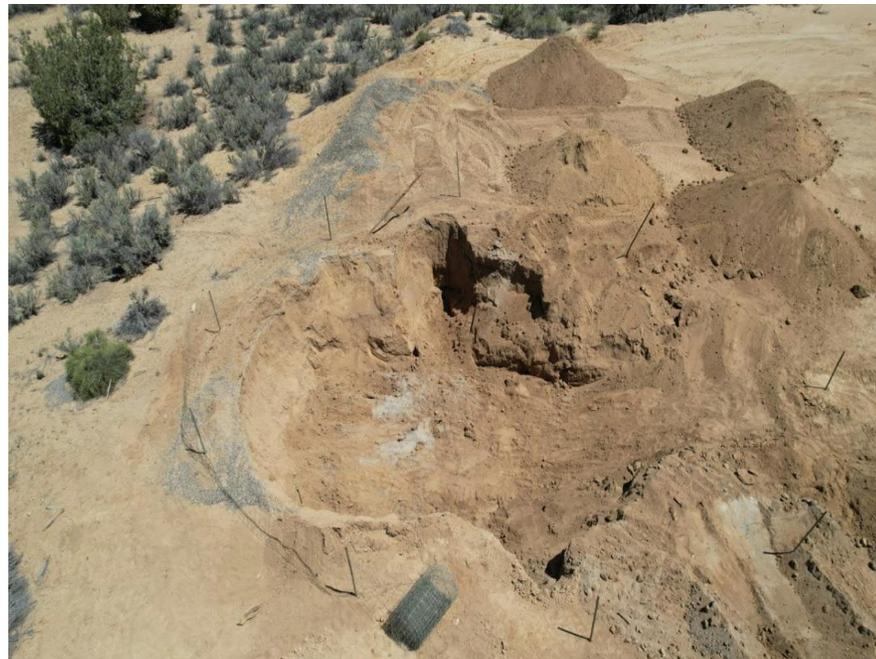
Photograph 8 (dated 6/2/2022) – Aerial view of JF Bell 2 excavation.
