Incident ID	NAB1909539458
District RP	2RP-5333
Facility ID	fAB190953882
Application ID

Gissler B 3-3

Water Transfer Pump 2/2/21

The following is a historical account of the actions that Burnett Oil Co., Inc (BOCI) has taken to date to address the release.

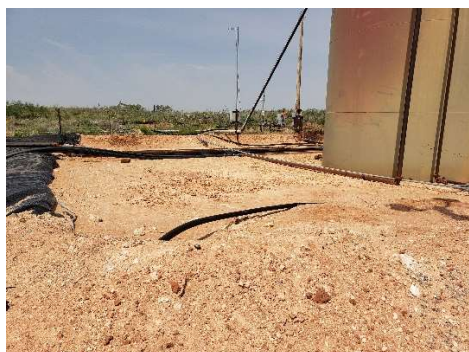
Sample Pt 3 Inside containment 9/8/22

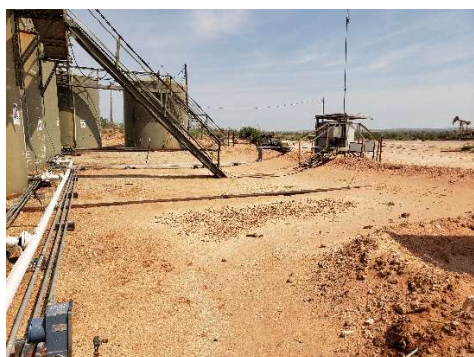
Sample Pt. 2 Inside Containment

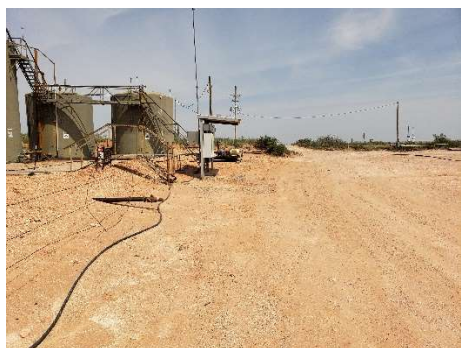
Roadway up to Transfer pump

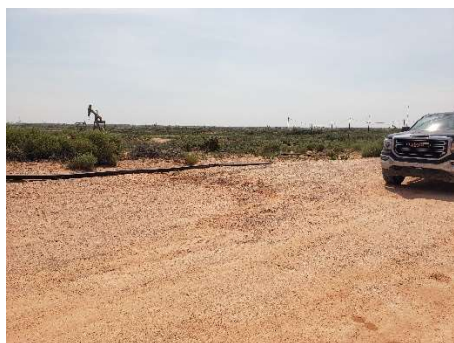
Road where it went off into pasture

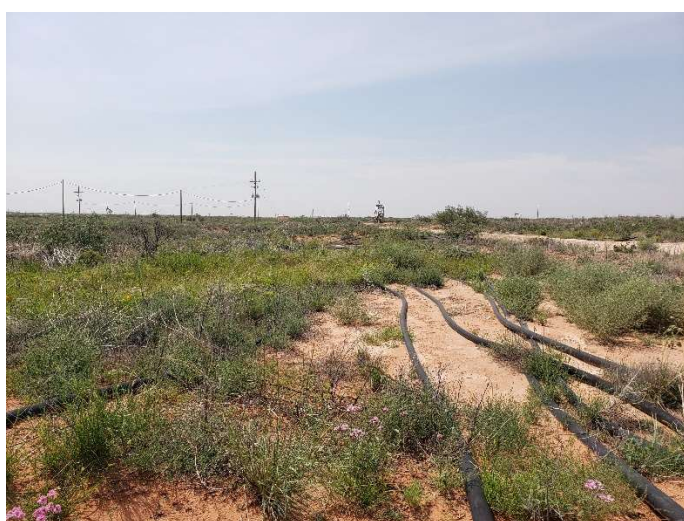
Already have a lot of growth in pasture 9/8/22
