Re: Status Report – 2nd Quarter 2021
Kaufman No. 1
San Juan County, New Mexico
OCD No.: AP-0138

On behalf of Hilcorp Energy Company (Hilcorp), Timberwolf Environmental, LLC (Timberwolf) prepared this letter to document the 2nd Quarter 2021 (2Q21) groundwater monitoring activities at the Kaufman No. 1 (Site). The Site is located approximately 9.1 miles north of Farmington in San Juan County, New Mexico (Figure 1).

Timberwolf Project No. HEC-180061

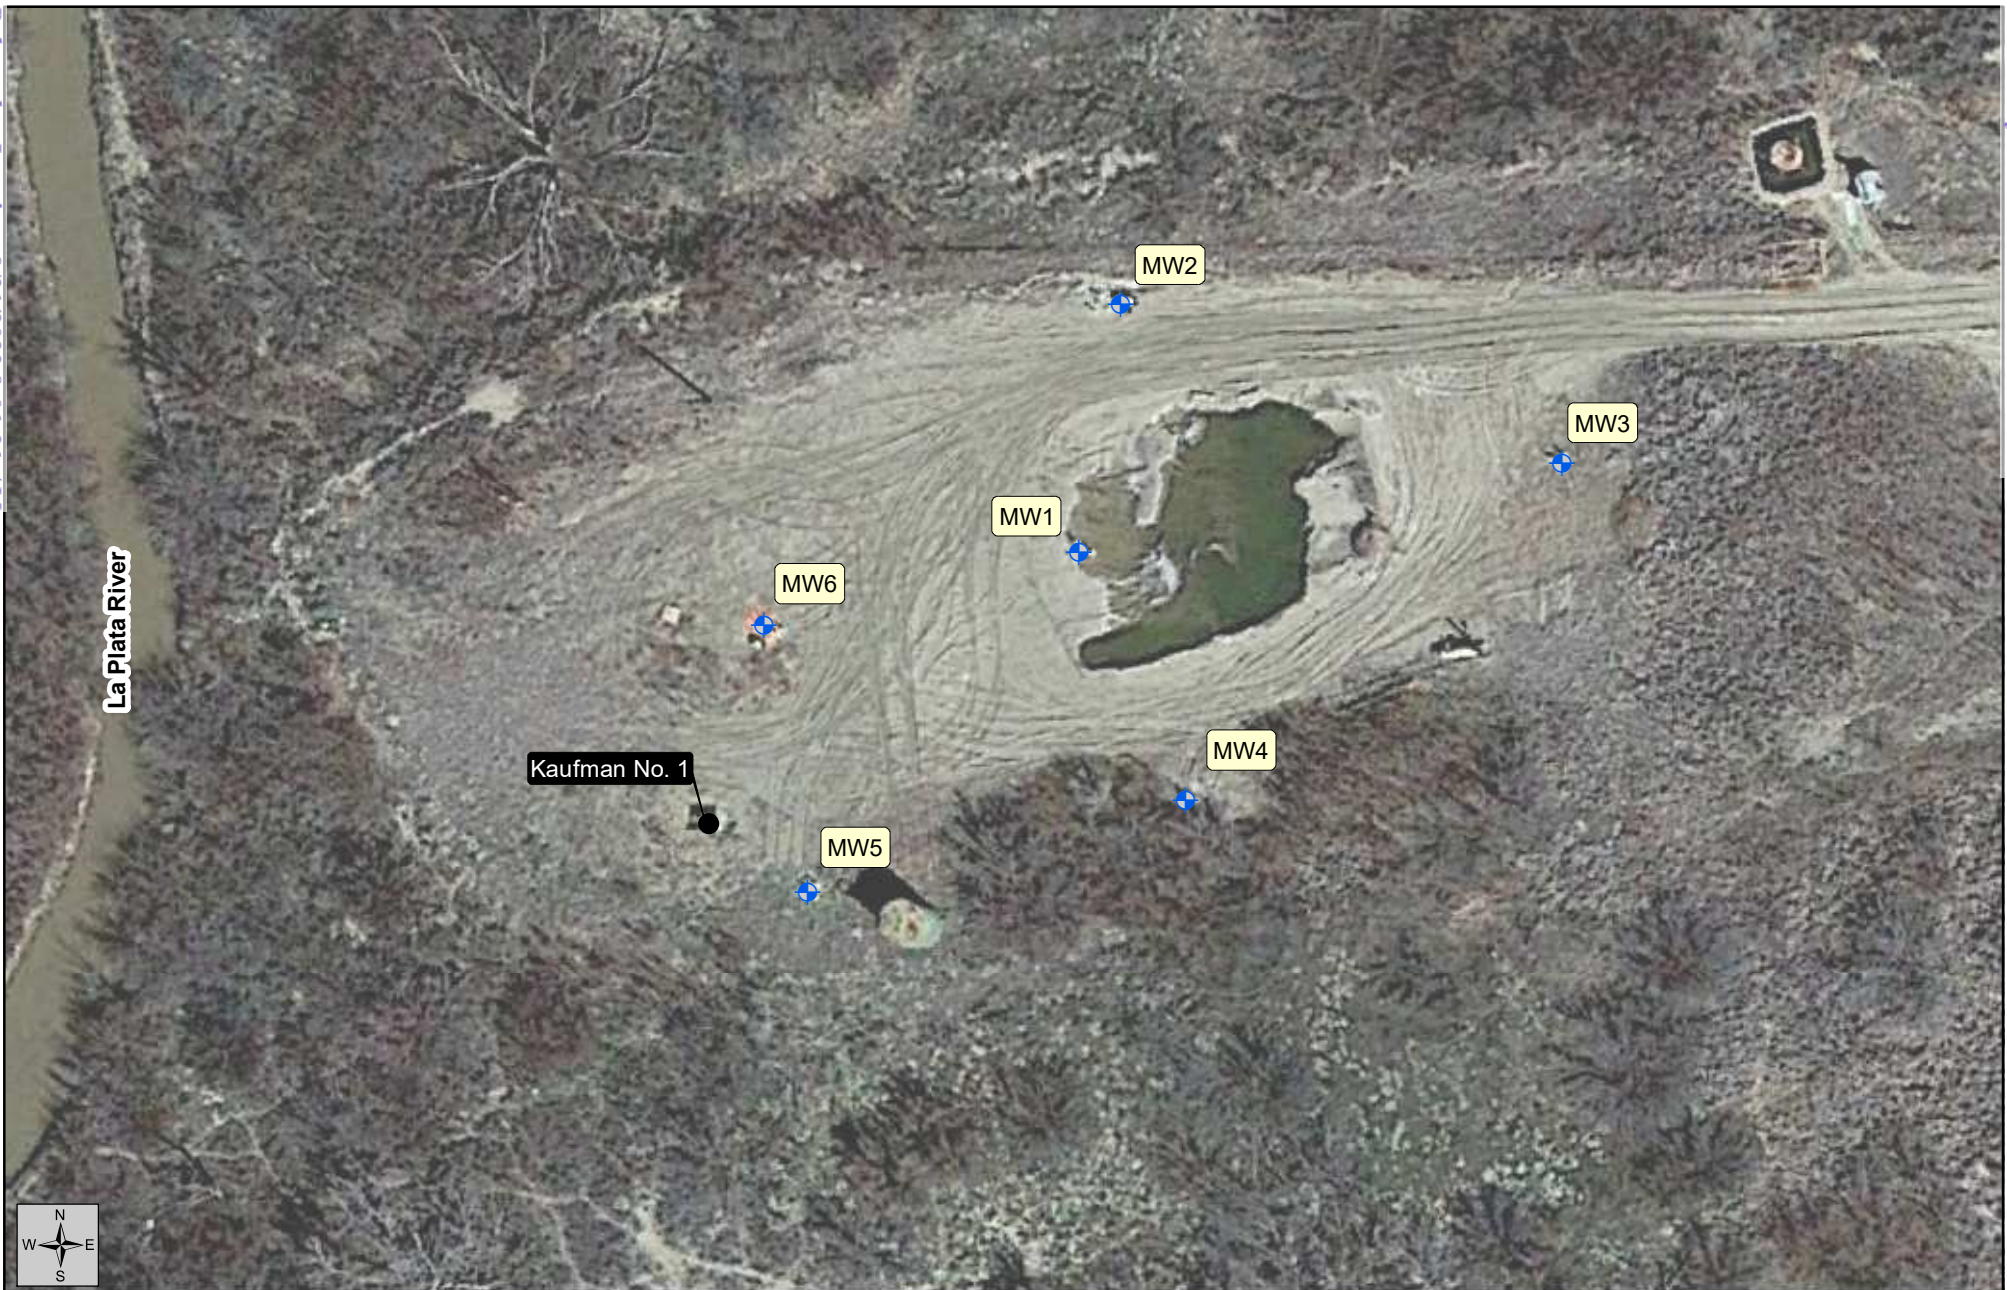
Figure 4
Monitor Well Location Map

On 05/26/21, Timberwolf conducted the 2Q21 groundwater monitoring event at the Site. Groundwater and surface water gauging, groundwater sample collection, and analytical results are documented below. Monitor well locations are shown in the attached Figure 4.

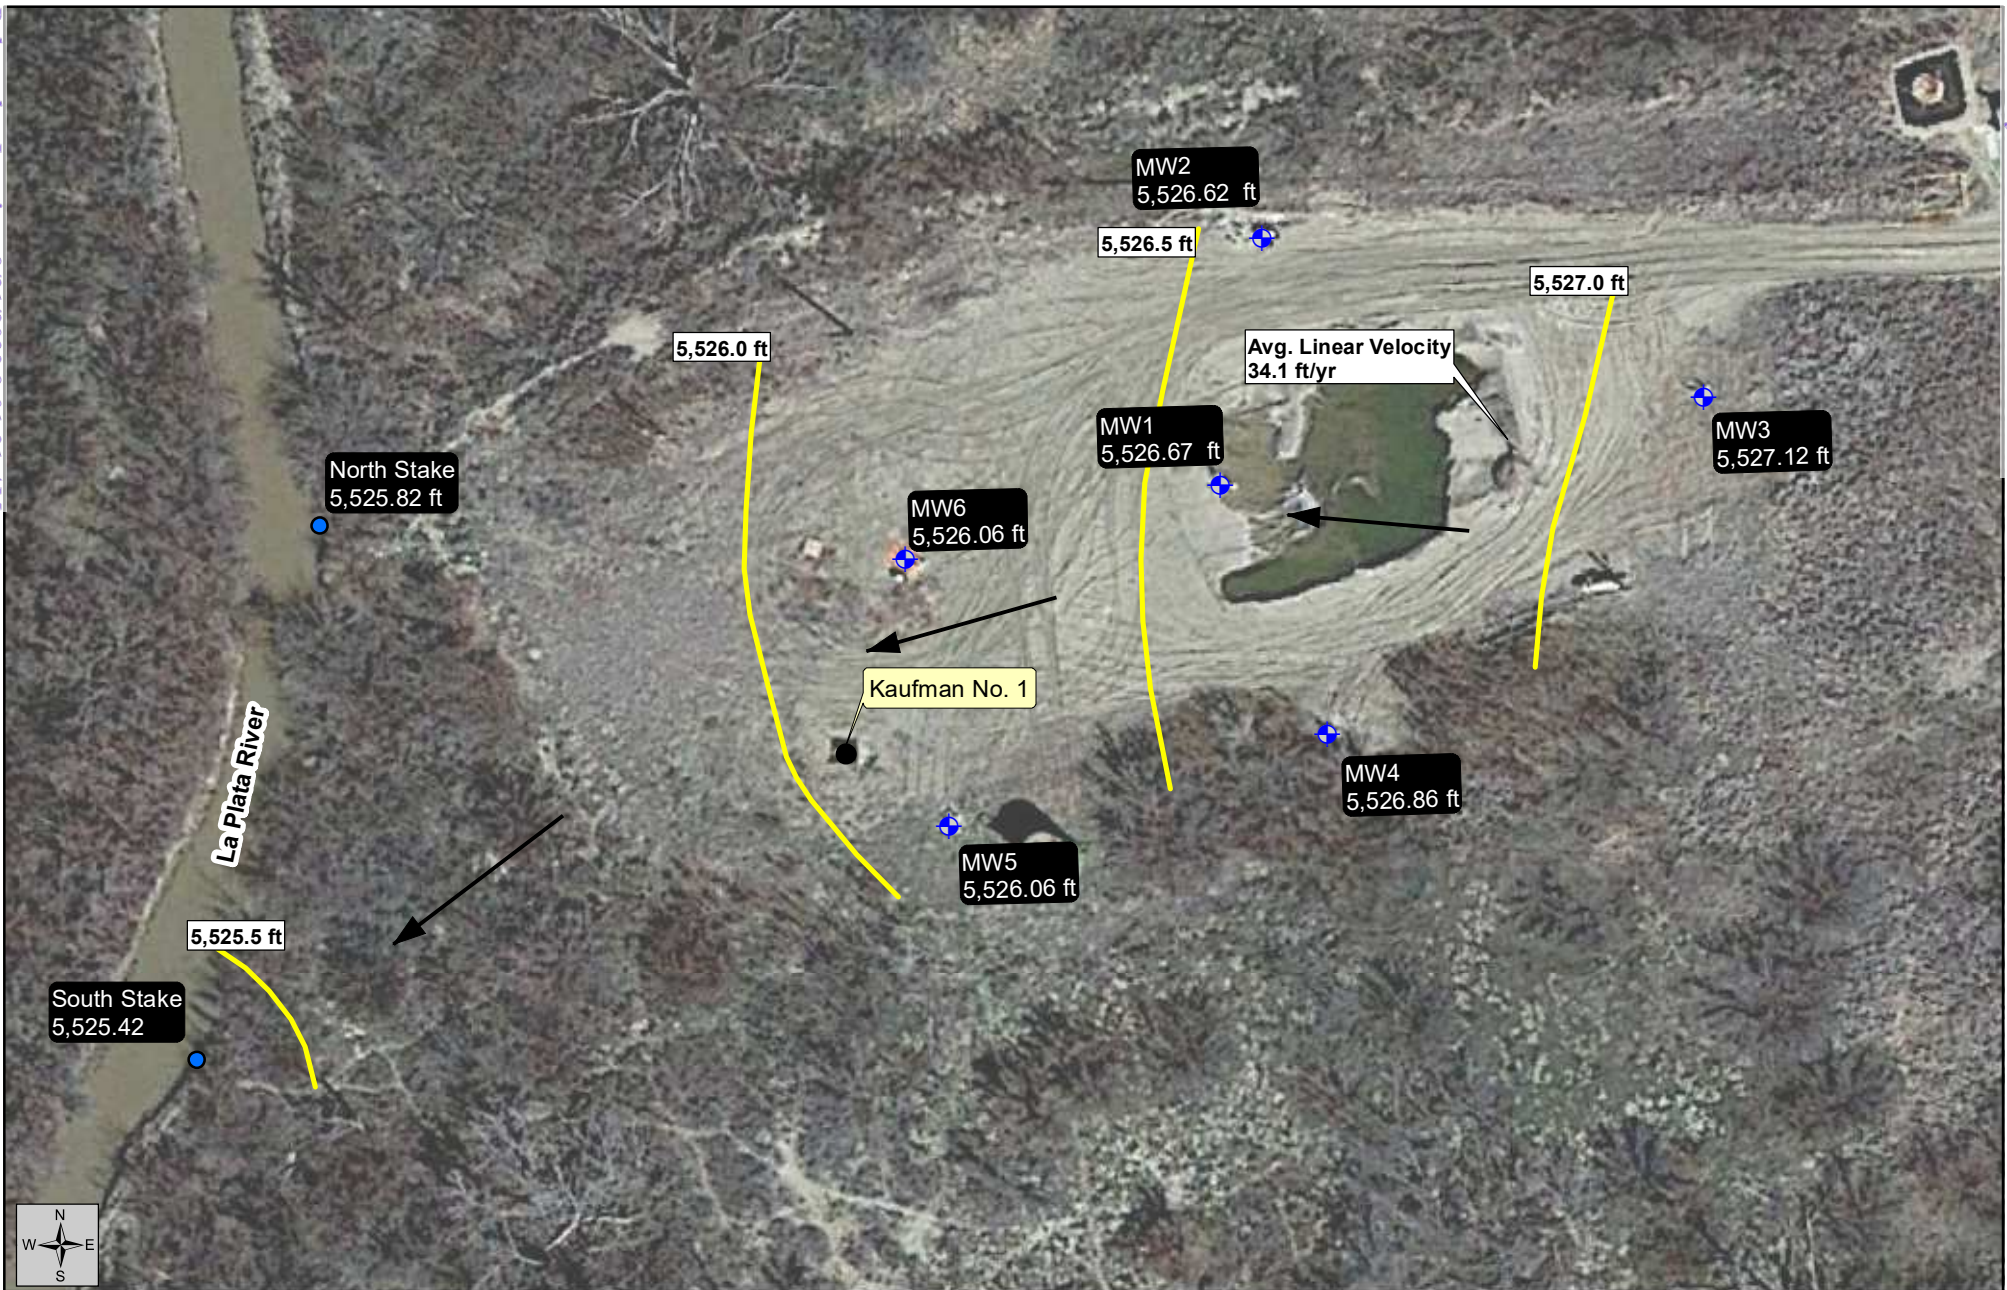
Figure 5
Potentiometric Surface
Elevation Map

Timberwolf prepared a potentiometric surface elevation (PSE) map as shown in Figure 5. The 2Q21 PSE map revealed that groundwater flow across the Site was west-southwest towards the La Plata River with an average linear velocity of 34.1 feet per year (ft/yr).

- BTEX concentrations were below regulatory human health criteria and laboratory detection limits at all sampling stations (i.e., MW1 – MW6)
- Groundwater flow across the Site is west-southwest towards the La Plata River

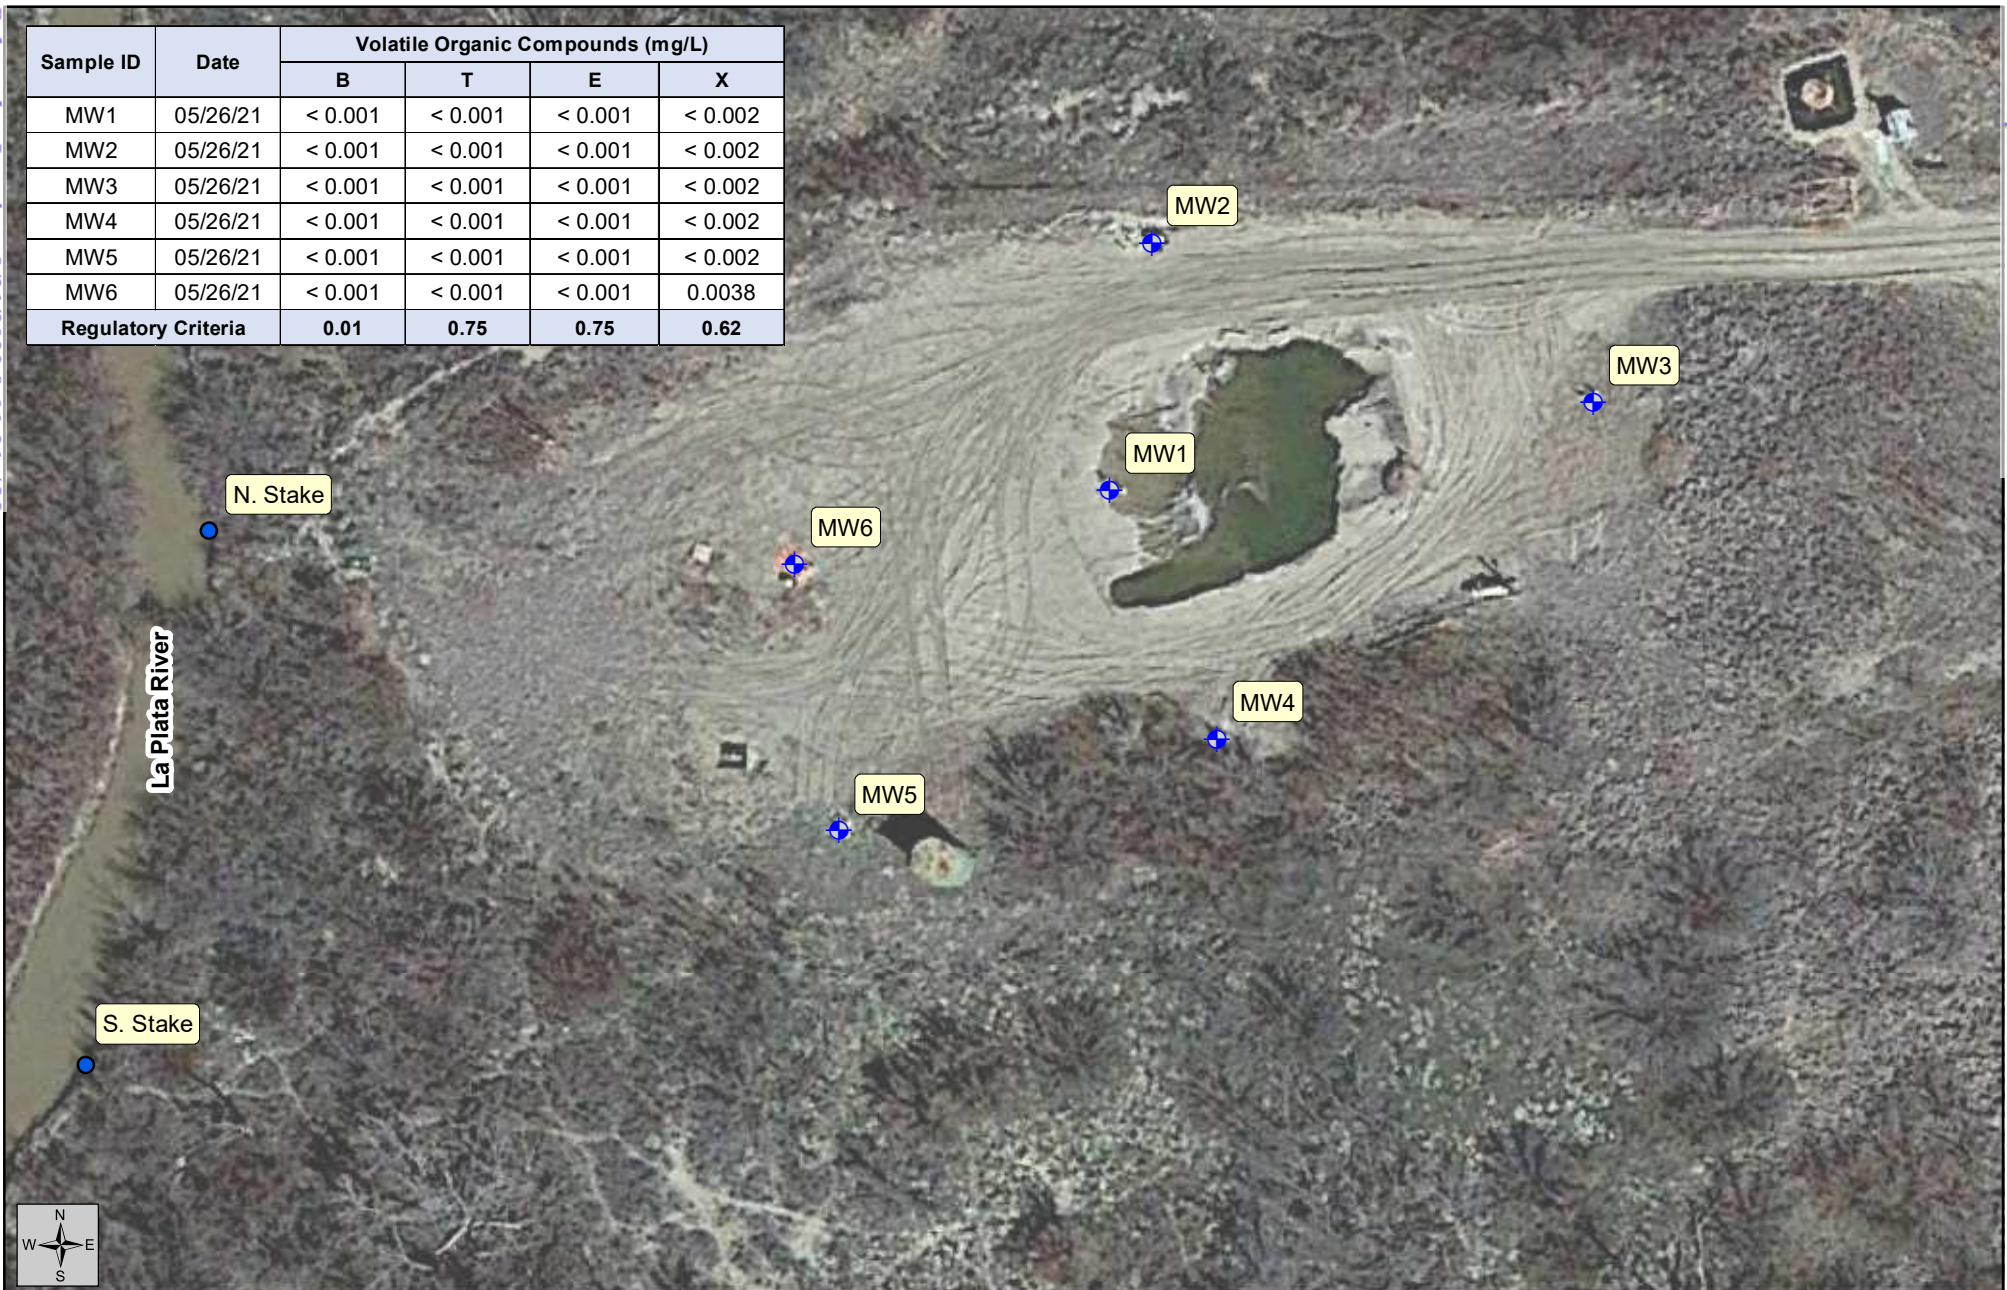
Figure 6
BTEX Results - 2Q21

Groundwater samples were analyzed for the following constituents: BTEX by EPA Method 8260. Cumulative analytical results from each groundwater sampling station are documented in Table A-3 (attached). Analytical results for the 2Q21 groundwater monitoring event are summarized in Table 2 below and shown in Figure 6.
