Release Notification

Site Name	Griffin #004 SWD	Site Type	SWD
Date Release Discovered	7/26/2017	API# (if applicable)	30-005-20809

Case Number: 1RP-4774

Actions Taken to Close Out the C-141

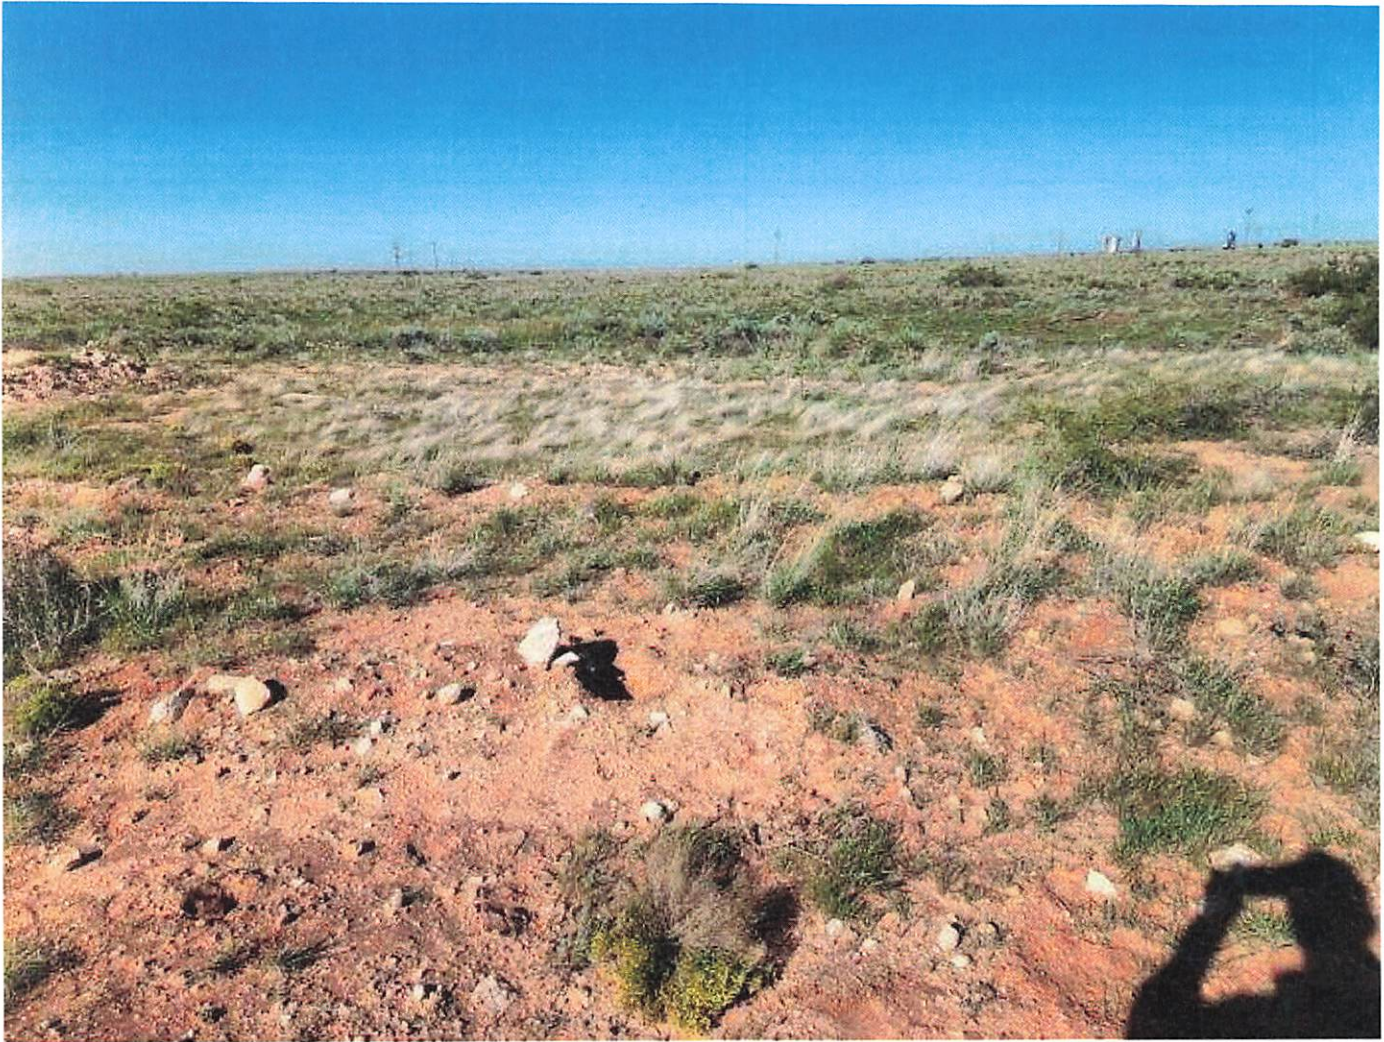
Upon receiving the OCD Directive, Wayne Parkinson (Production Manager) took pictures of the spill area which shows the location is covered in vegetation and that no damage was done to the surface or vegetation (pictures provided in separate attachment).

Photo #1 of release location currently

This incident occurred on private land and the landowner informed us that our initial quick actions to mix sand to soak up the produced water was satisfactory to him. Per the land owner, the groundwater depth in this area is at 250 feet. Vegetation is currently growing on the location of the leak.

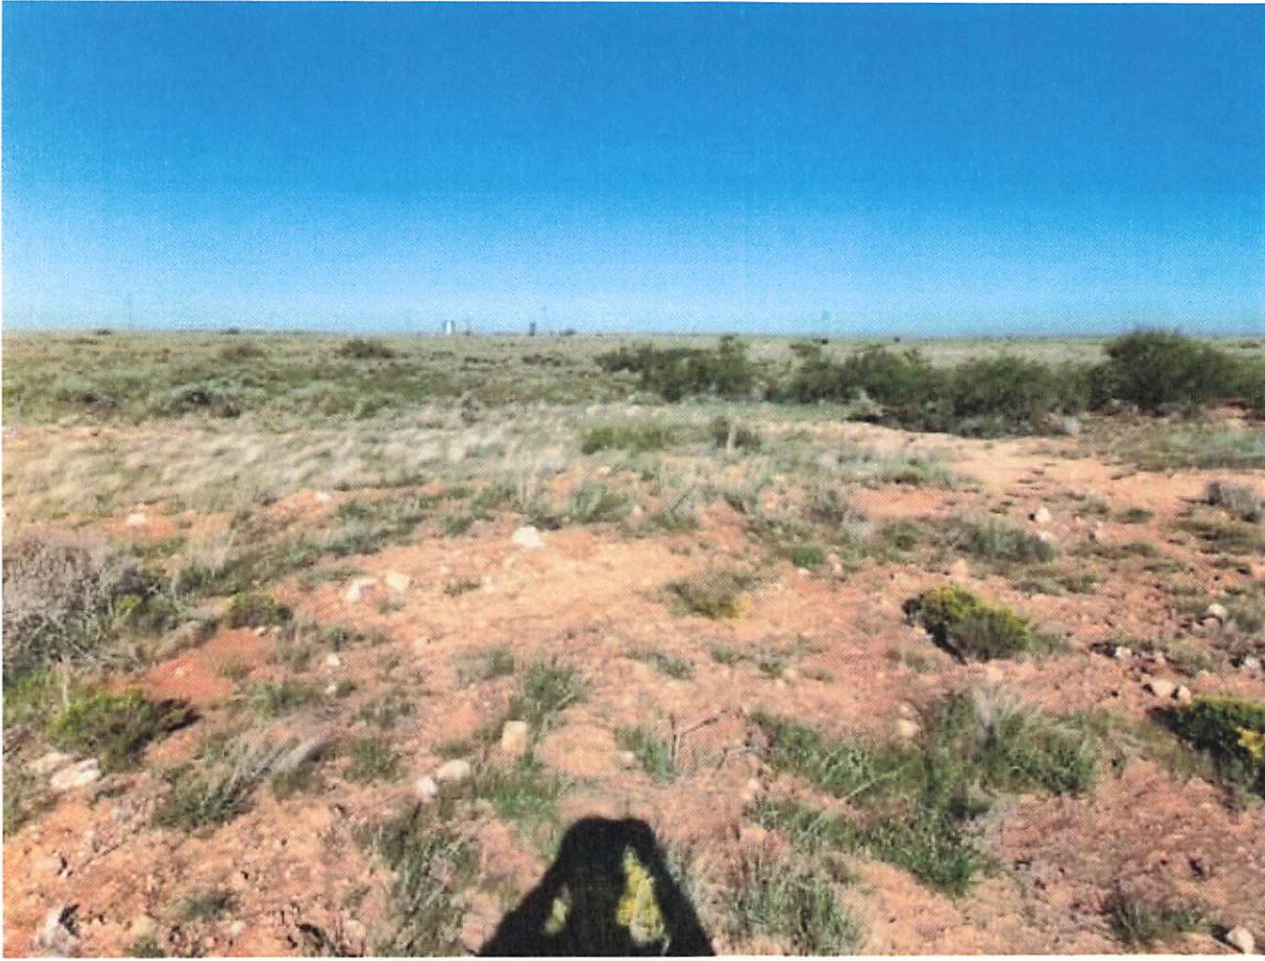
Photo #2 of release location currently
