Release Notification

Site Name Hardie LS 011	Site Type Natural Gas Well
Date Release Discovered	API# (if applicable) 3004521086

Cause of Release **TPH, BTEX, & chloride all below below-grade tank (BGT) permit closure standards for 5 point composite sample collected beneath BGT.**

CLIENT: SIMCOE	BLAGG ENGINEERING, INC. P.O. BOX 87, BLOOMFIELD, NM 87413 (505) 632-1199	APP #: 3004521086 TANK ID (if applicable): A								
FIELD REPORT: (circle one): <input checked="" type="checkbox"/> BGT CONFIRMATION / <input type="checkbox"/> RELEASE INVESTIGATION / <input type="checkbox"/> OTHER:		PAGE #: 1 of 1								
SITE INFORMATION: SITE NAME: HARDIE LS # 11 QUAD/UNIT: C SEC: 25 TWP: 29N RING: 8W PM: NM CNTY: SJ ST: NM 1/4 -1/4 FOOTAGE: 970'N / 1,500'W NE/NW LEASE TYPE: <input checked="" type="checkbox"/> FEDERAL / STATE / FEE / INDIAN LEASE #: SF078416A PROD. FORMATION: PC CONTRACTOR: KELLEY O.F.S. BPX - D. BULLER		DATE STARTED: 08/04/20 DATE FINISHED: _____ ENVIRONMENTAL SPECIALIST(S): JCB								
REFERENCE POINT: WELL HEAD (W.H.) GPS COORD.: 36.70121 X 107.63190 GL ELEV.: 6,379' 1) 95 BGT (SW/DB) GPS COORD.: 36.70117 X 107.63201 DISTANCE/BEARING FROM W.H.: 29', S51W 2) _____ GPS COORD.: _

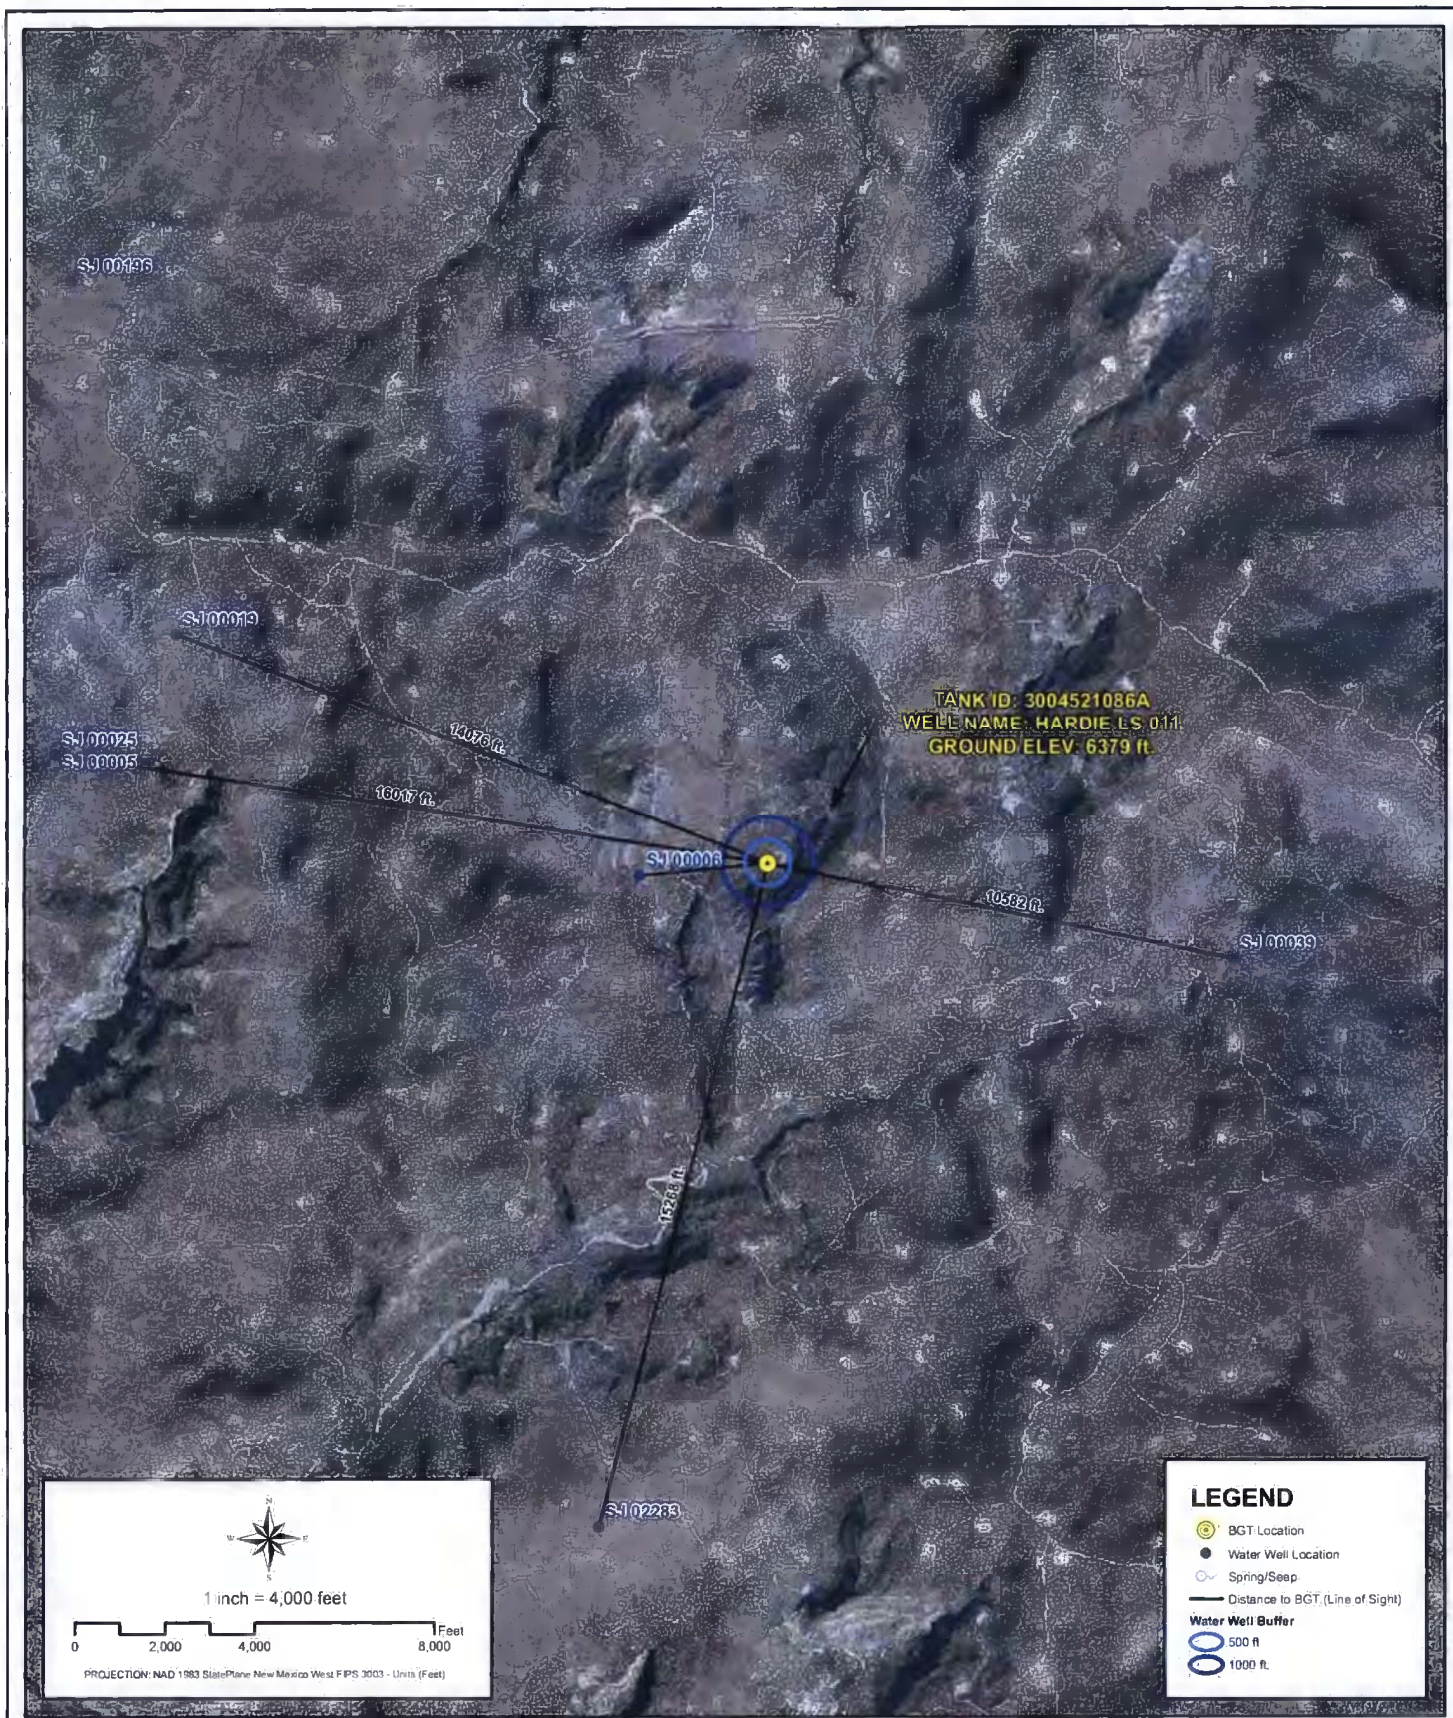
<h2 style="margin: 0;">PROXIMITY TO WATER WELLS</h2> <p style="margin: 0;">WELL NAME: HARDIE LS 011</p> <p style="margin: 0;">API NUMBER: 3004521086 TANK ID: 3004521086A</p> <p style="margin: 0;">SECTION 25, TOWNSHIP 29.0N, RANGE 08W, P.M. NM23</p>	<h1 style="margin: 0;">FIGURE 3</h1>
---	---	--

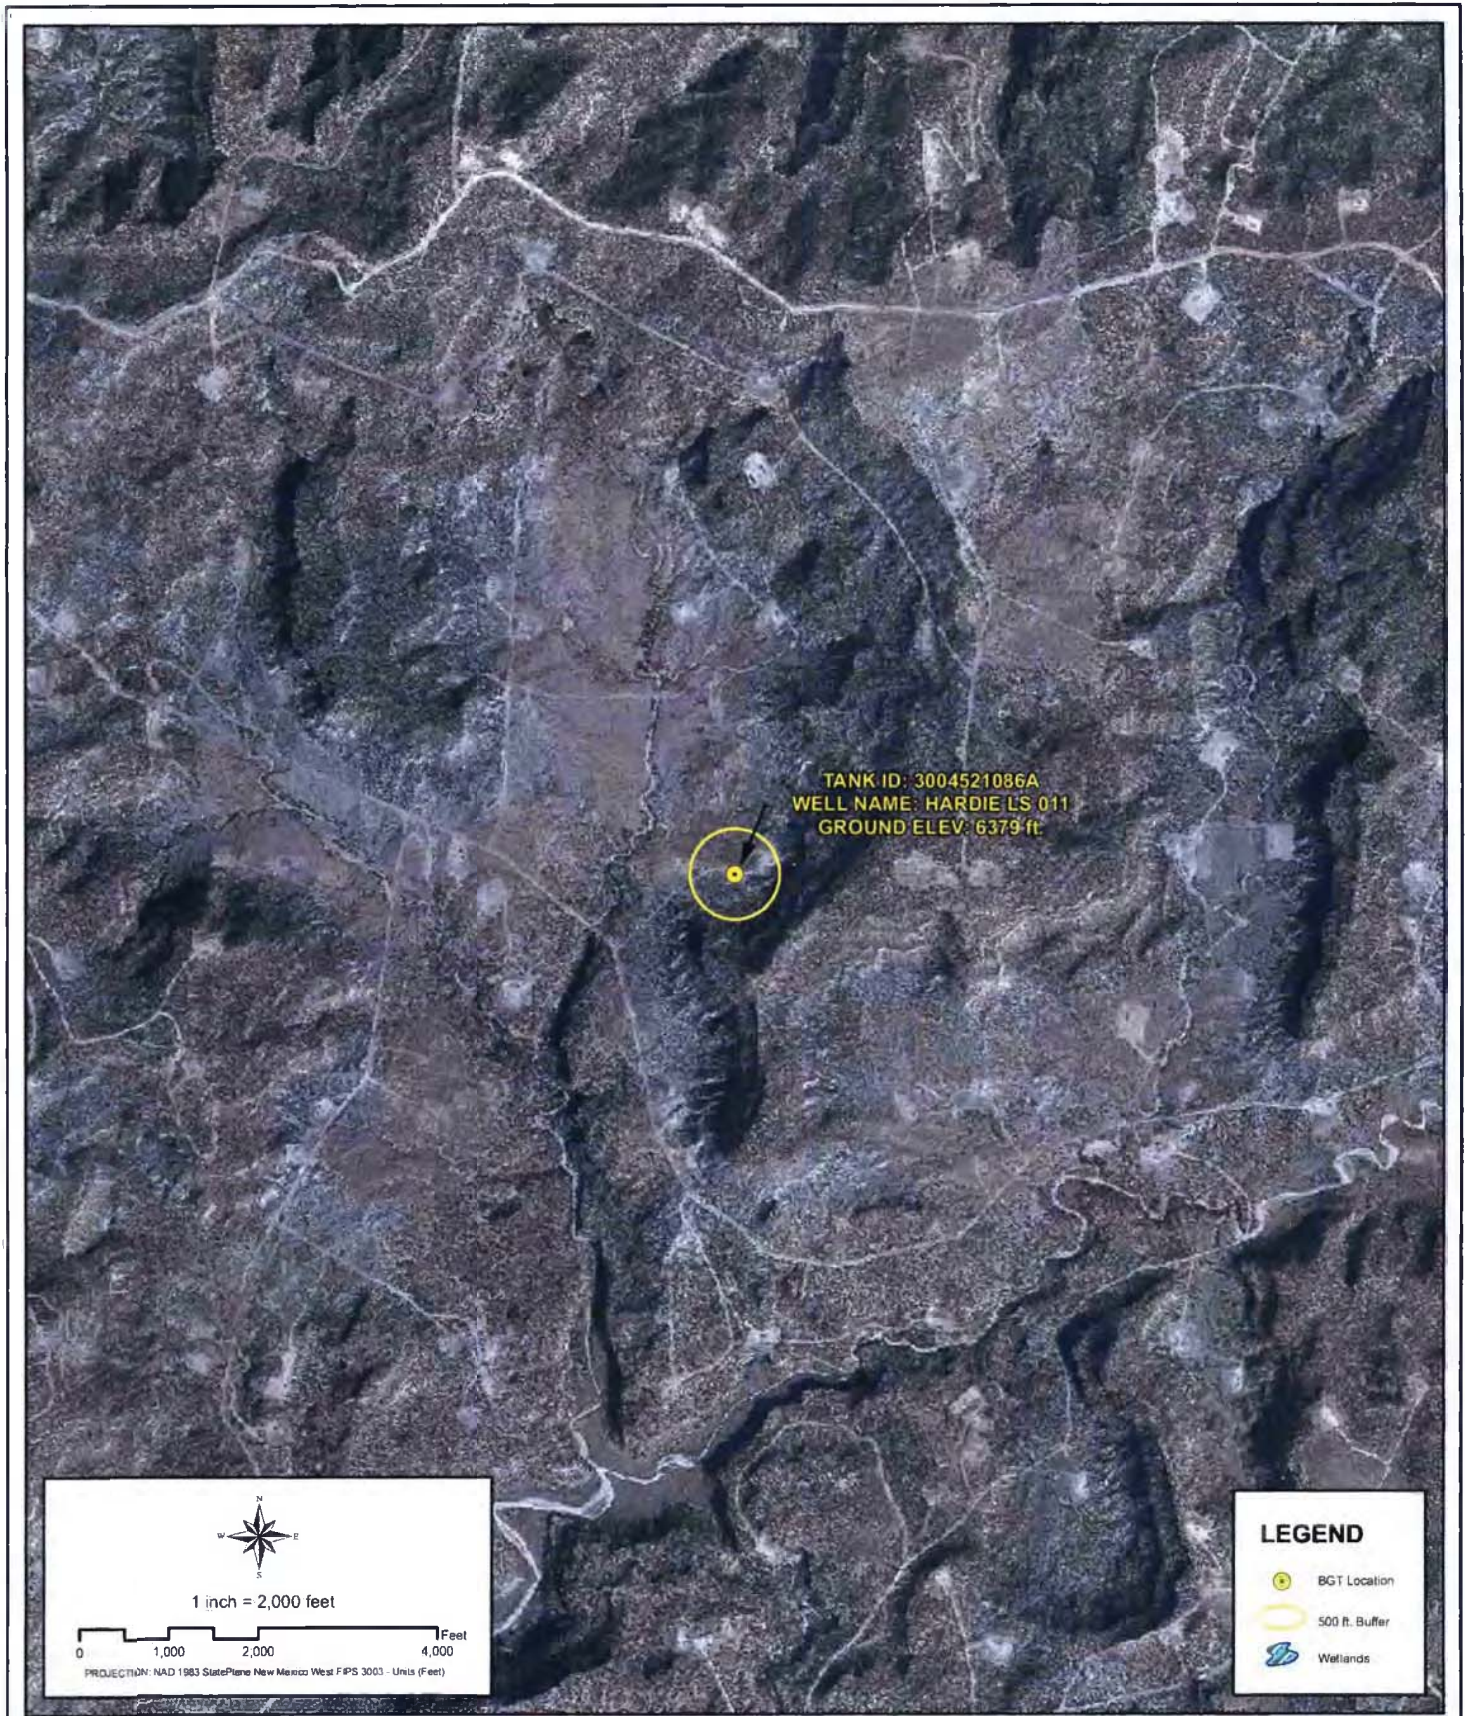
<p>PROXIMITY TO WETLANDS</p> <p>WELL NAME: HARDIE LS 011</p> <p>API NUMBER: 3004521086 TANK ID: 3004521086A</p> <p>SECTION 25, TOWNSHIP 29.0N, RANGE 08W, P.M. NM23</p>	<p>FIGURE</p> <p>4</p>
---	---	--------------------------------------

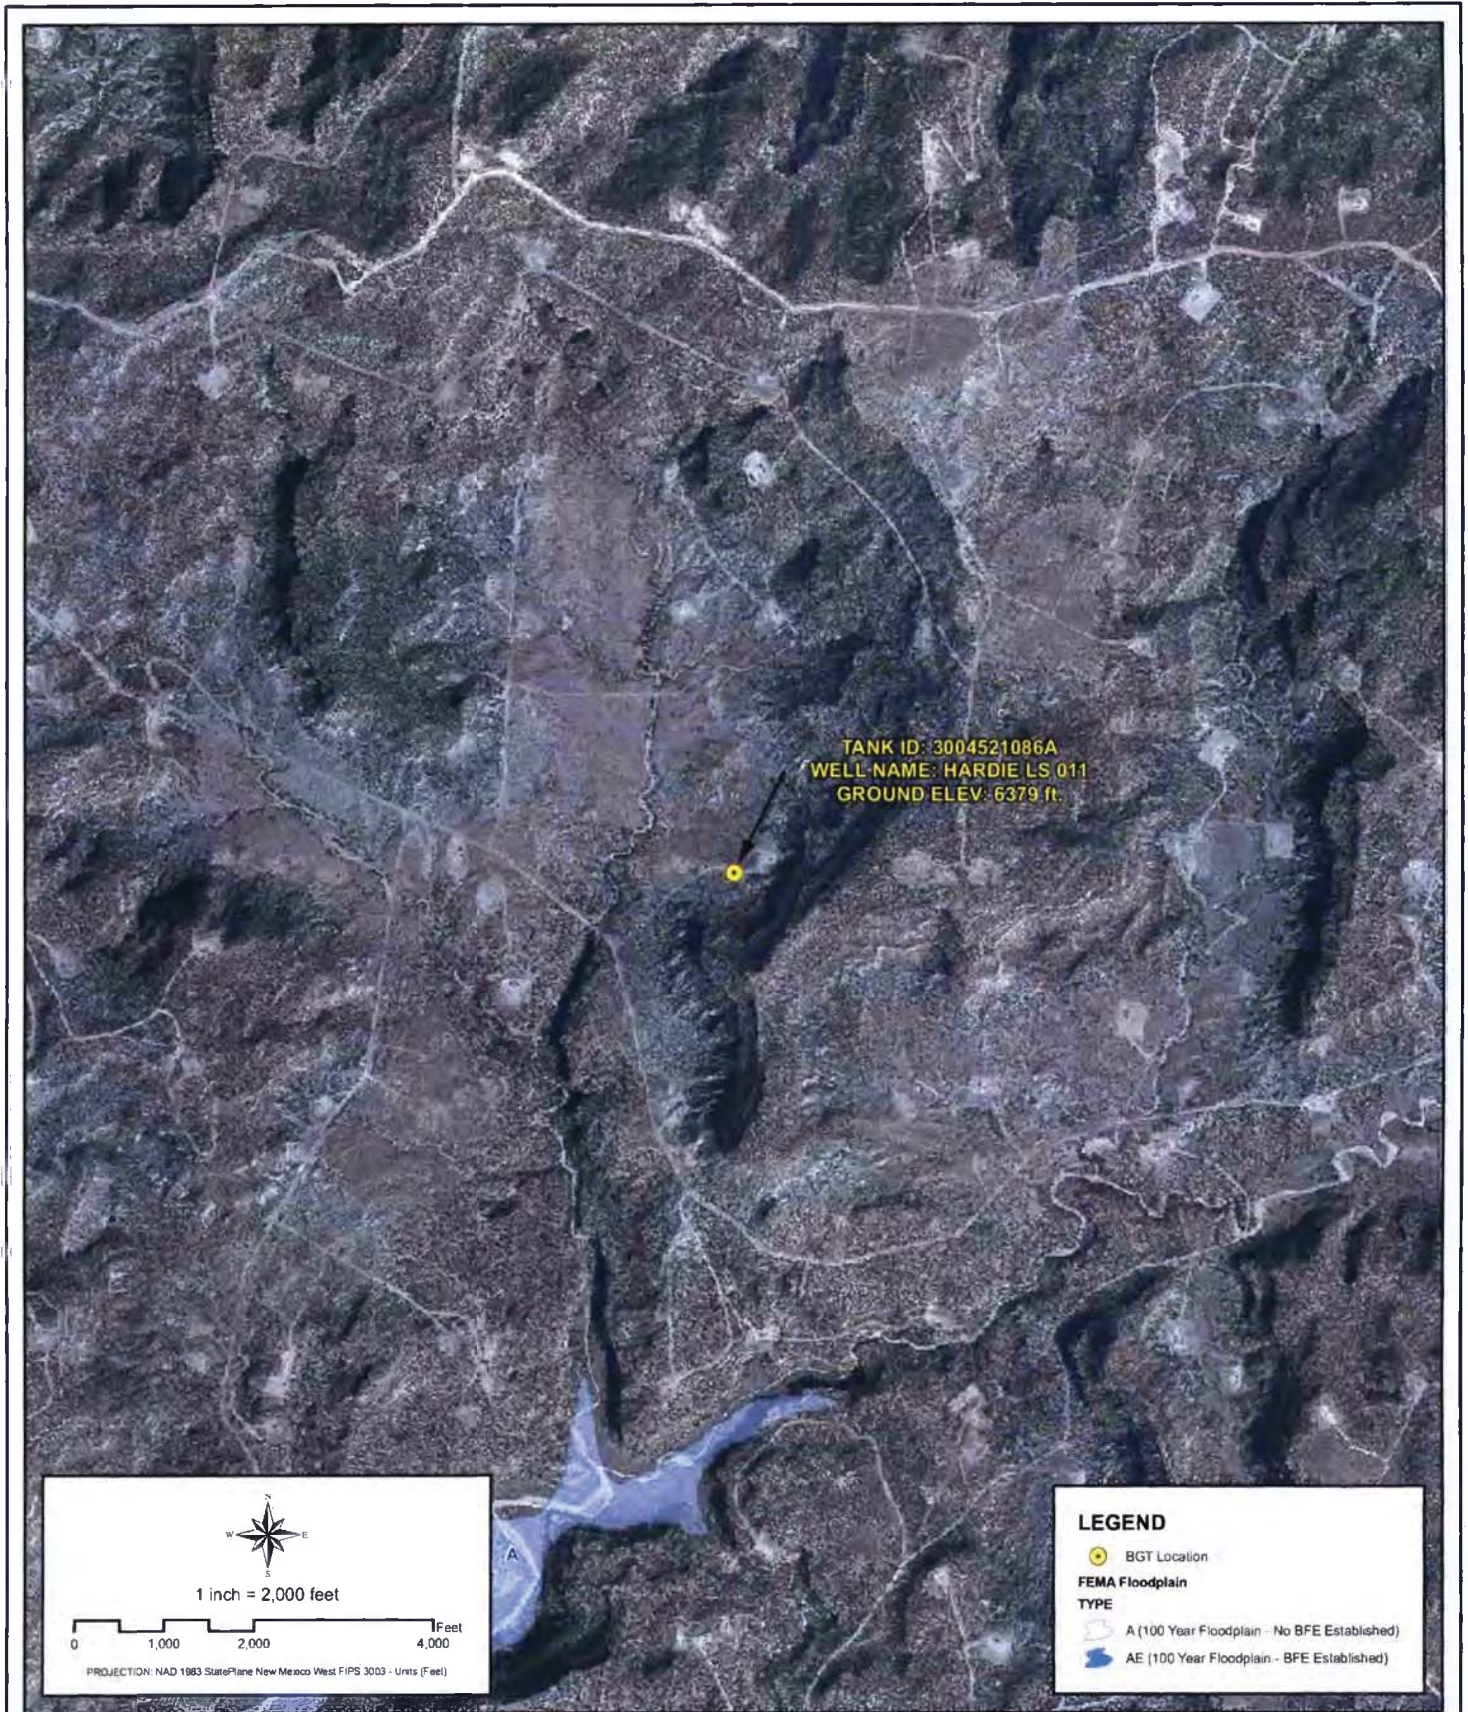
<p align="center">PROXIMITY TO FLOODPLAIN</p> <p align="center">WELL NAME: HARDIE LS 011</p> <p align="center">API NUMBER: 3004521086 TANK ID: 3004521086A</p> <p align="center">SECTION 25, TOWNSHIP 29.0N, RANGE 08W, P.M. NM23</p>	<p align="center">FIGURE</p> <p align="center">5</p>
---	---	--

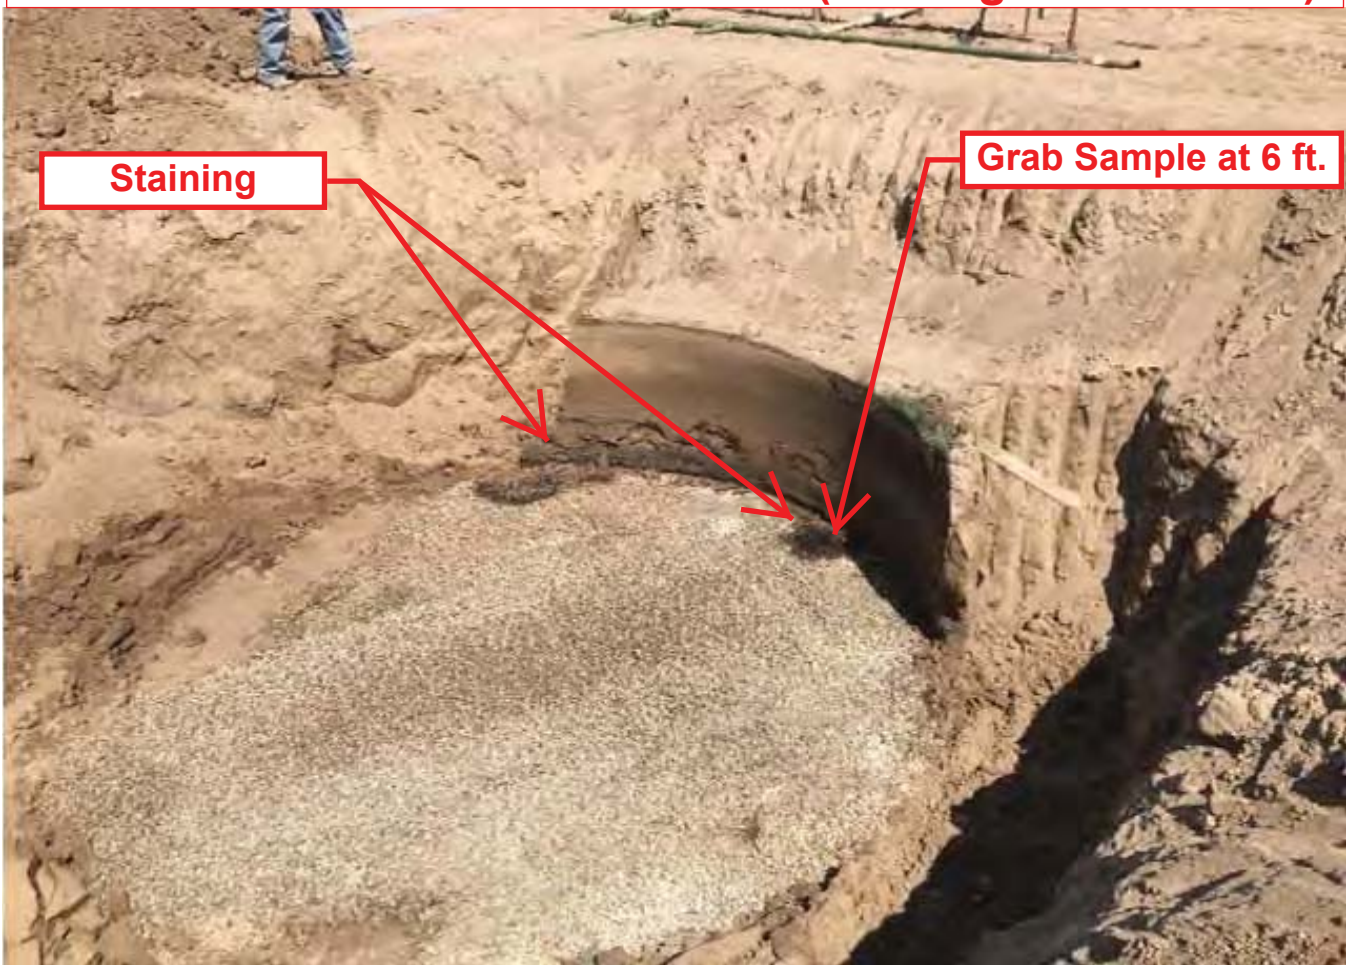
(viewing East direction)

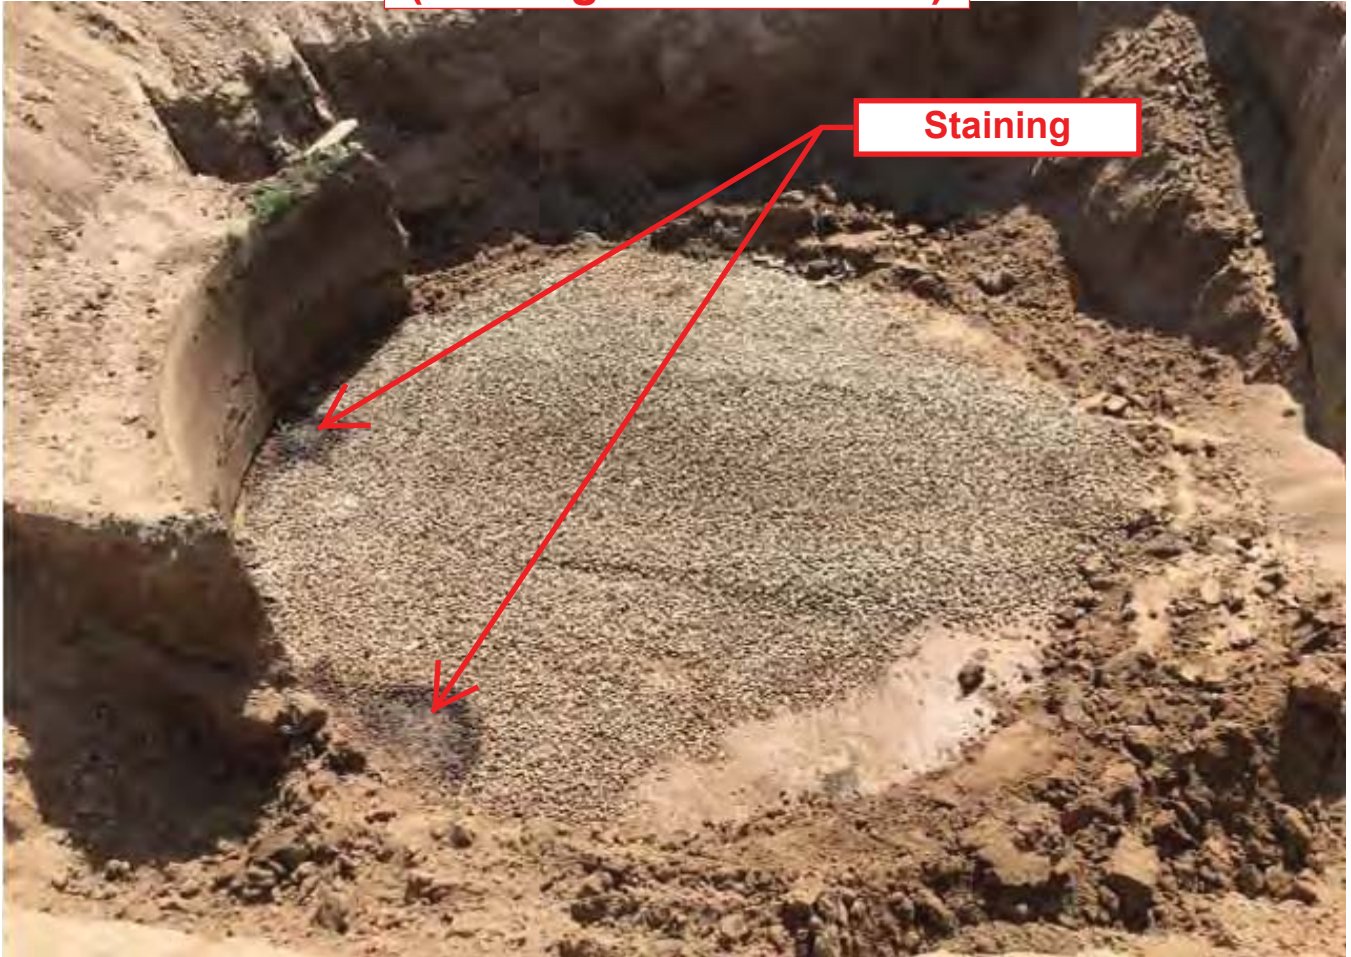
HARDIE LS 011 - Post-Excavation - (viewing NE direction)

3 point composite
sample at 7 ft.

Evidence of a release observed and most likely resulted from overflow event of BGT. Minor staining area at northern quadrant of BGT was sampled and removed via excavation.
