**Report Type: Work Plan      2RP-4118**

| Site: | Salada Vista State #1 | | | | | |

**Re: Closure Report for the COG Operating LLC., Salada Vista State #1, Unit A, Section 36, Township 19 South, Range 30 East, Eddy County, New Mexico. 2RP-4118.**

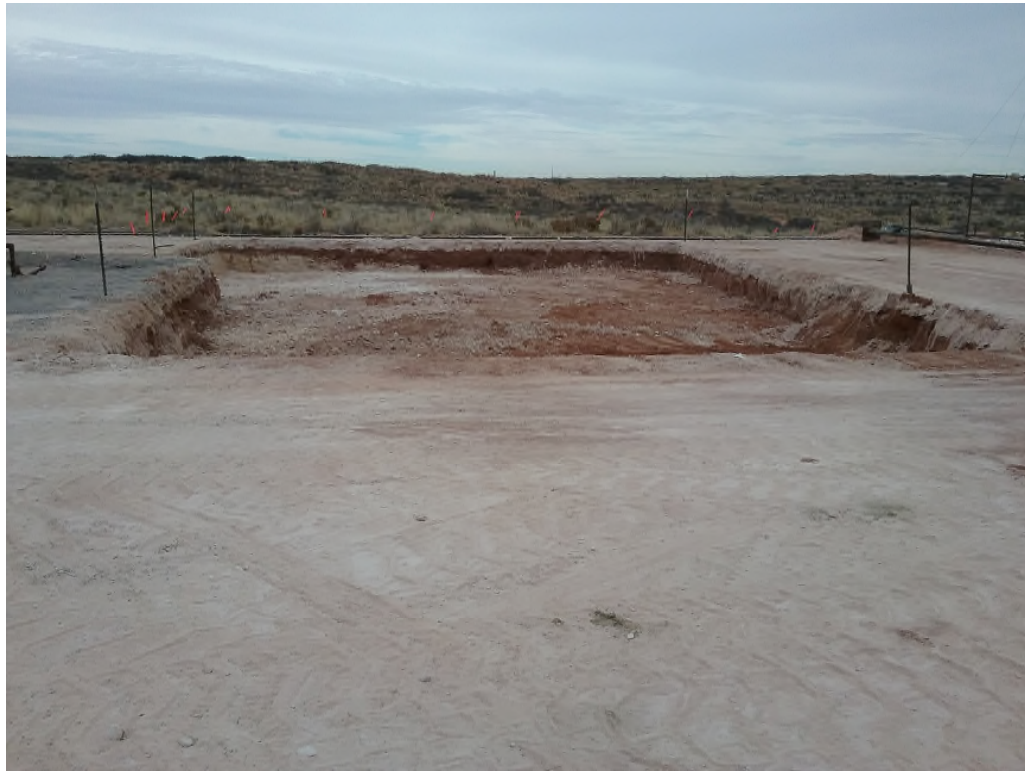
View North – Excavation Area

On February 26, 2019, Tetra Tech personnel were onsite to supervise the excavation and remediation activities. The remediation activities were performed in accordance to the approved work plan. The excavated areas and depths are shown on Figure 4 and highlighted (green) in Table 1. The area of trench (T-1) was excavated to approximately 3.0' below surface to remove the impacted soils above the RRAL and the excavation measured approximately 44' x 60'.

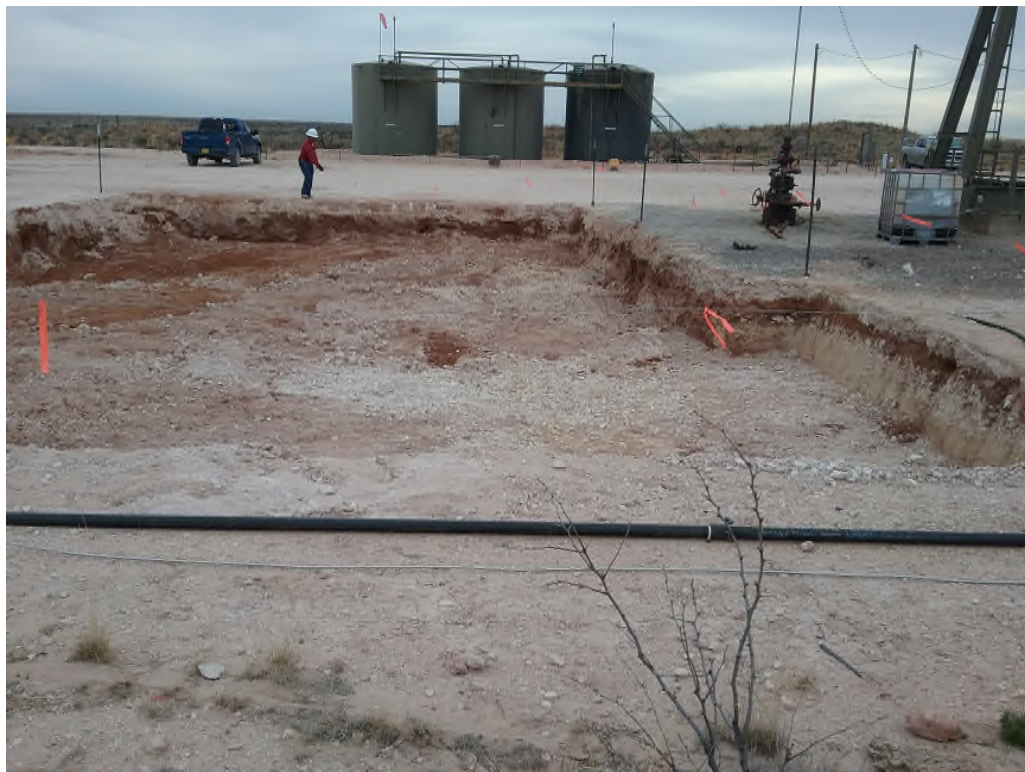
View South – Excavation Area
