Report Type: Closure Report 1RP-5159

Site:	Pygmy 27 State #001H Battery				
Company:	COG Operating LLC				
Section, Township and Range	Unit L	Sec. 27	T 21S	R 33E	
Lease Number:	API No. 30-025-40352				
County:	Lea County				
GPS:	32.4471062			-103.5665927	
Surface Owner:	Private				
Directions:	From the intersection of Highway 8 and Highway 176, travel west on Highway 76 for approximately 13.95 miles. Turn left (south) onto lease road. Travel approximately 3.7 miles to lease road intersection. Turn right (west) onto lease road. Travel approximately 4.4 miles and turn right (north) onto lease road. The location is approximately 250 feet north on lease road to the right (east).

Re: Closure Report for the COG Operating, LLC, Pygmy 27 #001H Battery, Unit L, Section 27, Township 21 South, Range 33 East, Lea County, New Mexico. 1RP-5159

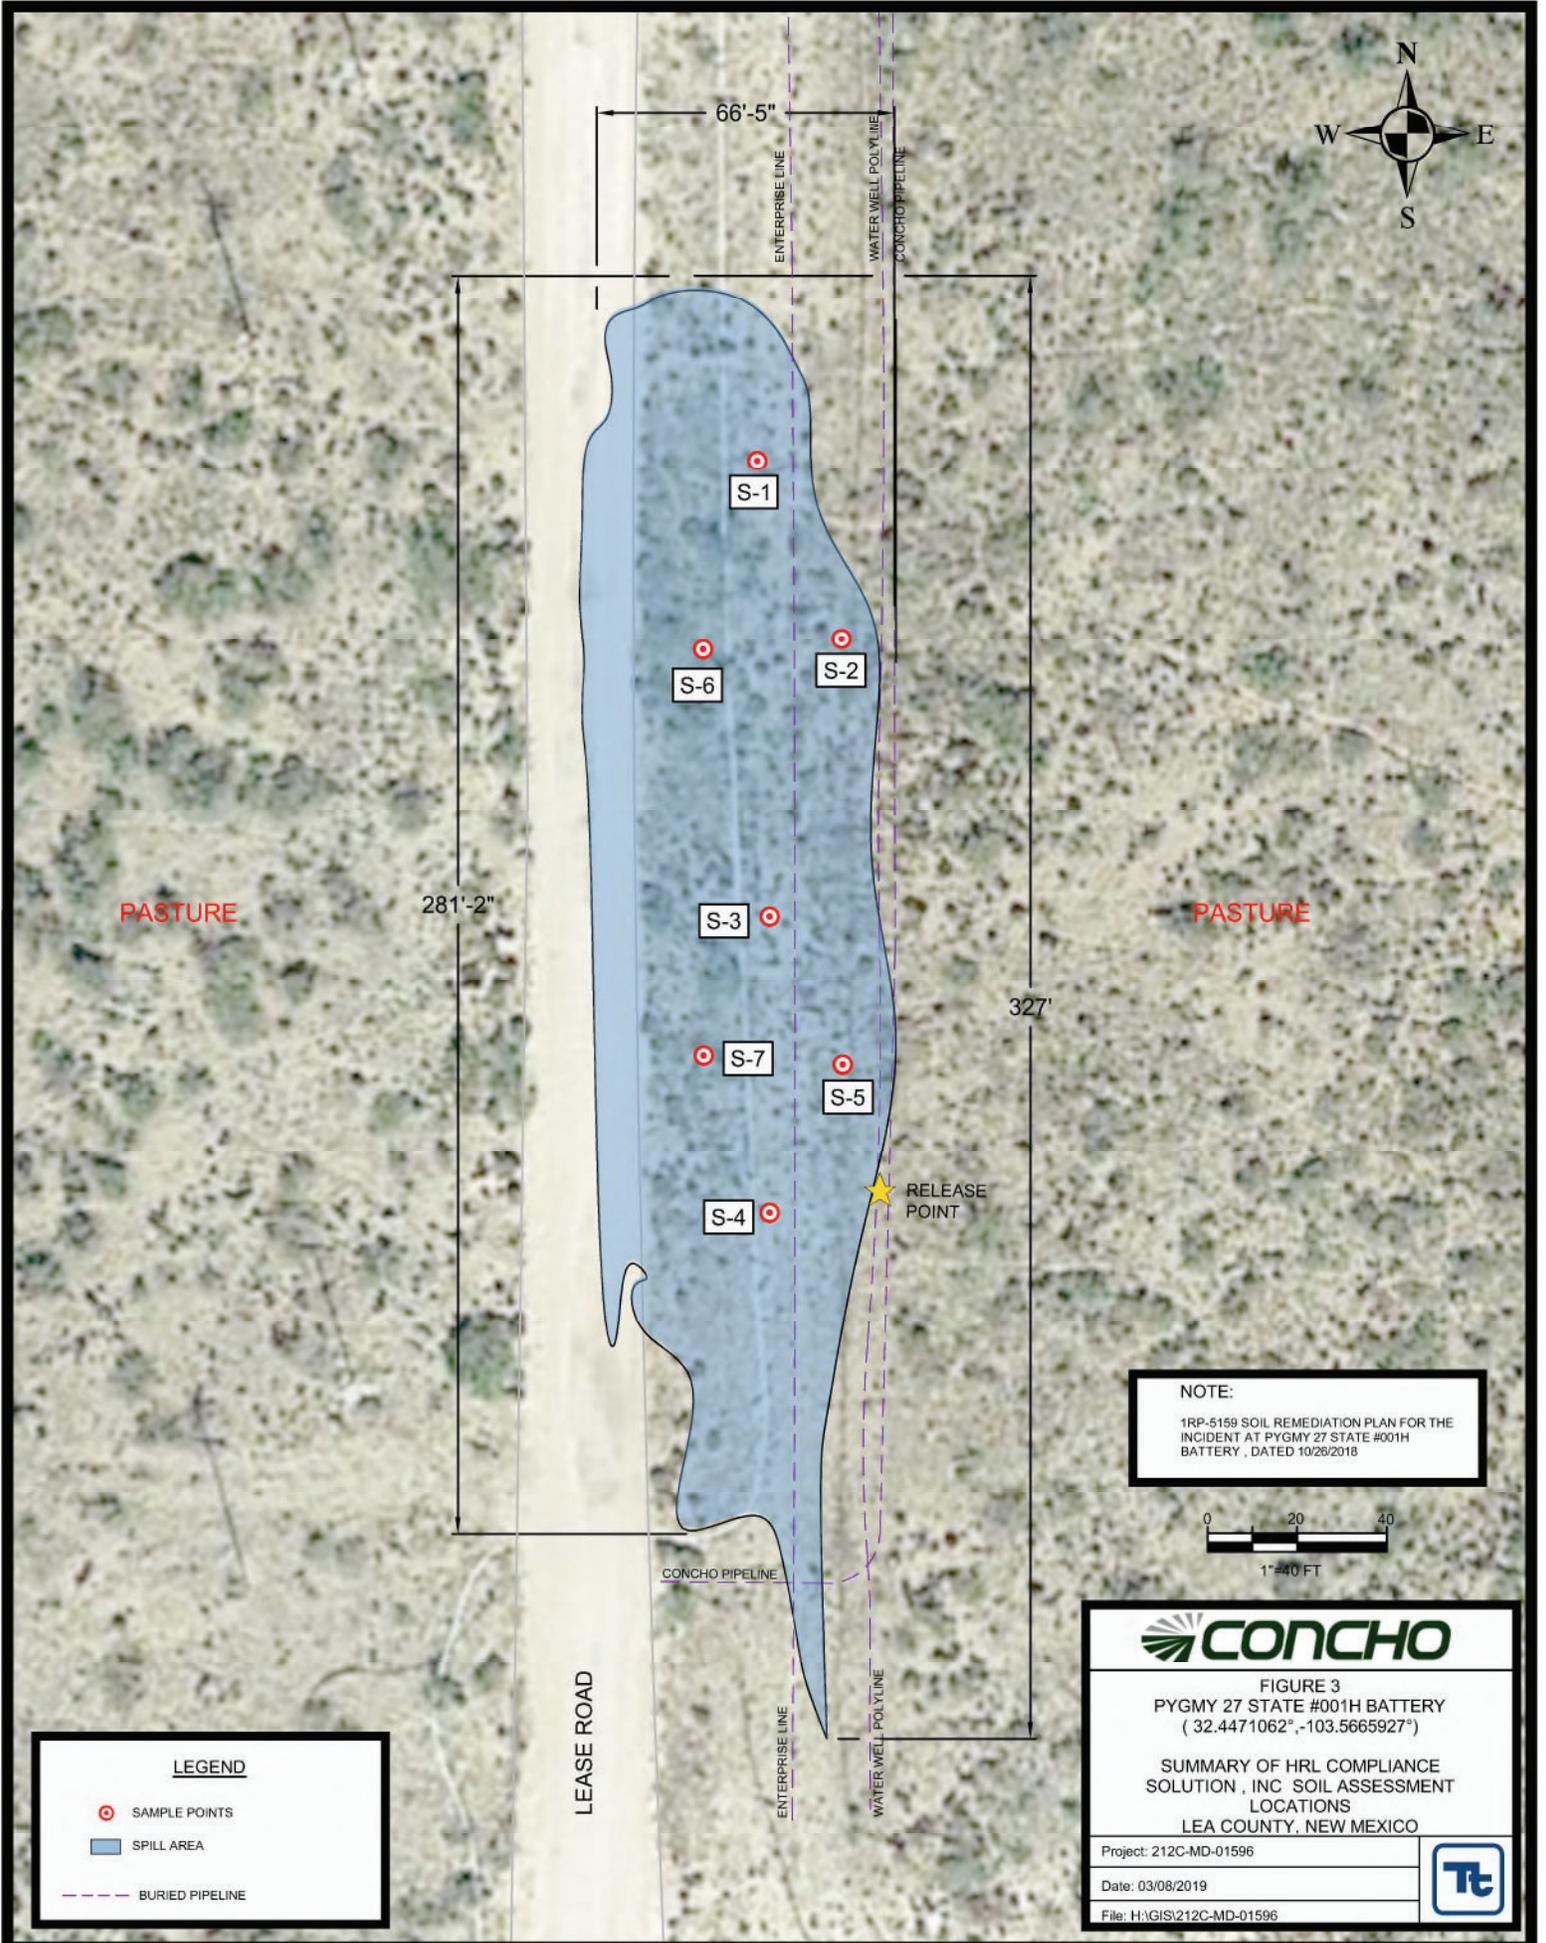
SUMMARY OF HRL COMPLIANCE
 SOLUTION , INC. SOIL ASSESSMENT
 LOCATIONS
 LEA COUNTY, NEW MEXICO

Referring to Table 1, the areas of auger holes (S1 through S7) showed benzene and total BTEX below the laboratory reporting limits. The TPH concentrations for the surface samples of S1, S2, and S5 exceeded the RRAL with concentrations of 500 mg/kg, 1,310 mg/kg, and 1,320 mg/kg and declined with depth at 1.0' below the surface, all showing non-detect. All seven (7) auger holes exhibited chloride concentrations above the RRAL. The vertical delineation of chlorides was observed to be six to eight feet below the ground surface.

- ⊙ SAMPLE POINTS
- SPILL AREA
- - - BURIED PIPELINE

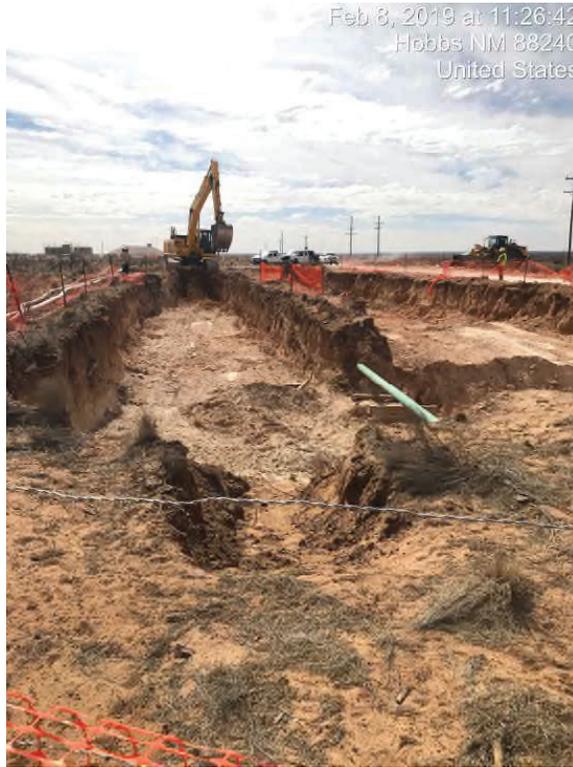
Area of Excavation – View South

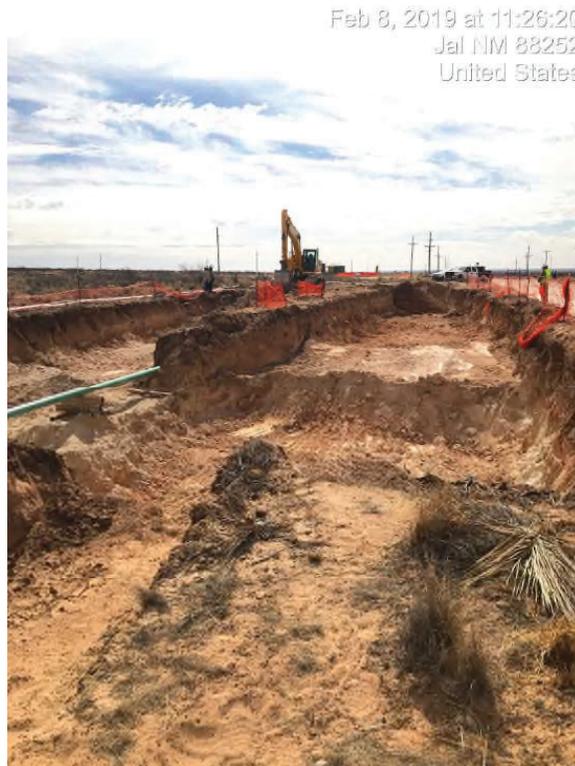
Area of Excavation – View South

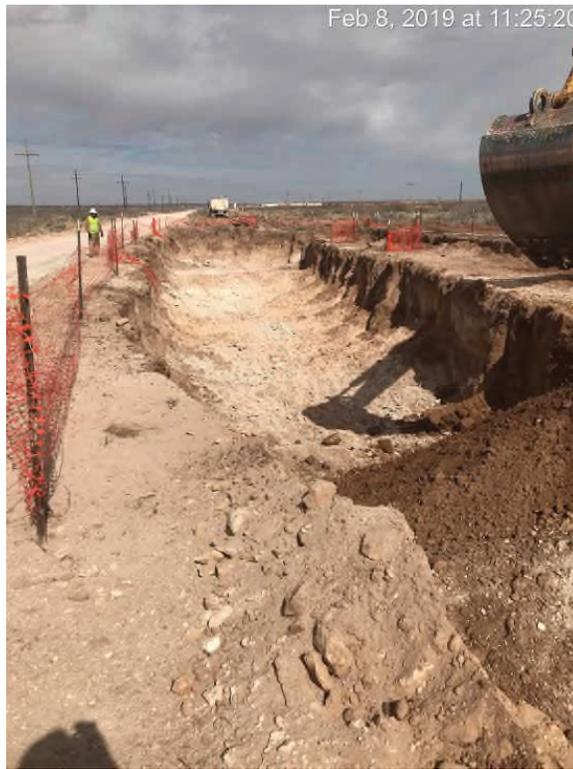
Area of Excavation – View North

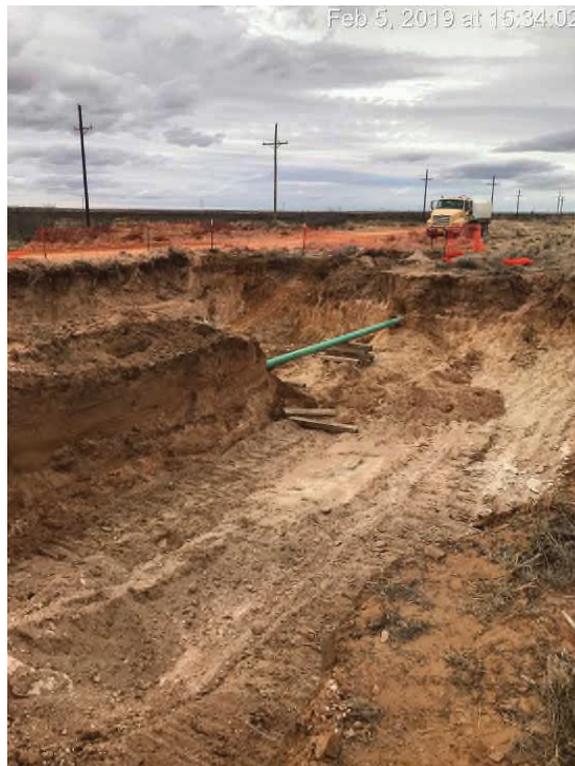
Area of Excavation – View Northwest
