Report Type: Closure Report 2RP-4494

Site:	SRO SWD #103					
Company:	COG Operating LLC					
Section, Township and Range	Unit M	Sec. 17	T 26S	R 28E		
Lease Number:	API No. 30-015-24462					
County:	Eddy County					
GPS:	32.0369301			-104.1160126		
Surface Owner:	State					
Mineral Owner:	State					
Directions:	From the intersection of Highway 285 and Whites City Road, travel west on Whites City Road for approximately 3.05 miles. Turn left (south) onto unnamed lease road and travel approximately 1.87 miles. Turn left (east) onto lease road. Site is located at the end of the pad approximately 0.12 miles.

Date Released:	11/13/2017
Type Release:	Oil and Produced Water
Source of Contamination:	Main Line failure
Fluid Released:	10 bbl oil / 1,390 bbls produced water
Fluids Recovered:	7 bbls oil / 413 bbls produced water

Re: Closure Report for the COG Operating, LLC, SRO SWD #103, Unit M, Section 17, Township 26 South, Range 28 East, Eddy County, New Mexico. 2RP-4494

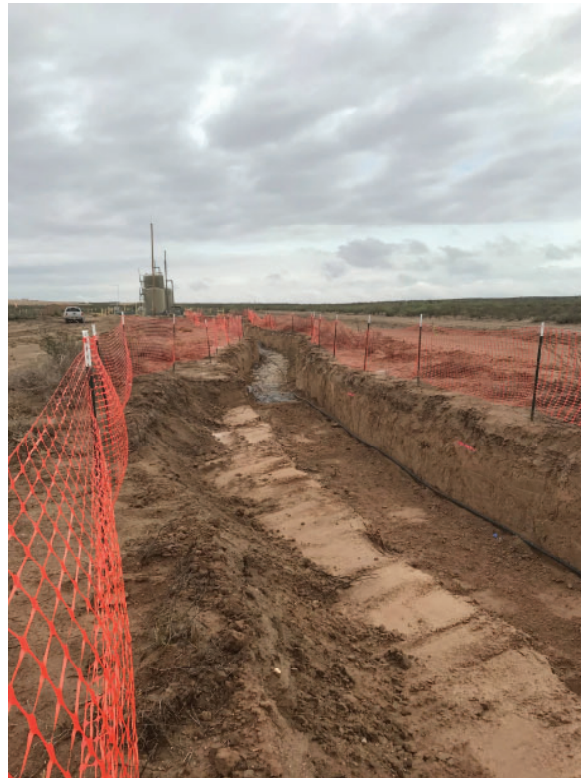
View North – Area of Bottom Areas 2 through 5

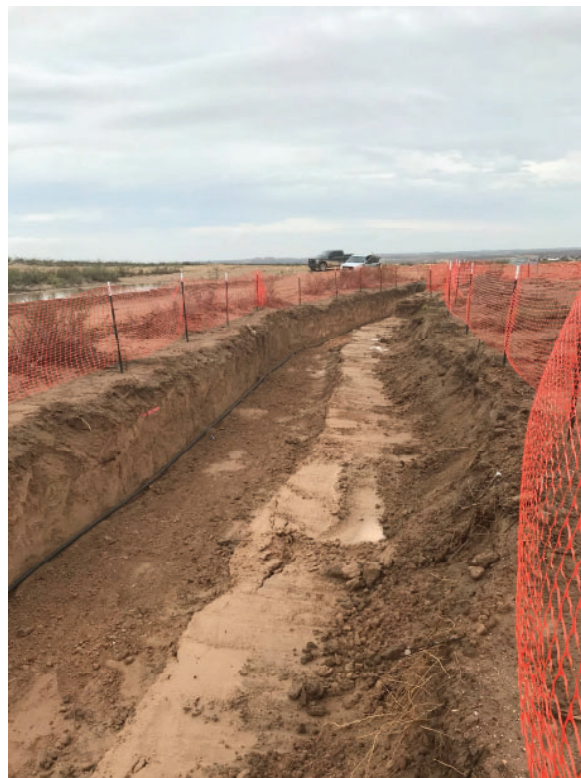
View West– Area of Bottom Areas 6 through 9

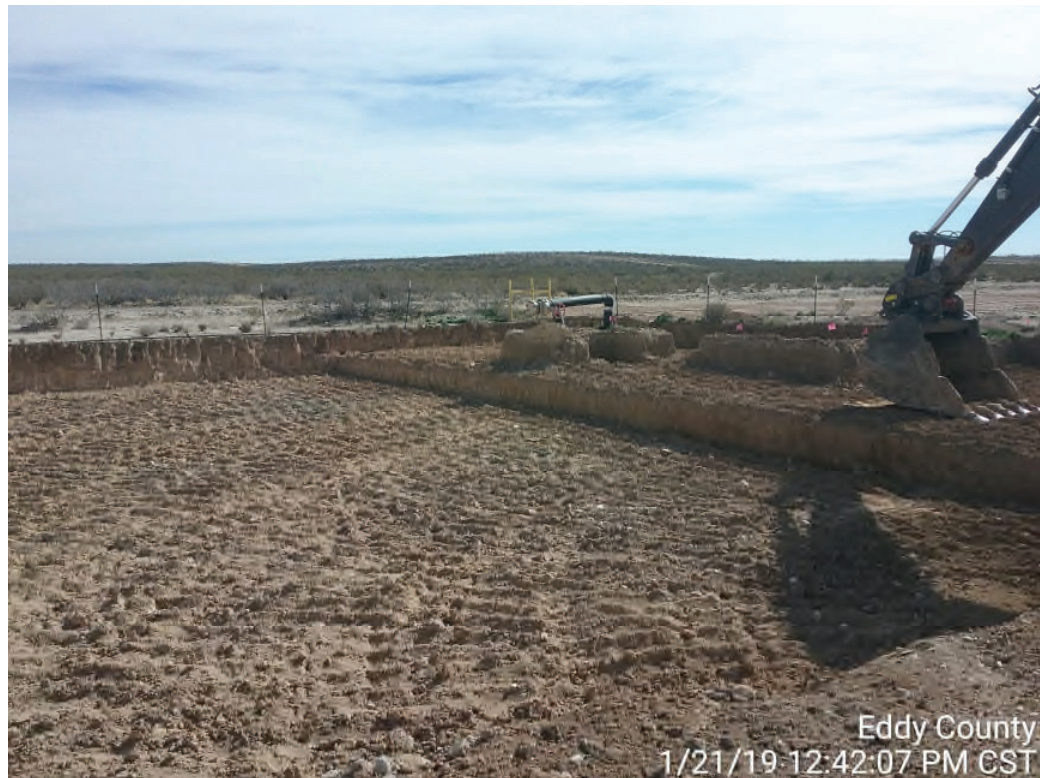
View Northeast – Area of Bottom Hole 4 and 5

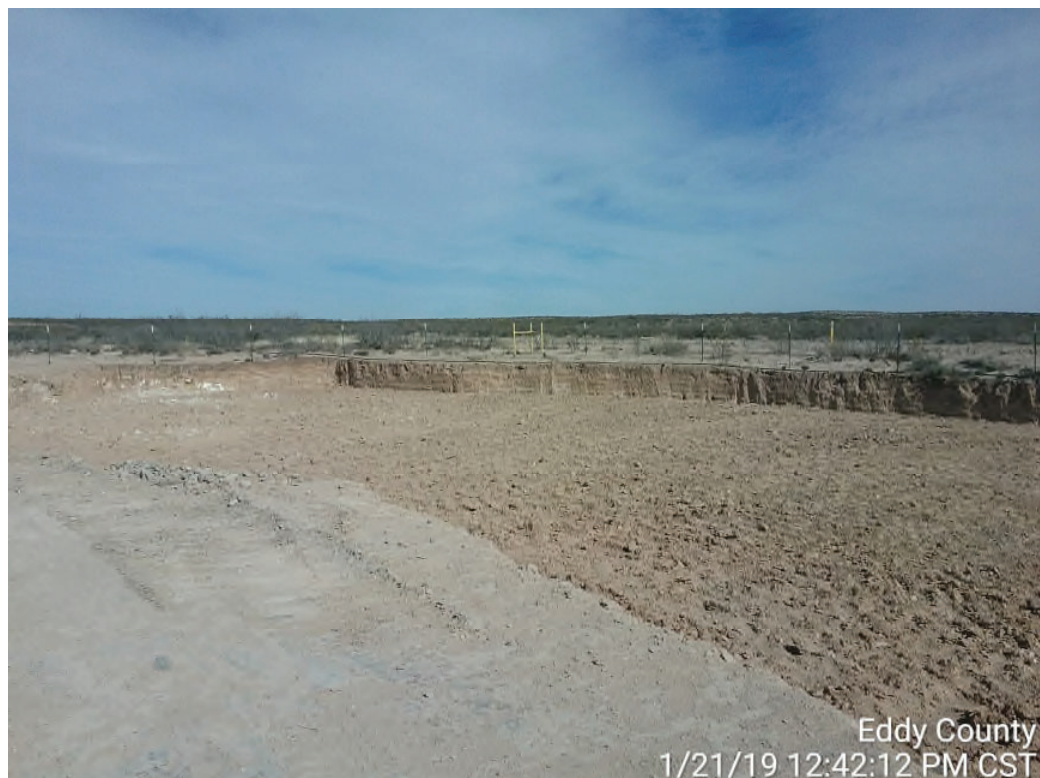
View Southwest– Area of Bottom Hole 1 through 3

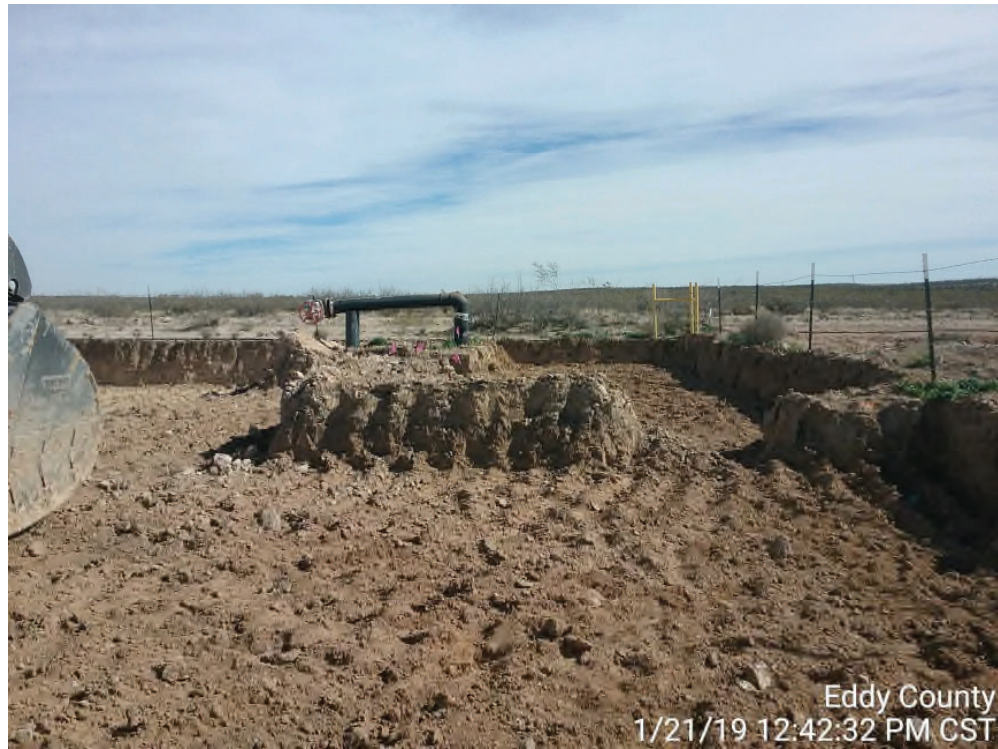
View East – Area of Bottom Hole 5 and 6

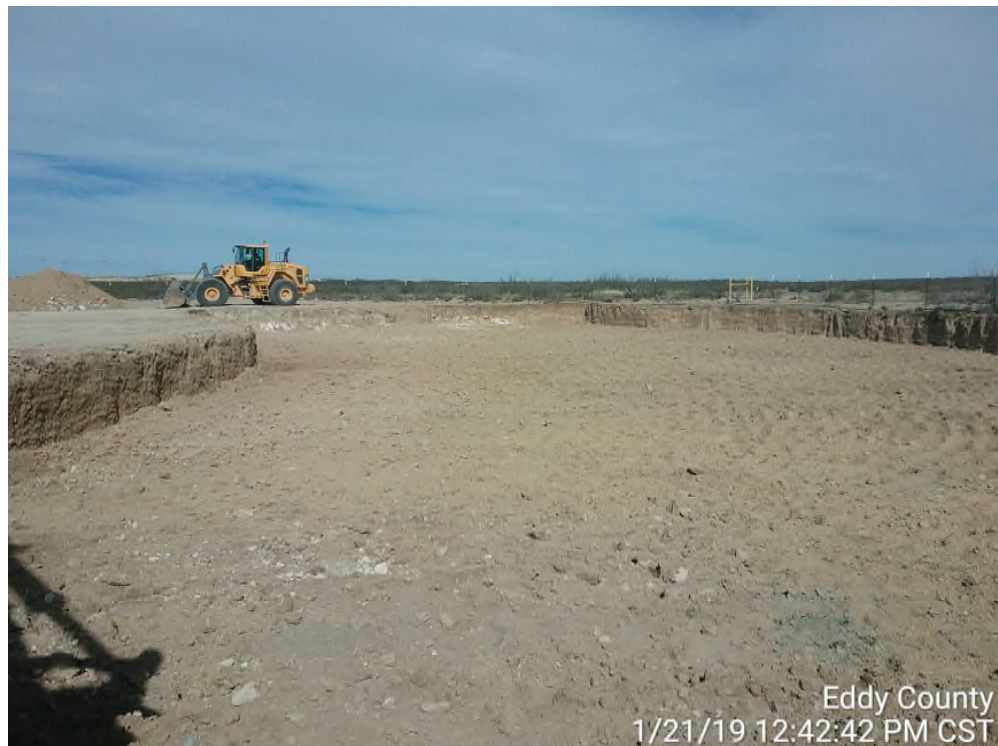
View North– Area of Bottom Hole 1 through 4
