**Re: Closure Letter  
Lusk Deep Unit A #019 SWD  
API #: 30-025-35244  
RP#: 1RP-5098  
Unit Letter M, Section 17, Township 19 S, Range 32 E  
Lea County, New Mexico**

COG Operating, LLC (COG) is pleased to submit for your consideration the following closure report for the Lusk Deep Unit #019 SWD. This release occurred on June 14, 2018. Following the release an assessment of impacted soils was conducted. A remediation work plan was submitted to and subsequently approved by the New Mexico Oil Conservation Division (NMOCD) and the Bureau of Land Management. A copy of the approved work plan is attached in Appendix V.

# APPENDIX I

# Lusk Deep Unit A #019 SWD

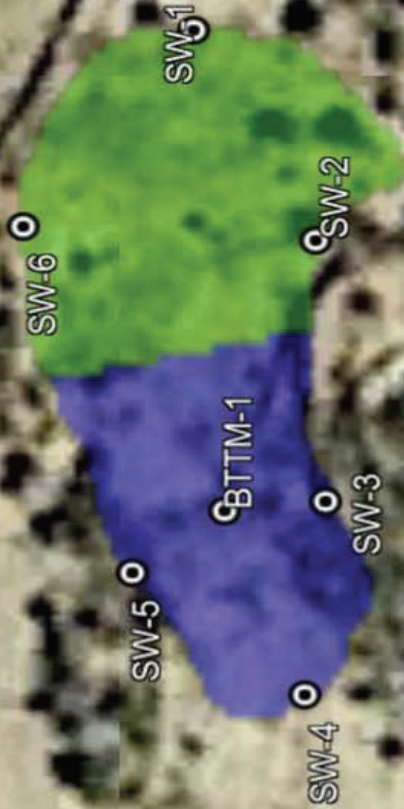
- The impacted area in the vicinity of sample location SP-1 was excavated to a depth of two and one-half (2.5) feet BGS.
- The impacted area in the vicinity of sample locations SP-2 and SP-3 was excavated to a depth of four (4) feet BGS.

- Per NMOCD stipulations, confirmation soil samples were taken from the bottom in the vicinity of SP-1 and the sidewalls of the excavated area. A site diagram is presented in Appendix I.

- 2.5' Excavation
- 4' Excavation
- Confirmation Sample Location

Remediation activities were conducted in accordance with the approved work plan and NMOCD/BLM stipulations. The analytical results from the NMOCD stipulated confirmation soil sampling activities are summarized in the table below. A site diagram of the excavated area is presented in Appendix I.

- All of the excavated material was hauled to an NMOCD approved solid waste disposal facility.
- Upon receipt of analytical results confirming that all impacted soil above NMOCD RRAL's was successfully removed from the sidewalls and the bottom in the vicinity of SP-1, a liner was installed at the bottom of the four (4) foot BGS excavation in order to encapsulate the remaining chloride impacts.

- The excavation was backfilled with top soil and contoured to match the surrounding location.
- The backfilled area will be seeded with BLM #2 upon proper seasonal timing.
