REMEDIATION SUMMARY AND SOIL CLOSURE REQUEST

**COG Operating, LLC
Canvasback 13 Federal #002H
Eddy County, New Mexico
Unit Letter "A", Section 13, Township 24 South, Range 31 East
Latitude 32.22260° North, Longitude 103.72296° West
NMOCD Reference No. 2RP-4682**

**TRC Environmental Corporation
10 Desta Drive, Suite 150E
Midland, Texas 79705**

April 2018

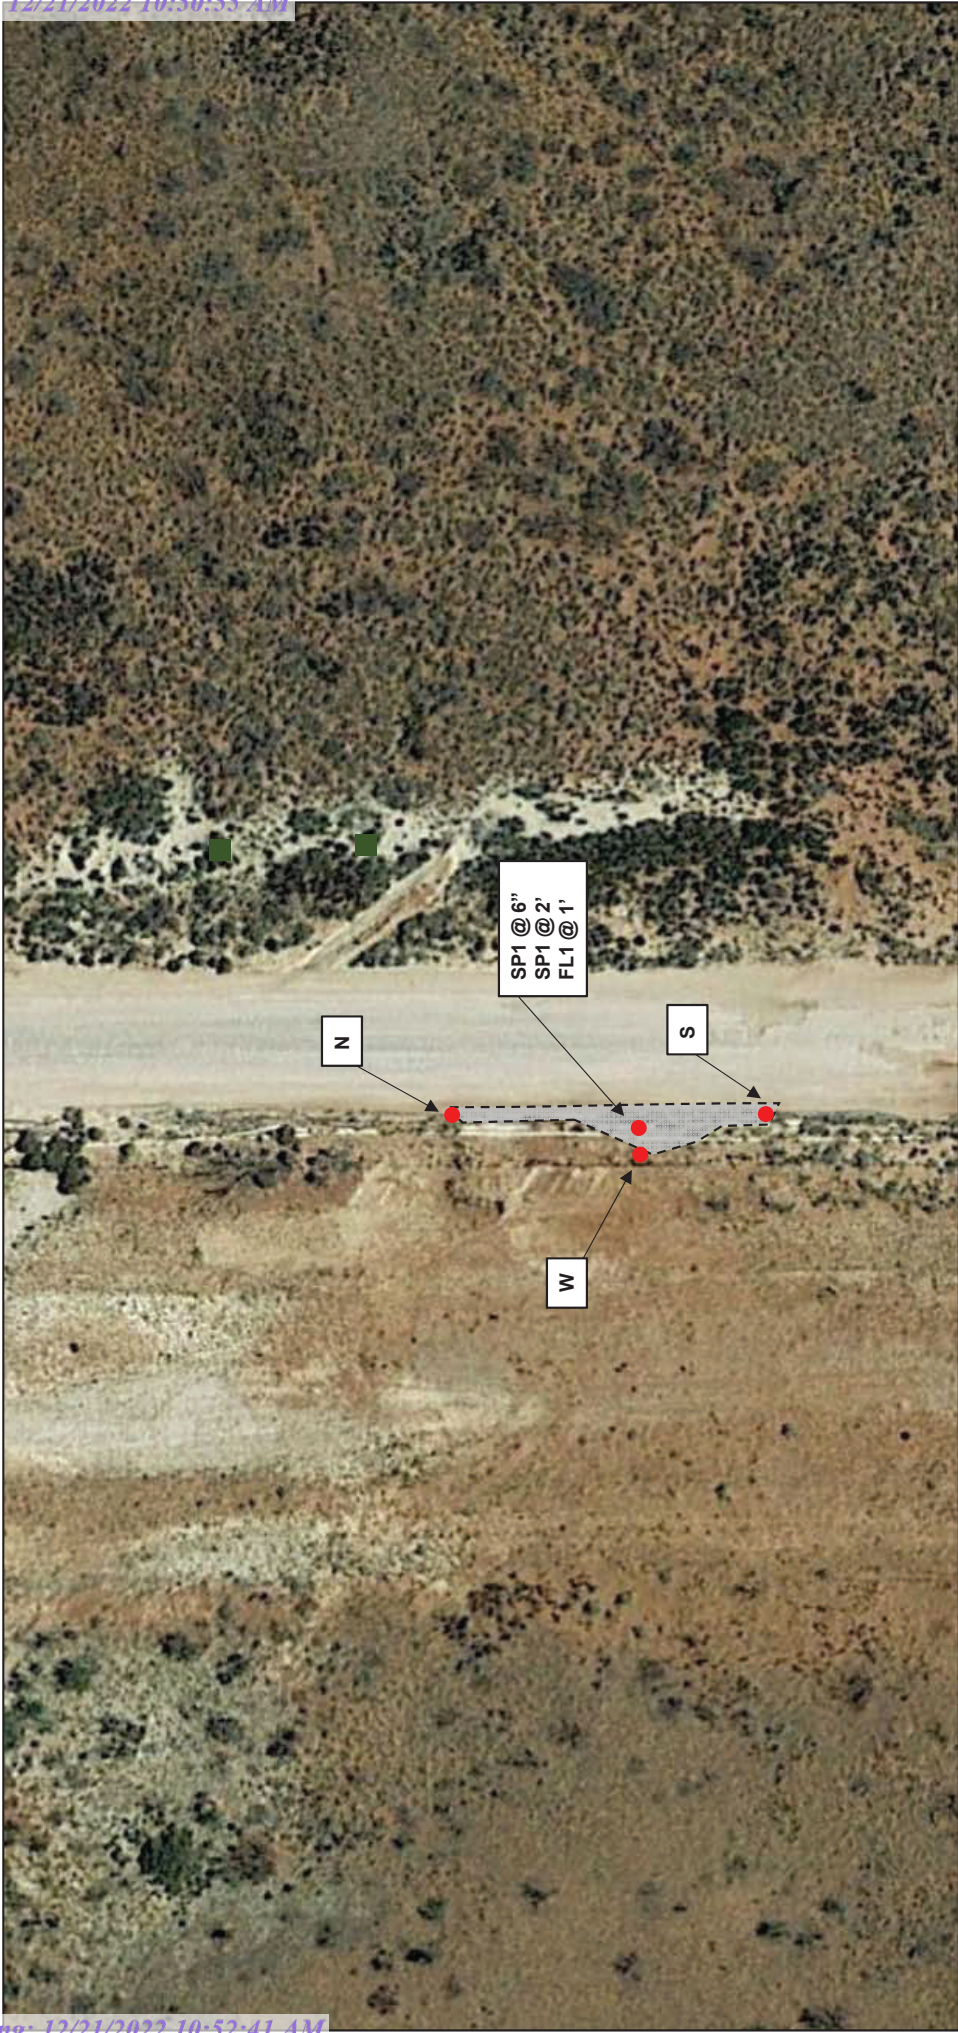
Figure 2

- Confirmation Soil Sample Location
- ▭ Excavated Area

Site & Sample Location Map
COG Operating, LLC
Canvasback 13 Federal #002H
Eddy County, New Mexico

Upon conducting the initial investigation, impacted soil within the release margins was excavated and transported to an NMOCD-permitted facility for disposal. Upon excavating impacted soil from within the release margins, four (4) excavation confirmation soil samples (FL1 @ 1', SP1 @ 2', N, S and W) were collected and submitted to the laboratory for analysis of BTEX, TPH and chloride concentrations. Laboratory analytical results indicated BTEX and TPH concentrations were below the NMOCD RRAL in each of the submitted soil samples. Analytical results indicated chloride concentrations ranged from less than the laboratory RL in soil samples N and W to 202 mg/kg in soil sample FL1 @ 1'. Sample collection and further excavation, if applicable, was precluded in eastern portion of the release site due to safety concerns associated with the proximity to the active oilfield access road.

Upon collecting the required confirmation soil samples, the excavated area was backfilled with locally-sourced, non-impacted material. Prior to backfilling, the final dimensions of the excavated area were approximately sixty (60) ft. in length, two (2) to ten (10) ft. in width and six (6) in. to one (1) ft. in depth.

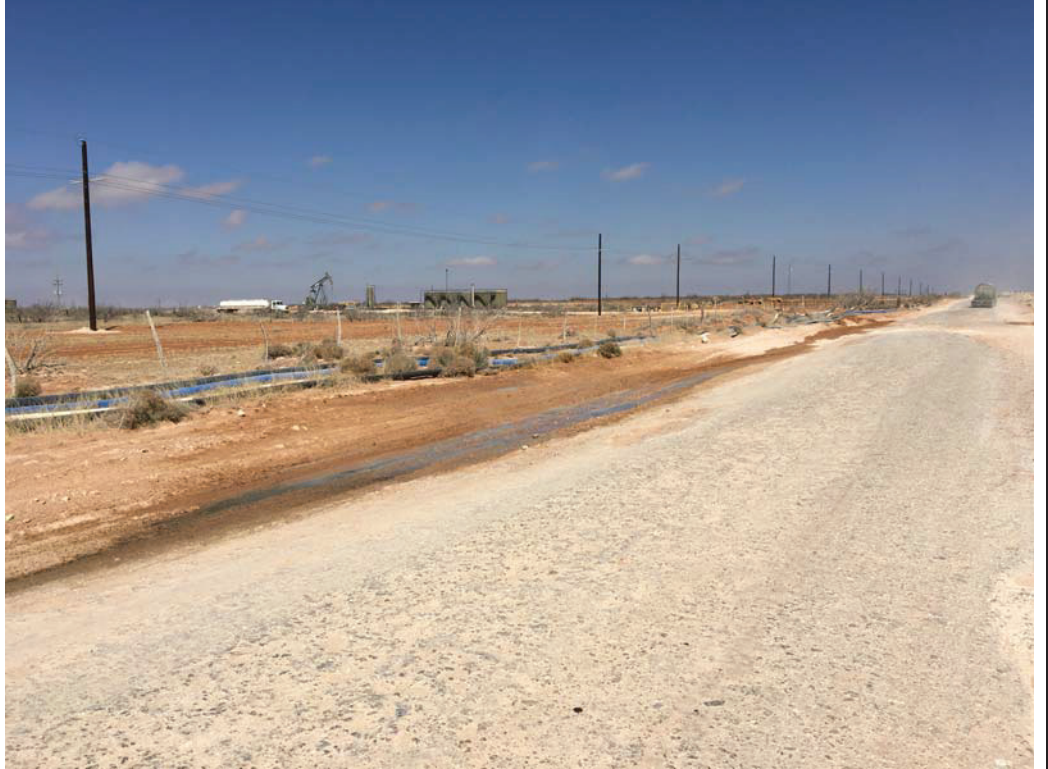
Description:
View of the initial
release.

Direction:
Northwest

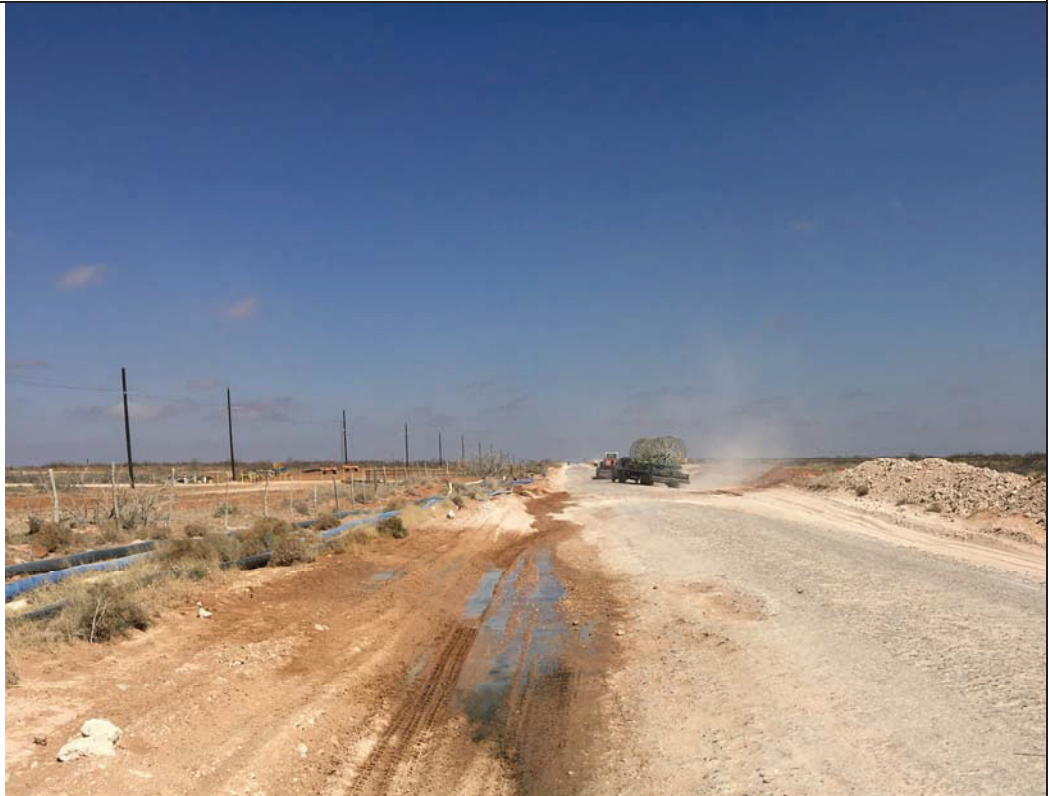
Photograph No. 2

Description:
View of the initial
release.

Direction:
North

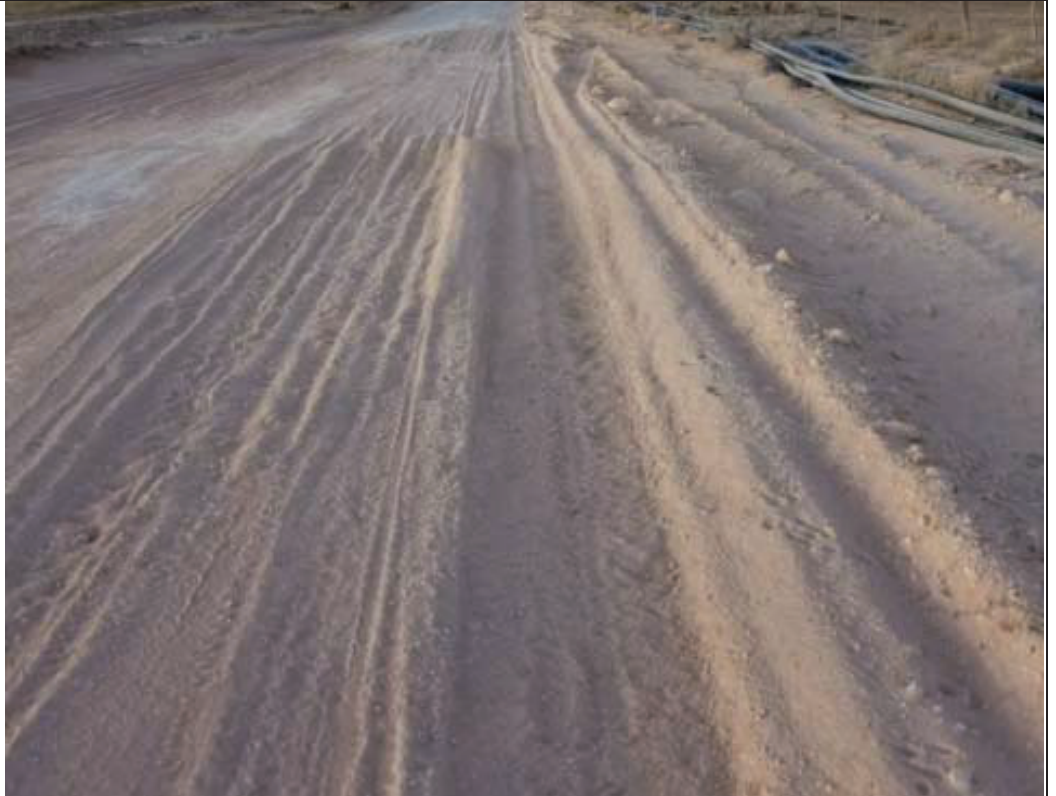
Description:
View of portion of
the excavated
area.

Direction:
South

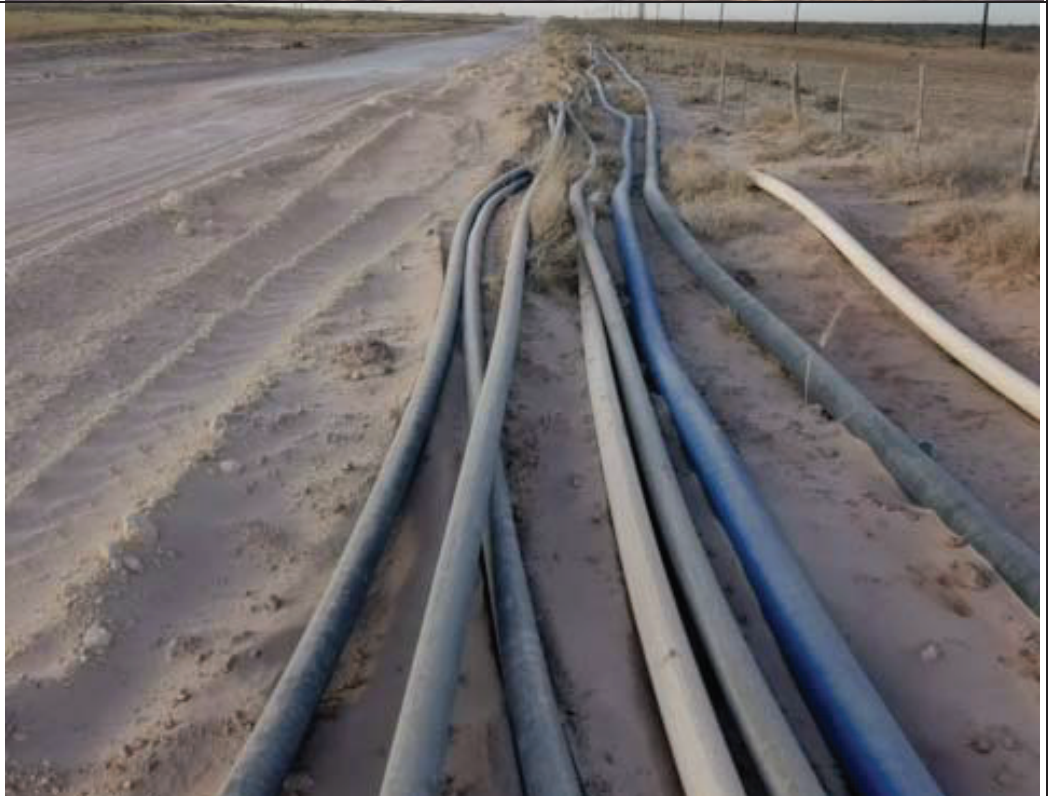
Photograph No. 4

Description:
View of the
affected area after
remediation
activities.

Direction:
South
