Closure

Frontier Field Services, LLC
Devon Continental to Lusk Groundwater Test Bore Summary
UL-M, Sec 5, T19S, R32E
32.683400, -103.795621

Durango Midstream, LLC (Durango) retained Vertex Resource Services Inc. (Vertex) to conduct a Spill Assessment for a release of natural gas condensate due to internal and external corrosion of the Devon Continental 6” Poly Line to Lusk, incident nAPP2207756767 (hereafter referred to as “Devon Continental”). Durango provided spill notification to the New Mexico Oil Conservation District (NMOCD) District 2, via submission of an initial C-141 Release Notification (Attachment 1). This letter provides a description of the spill assessment and includes a request for spill closure. The spill area is located at N 32.683440, W -103.795819.

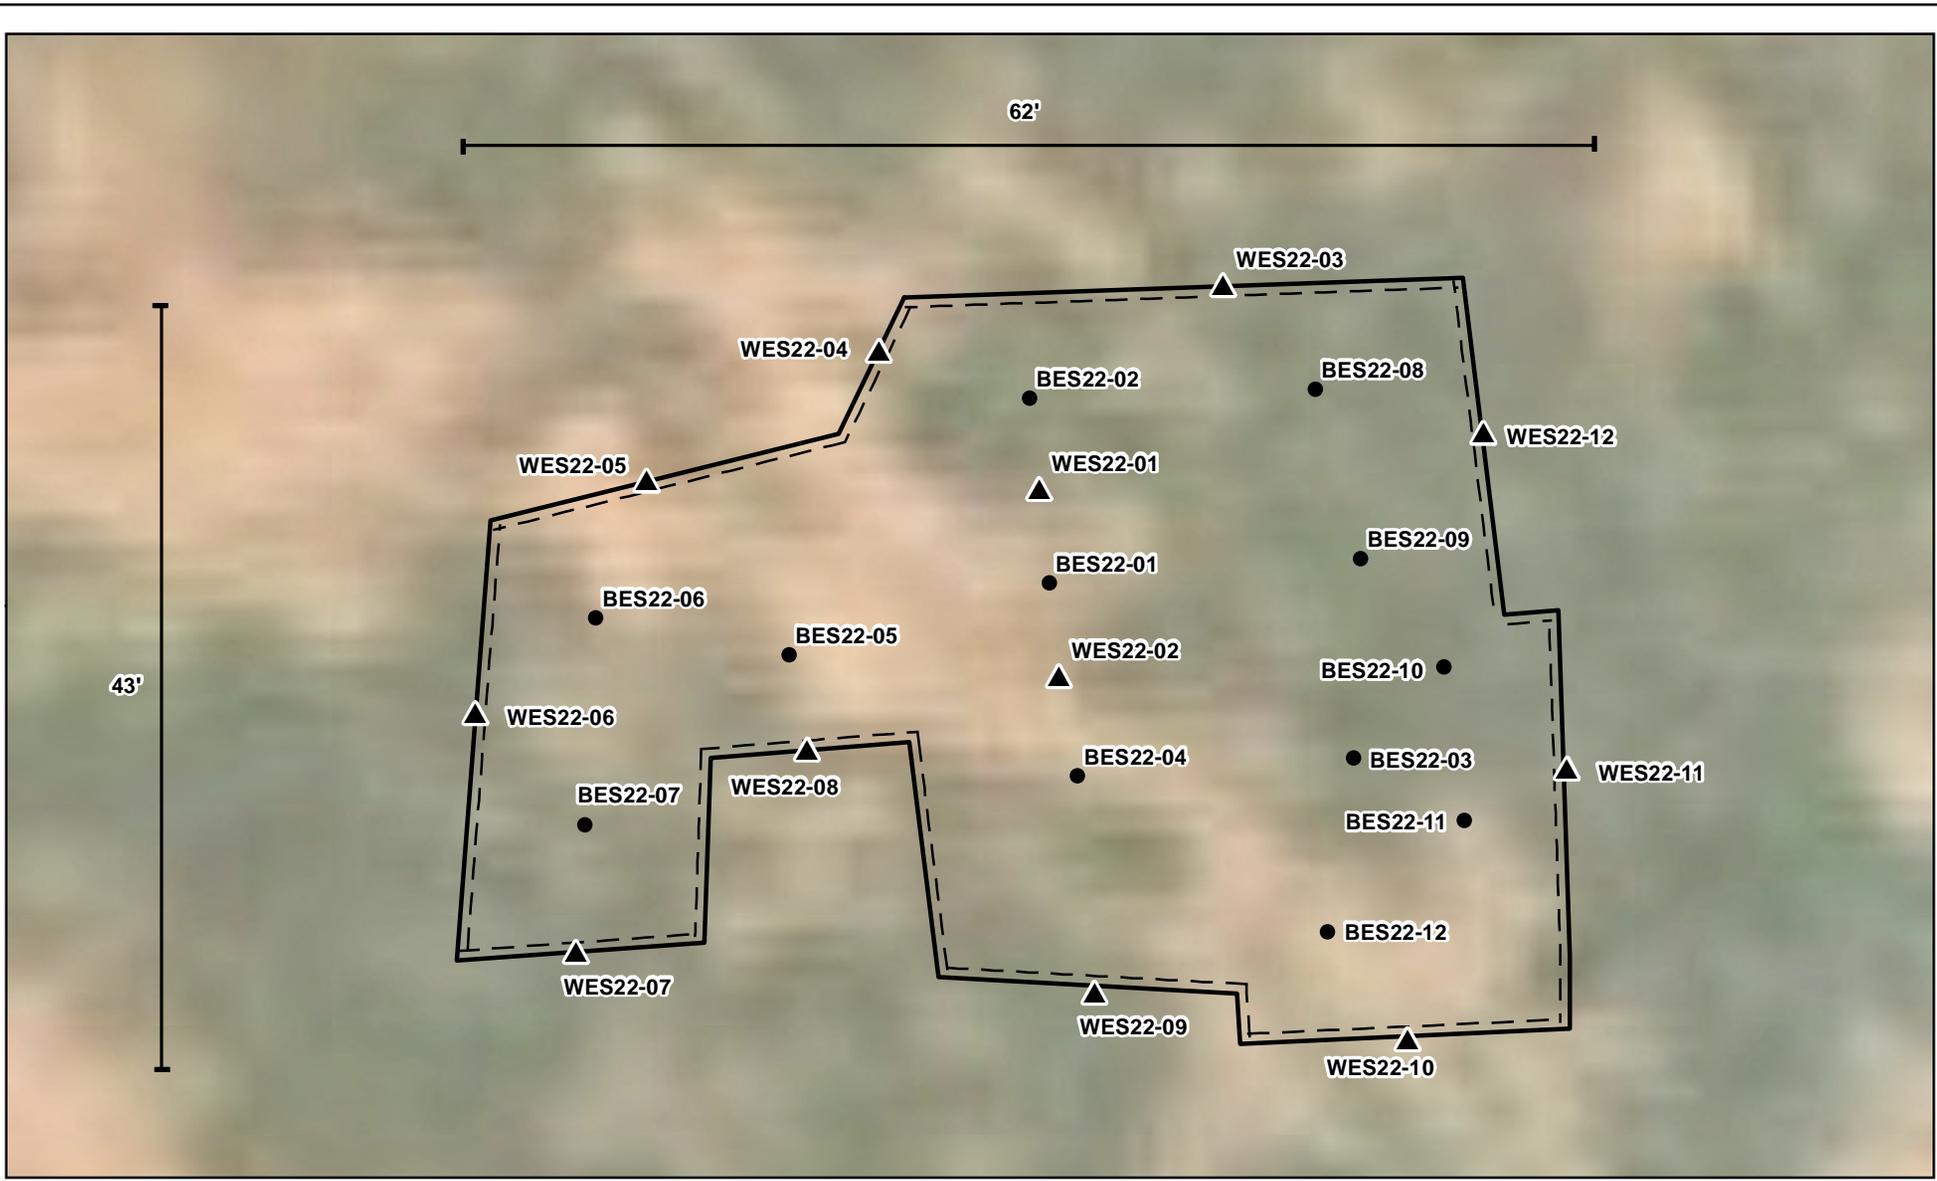
● Base Sample ▲ Wall Sample [---] Excavation Area (~171 sq. ft.)

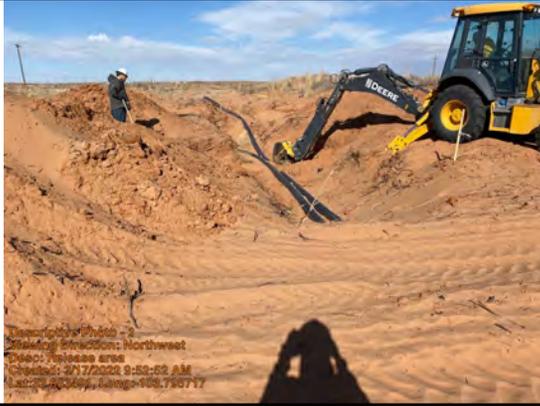
Descriptive Photo - 3
Viewing Direction: Northwest
Photo Release Area
Created: 3/17/2022 9:53:53 AM
Lat:32.83344, Long:-103.738717

Release area

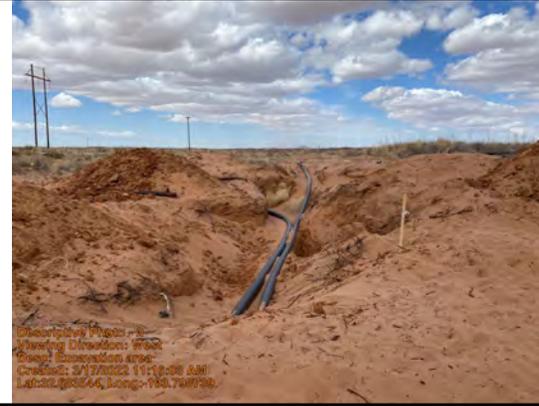
Descriptive Photo - 4
Viewing Direction: West
Photo Release Area
Created: 3/17/2022 11:18:08 AM
Lat:32.83344, Long:-103.738738

Excavation area

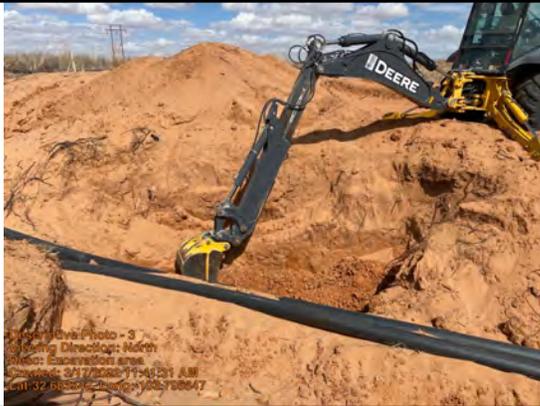
Descriptive Photo - 3
Viewing Direction: North
Photo Release Area
Created: 3/17/2022 11:44:31 AM
Lat:32.83344, Long:-103.738847

Excavation area

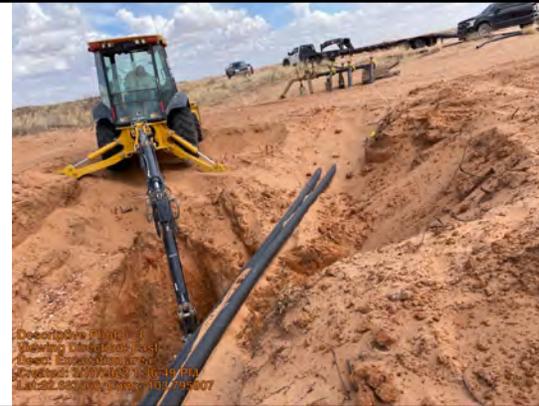
Descriptive Photo - 3
Viewing Direction: East
Photo Release Area
Created: 3/17/2022 11:36:49 AM
Lat:32.83344, Long:-103.738807

Excavation area

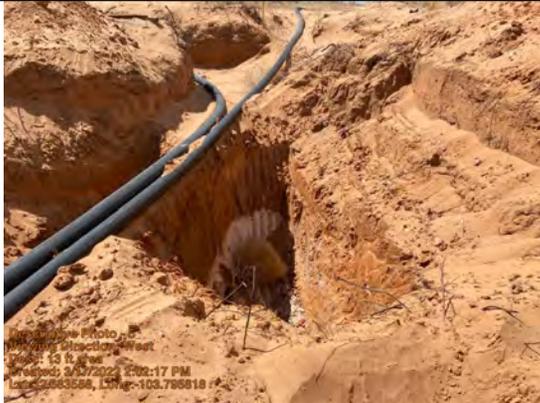
13 ft area

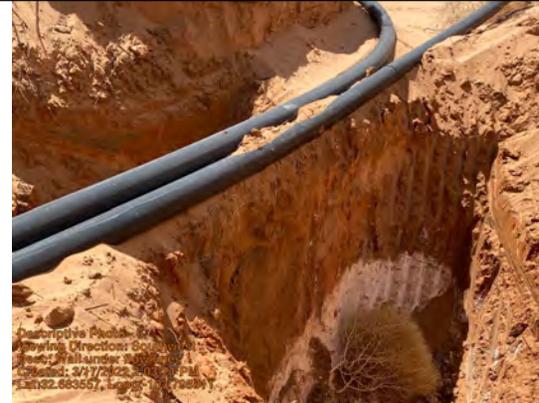
Wall under flow lines

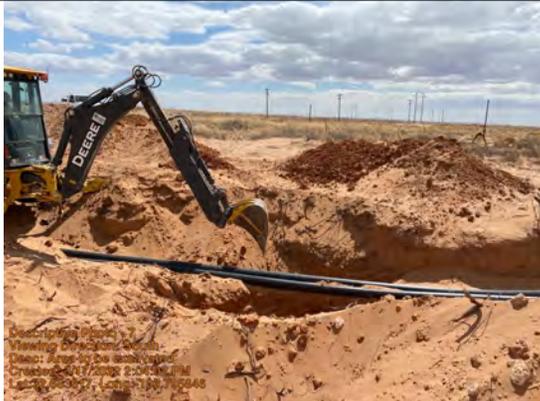
Area to be excavated

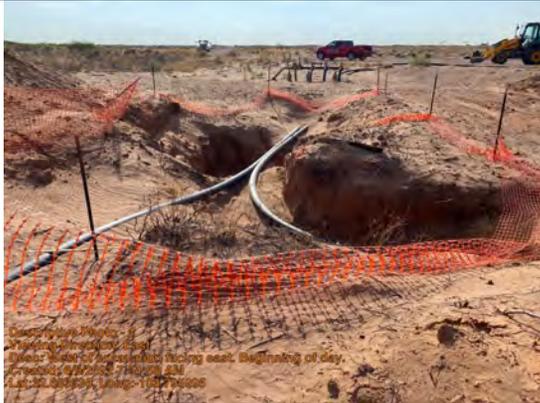
Descriptive Photo - 10
Viewing Direction: East
Desc: West of excavation facing east. Beginning of day.
Created: 6/9/2022 9:48:08 AM
Lat:32.89395, Long:-103.79816

West of excavation facing east. Beginning of day.

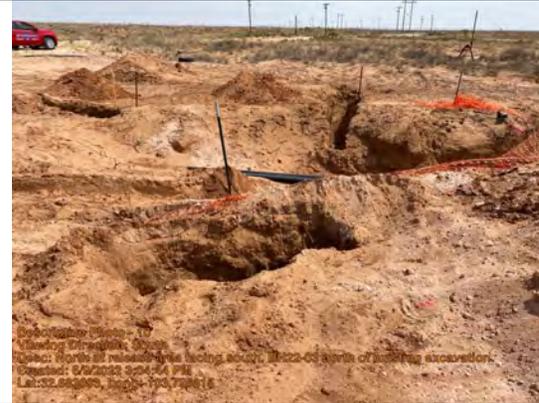
Descriptive Photo - 11
Viewing Direction: South
Desc: North of release area facing south. BH22-03 north of existing excavation.
Created: 6/9/2022 9:54:44 PM
Lat:32.89395, Long:-103.79816

North of release area facing south. BH22-03 north of existing excavation.

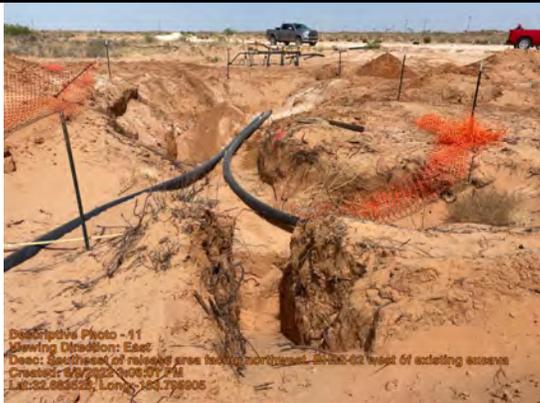
Descriptive Photo - 11
Viewing Direction: East
Desc: Southeast of release area facing northwest. BH22-02 west of existing excava
Created: 6/9/2022 9:55:17 PM
Lat:32.89395, Long:-103.79805

Southeast of release area facing northwest. BH22-04 west of existing excavation.

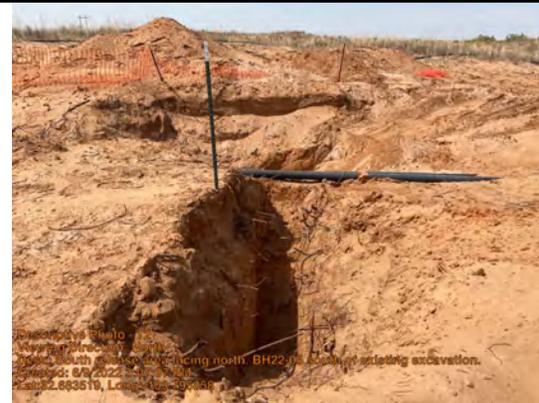
Descriptive Photo - 10
Viewing Direction: North
Desc: South release area facing north. BH22-05 south of existing excavation.
Created: 6/9/2022 9:55:17 PM
Lat:32.89395, Long:-103.79816

South release area facing north. BH22-05 south of existing excavation.

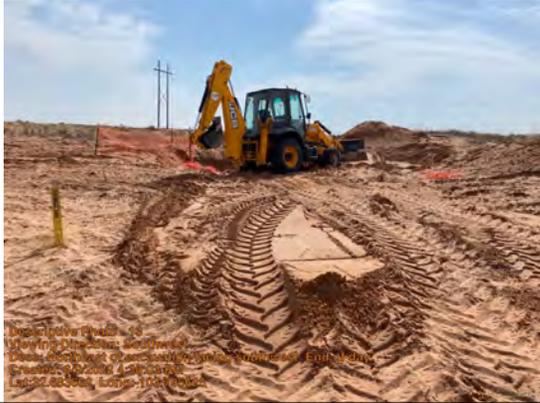
Descriptive Photo - 14
Viewing Direction: Southwest
Desc: Northeast of excavation facing southwest. End of day.
Created: 6/9/2022 4:39:53 PM
Lat: 32.83384, Long: -103.75208

Northeast of excavation facing southwest. End of day.

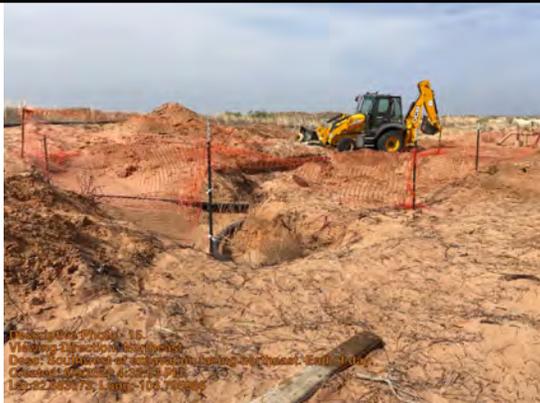
Descriptive Photo - 16
Viewing Direction: Northeast
Desc: Southwest of excavation facing northeast. End of day.
Created: 6/9/2022 4:42:23 PM
Lat: 32.83384, Long: -103.75208

Southwest of excavation facing northeast. End of day.

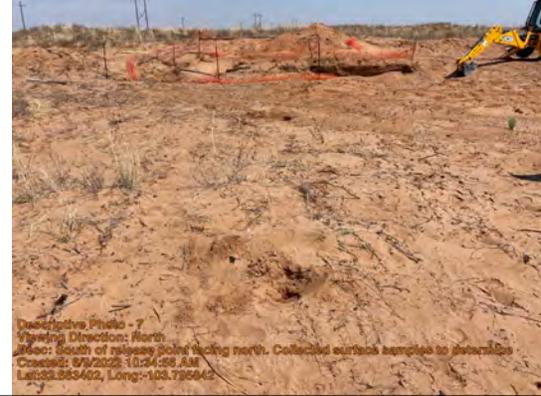
South of release point facing north. Collected surface samples to determine where to start boreholes.

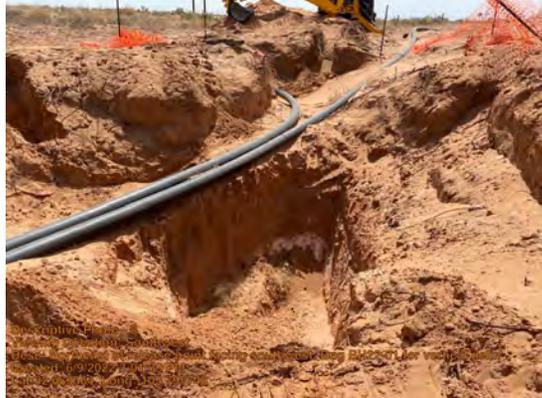
Northeast of release point facing southwest. Dug BH22-01 for vertical delineation within feet of release point.

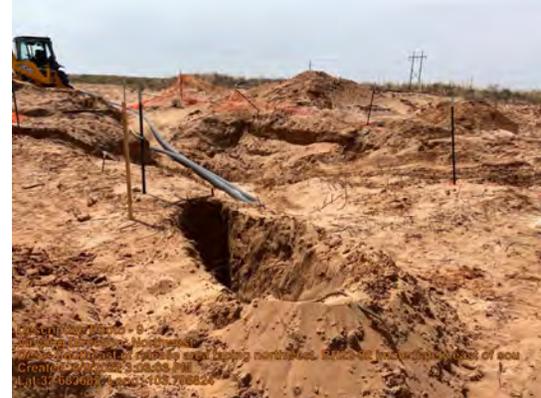
Southeast of release area facing northwest. BH22-02 east of southeast corner of existing excavation.

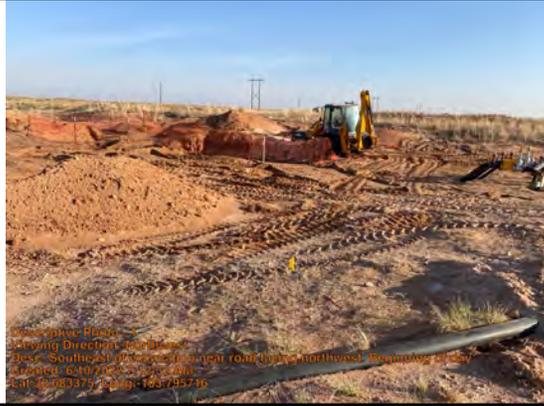
Descriptive Photo - 11
Viewing Direction: Northwest
Desc: Southeast of excavation near road facing northwest. Beginning of day.
Created: 6/11/2022 4:20:28 AM
Elev: 6600.0, Long: -103.49333

Southeast of excavation near road facing northwest. Beginning of day.

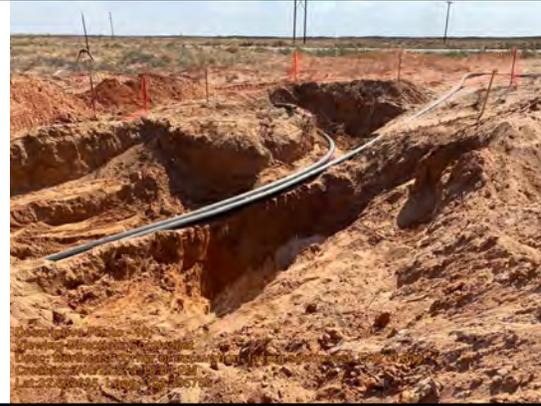
Descriptive Photo - 10
Viewing Direction: Southwest
Desc: Northeast corner of excavation, facing southwest. End of day.
Created: 6/11/2022 4:20:28 AM
Elev: 6600.0, Long: -103.49333

Northeast corner of excavation, facing southwest. End of day.

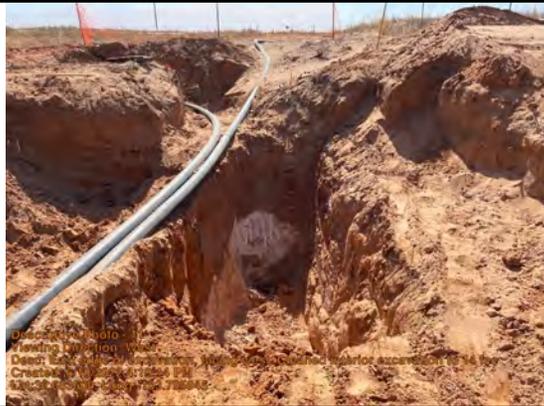
Descriptive Photo - 10
Viewing Direction: West
Desc: East edge of excavation, cleaned interior excavation to 14 feet bgs.
Created: 6/11/2022 4:20:28 AM
Elev: 6600.0, Long: -103.49333

East edge of excavation, facing west. Cleaned interior excavation to 14 feet bgs.

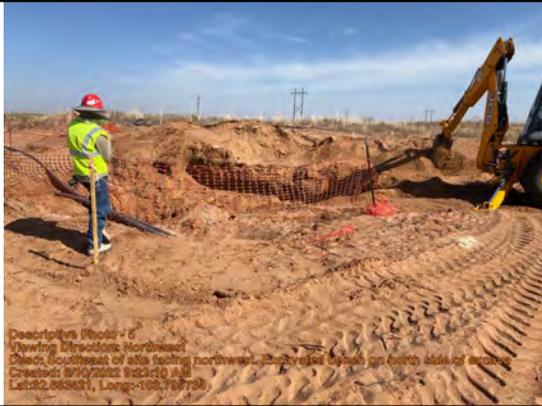
Description Photo # 6
Viewing Direction: Northwest
Date: Southeast of site facing northwest. Excavated bench on north side of excavation.
Created: 8/10/2022 8:23:10 AM
Lat:32.883631, Long:-103.709791

Southeast of site facing northwest. Excavated bench on north side of excavation for stability.

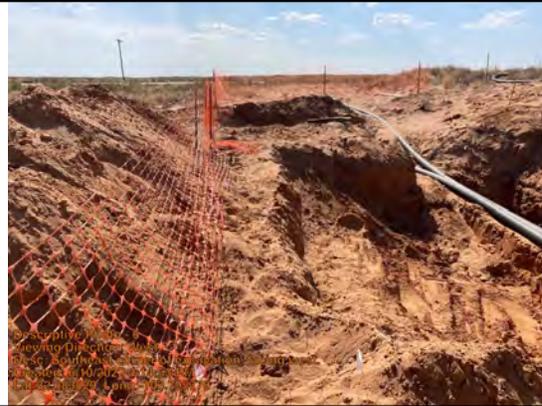
Description Photo # 7
Viewing Direction: West
Date: Southeast corner of excavation, facing west.
Created: 8/10/2022 8:23:10 AM
Lat:32.883631, Long:-103.709791

Southeast corner of excavation, facing west. End of day.

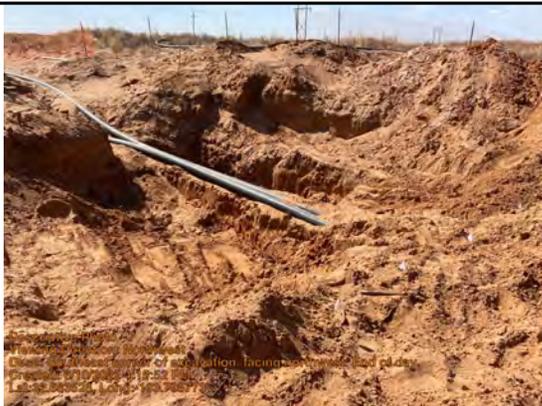
Description Photo # 8
Viewing Direction: Northwest
Date: Southeast corner of excavation, facing northwest.
Created: 8/10/2022 8:23:10 AM
Lat:32.883631, Long:-103.709791

Southeast corner of excavation, facing northwest. End of day.

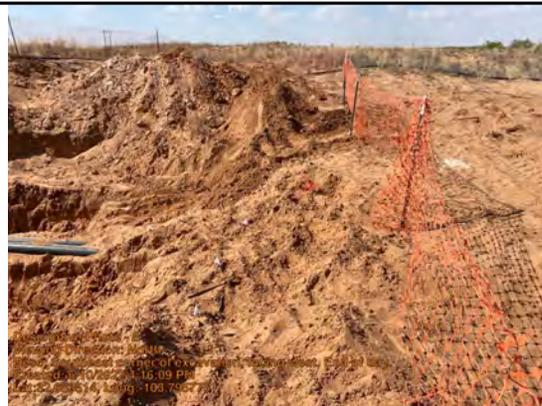
Description Photo # 9
Viewing Direction: North
Date: Southeast corner of excavation, facing north.
Created: 8/10/2022 8:23:10 AM
Lat:32.883631, Long:-103.709791

Southeast corner of excavation, facing north. End of day.

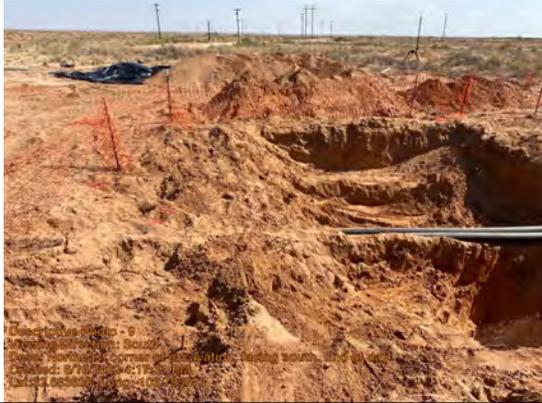
Northeast corner of excavation, facing south.
End of day.

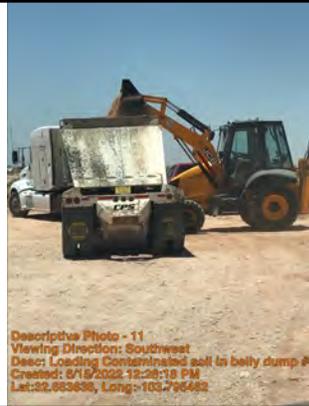
Descriptive Photo - 11
Viewing Direction: Southwest
Desc: Loading Contaminated soil in belly dump #6
Created: 8/15/2022 12:28:18 PM
Lat:32.683636, Long:-103.796482

Loading Contaminated soil in belly dump #6

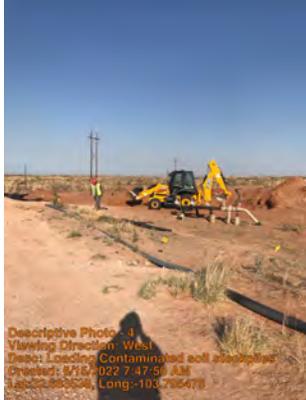
Descriptive Photo - 4
Viewing Direction: West
Desc: Loading Contaminated soil stockpiles
Created: 6/15/2022 7:47:56 AM
Lat:32.883626, Long:-103.795478

Loading Contaminated soil stockpiles in belly dump #1

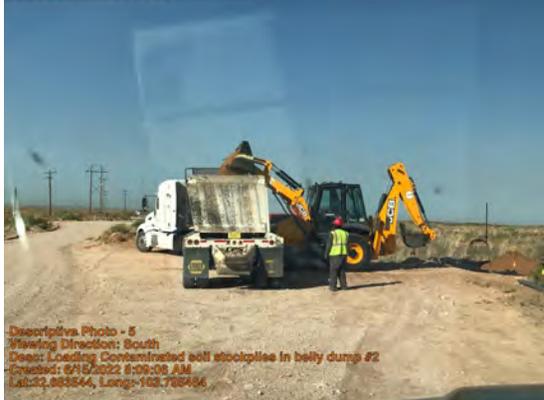
Descriptive Photo - 5
Viewing Direction: South
Desc: Loading Contaminated soil stockpiles in belly dump #2
Created: 6/15/2022 8:09:08 AM
Lat:32.883444, Long:-103.795466

Loading Contaminated soil stockpiles in belly dump #2

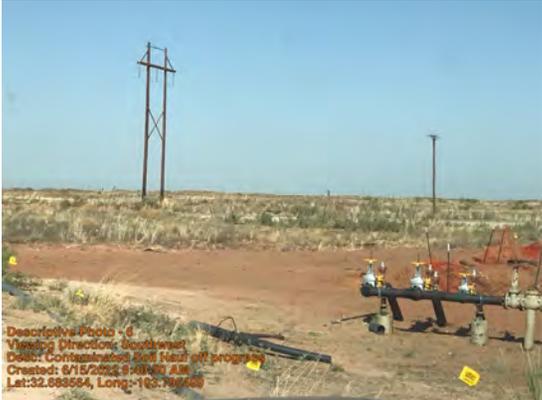
Descriptive Photo - 6
Viewing Direction: Southwest
Desc: Contaminated Soil Haul off progress
Created: 6/15/2022 9:01:57 AM
Lat:32.883554, Long:-103.795464

Contaminated Soil Haul off progress

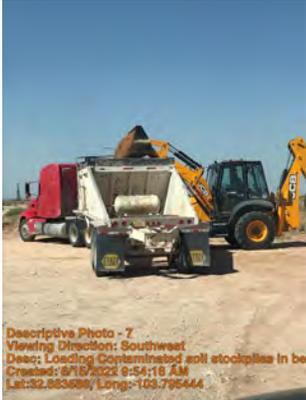
Descriptive Photo - 7
Viewing Direction: Southwest
Desc: Loading Contaminated soil stockpiles in be
Created: 6/15/2022 9:54:18 AM
Lat:32.883688, Long:-103.795444

Loading Contaminated soil stockpiles in belly dump #3

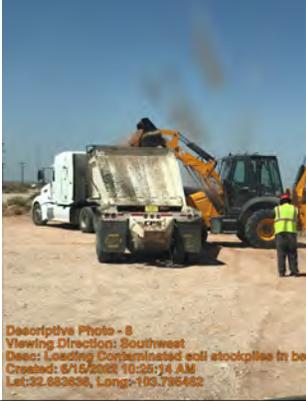
Descriptive Photo - 8
Viewing Direction: Southwest
Desc: Loading Contaminated soil stockpiles in belly dump #4
Created: 6/18/2022 10:25:14 AM
Lat:32.683636, Long:-103.795452

Loading Contaminated soil stockpiles in belly dump #4

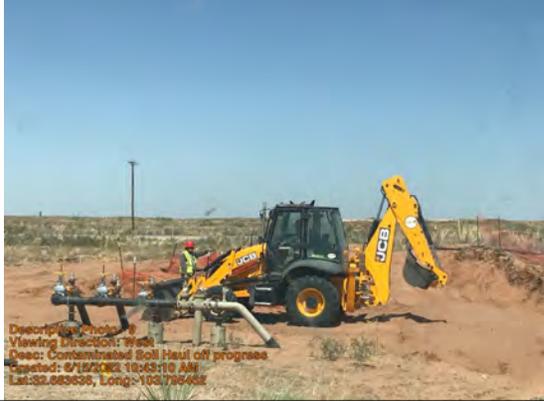
Descriptive Photo - 9
Viewing Direction: West
Desc: Contaminated Soil Haul off progress
Created: 6/18/2022 10:43:10 AM
Lat:32.683636, Long:-103.795452

Contaminated Soil Haul off progress

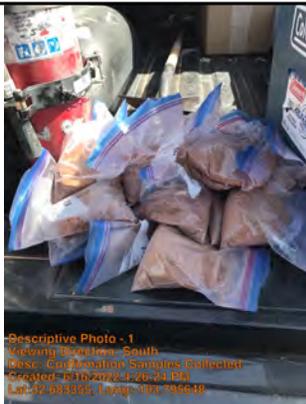
Descriptive Photo - 1
Viewing Direction: South
Case: Confirmation Samples Collected
Created: 01/18/2023 4:26:24 PM
Lat: 32.88326, Long: -103.75543

Confirmation Samples Collected

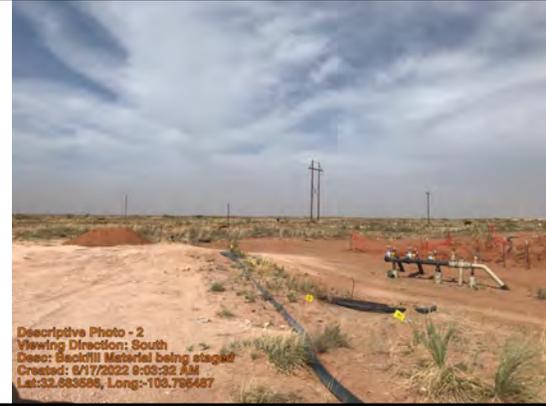
Descriptive Photo - 2
Viewing Direction: South
Desc: Backfill Material being staged
Created: 8/17/2022 9:03:32 AM
Lat:32.68366, Long:-103.795467

Backfill Material being staged

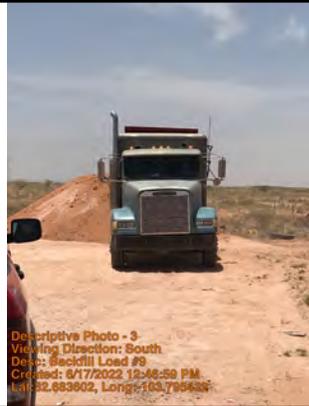
Descriptive Photo - 3
Viewing Direction: South
Desc: Backfill Load #9
Created: 8/17/2022 12:46:59 PM
Lat:32.683602, Long:-103.795435

Backfill Load #9

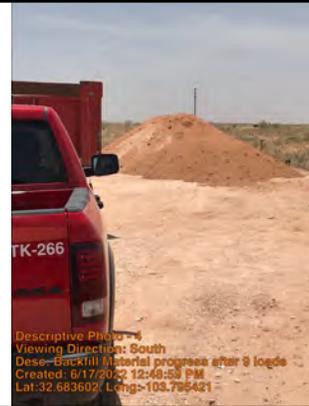
Descriptive Photo - 4
Viewing Direction: South
Desc: Backfill Material progress after 9 loads
Created: 8/17/2022 12:48:53 PM
Lat:32.683602, Long:-103.795421

Backfill Material progress after 9 loads

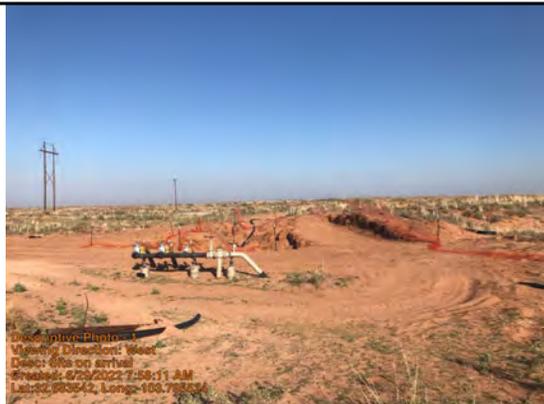
Descriptive Photo - 14
Viewing Direction: West
Event: Site on arrival
Created: 6/29/2022 7:58:11 AM
Lat:32.883542, Long:-103.798571

Site on arrival

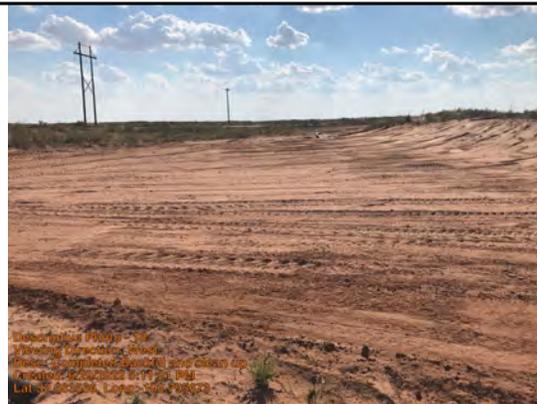
Descriptive Photo - 14
Viewing Direction: West
Event: Completed Backfill and clean up
Created: 6/29/2022 8:11:21 PM
Lat:32.883538, Long:-103.798571

Completed Backfill and clean up

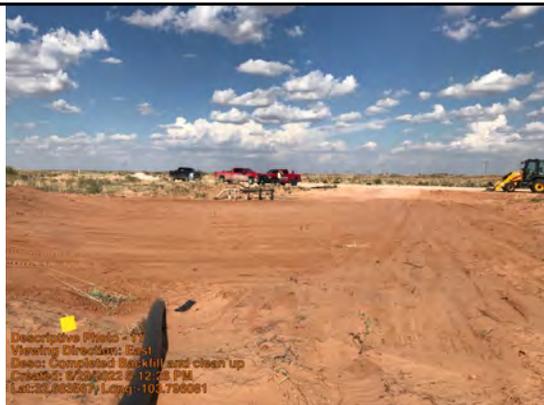
Descriptive Photo - 14
Viewing Direction: East
Event: Completed Backfill and clean up
Created: 6/29/2022 8:12:03 PM
Lat:32.883567, Long:-103.798061

Completed Backfill and clean up

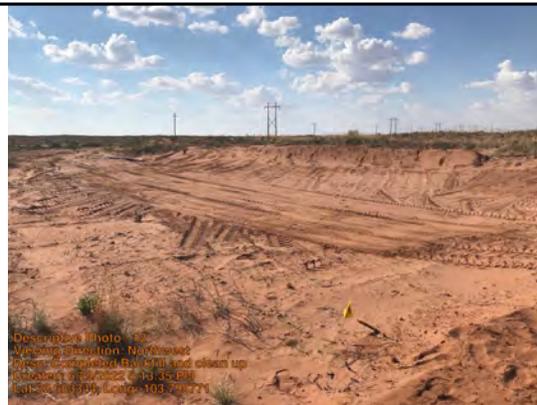
Descriptive Photo - 14
Viewing Direction: Northwest
Event: Completed Backfill and clean up
Created: 6/29/2022 8:13:35 PM
Lat:32.883574, Long:-103.798271

Completed Backfill and clean up
