Incident ID	NAB1822127797
District RP	2RP-4900
Facility ID	
Application ID

State of New Mexico
Oil Conservation Division

Devon Energy
API #30-015-40835
Eddy County, NM
Topographic Map

Devon Energy
API #30-015-40835
Eddy County, NM
Excavation Map-Sidewalls

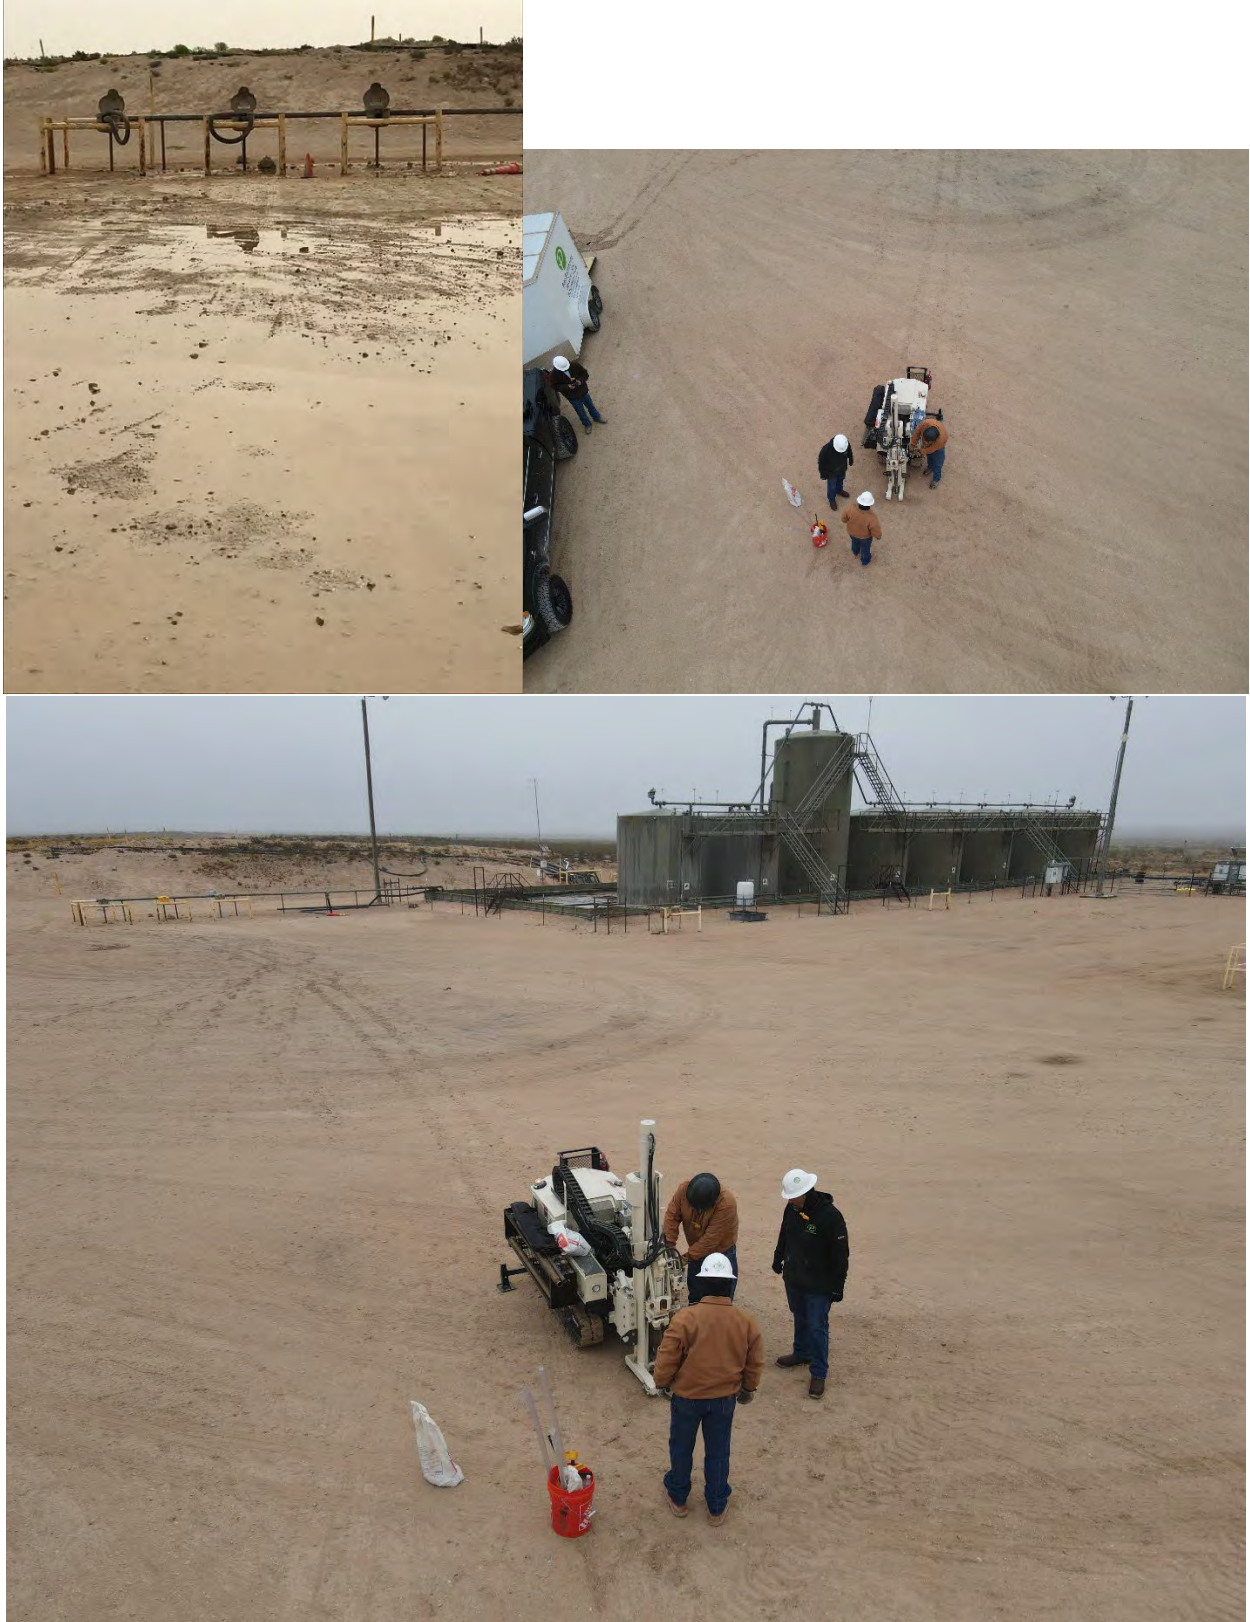
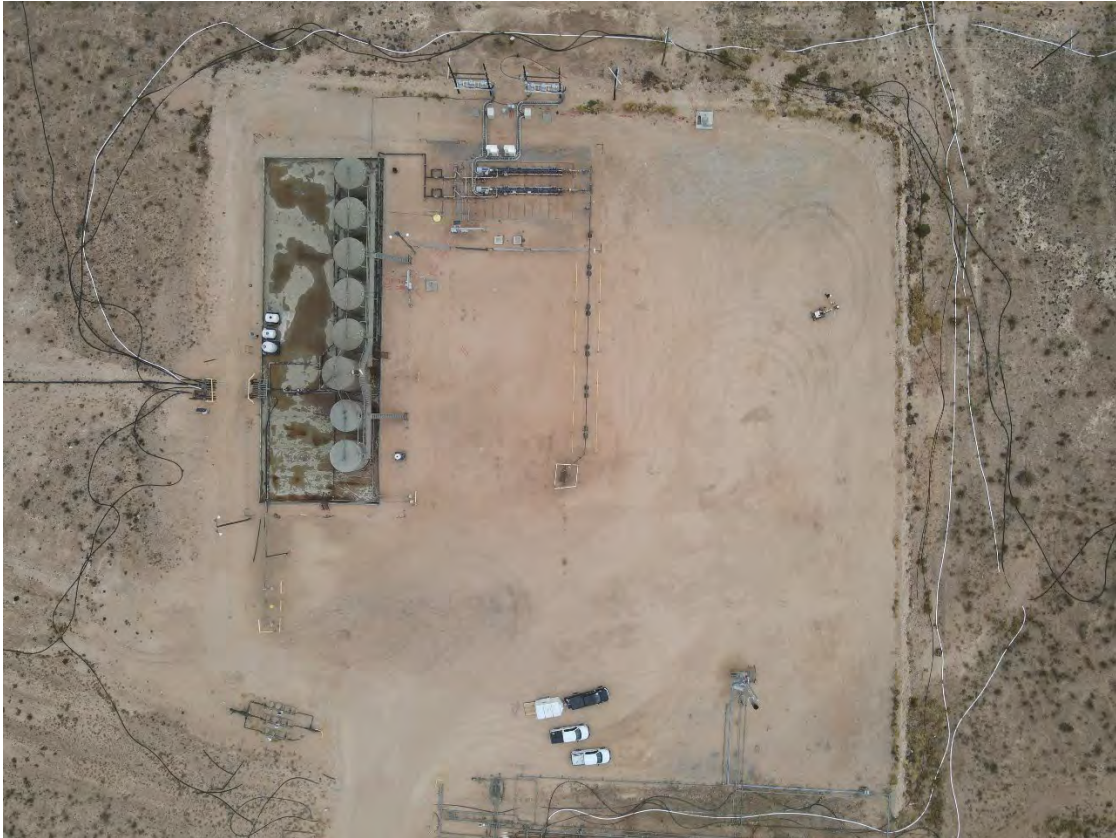
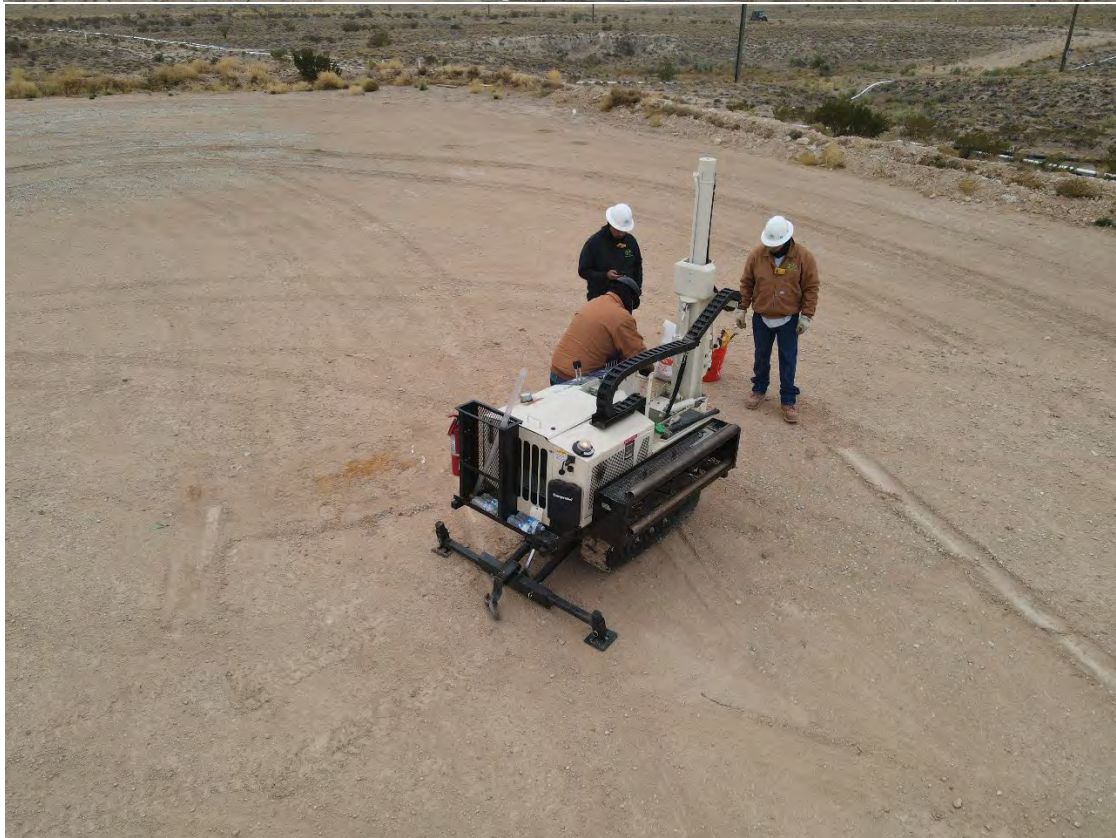
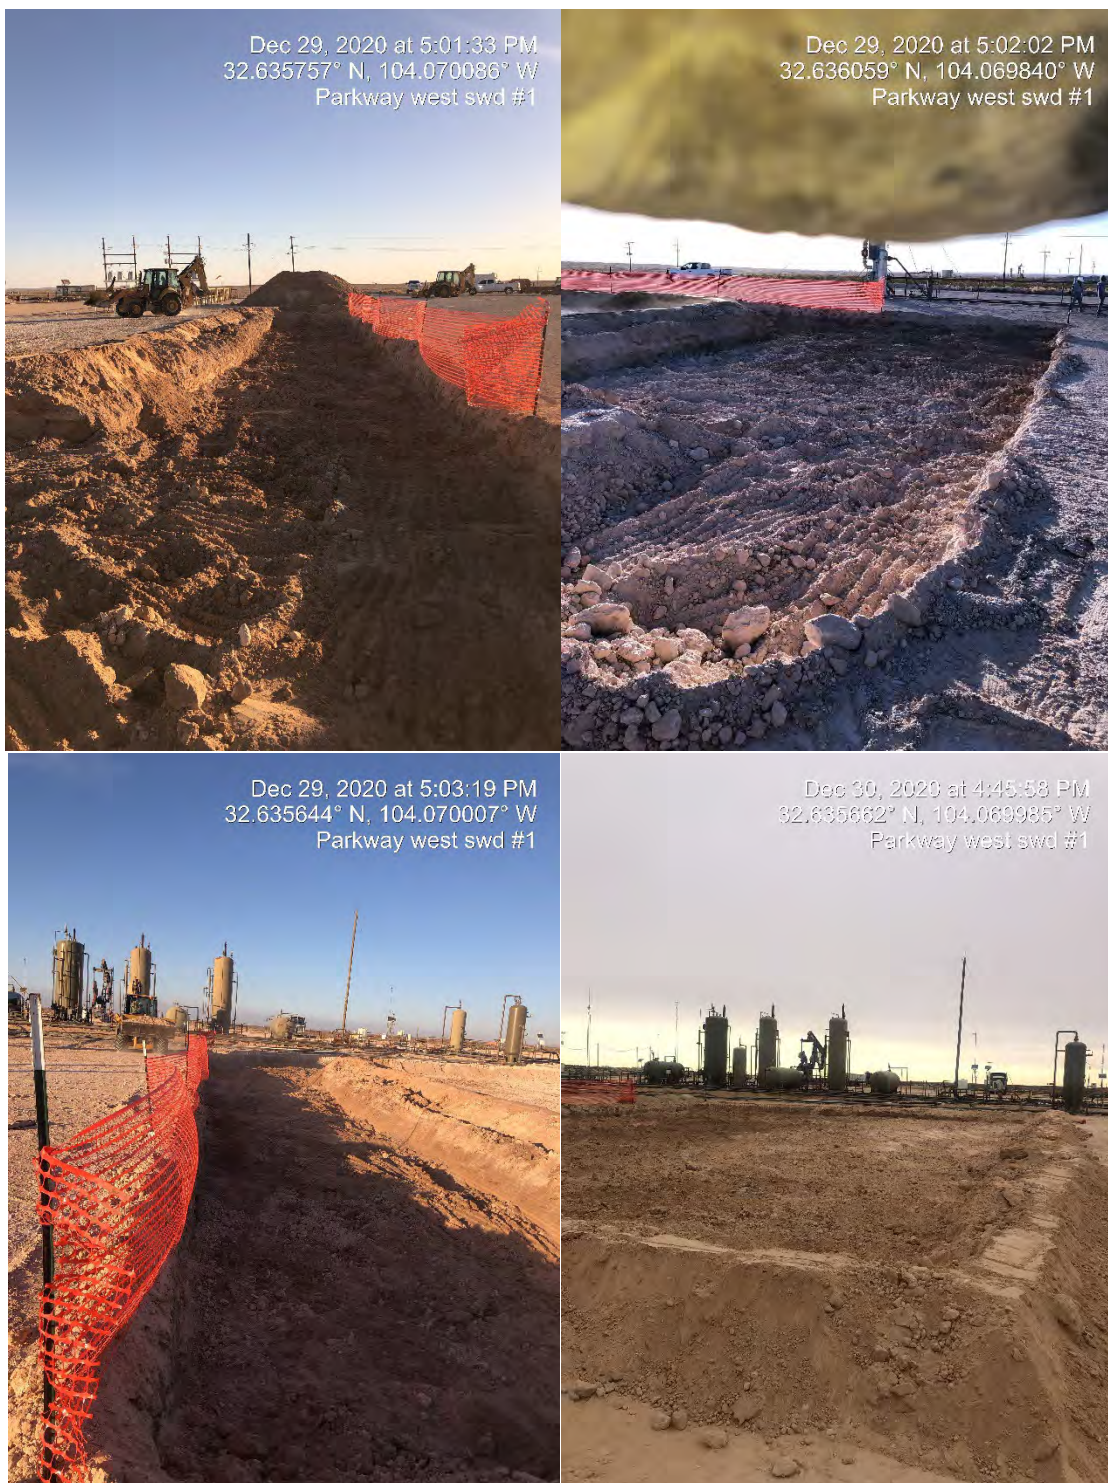
Photographic Documentation

On December 29, 2020, Pima mobilized personnel and equipment to conduct remedial activities. We began excavating the contaminated material from the affected area, hauling it to Lea Land disposal, then hauling in clean material for backfill. Samples were taken from the sidewalls as we excavated. The results of this first sampling event can be seen in the following data table. Photographic documentation can be found in Appendix D.
