**BEECH 25 FEDERAL #9H
CLOSURE REPORT**

**API NO. 30-015-40208
U/L M, SECTION 25, TOWNSHIP 17S, RANGE 27E
EDDY COUNTY, NEW MEXICO**

**RELEASE DATE: 2/2/2021
INCIDENT NO. NAPP2103557511**

Subject: Closure Report for Spur Energy – Beech 25 Federal #009H

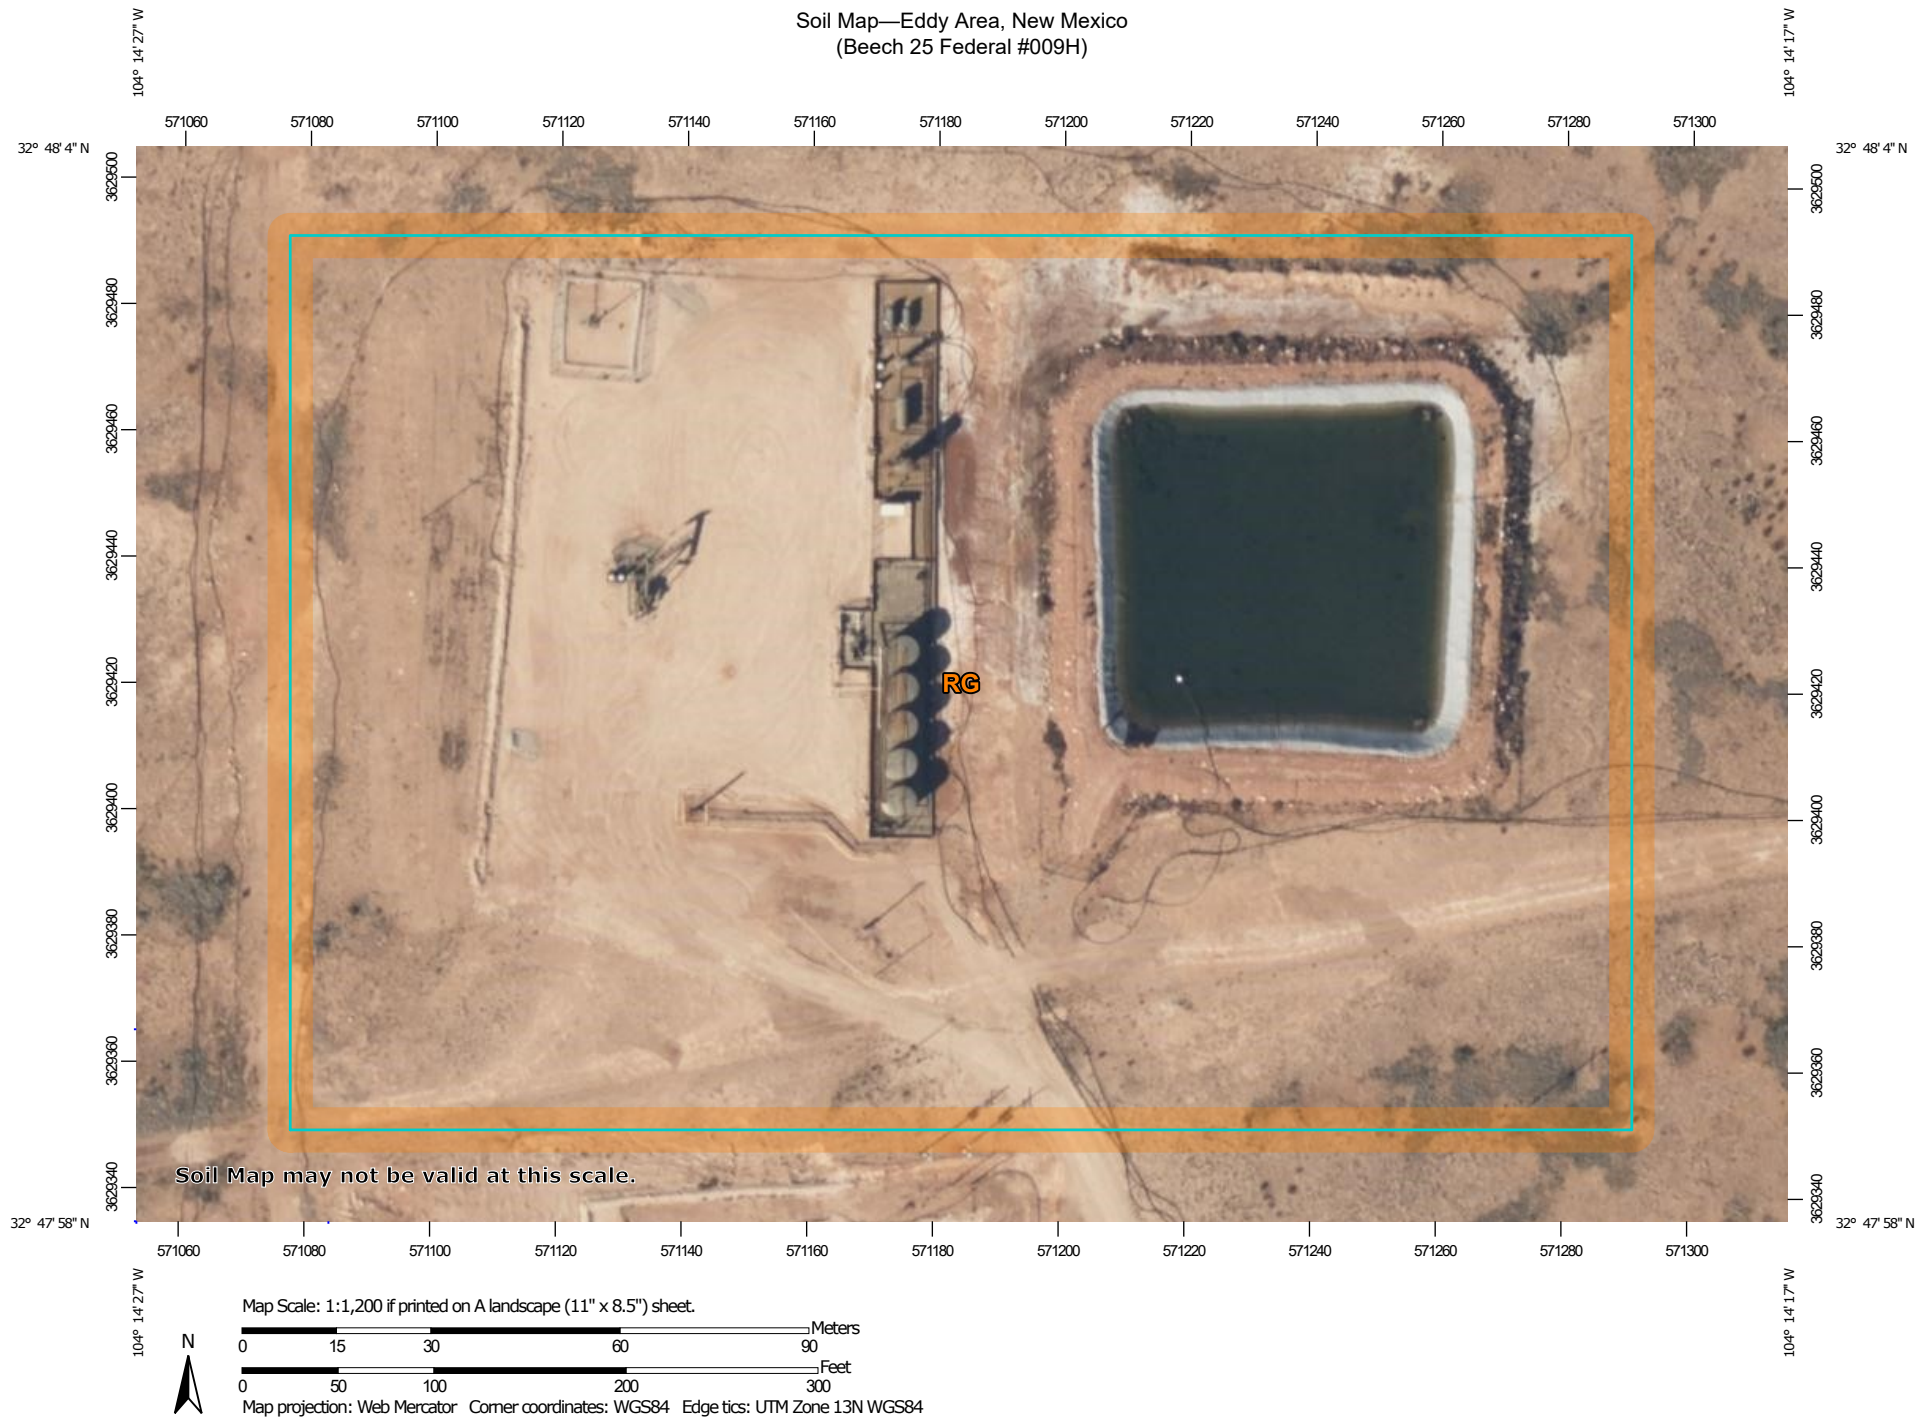
Soil Map—Eddy Area, New Mexico
(Beech 25 Federal #009H)

The United States Department of Agriculture Natural Resources Conservation Services indicates that the soil type found in the area consists of Reeves-Gypsum Land Complex, with 1 to 3 percent slopes. Please see the soil map attached herein.

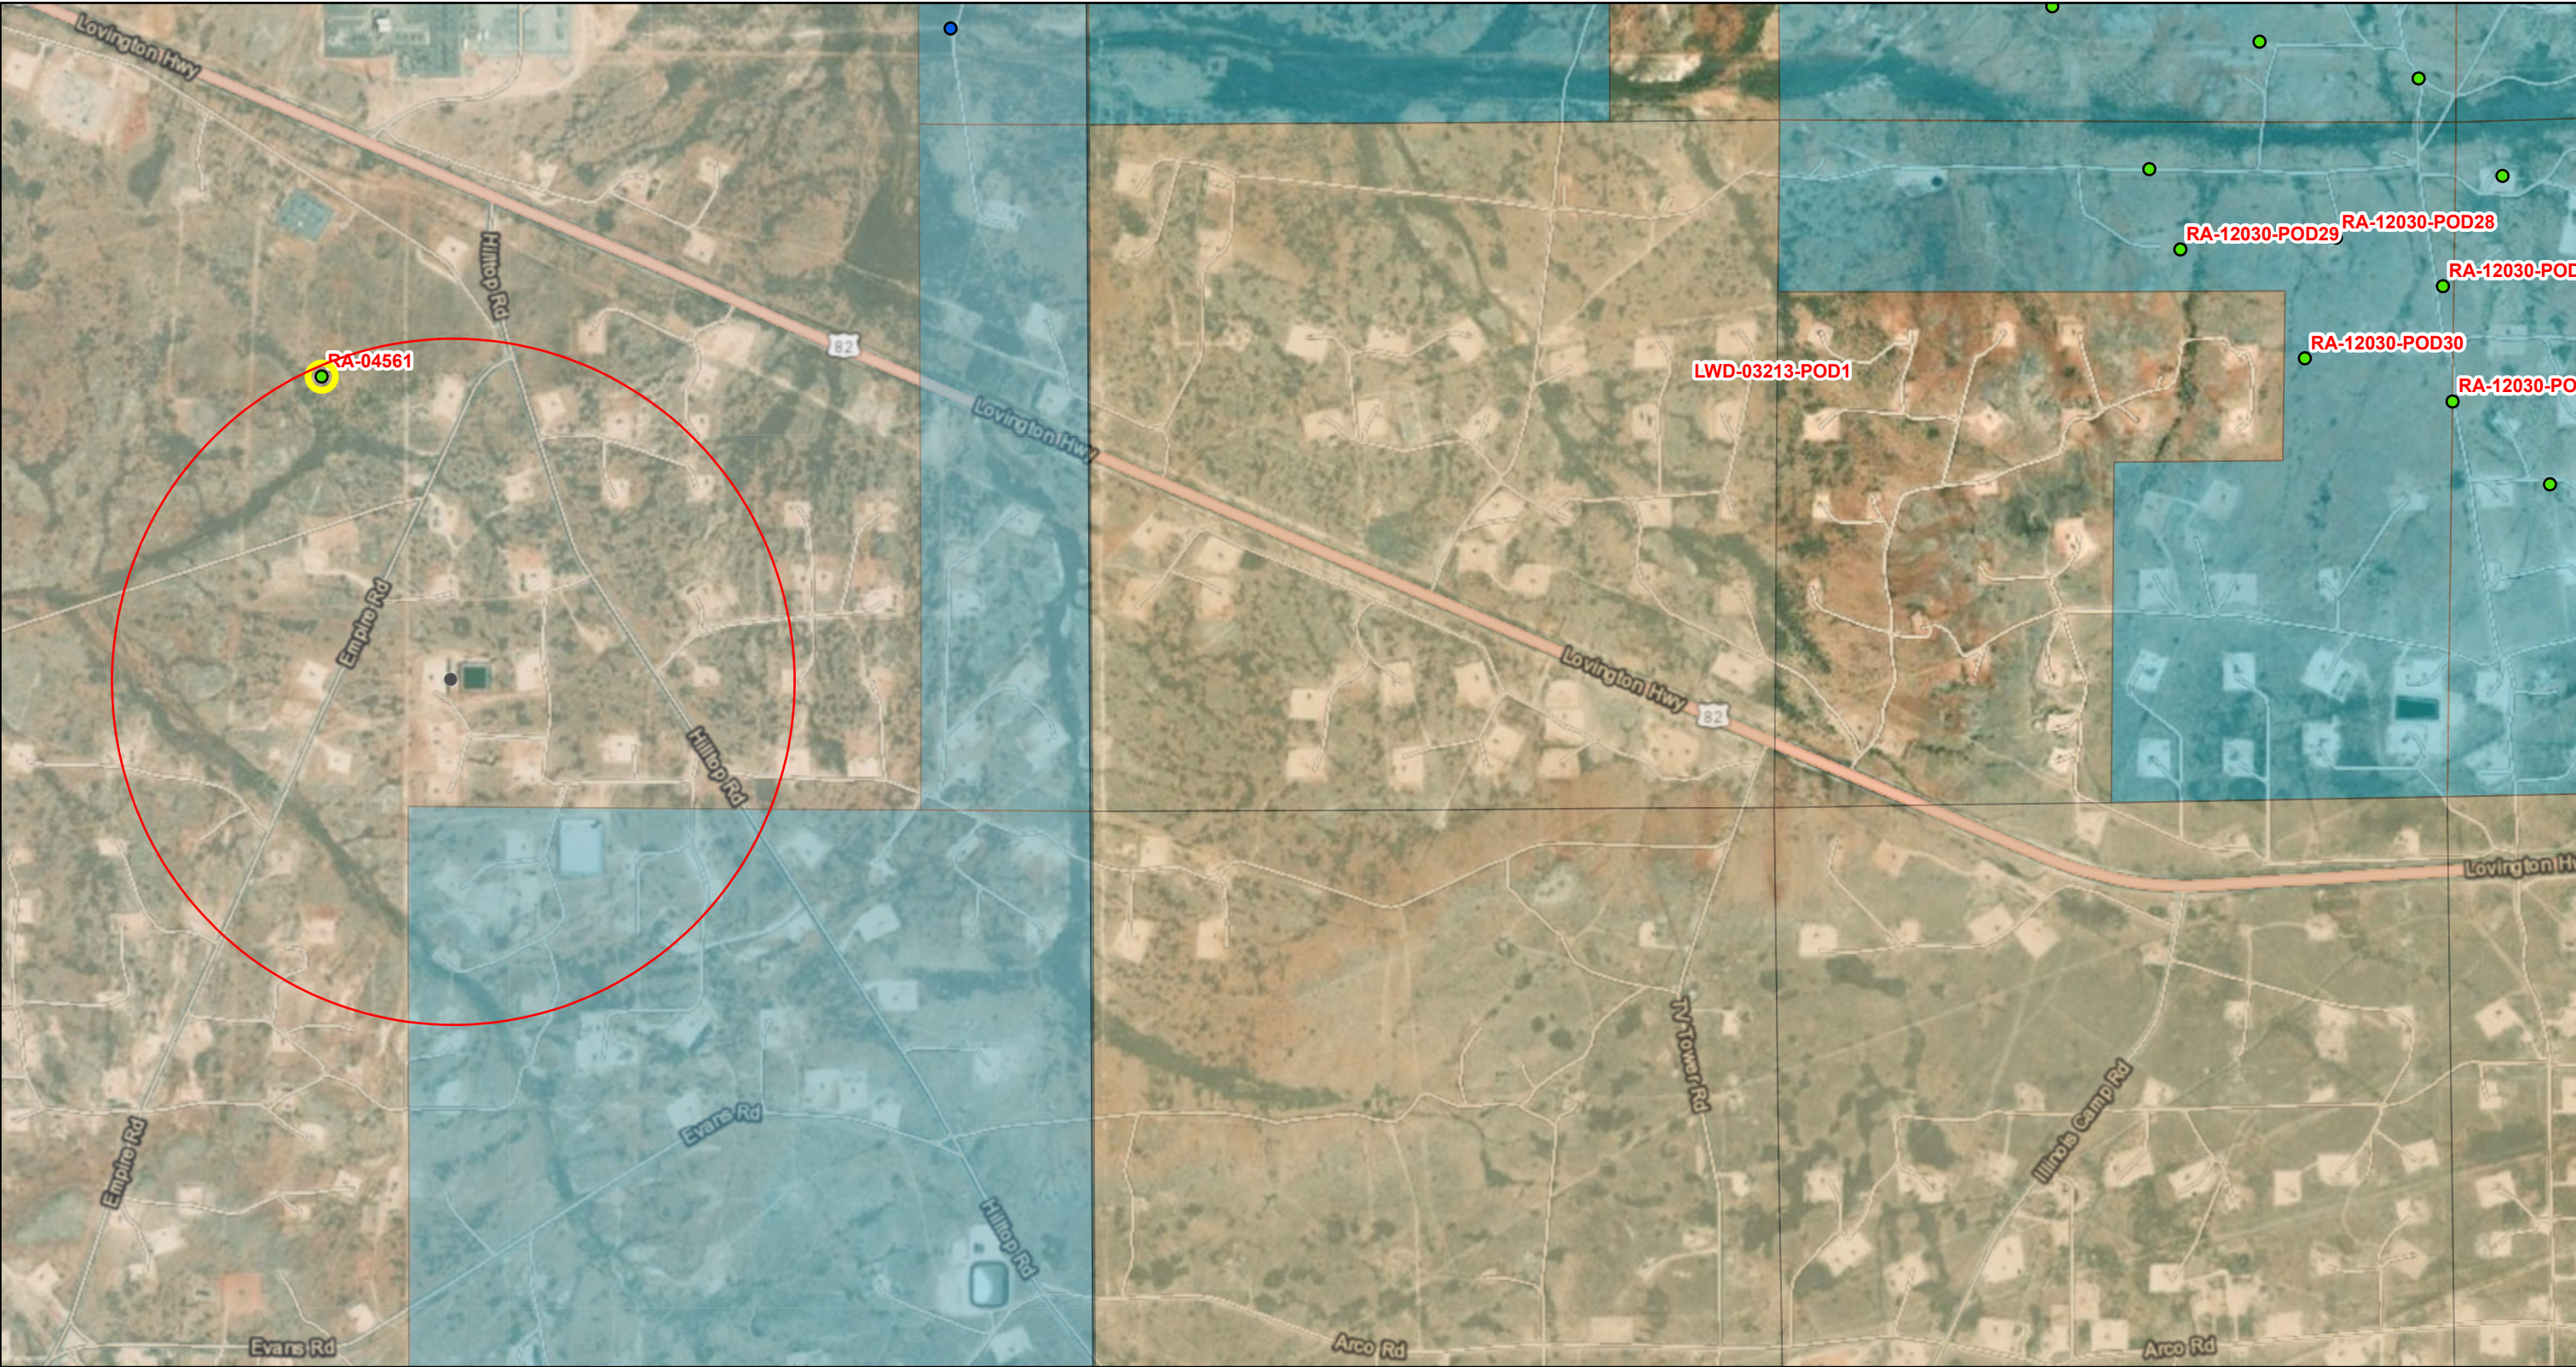
OSE POD Locations Map

conducted using the *OSE POD Location Mapping System* and it has been determined that there is no groundwater well within ½ a mile from the Beech 25. In 1954 RA-04561 (inside the ½ mile radius) was logged by the State Engineer, additional development of the underground water supply would be a detriment to existing rights within the Roswell Artesian Basin. It also states in the document attached herein that the applications to appropriate underground waters both shallow and artesian is closed. Please find all groundwater information attached to this report.

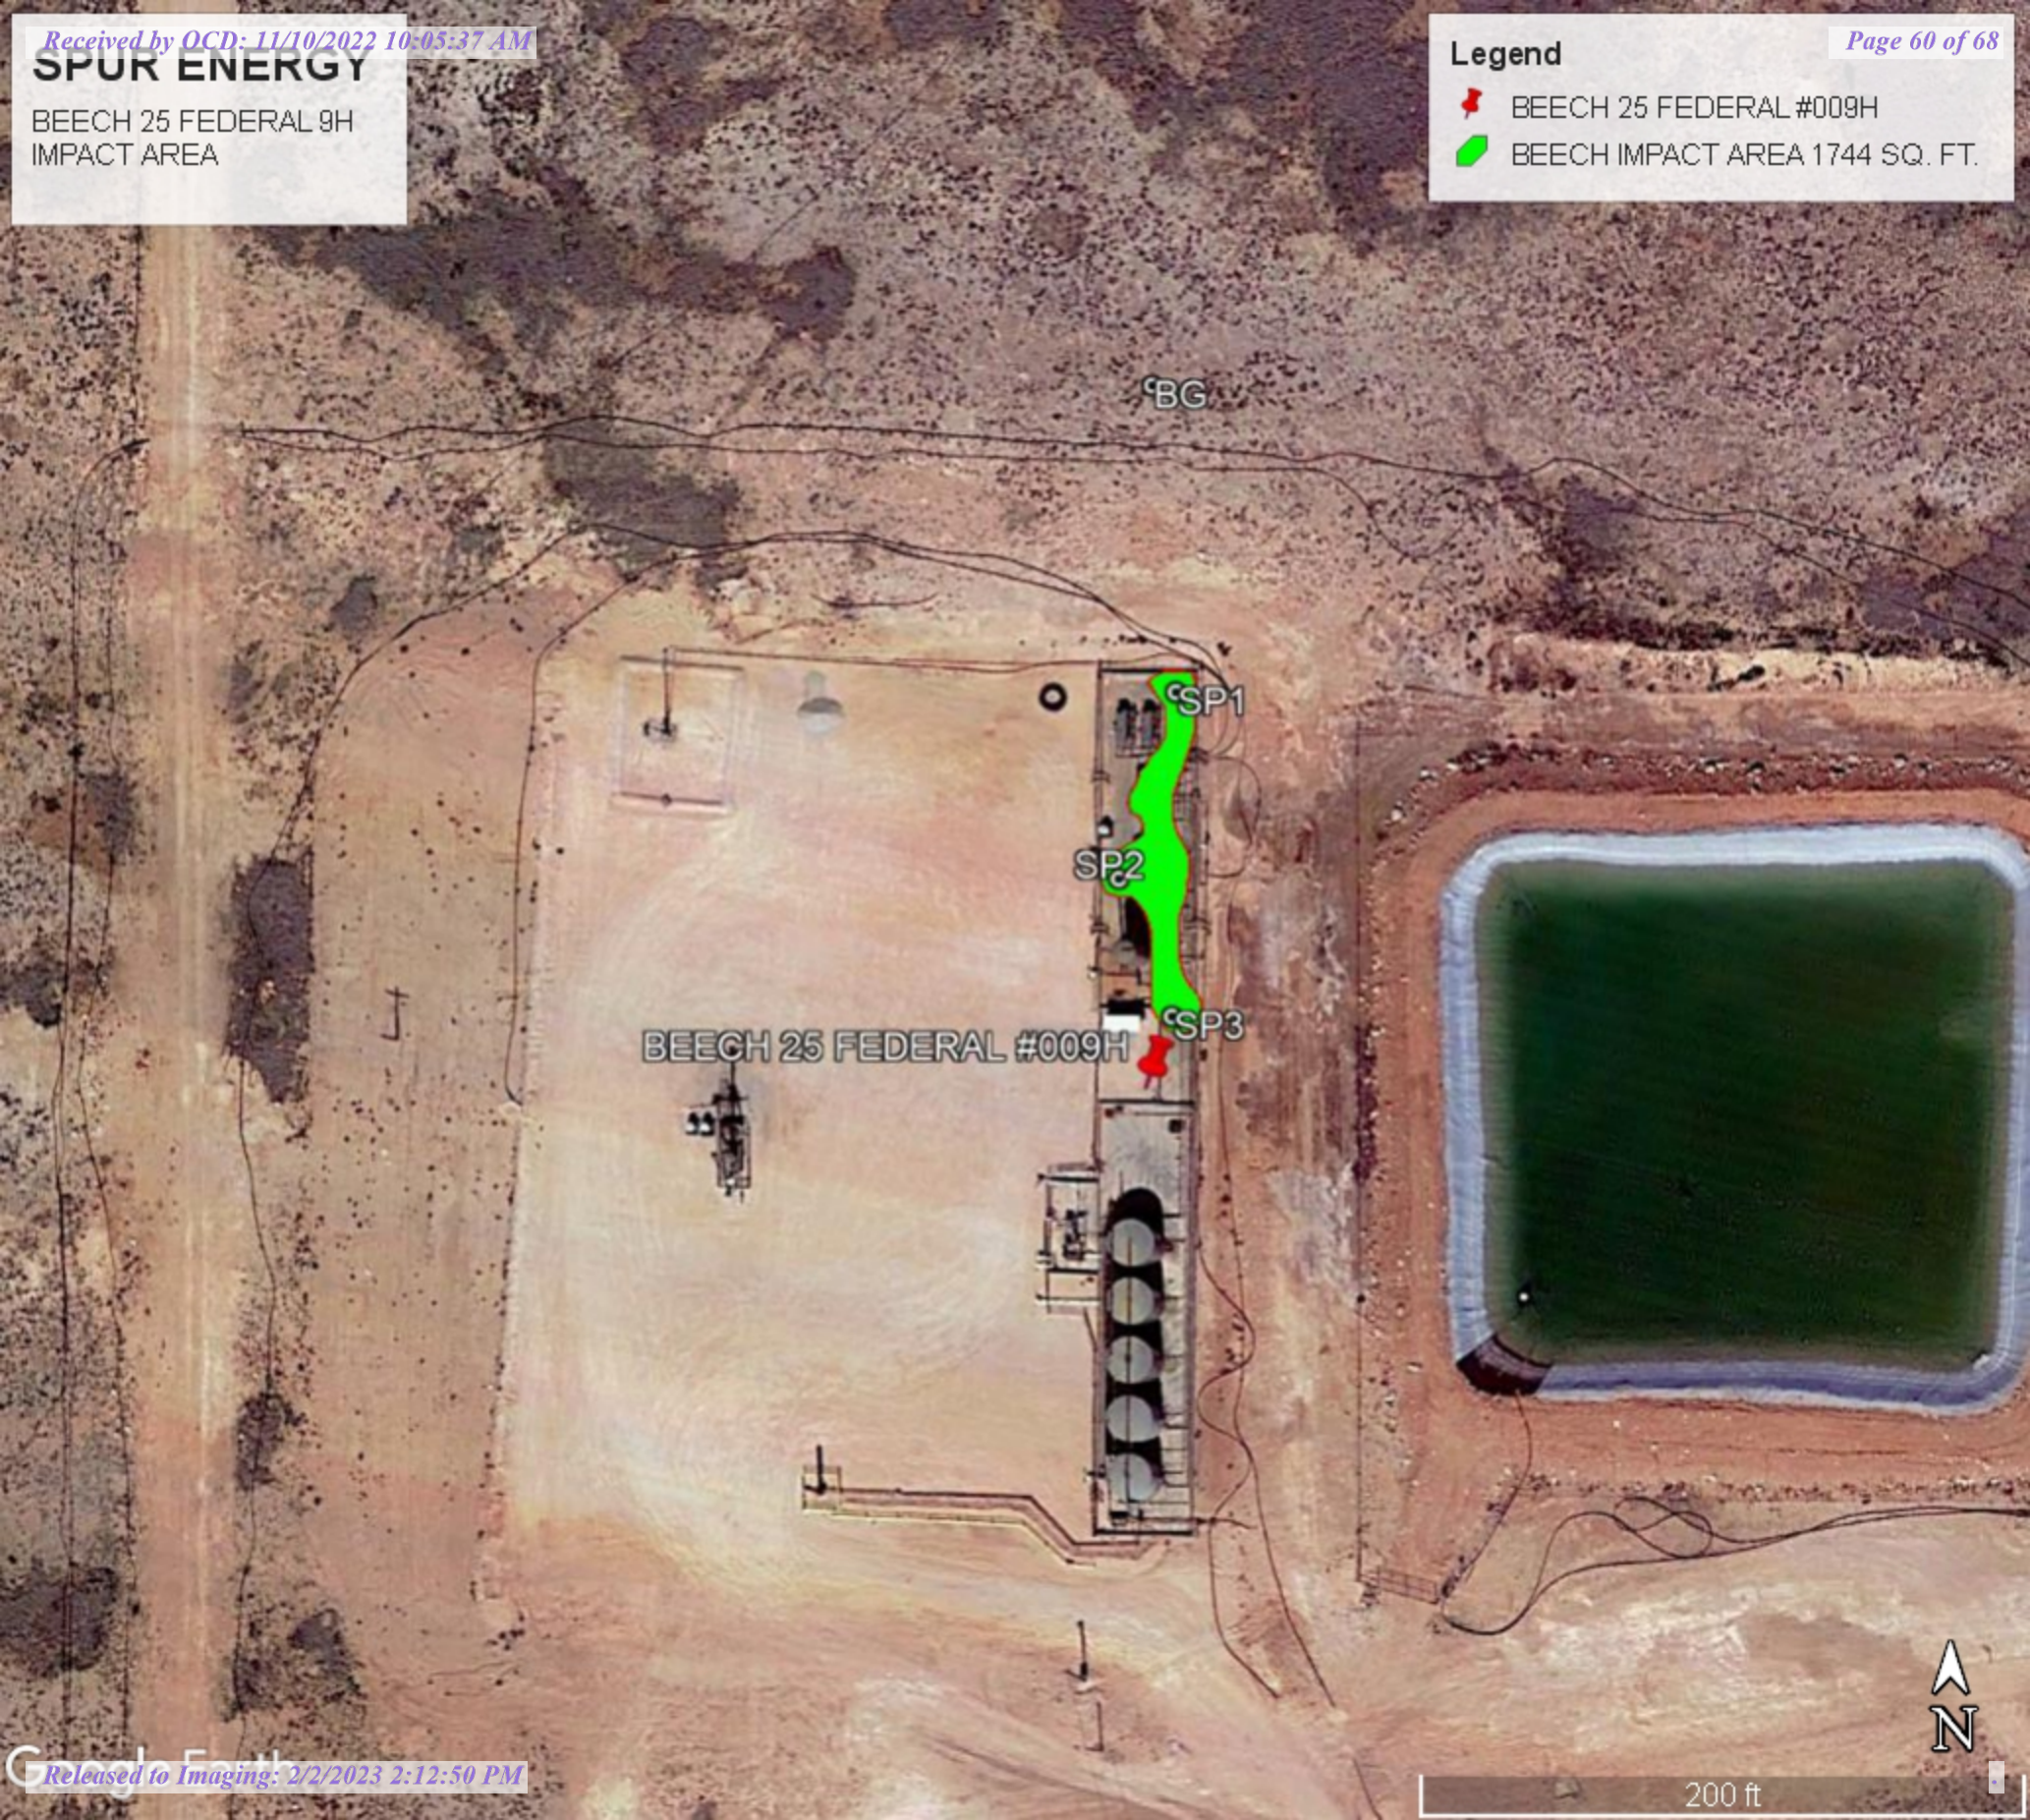
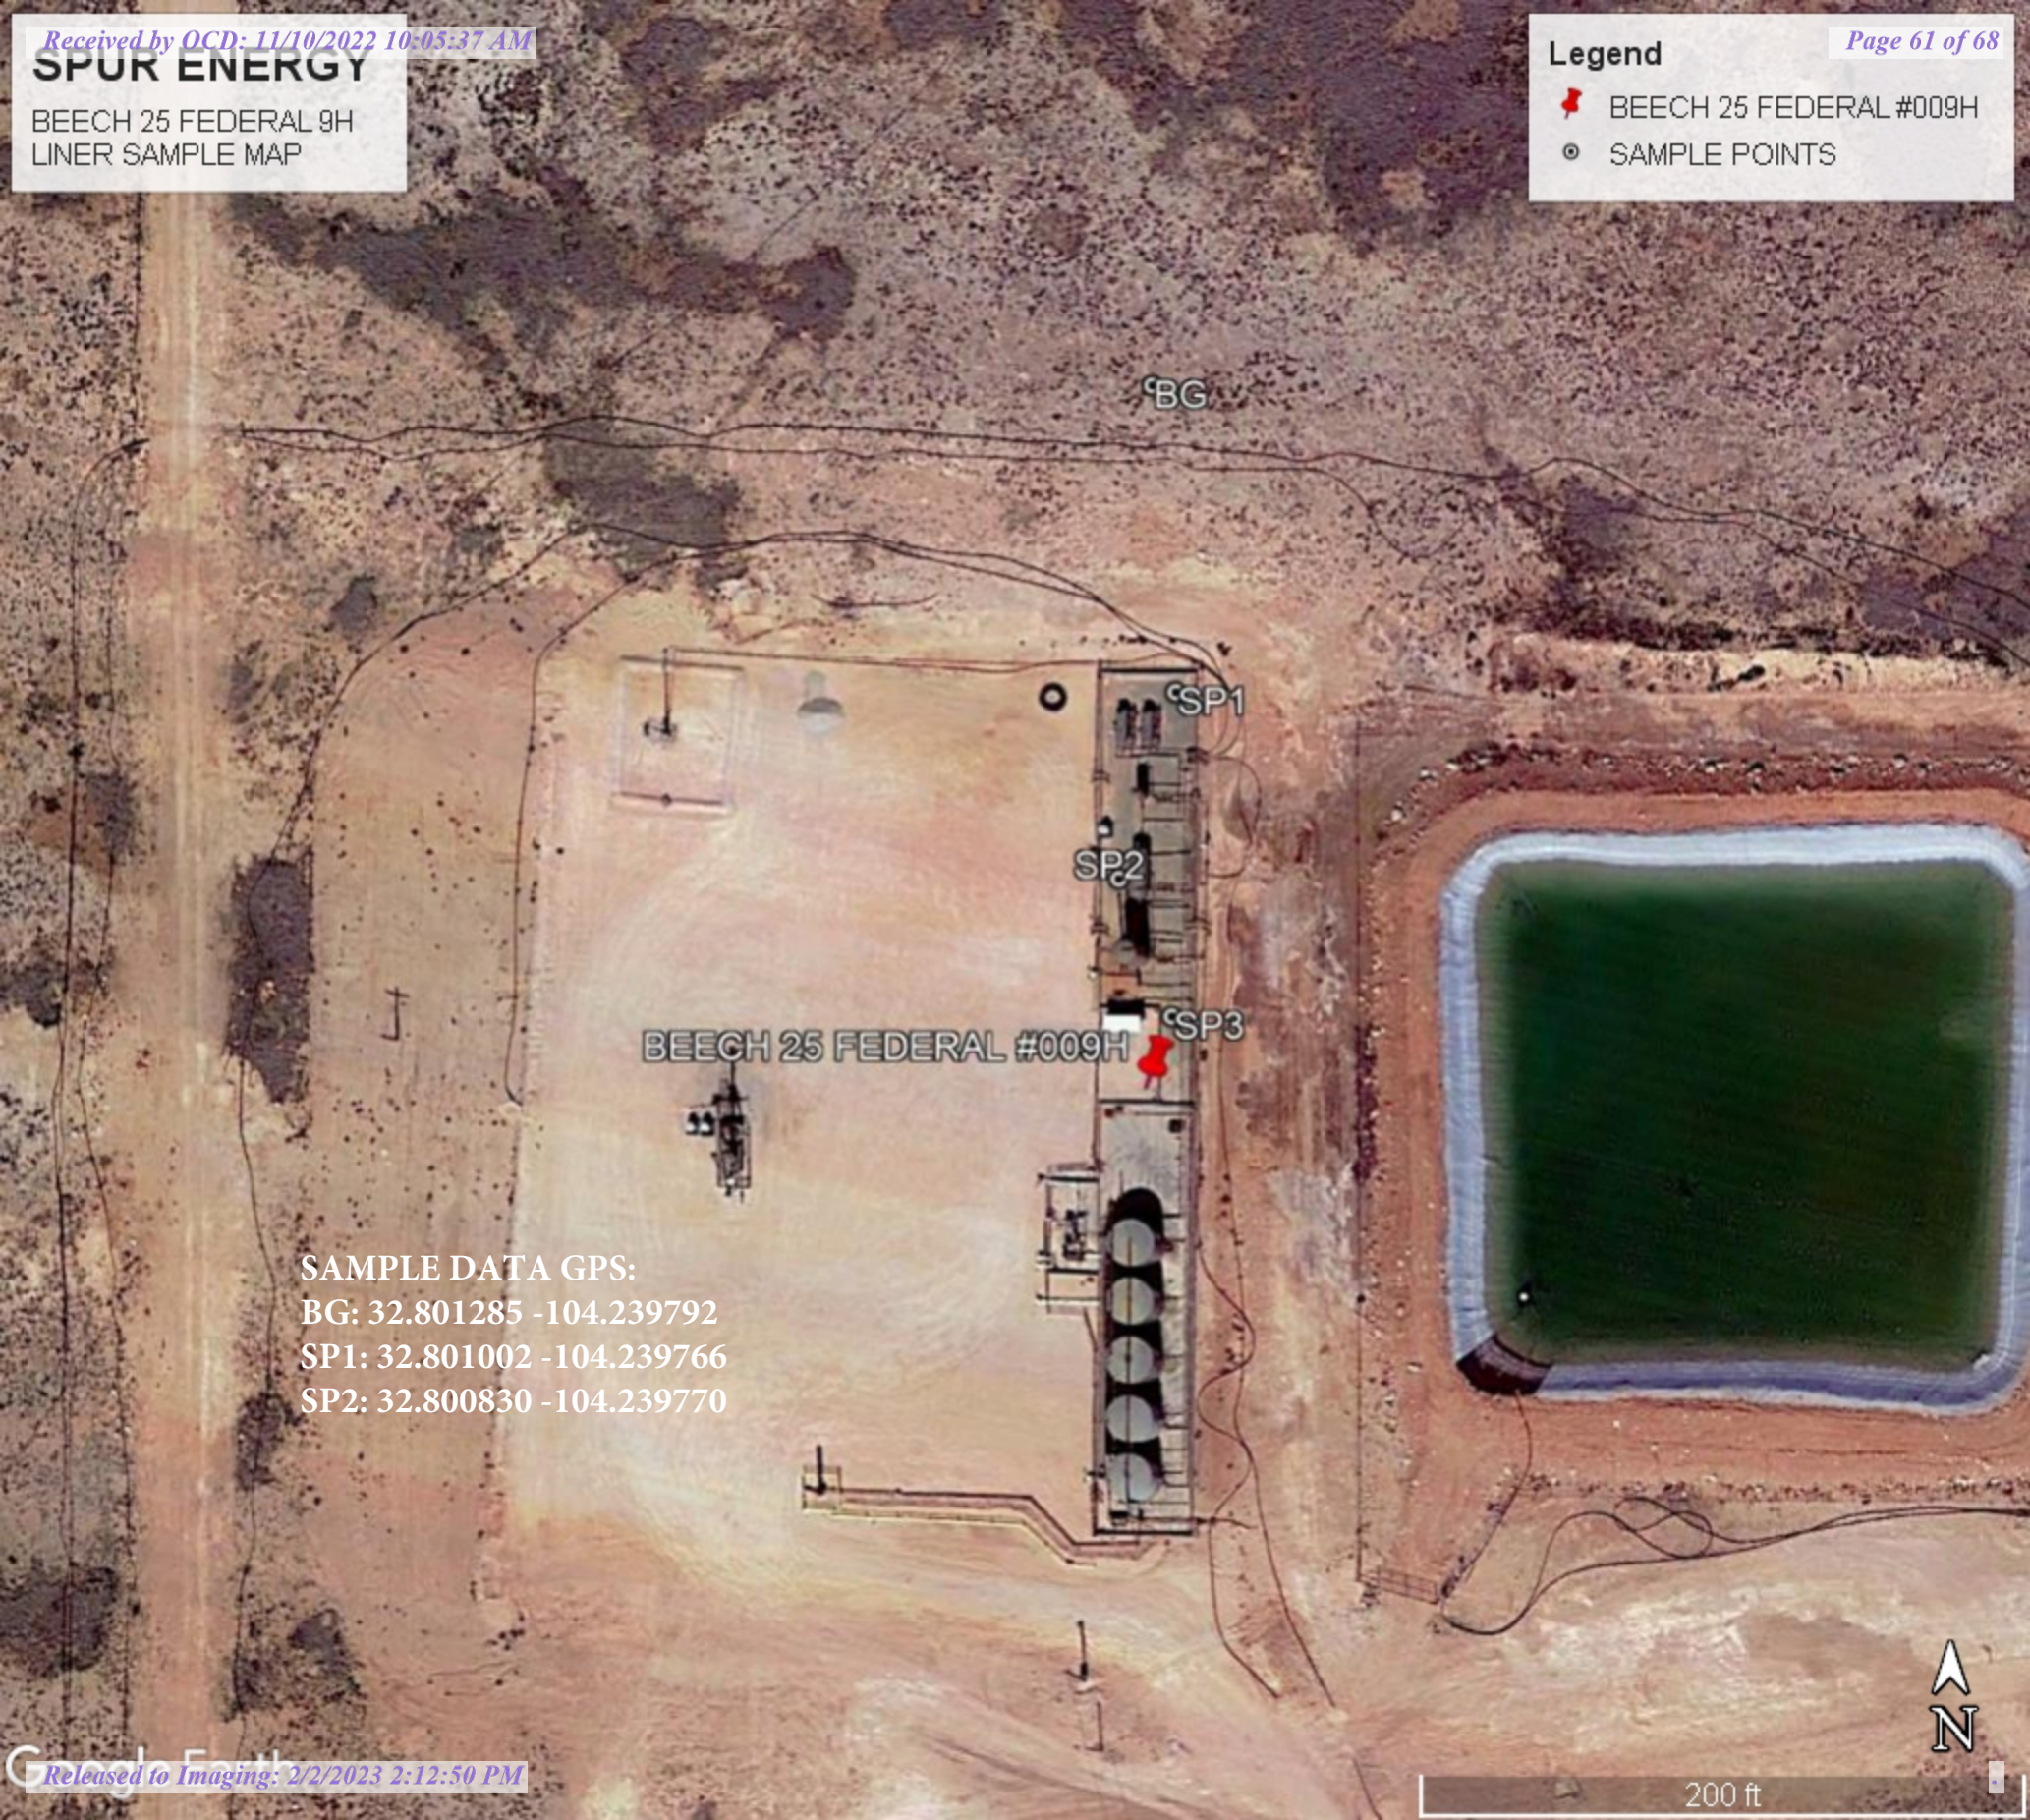
BEECH 25 FEDERAL 9H
LINER SAMPLE MAP

A background sample was taken and no natural contaminants were found outside the facility area. Then three sample points were selected where the most prominent issues were found in the liner during the liner inspection. Each sample point was hand augured to 3'bgs and no contaminants were located. Each sample was field tested for chlorides by use of a titration kit in 1' intervals and TPH was tested by use of a PID Meter. Each bottom hole sample was jarred and delivered to Envirotech Laboratories for confirmation.

A Geo 700 Series Trimble, a global positioning system (GPS) was used to map the approximate center of each sample point that was obtained. Please refer to the Sample Map with GPS, that is attached herein.

BEECH IMPACT AREA 1744 SQ. FT.

After the sampling was completed, the areas that were sampled were then patched, primed and sprayed to ensure the integrity of the liner.
