M&M Excavating, Inc. (MMX) has prepared this Remediation Closure Report for Devon Energy Production Company that describes the site characterization and remediation of the fire associated with 1RP-5176 at the Thistle Unit #118H site. The site is in Unit N, Section 34, Township 23S, Range 33E, Latitude 32.2556006, Longitude - 103.5616293, Lea County, New Mexico, on State land. Figure 1 provides the vicinity and site location on an USGS 7.5-minute quadrangle map.

Release Information and Closure Criteria			
Name	Thistle Unit #118H		
API Number	30-025-43451		
Incident Number	1RP-5176		
Source of Release	Fire/Compressor		
Released Material	N/A	Released Volume	0 BBLS
Recovered Volume	0 BBLS	Net Release	0 BBLS
NMOCD Closure Criteria	>51 but < 100 feet to groundwater

Site & Sample Locations
 Thistle Unit #118H - Devon Energy
 Sec. 33 T23S R33E, Lea County, NM

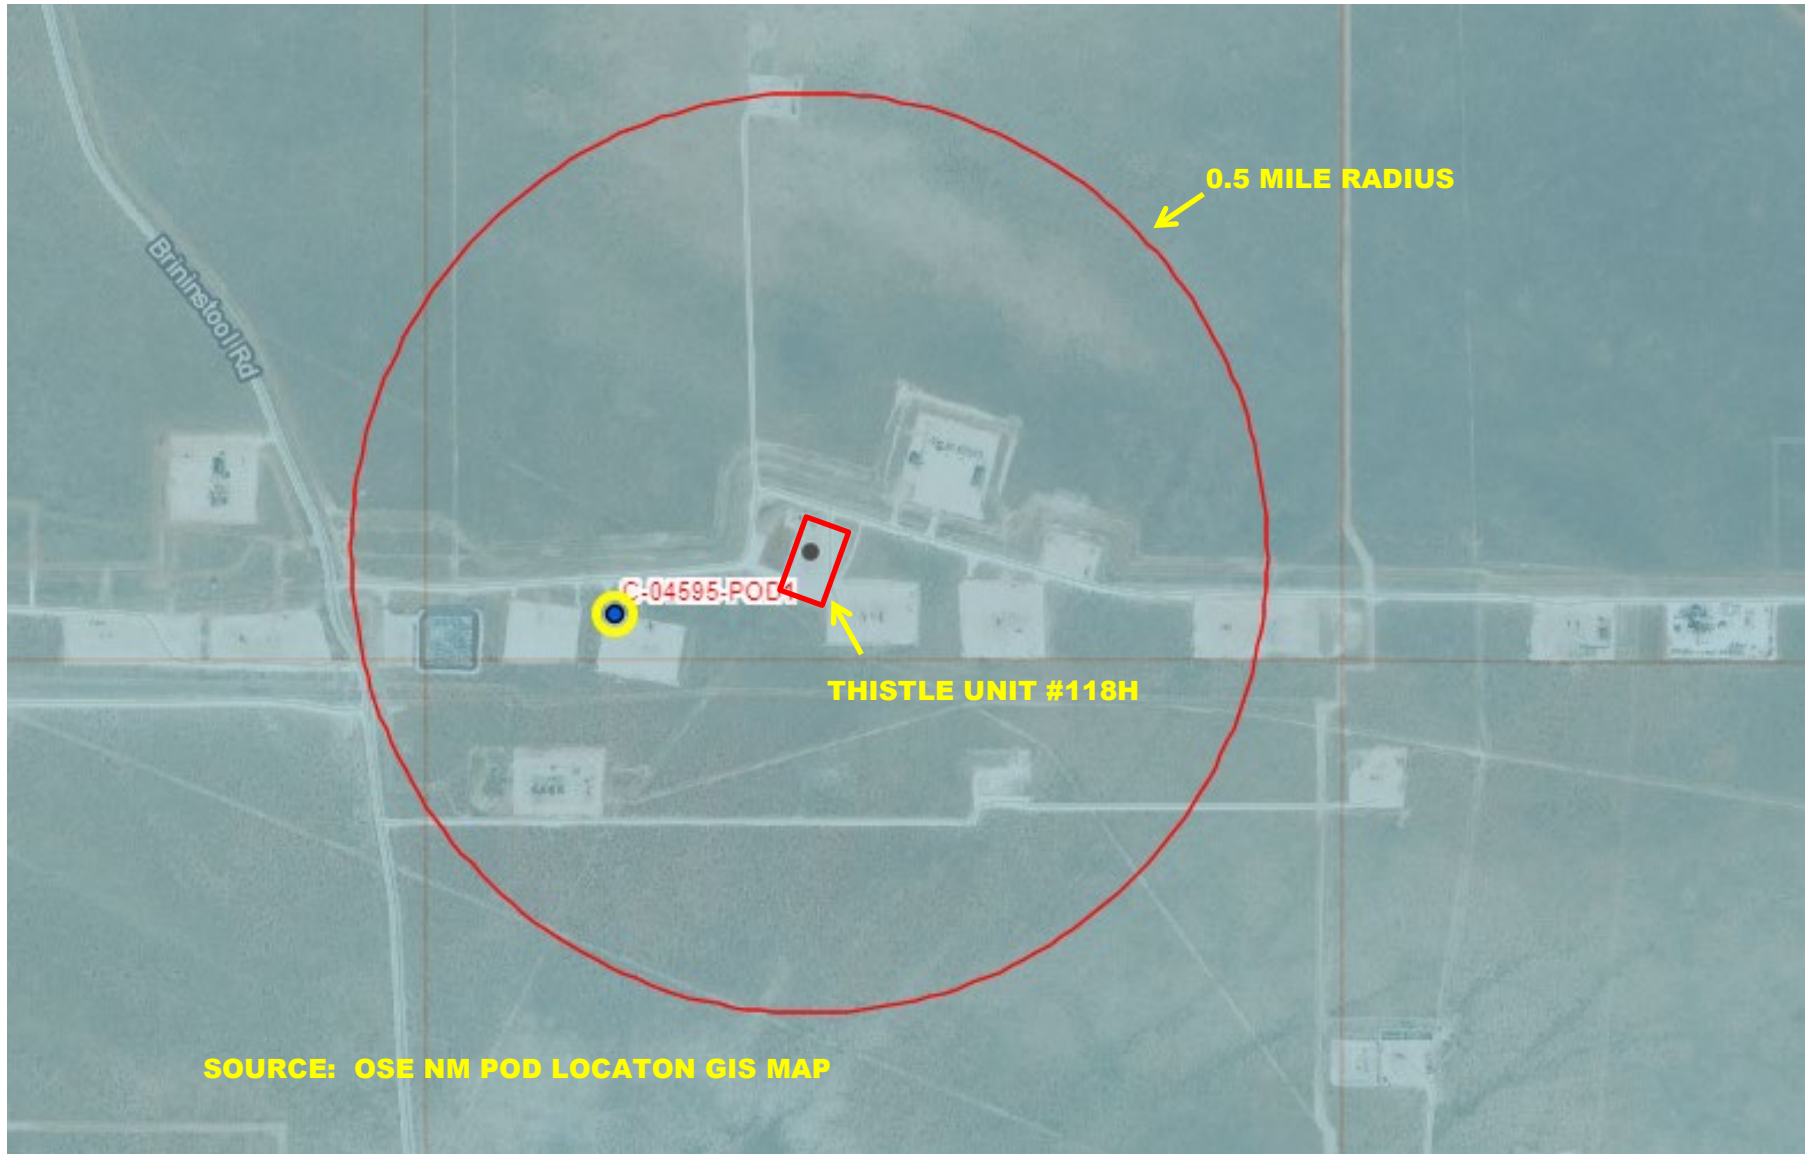
FIGURE 1: NM OSE POD LOCATIONS	
THISTLE UNIT 118H	
32.2556006,-103.5616293	
OCD INCIDENT nCH1823935024	
drawn by: RDW	Date: 12/2022

Based upon well water data. (Appendix B), depth to groundwater in the area is estimated to be between > 51 feet below grade surface (bgs). 12/7/2022 Edit: There is one well within 0.5 miles of the location, C-0495 POD1, according to the New Mexico Office of the State Engineer (NMOSE) and USGS. The nearest significant watercourse is an unnamed pond located approximately 5975 feet to the southwest.

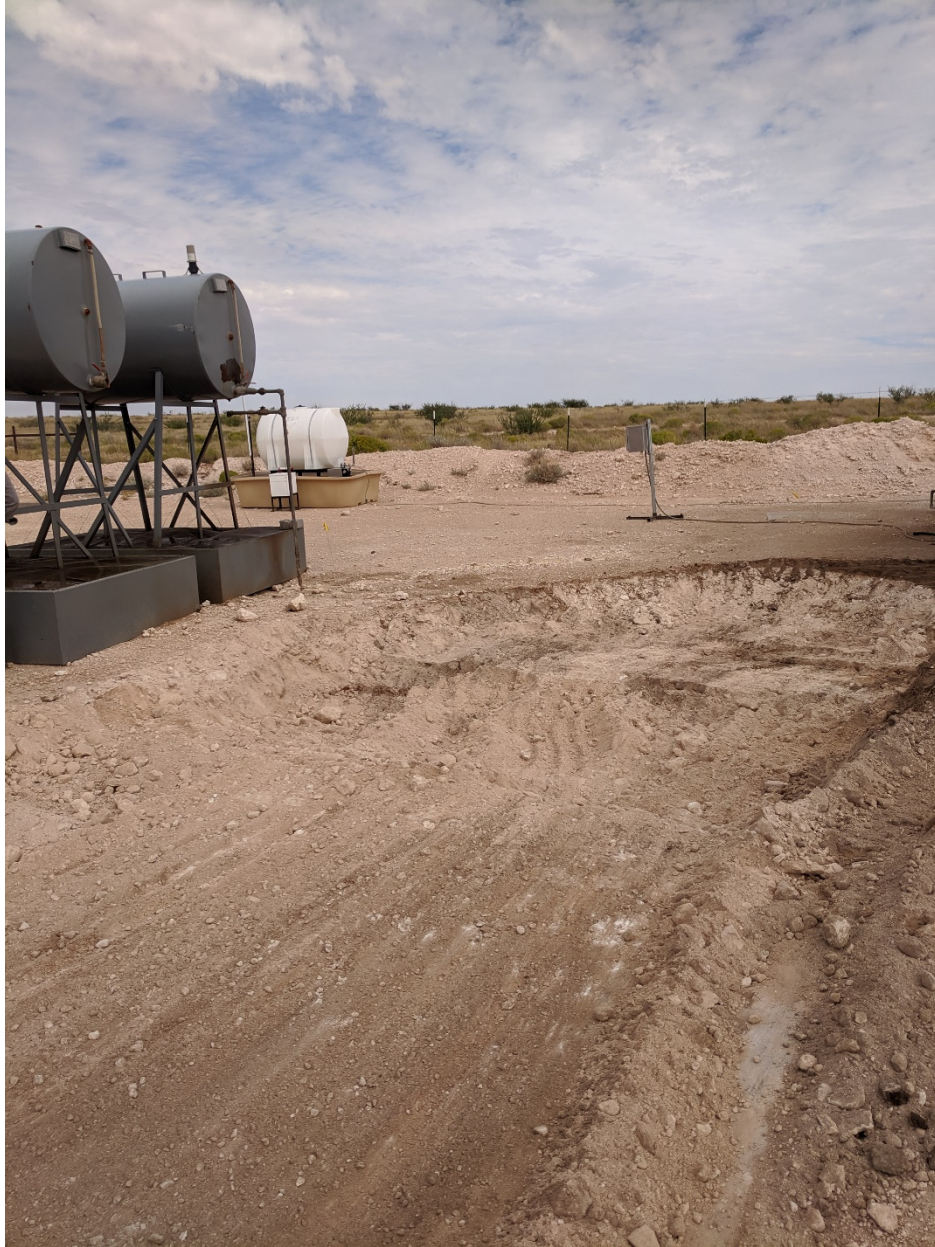
Appendix D Excavation Photo

Contaminated soils were removed and replaced with clean backfill material to return the surface to previous contours. The contaminated soil was transported and disposed of at an NMOCD permitted disposal facility. A photo of the excavation prior to backfill is included in Appendix D.
