Subject: **Birdseye 32 State #001H Release  
Unit Letter O, Section 32, Township 19 South, Range 31 East  
Eddy County, New Mexico  
Incident ID nAB1711829670  
2RP-4189**

# Birdseye 32 State #001H

**REMEDIATION WORK PLAN**

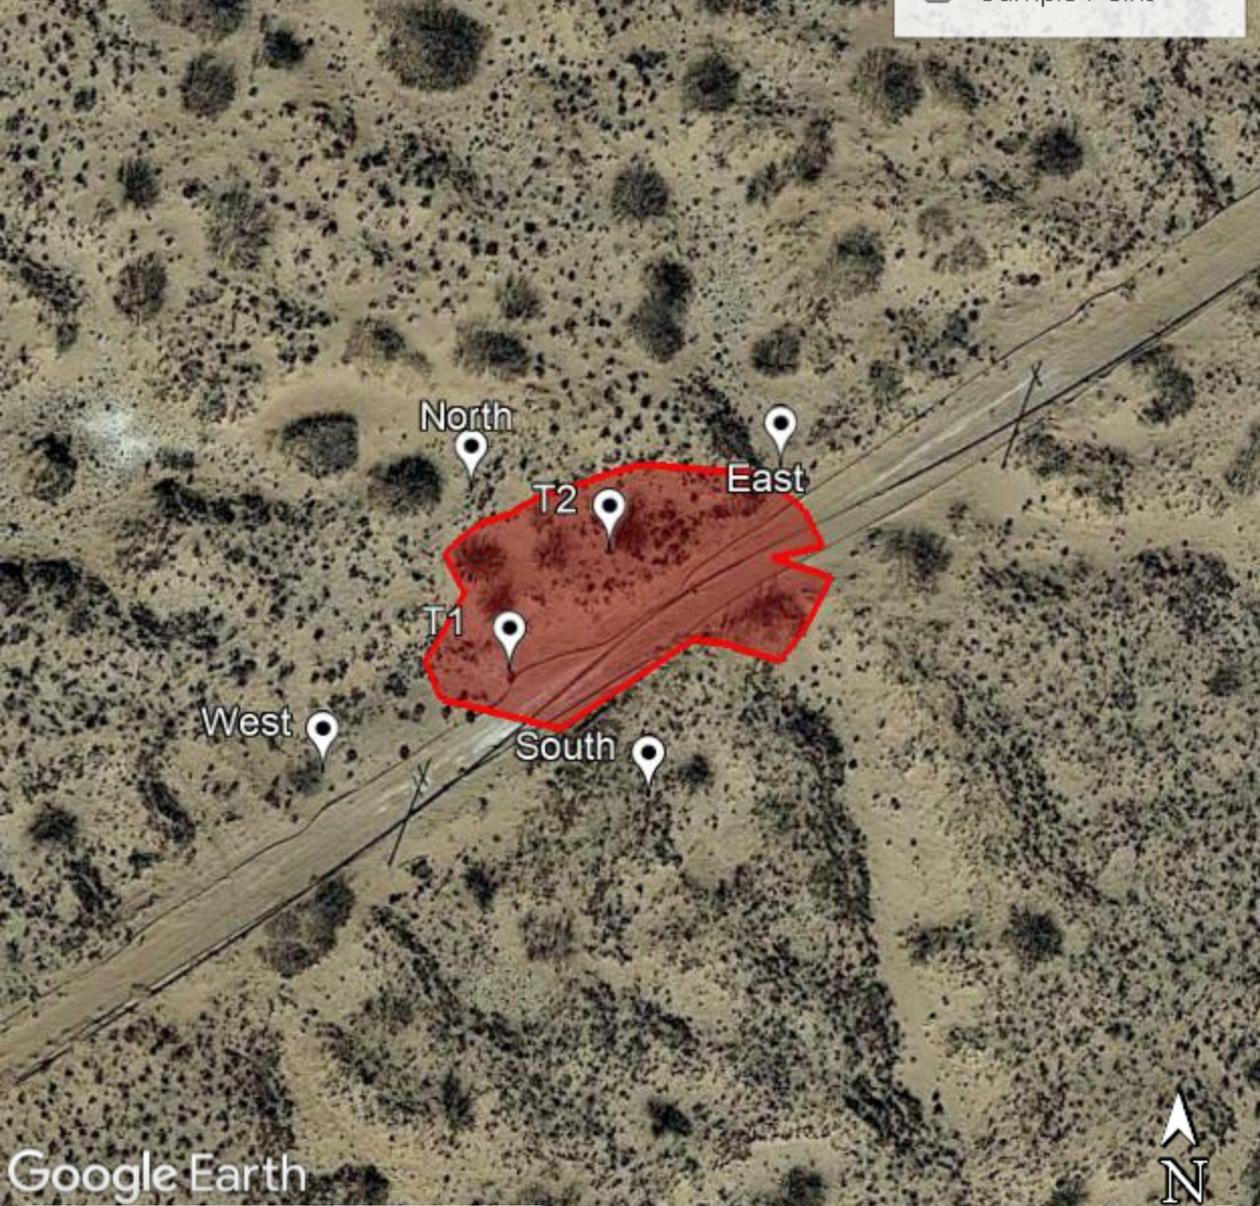
Figure 3

Sample Point

Based upon the data collected and the work completed by COG and ASSI, the constituent of concern (COC) has been vertically delineated at both sample locations. Furthermore, laboratory analysis shows that TPH and BTEX concentrations are below the NMOCD clean-up goals.

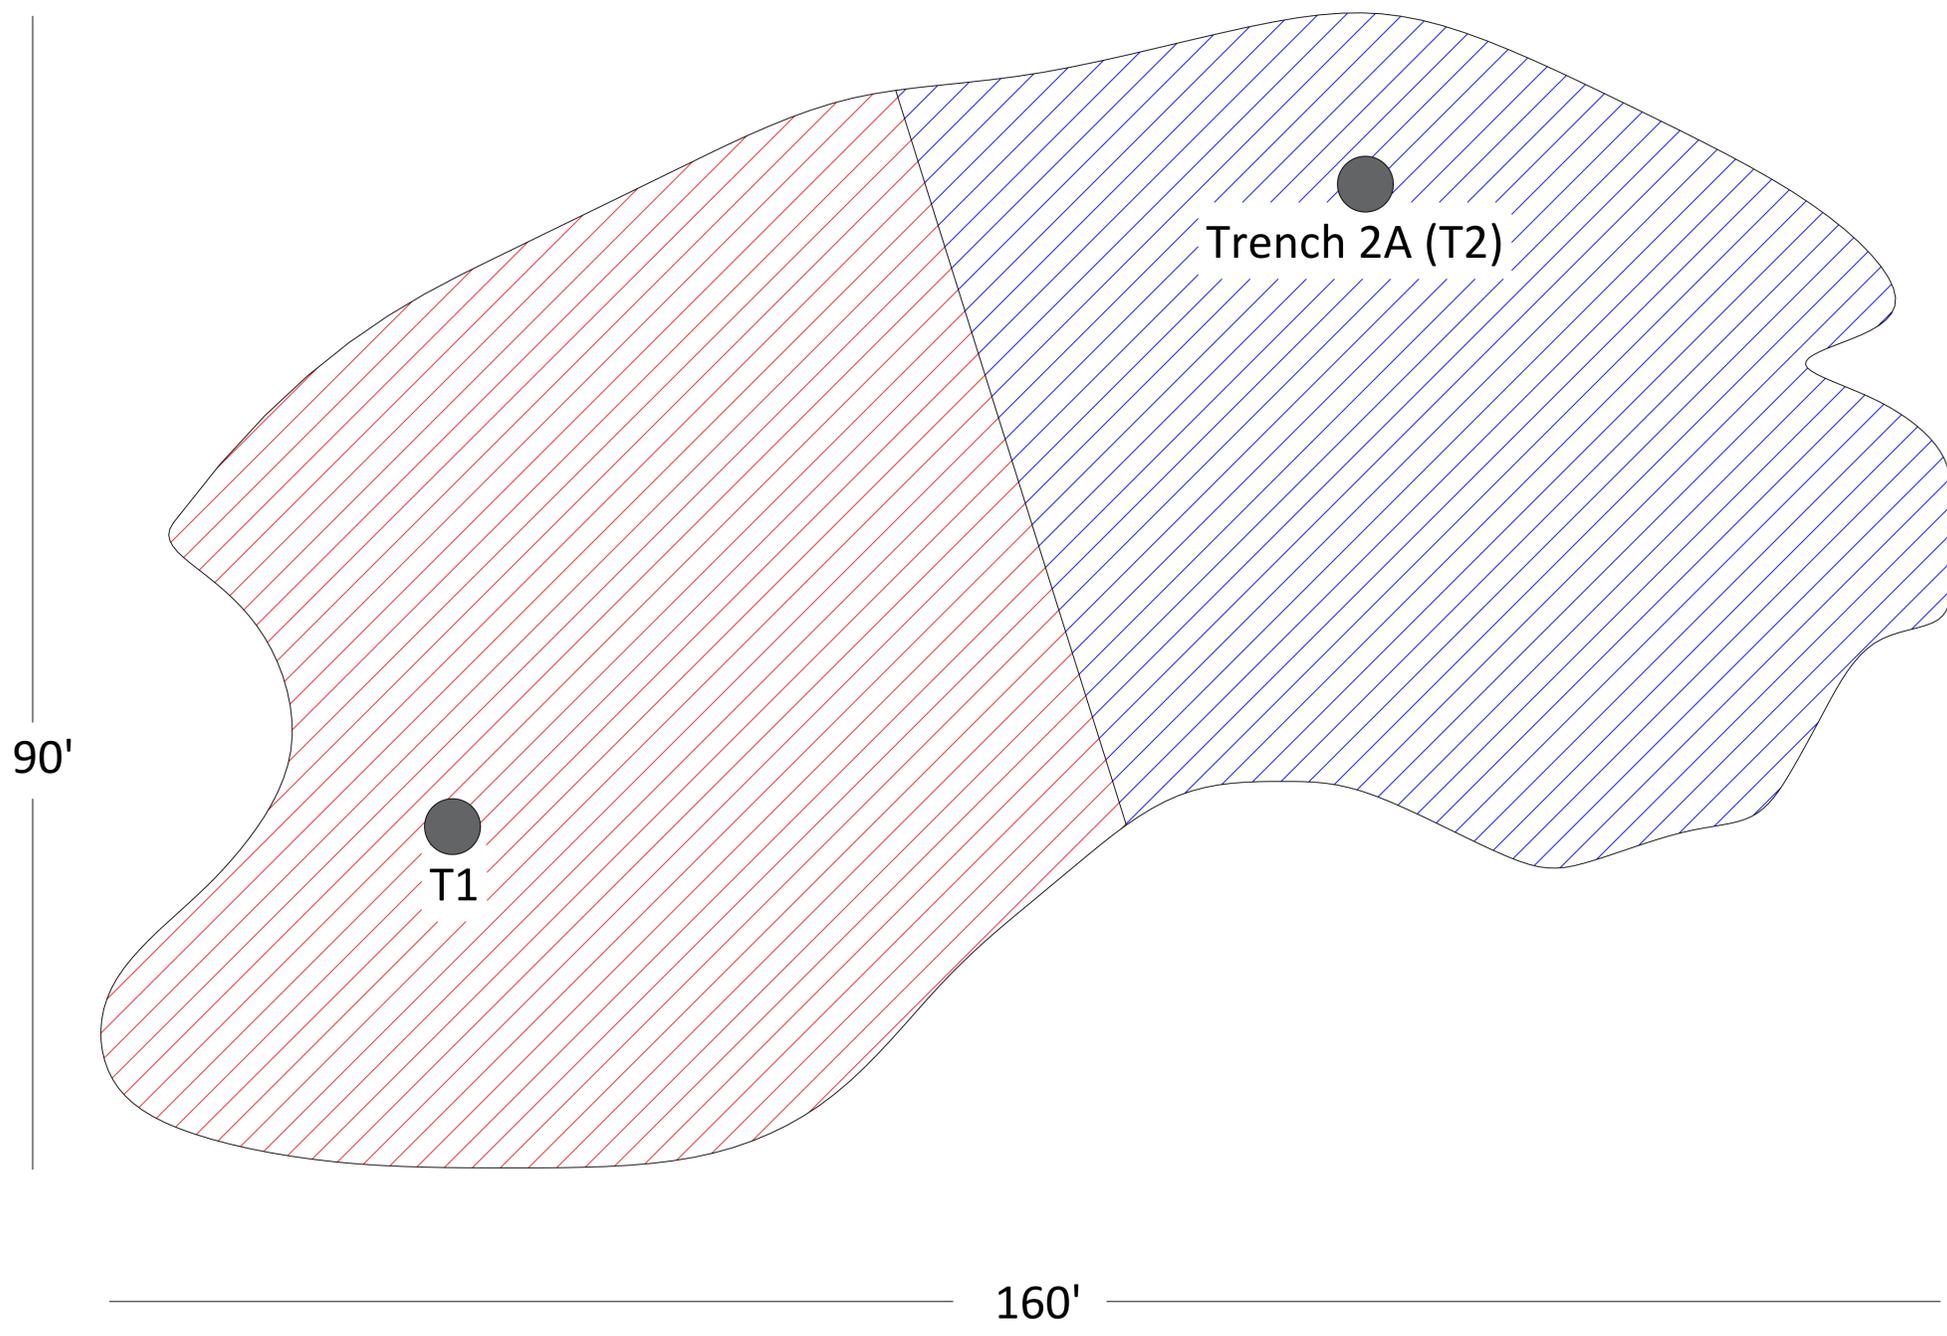
**FIGURE 4**  
**Proposed Excavation**  
**Depths**

Based on the analytical data presented in Table 1, COG and ASSI propose to complete a removal action of the impacted material. The area adjacent to and around T1 will be excavated to a depth of approximately four (4) feet bgs and have a 20 mil liner installed at the bottom of the excavated area. The area adjacent to and around Trench 2 (T2) will be excavated to a depth of approximately two (2) feet bgs (Figure 4). All material will be removed by mechanical means, be temporarily stockpiled onsite and subsequently removed (hauled away) offsite to a proper disposal facility under appropriate manifest. The excavated areas will be backfilled to grade with clean imported material and the surface grade contoured to the surrounding landscape.
