Subject: **Canvasback 13 Federal #002H Release  
Unit Letter A, Section 13, Township 24 South, Range 31 East  
Eddy County, New Mexico  
Incident ID nAB1721951563  
2RP-4324**

## REMEDIATION SUMMARY AND SOIL CLOSURE REQUEST

**COG Operating, LLC**  
**Canvasback 13 Federal #002H**  
**Eddy County, New Mexico**  
**Unit Letter "A", Section 13, Township 24 South, Range 31**  
**East Latitude 32.222781° North, Longitude 103.723086° West**  
**NMOCD Reference No. 2RP-4324**

**May 2018**

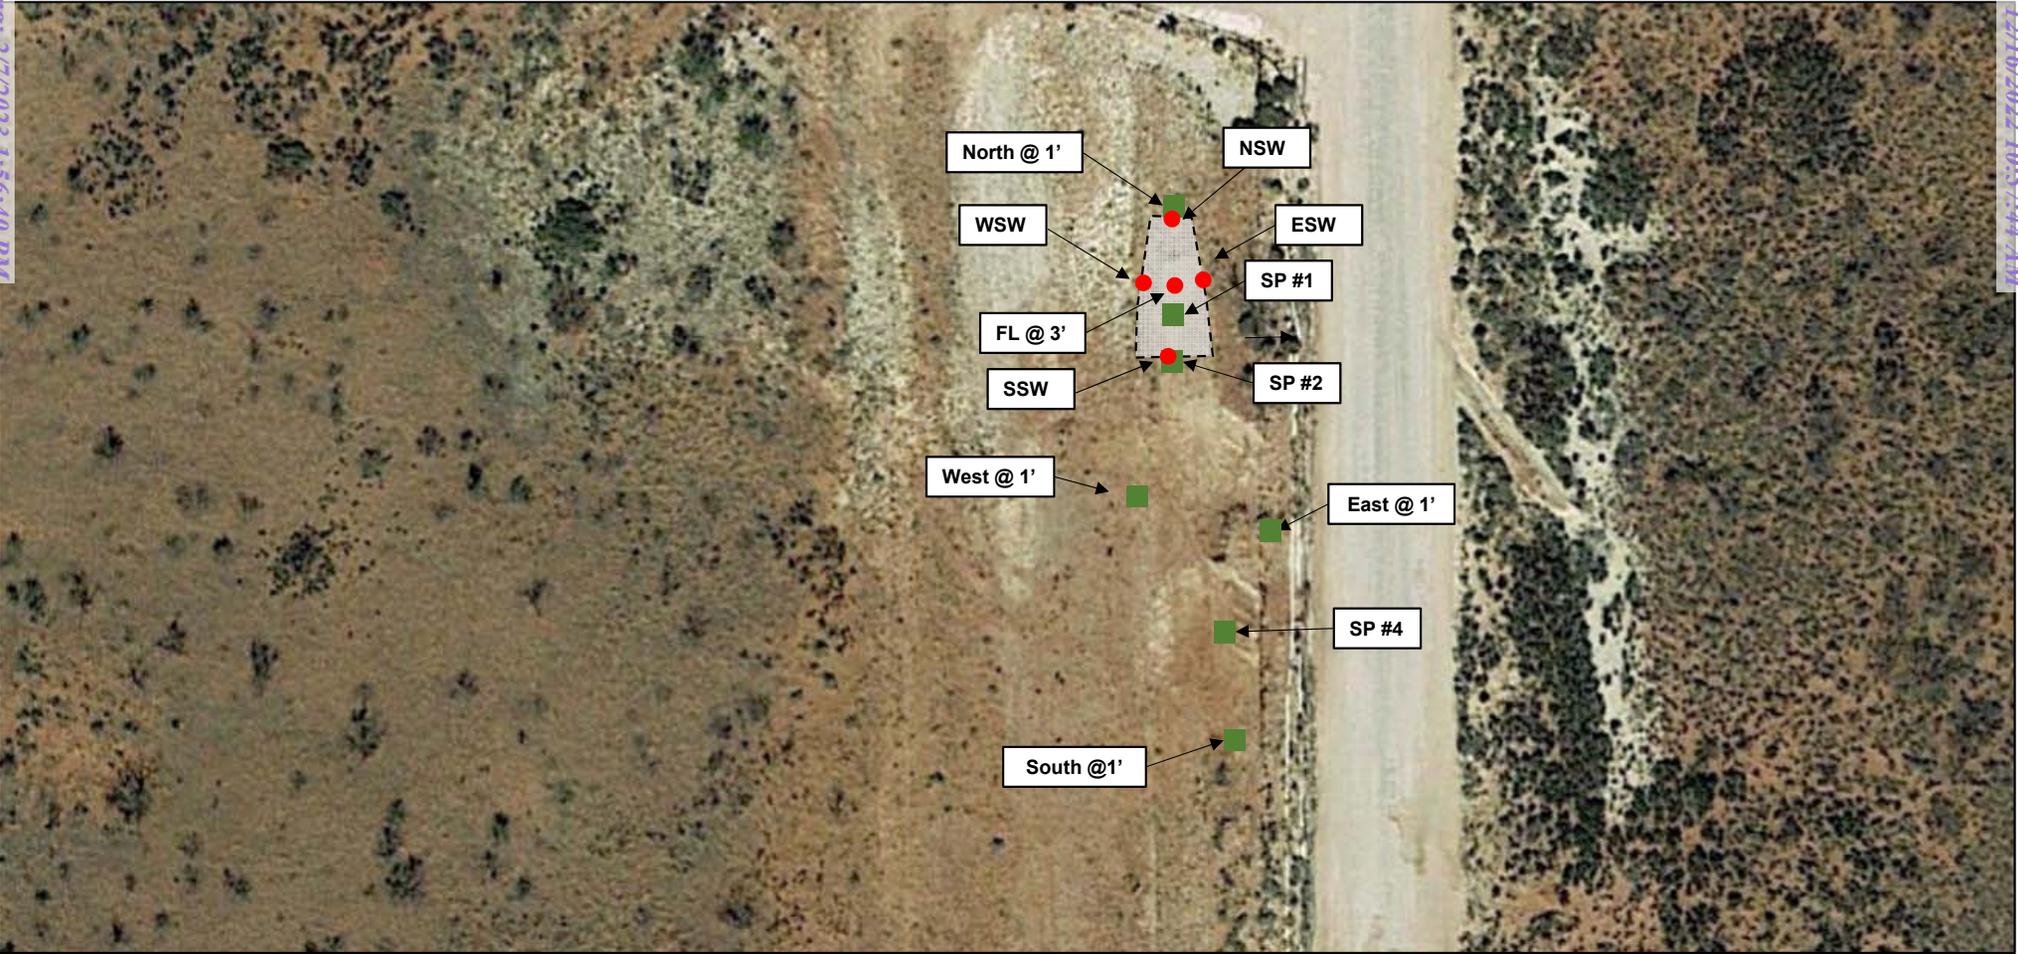
Figure 2  
 Site & Sample Location Map  
 COG Operating, LLC  
 Canvasback 13 Federal #002H  
 Eddy County, New Mexico

On January 19, 2018, TRC revisited the site in an effort to determine the extent soil was affected above the NMOCD RRAL for chloride. During the site visit, a series of investigated hand-augered soil bores were advanced within the release margins. During the advancement of the investigative hand-augered soil bores, soil samples were collected and field screened for concentrations of chloride. Chloride field screen results indicated soil samples collected from one soil bore (SP-1) exhibited chloride concentrations above the NMOCD RRAL. Based on chloride field screen results, three (3) soil samples (SP-1 @ 1’, SP-1 @ 2’, and SP-1 @ 3’) were submitted to the laboratory for analysis of chloride concentrations. Laboratory analytical results indicated chloride concentrations ranged from 1,330 mg/kg in soil sample SP-1 @ 2’ to 153 mg/kg in soil sample SP-1 @ 3’. Chloride concentrations were below the NMOCD RRAL in each of the submitted soil samples, with the exception of soil samples SP-1 @ 1’ (603 mg/kg) and SP-1 @ 2’ (1,330 mg/kg).

**LEGEND:** ■ Initial Investigation Sample Location  
 ● Horizontal Delineation Sample Location  
 - - - Excavated Area

On April 3, 2018, remediation activities commenced at the Release Site. Impacted soil within the release margins in the area represented by sample point SP-1 was excavated and transported to an NMOCD-permitted facility for disposal. The floor and sidewalls of the excavated area were advanced until chloride field test results indicated chloride concentrations were below the NMOCD RRAL.

On April 4, 2018, TRC collected five (5) excavation confirmation soil samples (FL @ 3’, ESW, WSW, SSW and NSW) from the floor and sidewalls of the excavated area. The collected soil samples were submitted to the laboratory for analysis of BTEX, TPH and chloride concentrations. Laboratory analytical results indicated BTEX and TPH concentrations were less than the applicable laboratory RL in each of the submitted soil samples. Analytical results indicated chloride concentrations ranged from 249 mg/kg in soil sample NSW to less than the applicable laboratory RL in soil sample NSW. BTEX, TPH and chloride concentrations were below the NMOCD RRAL in each of the submitted soil samples. Upon collecting the required confirmation soil samples, the excavated area was backfilled with locally-sourced, non-impacted material. Prior to backfilling, the final dimensions of the excavated area were approximately thirty-five (35) ft. in length, ten (10) ft. to twenty (20) ft. in width and three (3) ft. in depth

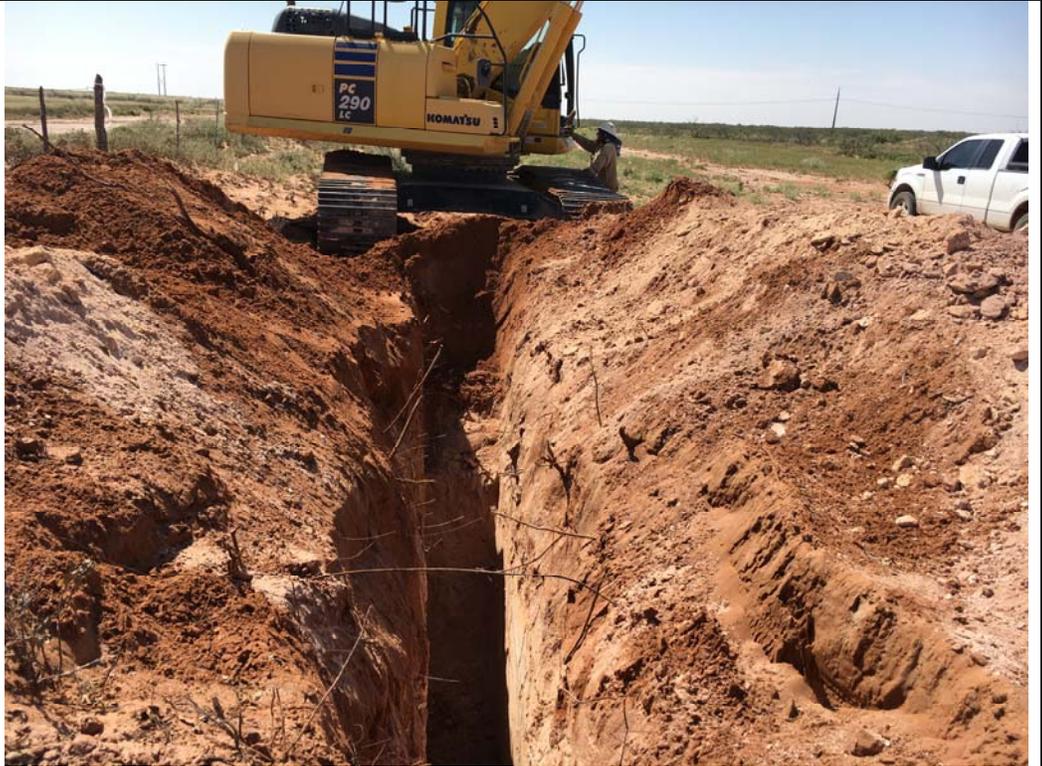
**Description:**  
View of delineation activities.

**Direction:**  
South

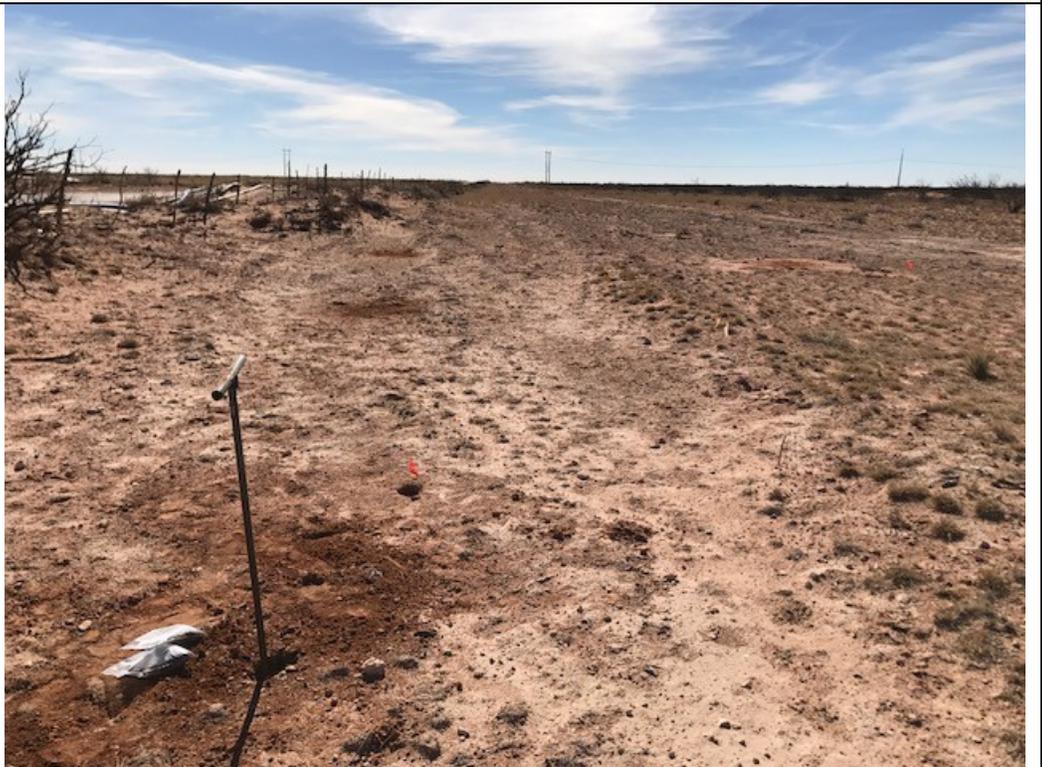
**Photograph No. 4**

**Description:**  
View of delineation activities.

**Direction:**  
South

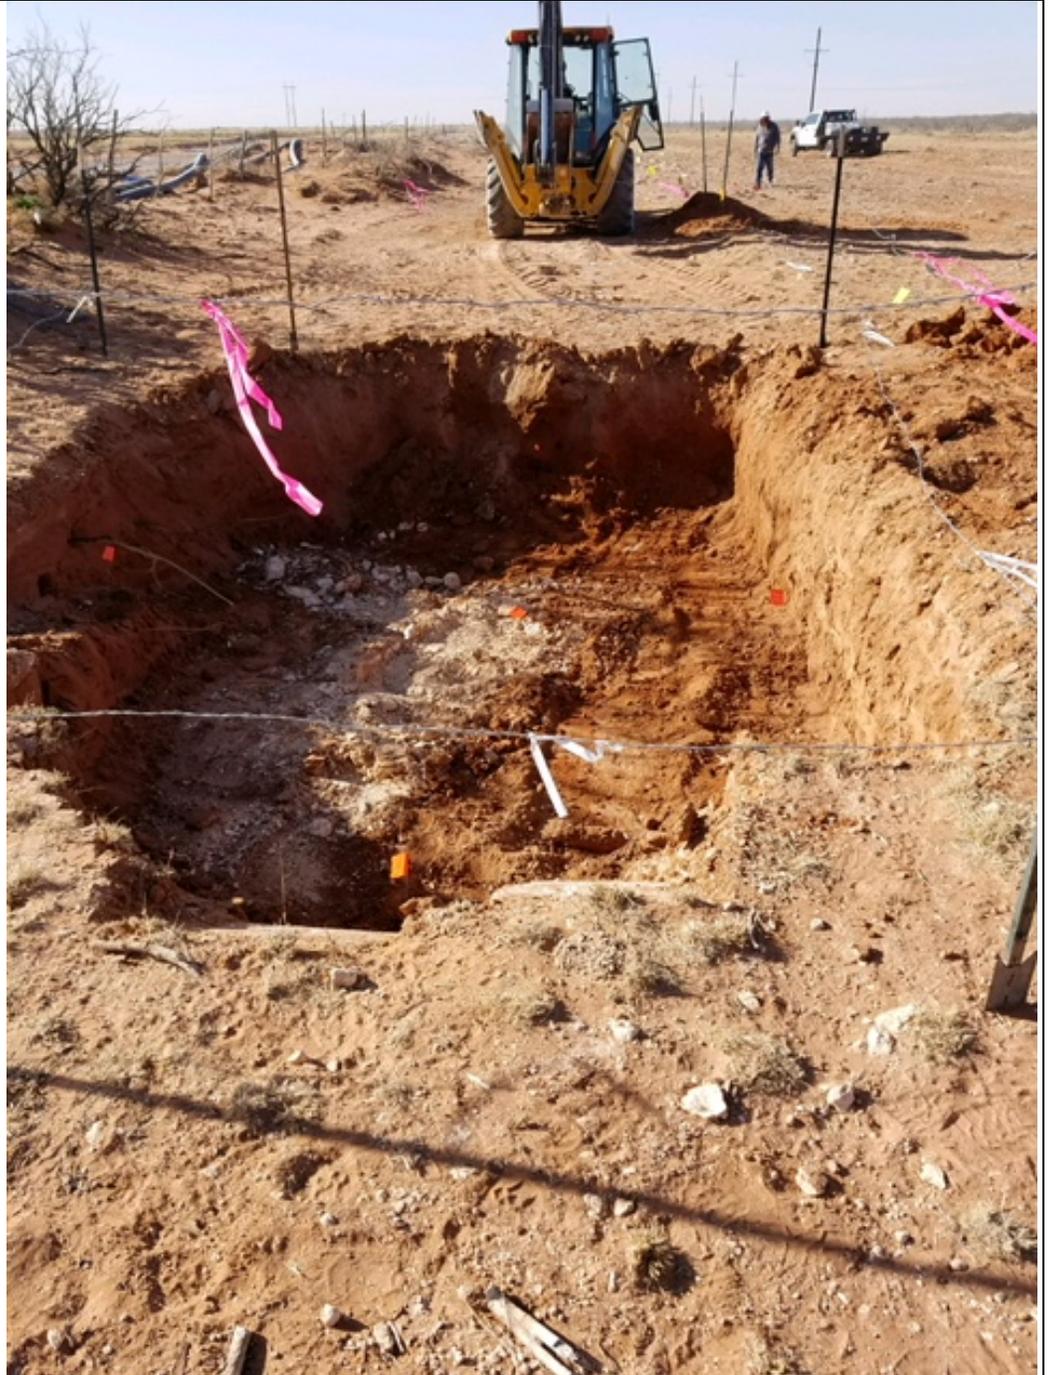
**Description:**  
View of portion of the excavated area.

**Direction:**  
South

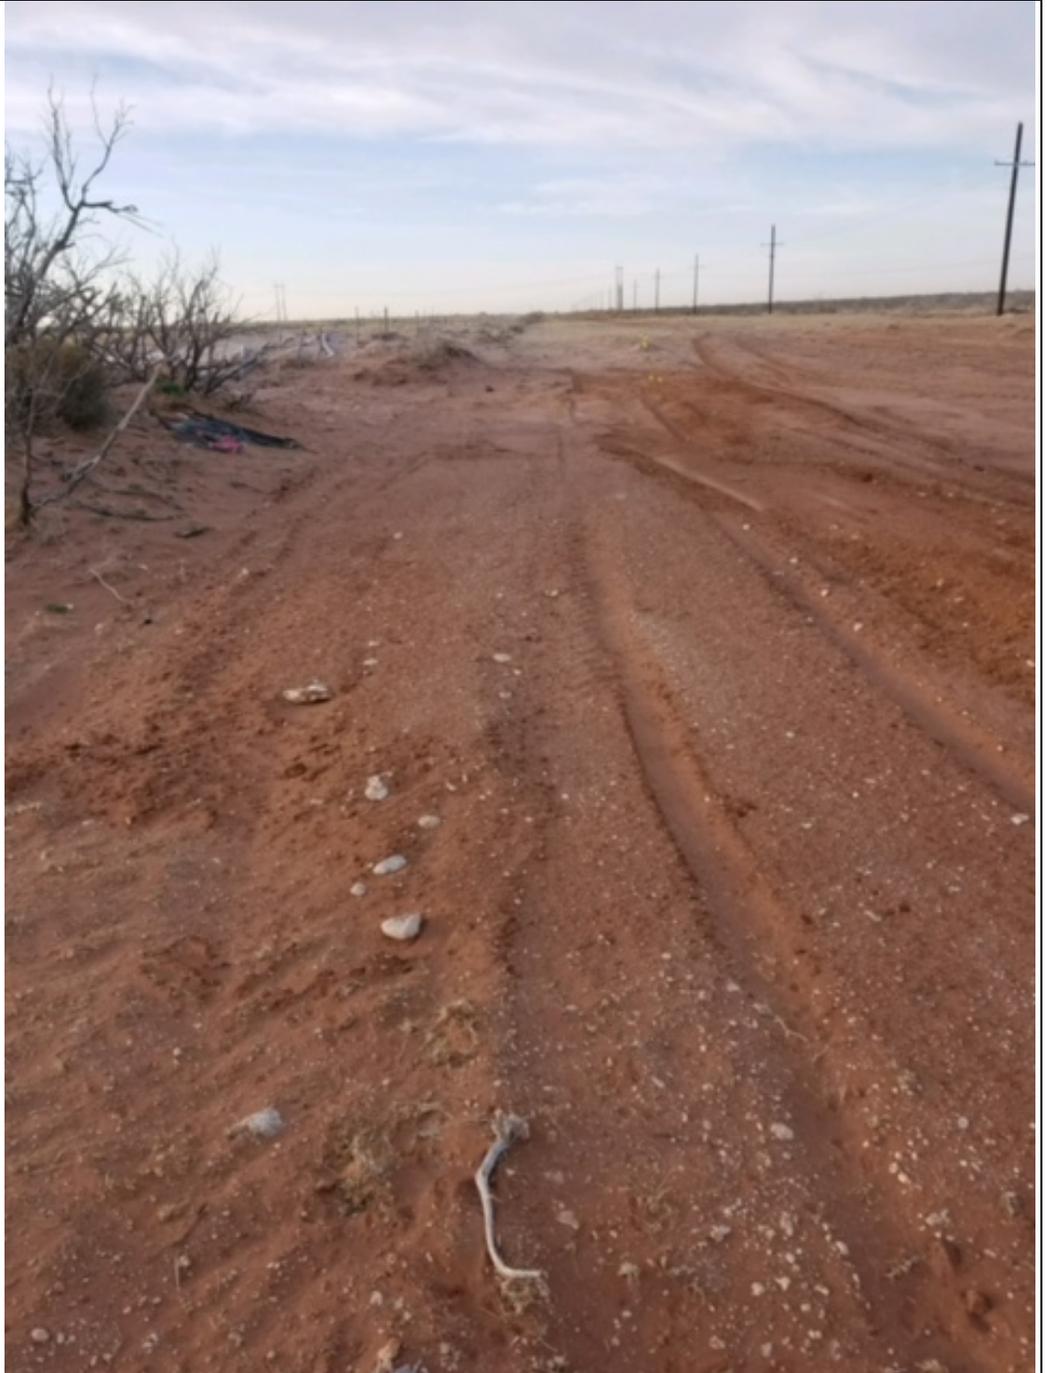
**Description:**  
View of the affected area after remediation activities.

**Direction:**  
South

Laboratory analytical results from confirmation soil samples collected from the floor and sidewalls of the excavated areas indicated benzene, BTEX, TPH and/or chloride concentrations were below the NMOCD RRAL in each of the submitted soil samples. Upon collecting the required excavation confirmation soil samples, the excavated area was backfilled with locally-sourced, non-impacted material. Based on laboratory analytical results and field activities conducted to date, TRC recommends COG provide copies of this *Remediation Summary and Soil Closure Request* to the NMOCD and BLM and request closure status to the Canvasback 13 Federal #002H Site.
