## Remediation Summary & Soil Closure Request

**Contango Oil & Gas, Inc.**

**Kersey State Battery Historical**

**NMOCD Reference No. 2RP-2122/nJMW1335341610**

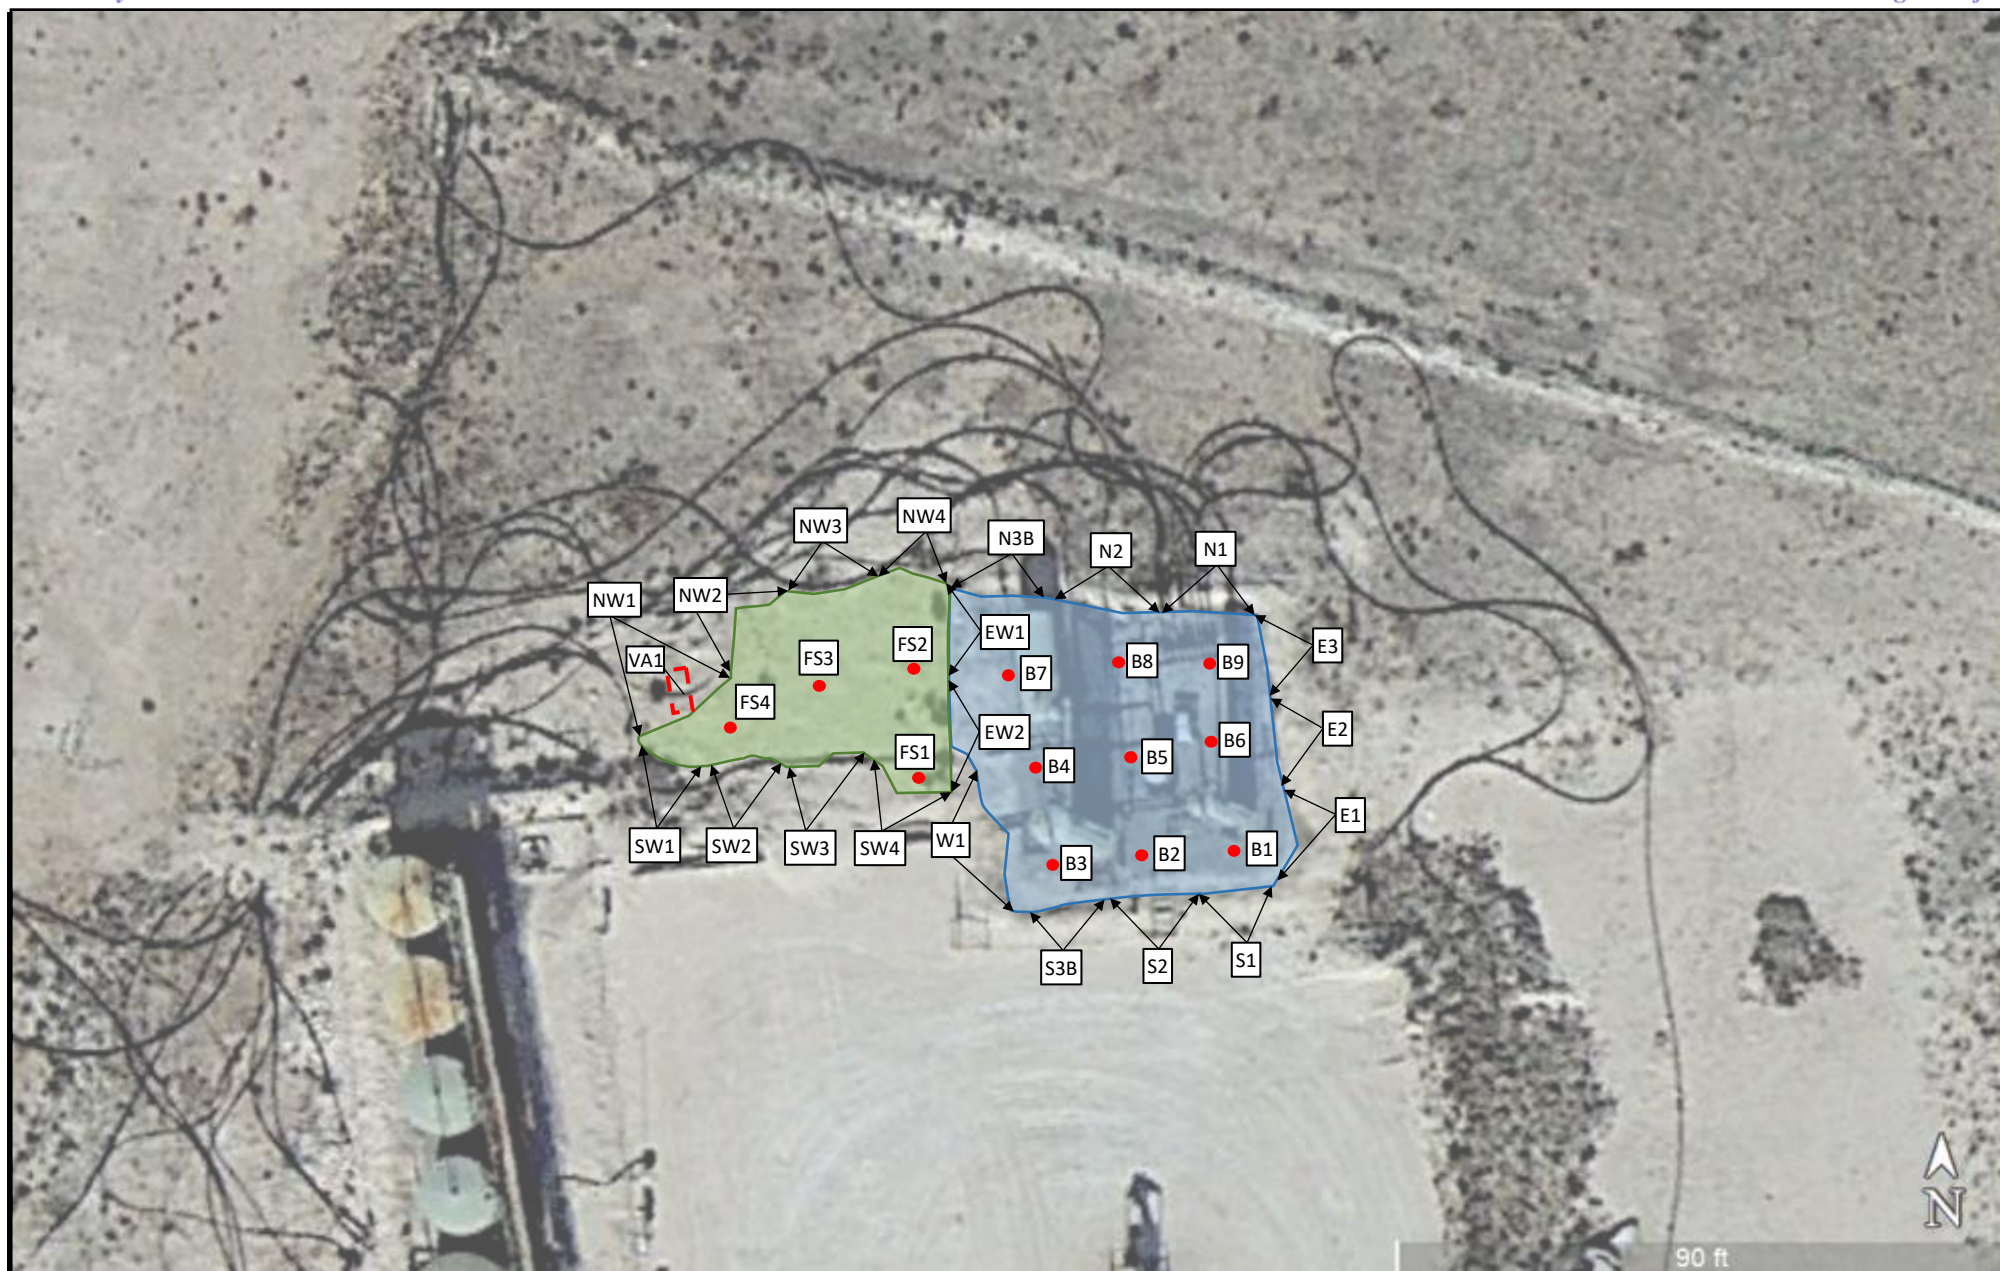
### **Figure 3**

## **Site & Sample Location Map**

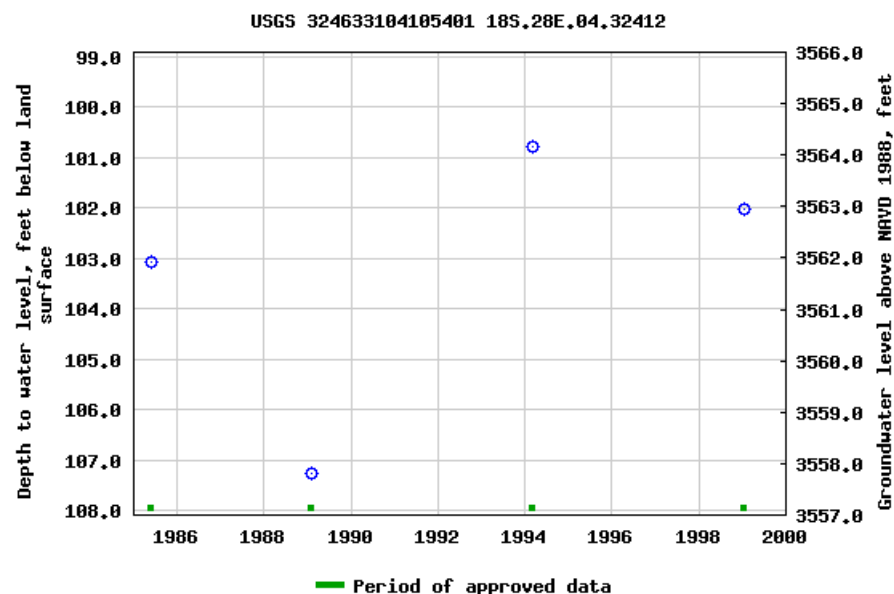
Breaks in the plot represent a gap of at least one year between field measurements.

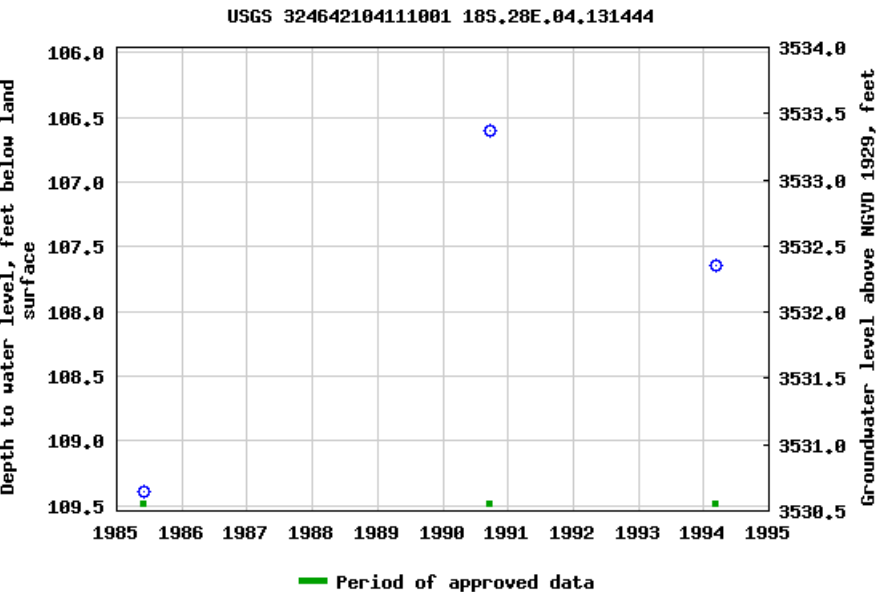
Eddy County, New Mexico  
Hydrologic Unit Code 13060011  
Latitude 32°46'42", Longitude 104°11'10" NAD27  
Land-surface elevation 3,640 feet above NGVD29  
The depth of the well is 145.00 feet below land surface.  
This well is completed in the Rustler Formation (312RSLR) local aquifer.

Breaks in the plot represent a gap of at least one year between field measurements.
