Site Assessment/Characterization

Closure

Re: Site Assessment, Remediation, and Closure Report
Bell Lake 24 CTB 3
API No. N/A
GPS: Latitude 32.2003159 Longitude -103.6269619
UL -- K, 24, T24S, R32E
Lea County, NM
NMOCD Ref. No. NAPP2201840215

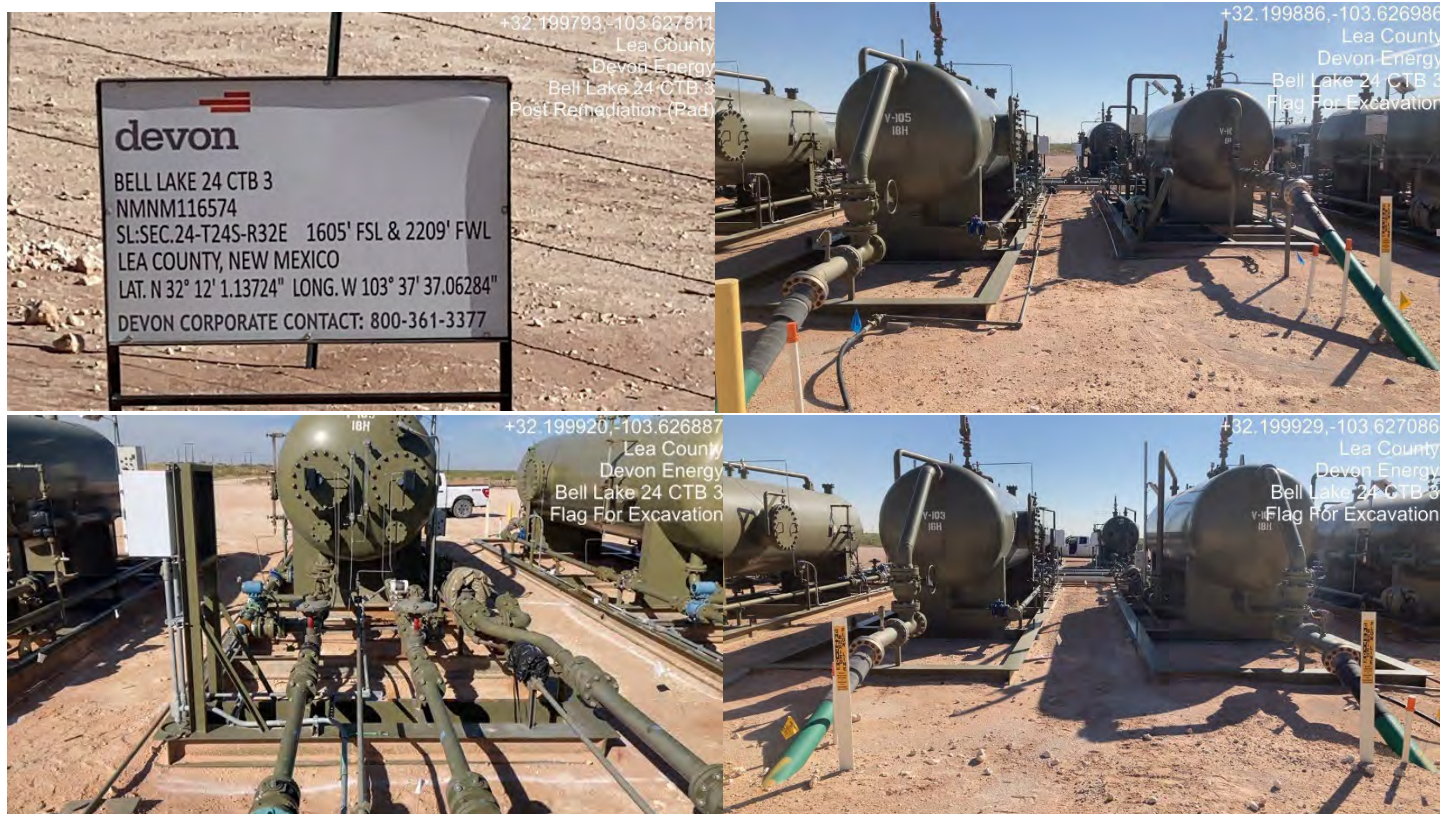
Before

BELL LAKE 24 CTB 3

Based on the sample results, the bottoms and sidewalls were below NMOCD Closure Criteria 19.15.29 NMAC. The contaminated material was sufficiently removed then transported to an NMOCD approved disposal site. The excavation was then backfilled with clean like material, machine compacted and returned to its previous state. See Appendix D for Photographic Documentation.
