**Devon Energy Production Company  
Lusitano 27-34 Fed Com 718H**

**Closure Report  
UL M, Section 15, T23S, R33E  
Eddy County, New Mexico**

**NOY1817145696**

**July 22, 2021**

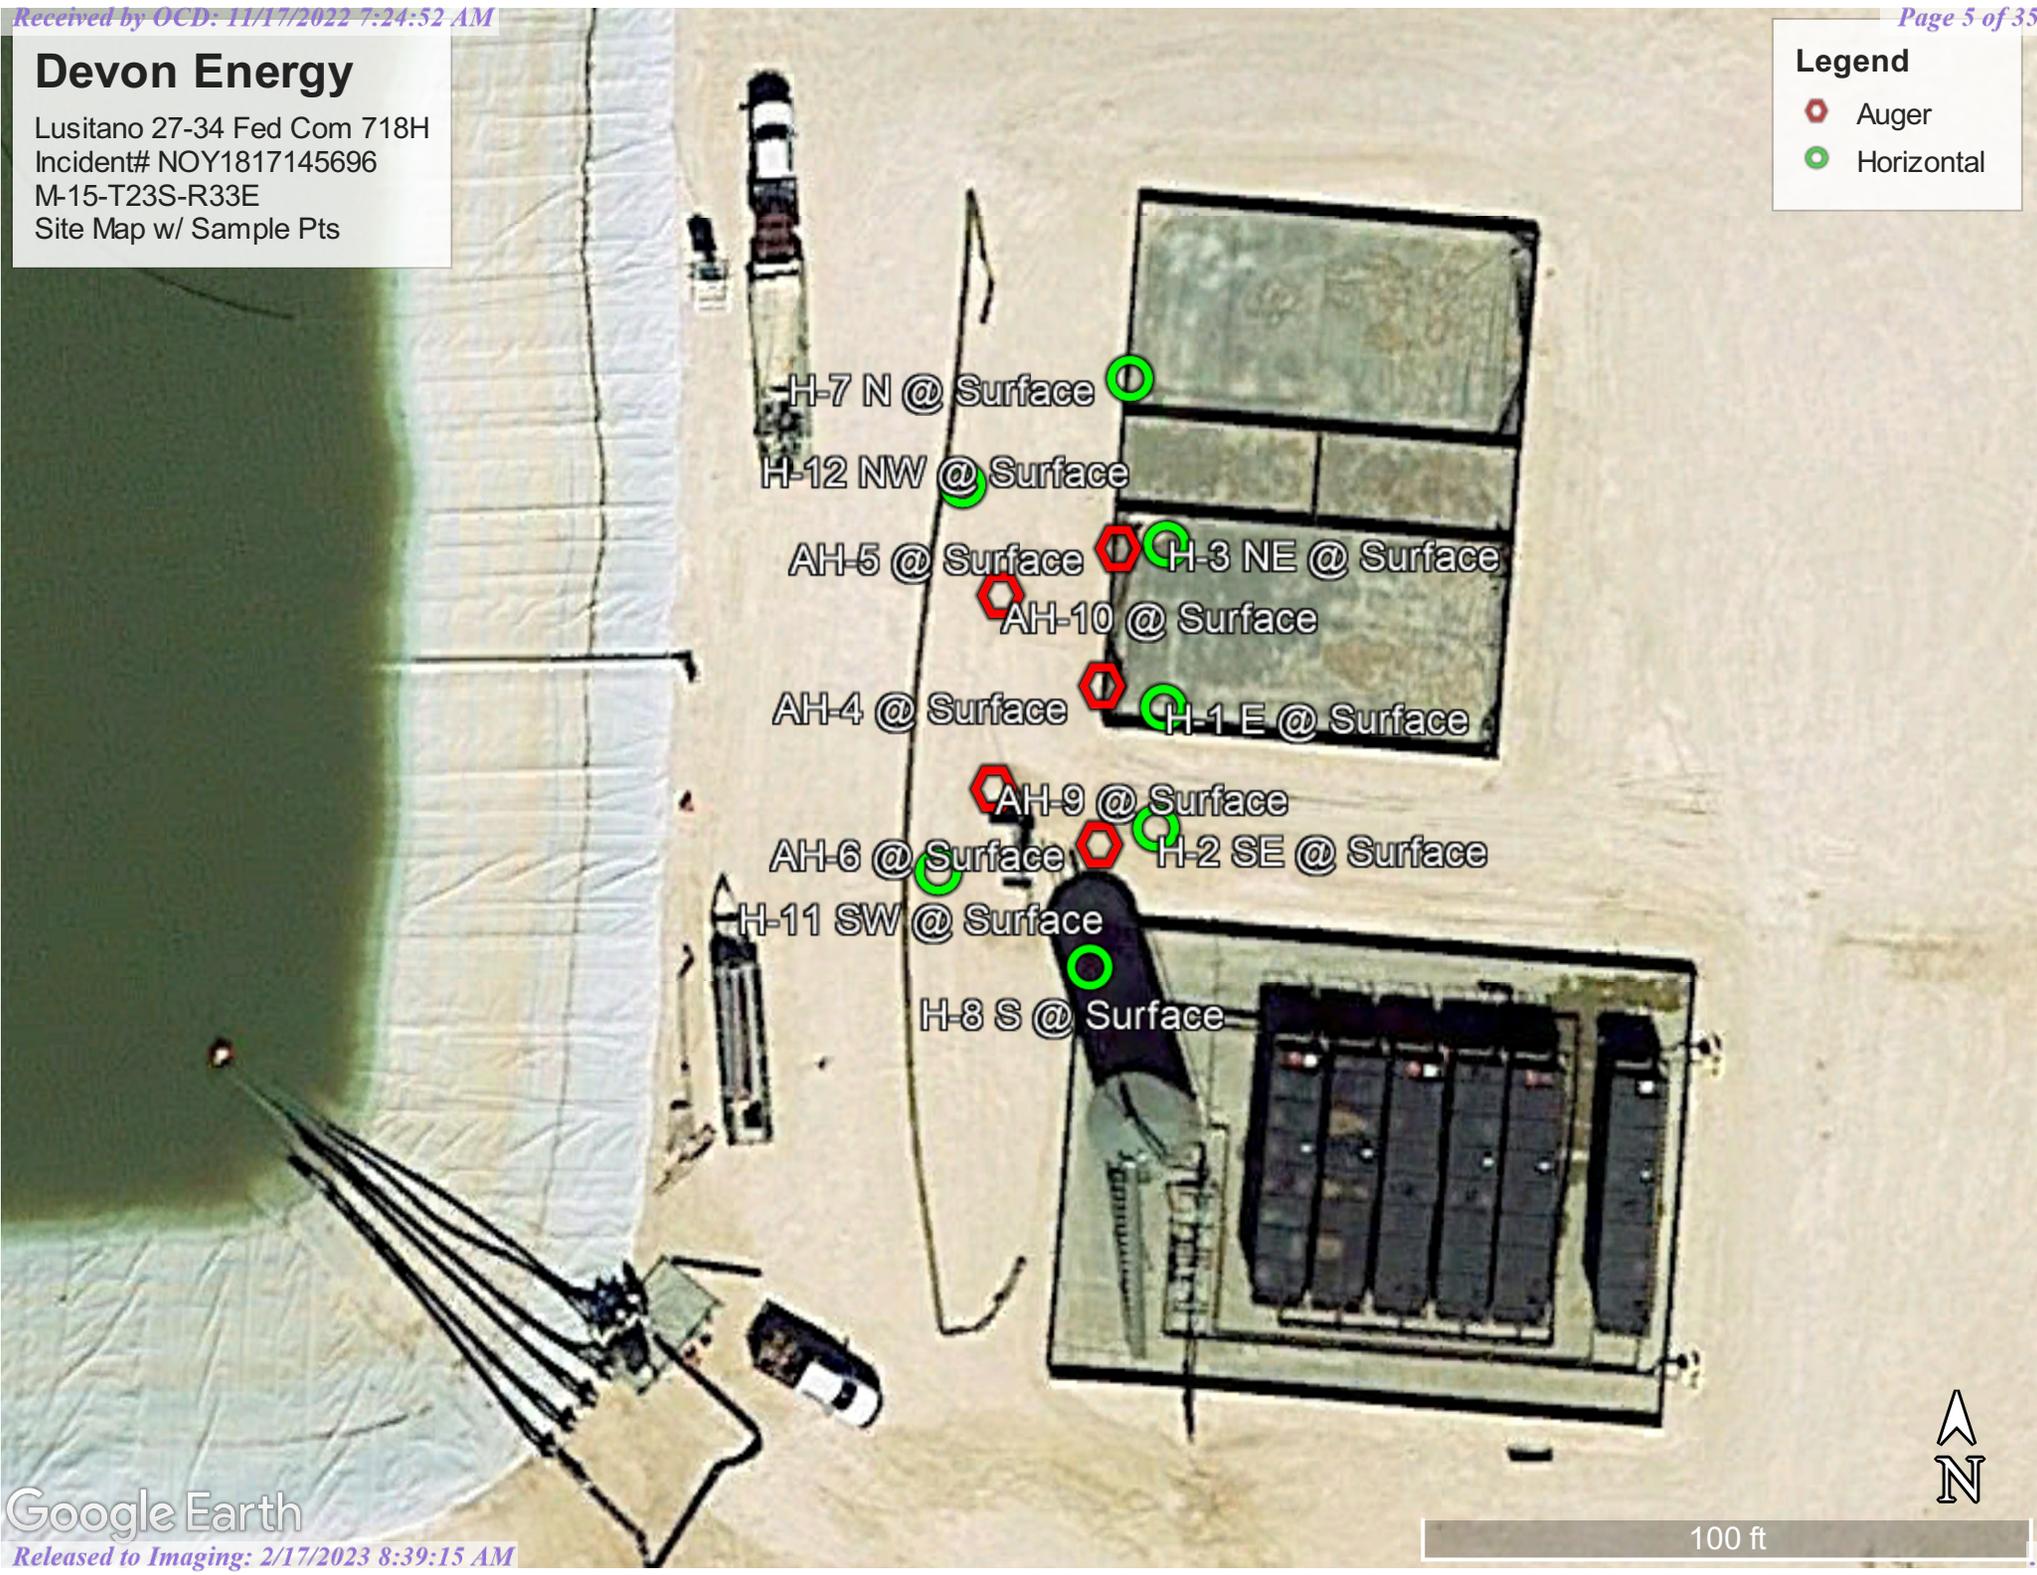
Lusitano 27-34 Fed Com 718H  
Incident# NOY1817145696  
M-15-T23S-R33E  
Site Map w/ Sample Pts

SESI personnel performed an assessment of the site in April of 2020 based on generator knowledge of the leak location. SESI personnel mapped the leak and performed delineation.

In September 2020, SESI personnel performed sampling to determine vertical extent of the release. SESI advanced 2 auger holes within the leak area. The samples were properly packaged and preserved and sent to Hall Laboratories for analysis. The results of the testing are captured in the summary below:
