LT Environmental, Inc.

October 17, 2019

Mr. Bradford Billings  
New Mexico Oil Conservation Division  
1220 South St. Francis Drive, #3  
Santa Fe, New Mexico 87505**RE: Closure Request  
Poker Lake Unit #144 Flowline  
Remediation Permit Number 2RP-3067  
Eddy County, New Mexico**

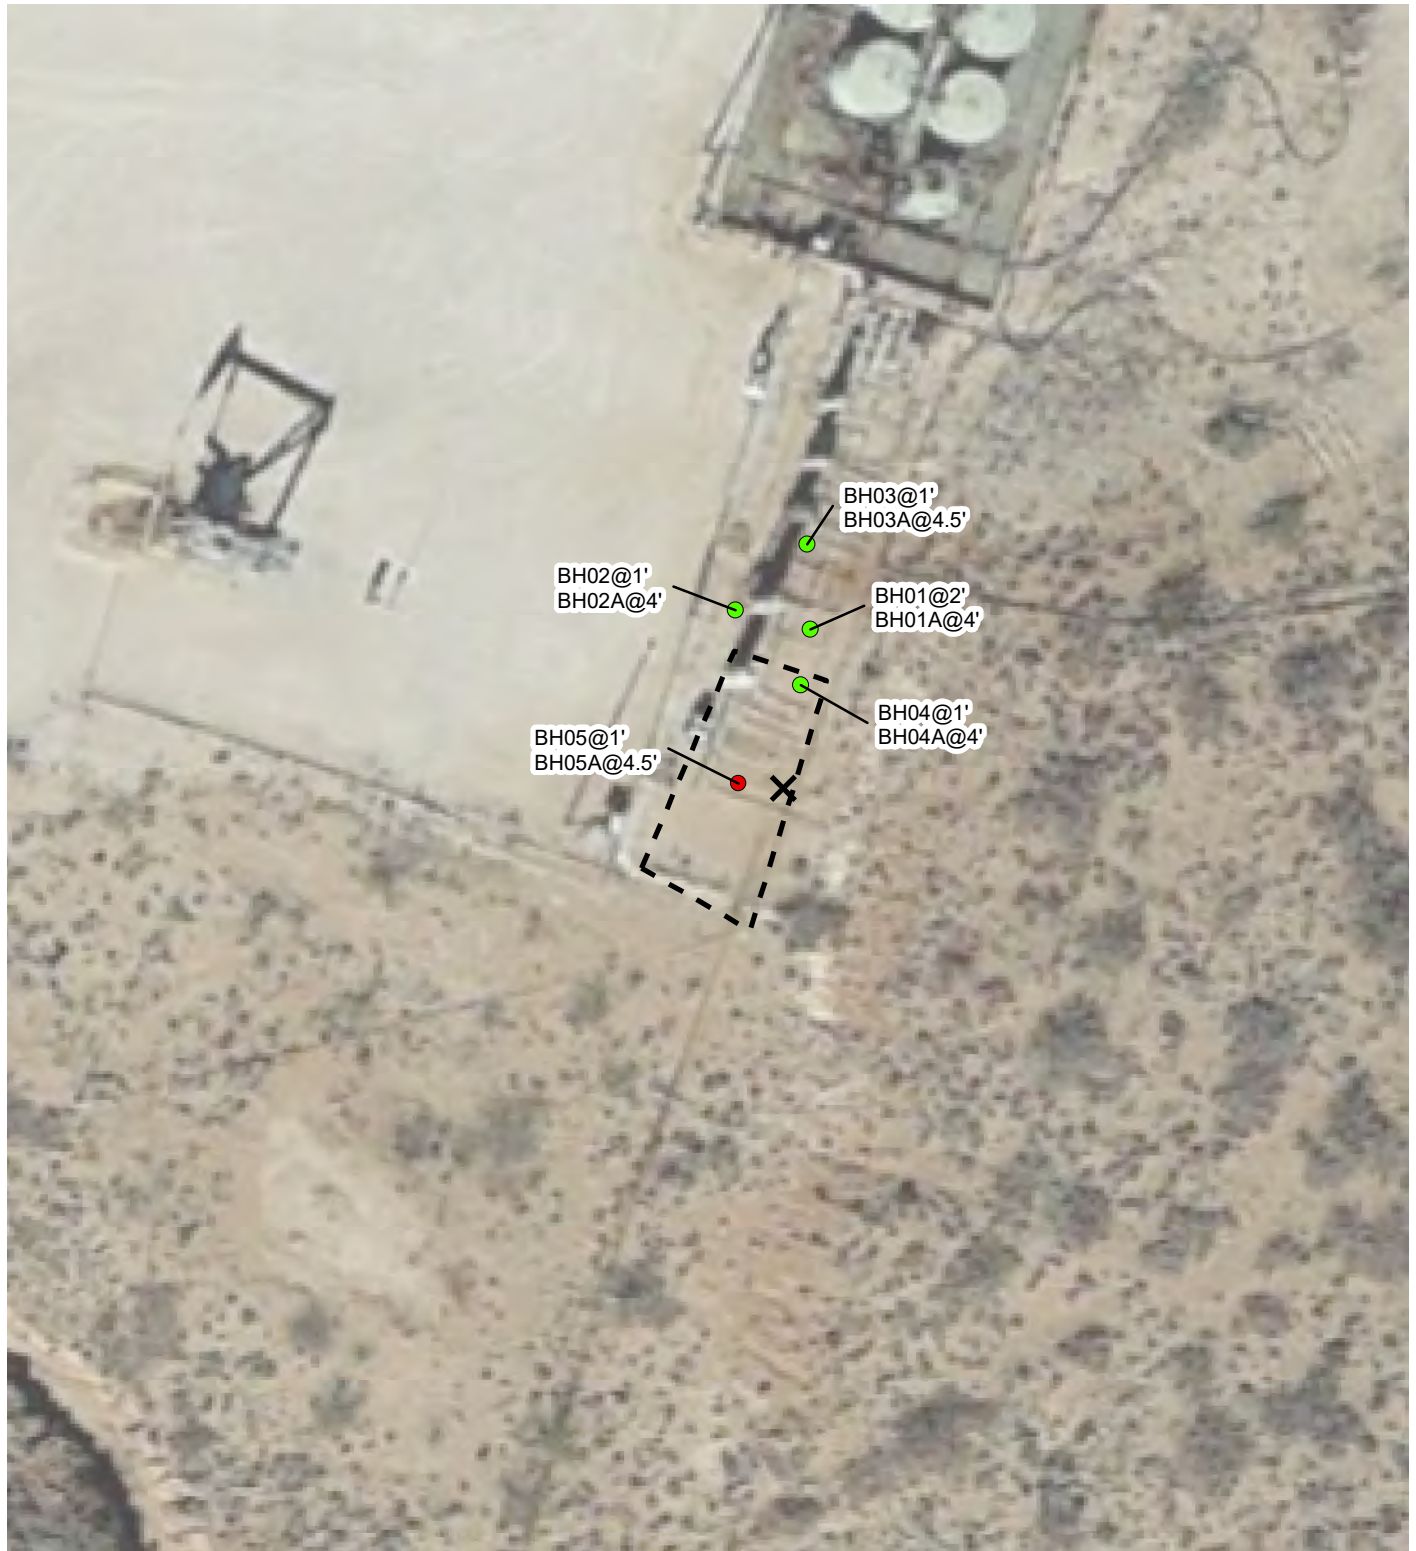
**FIGURE 3**  
**DELINEATION SOIL SAMPLE LOCATIONS**  
**POKER LAKE UNIT #144 FLOWLINE**  
**UNIT E SEC 32 T23S R30E**  
**EDDY COUNTY, NEW MEXICO**  
**XTO ENERGY, INC.**

Boreholes were advanced via hand auger at five locations within the release area to assess for soil impacts. Boreholes BH01 through BH05 were advanced to a depth of 4 feet or 4.5 feet bgs. Two delineation soil samples were collected from each borehole from depths ranging from 1 foot to 4.5 feet bgs. Soil from the boreholes was field screened for volatile aromatic hydrocarbons and chloride utilizing a calibrated photoionization detector (PID) and Hach® chloride QuanTab® test strips, respectively. Field screening results and observations for each borehole were logged on lithologic/soil sampling logs, which are included in Attachment 2. The borehole delineation soil sample locations are depicted on Figure 3.

Laboratory analytical results for the delineation soil samples collected from boreholes BH01 through BH04, indicated that BTEX, TPH, and chloride concentrations were compliant with the Closure Criteria. Laboratory analytical results for the delineation soil samples (BH05/BH05A), collected from borehole BH05, indicated that TPH or chloride concentrations exceeded the Closure Criteria. Impacted soil was excavated and laboratory analytical results for excavation soil samples SW01 through SW06, FS01 through FS03, FS04A, FS05, and FS06A, collected from the final excavation extent, indicated that BTEX, TPH, and chloride concentrations were compliant with the Closure Criteria. Laboratory analytical results for excavation floor samples FS04 and FS06 initially exceeded the Closure Criteria for TPH. Additional soil was removed from the floor of the excavation and subsequent floor samples FS04A and FS06A were compliant with the Closure Criteria. Laboratory analytical results are summarized in Table 1 and the complete laboratory analytical reports are included as Attachment 4.

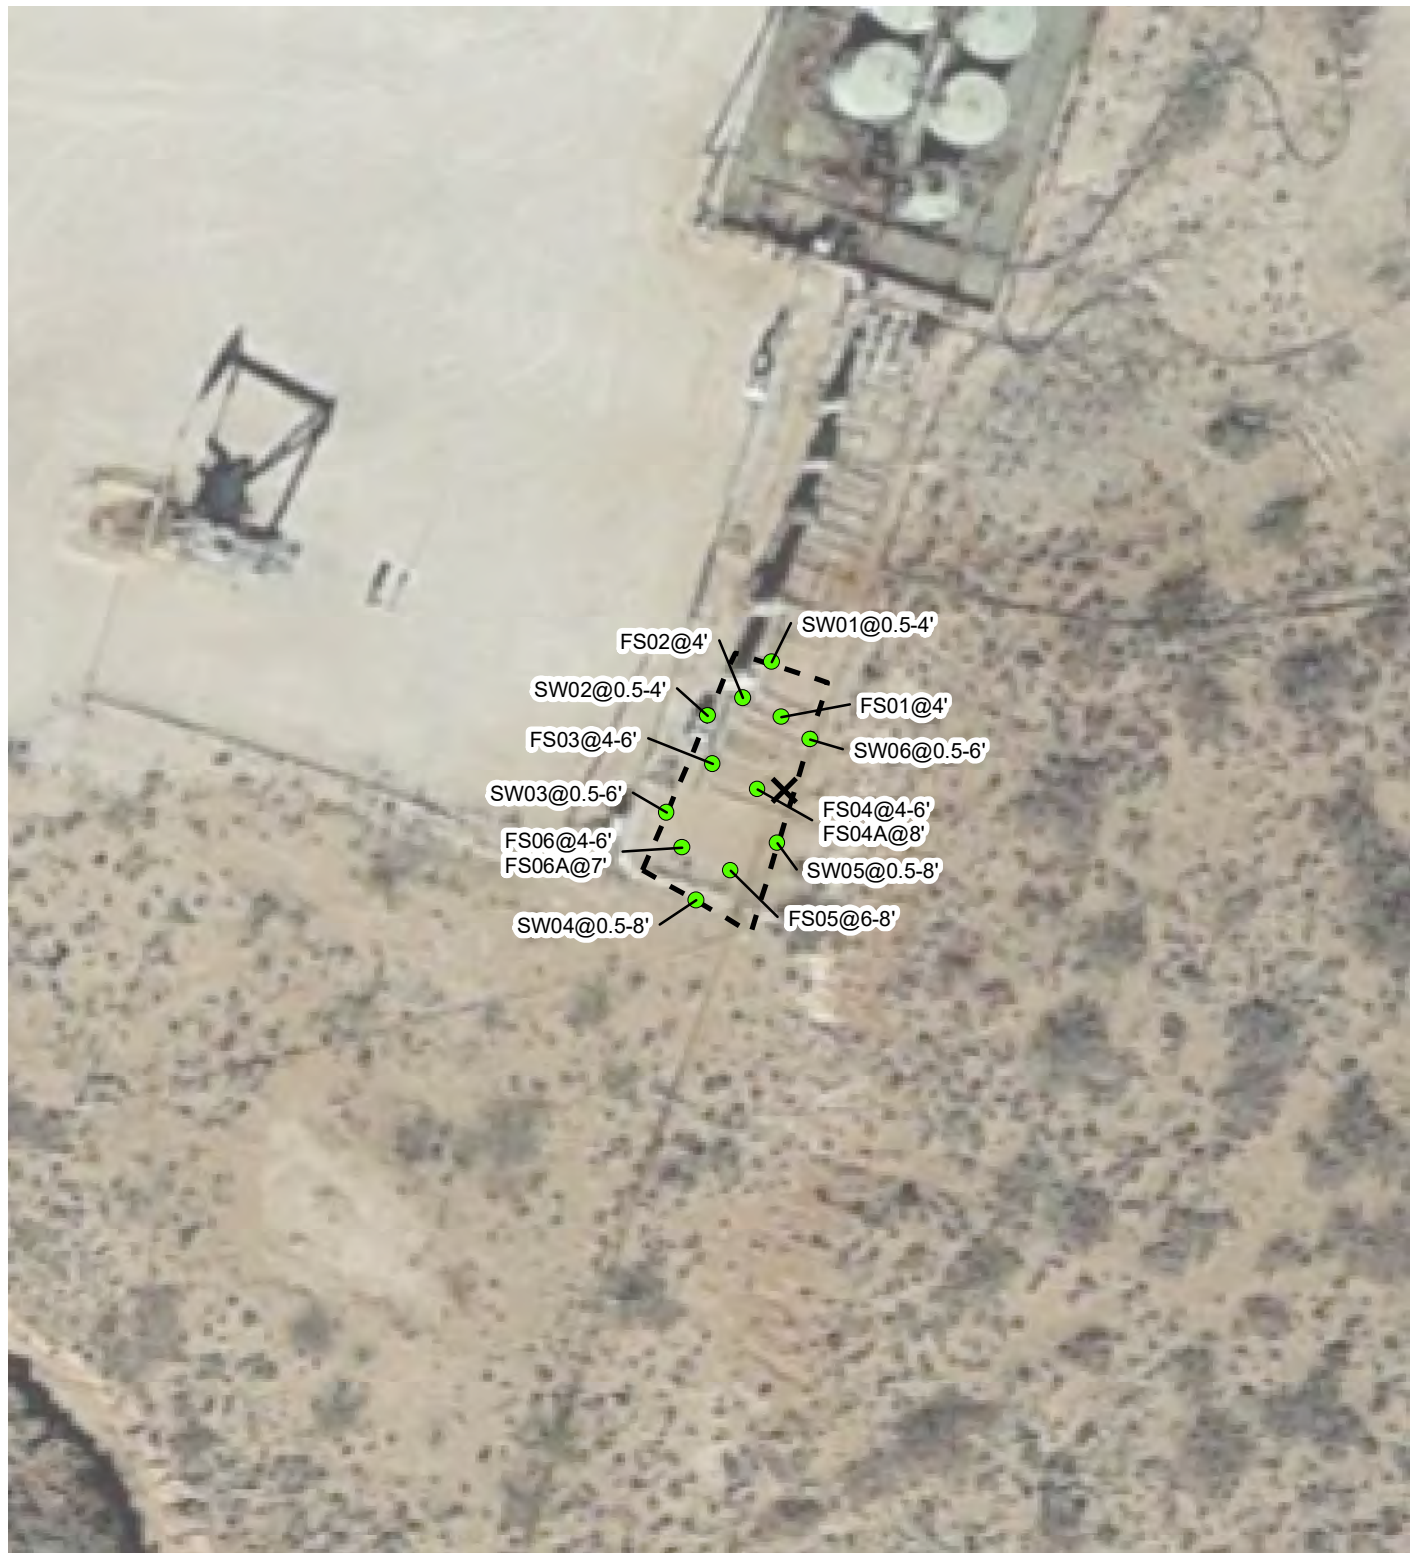
**FIGURE 4**  
EXCAVATION SOIL SAMPLE LOCATIONS  
POKER LAKE UNIT #144 FLOWLINE  
UNIT E SEC 32 T23S R30E  
EDDY COUNTY, NEW MEXICO  
**XTO ENERGY, INC.**

Impacted soil was excavated from the release area as indicated by visual observations, potholing activities, and laboratory analytical results for the preliminary soil samples. To direct excavation activities, LTE screened soil for volatile aromatic hydrocarbons and chloride utilizing a PID and Hach® chloride QuanTab® test strips, respectively. Impacted soil was excavated to a depth ranging from 4 feet to 8 feet bgs. Following removal of impacted soil, LTE collected 5-point composite soil samples every 200 square feet from the sidewalls and floor of the excavation. The 5-point composite samples were collected by depositing five aliquots of soil into a 1-gallon, resealable plastic bag and homogenizing the samples by thoroughly mixing. Composite soil samples SW01 through SW06 were collected from the sidewalls of the excavation from depths ranging from 0.5 feet to 8 feet bgs. Composite soil samples FS01 through FS06, FS04A, and FS06A were collected from the floor of the excavation from depths ranging from 4 feet to 8 feet bgs. The excavation extent and excavation soil sample locations are depicted on Figure 4.

The excavation measured approximately 1,185 square feet in area. A total of approximately 265 cubic yards of impacted soil were removed from the excavation. The impacted soil was transported and properly disposed of at the Lea Land Landfill located in Hobbs, New Mexico.

Delineation and excavation activities were conducted to address impacts to soil resulting from a historical release of crude oil at the Site. Laboratory analytical results for the delineation soil samples collected from boreholes BH01 through BH04 indicated that BTEX, TPH, and chloride concentrations were compliant with the Closure Criteria. The impacted soil identified in preliminary soil samples SS01 and SS03 and delineation soil samples BH05 and BH05A was excavated. Laboratory analytical results for excavation soil samples SW01 through SW06, FS01 through FS03, FS04A, FS05, and FS06A, collected from the final excavation extent, indicated that BTEX, TPH, and chloride concentrations were compliant with the Closure Criteria. Based on the excavation and delineation soil sample analytical results, no further remediation was required.

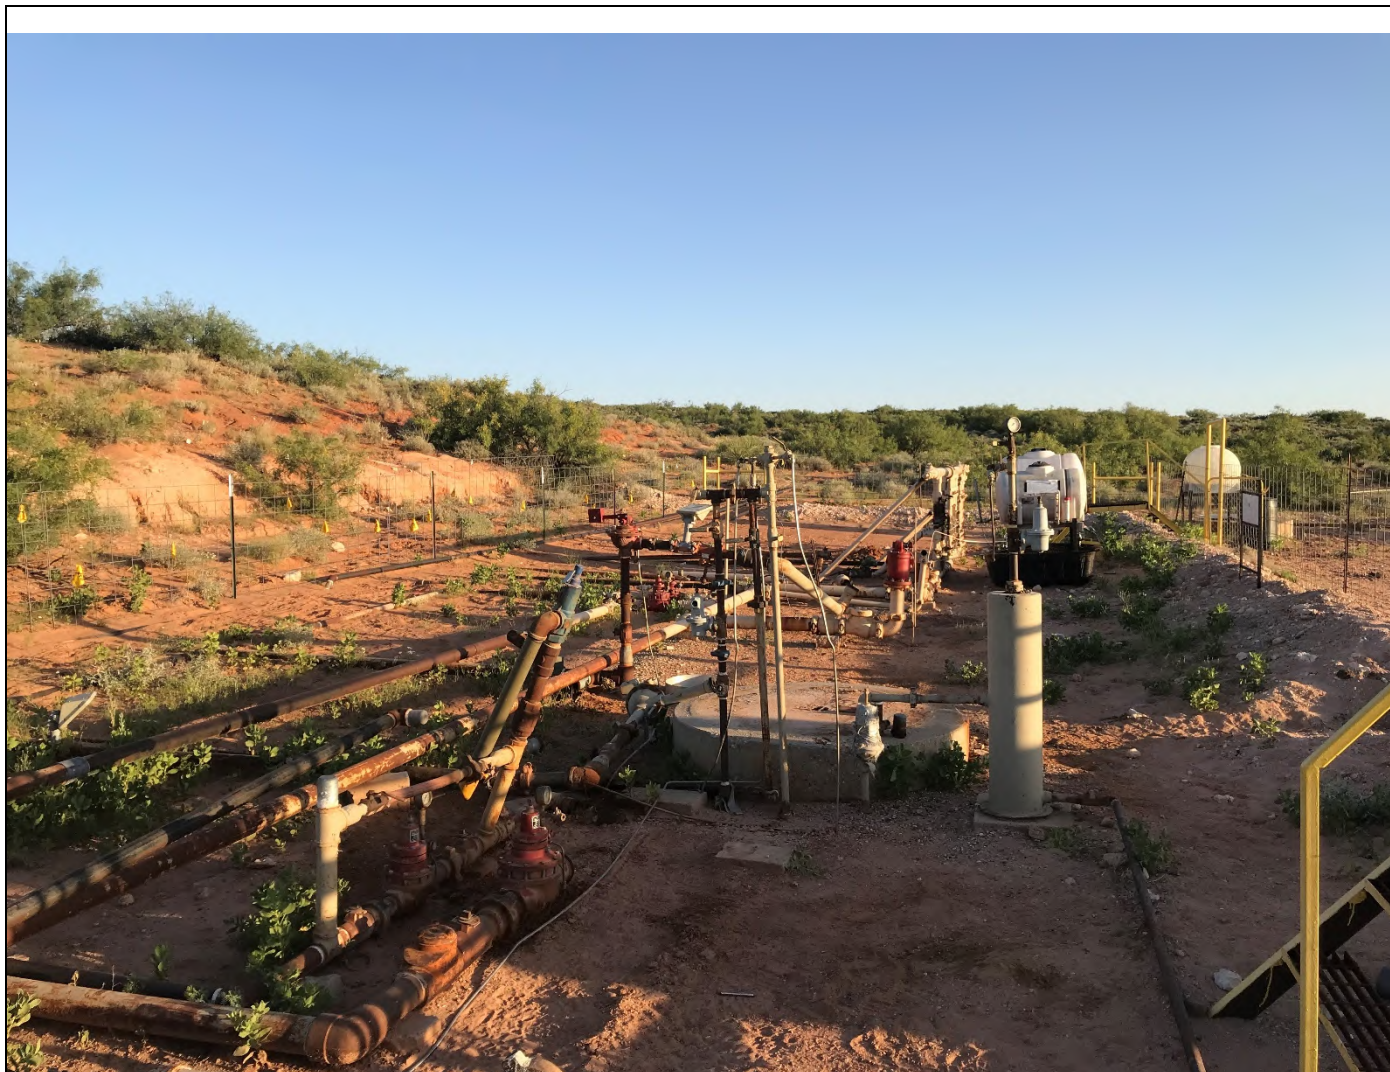
**Southwestern view of the release area prior to equipment removal.**

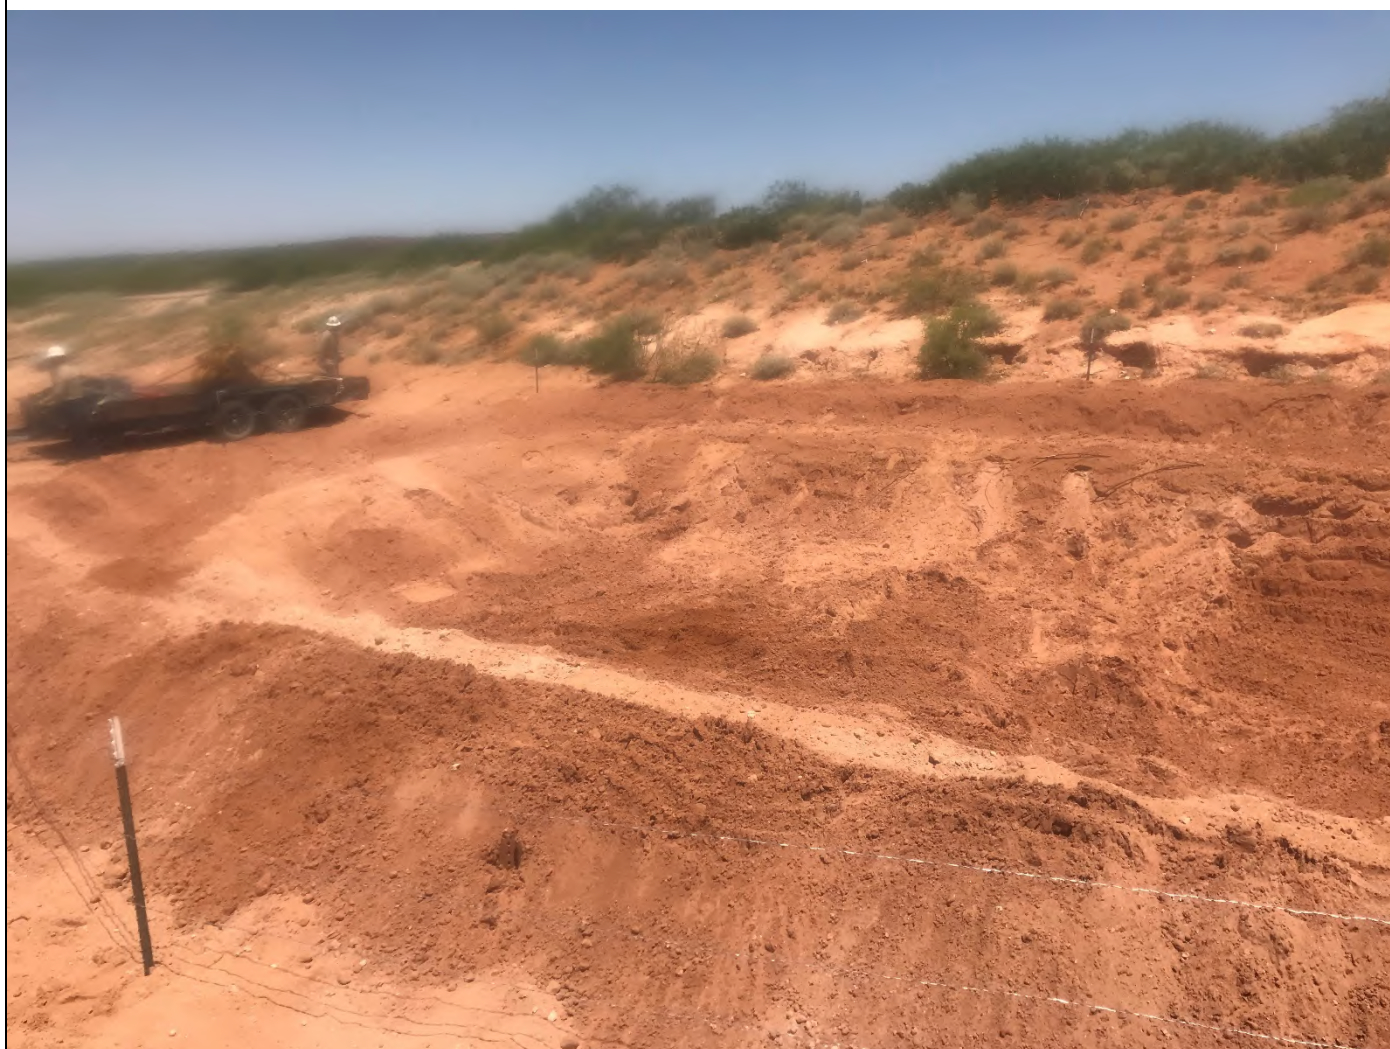
**Northeastern view of the excavation.**

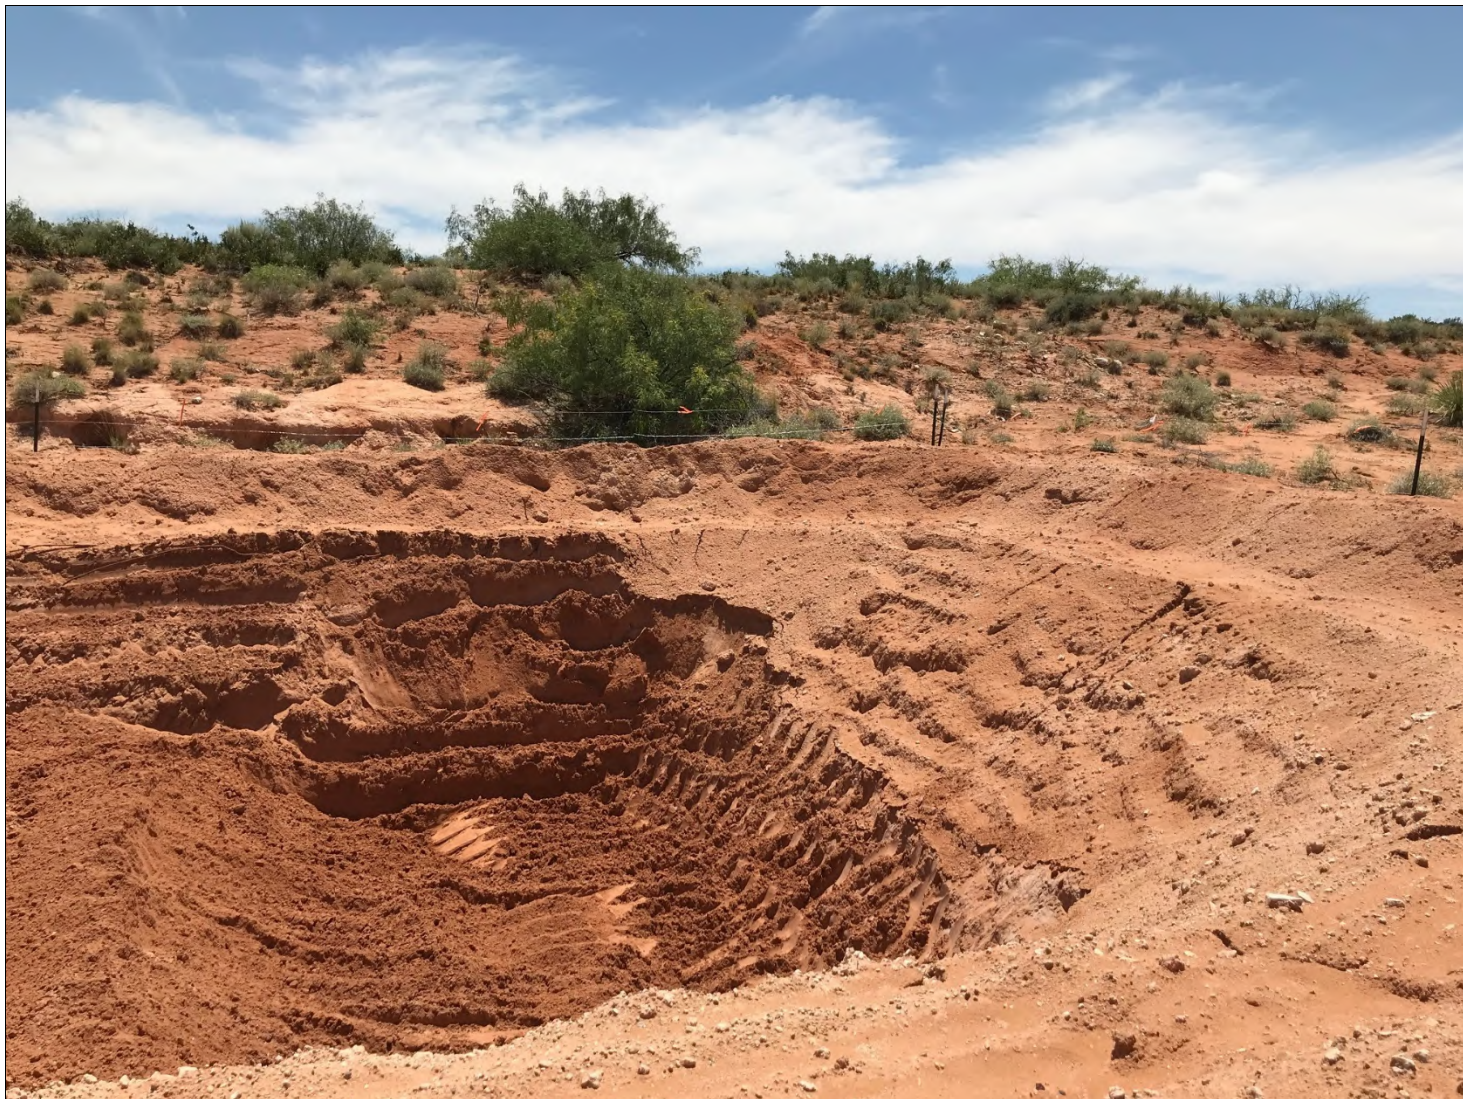
**Eastern view of the final excavation.**

Initial response efforts, natural attenuation, and excavation of impacted soil have mitigated impacts at this Site. XTO requests no further action for RP Number 2RP-3067. XTO will backfill the excavation with material purchased locally and recontour the Site to match pre-existing site conditions. An updated NMOCD Form C-141 is included in Attachment 1.
