Re: Closure Report
Central Dagger Draw Water Station
2RP-4298
Section 3, T20S-R24E
Eddy County, New Mexico

On behalf of EOG Resources, Inc. (EOG Y), Ranger Environmental Services, Inc. (Ranger) has prepared this Closure Report to document soil remediation and cleanup confirmation soil sampling activities conducted at the Central Dagger Draw Water Station ("subject site"). The work was conducted in general accordance with Ranger's April 23, 2018 Remediation Work Plan.

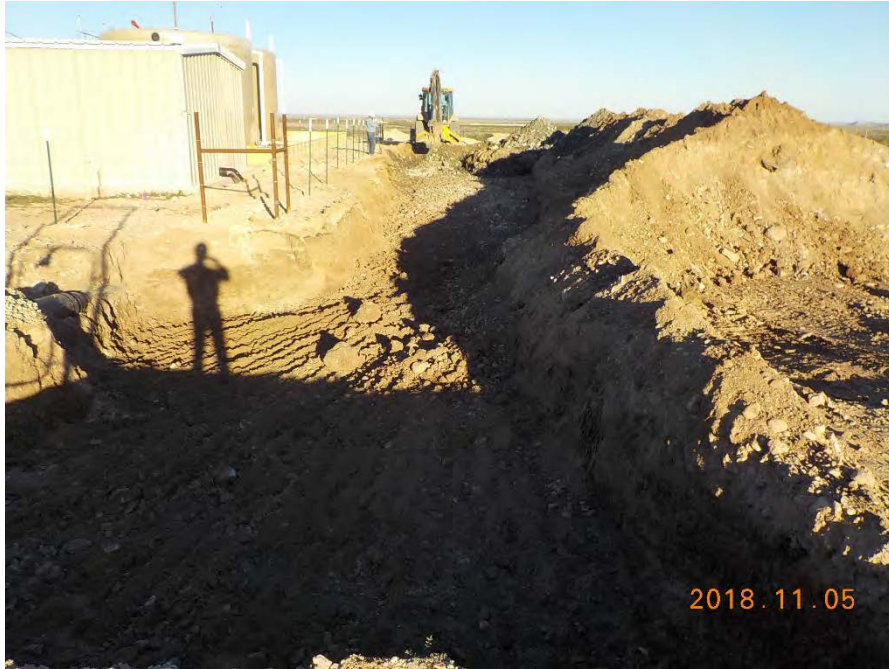
Photograph documenting initiation of site excavation activities in November 2018. View toward the east.

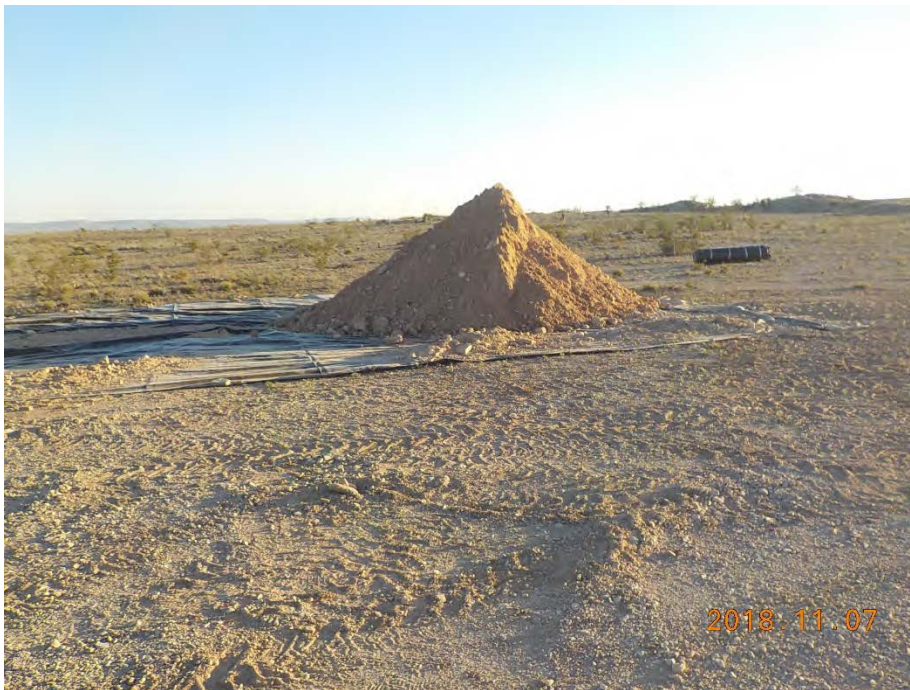
Typical view of excavated soil stockpile. View toward the south.

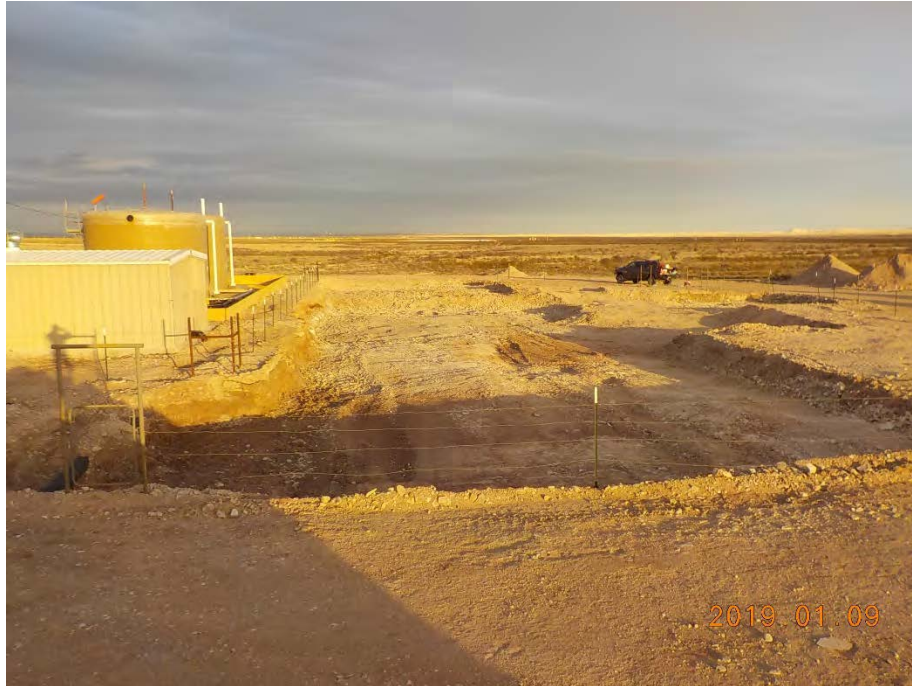
View of excavated area on January 9, 2019 prior to collection of soil cleanup confirmation samples. View toward the east.

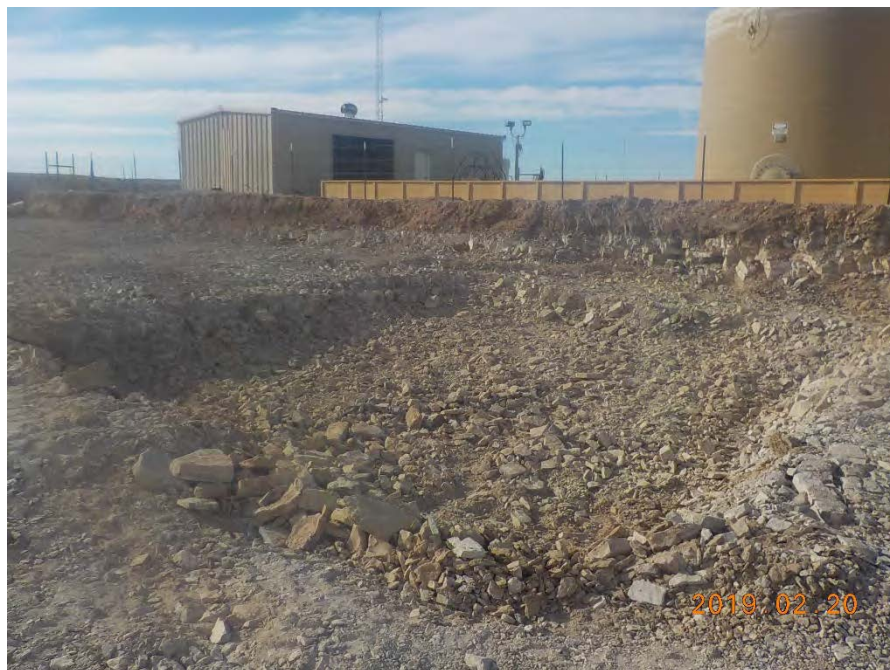
View of initial stages of excavation of the area with TPH RRAL exceedance (SS-10 area) that was ultimately excavated to approximately 6.5' in depth. View toward the northwest.

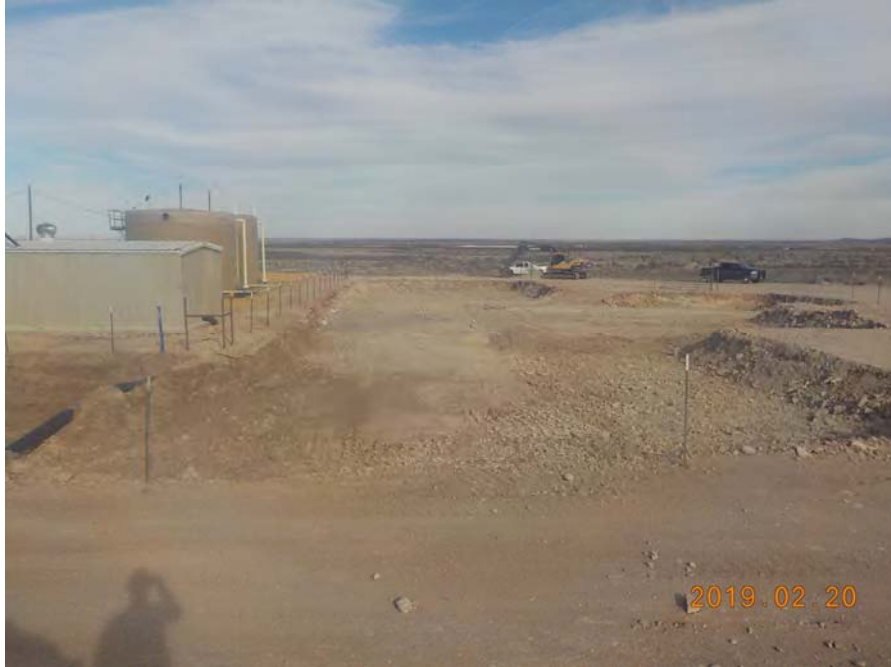
Photograph of final excavation prior to emplacement of liner and backfilling. View toward the east.
