Re: Status Report – 4<sup>th</sup> Quarter 2022  
San Juan 28-7 Unit 183M  
Rio Arriba County, New Mexico  
OCD Incident No. NCS1901627746

On behalf of Hilcorp Energy Company (Hilcorp), Timberwolf Environmental, LLC (Timberwolf) presents this report to document remedial activities conducted during the fourth quarter of 2022 (4Q22) at the San Juan 28-7 Unit 183M (Site).

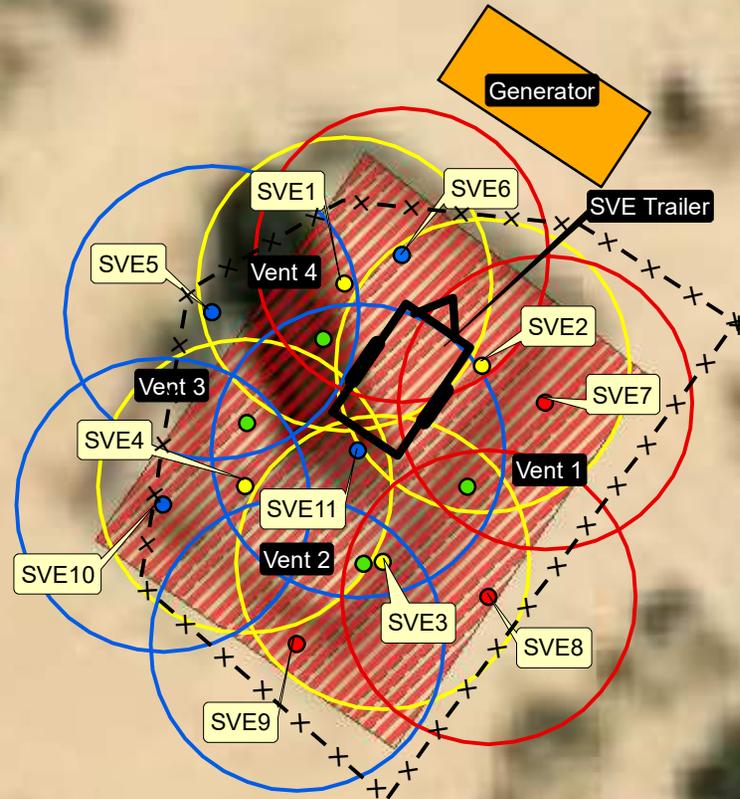
**Figure 4**  
**SVE System Overview**

Treatment Area= 6,320 ft<sup>2</sup>  
 Assuming a 25 ft radius of influence

- Leg 1 SVE Wells (7, 8, & 9)
- Leg 2 SVE Wells (1, 2, 3, & 4)
- Leg 3 SVE Wells (5, 6, 10, & 11)
- Vent
- Leg 1
- Leg 2
- Leg 3
- ▨ Impacted Area
- SVE Trailer
- Generator
- x- Fence

The SVE system creates a treatment field of approximately 0.15 acres and treats soil to a depth of approximately 30 ft bgs for a total volume of approximately 7,021 cubic yards of soil. The SVE wells, measured radius of influence of 25 ft, and leg configurations are shown in Figure 4.

The SVE system was designed with three independent legs (i.e., Leg 1, Leg 2, and Leg 3). Legs 1 and 3 provide vacuum extraction to the deep SVE wells; Leg 2 is piped to the shallow wells. The automation panel was programmed to oscillate between Legs 1, 2, and 3 every four hours for continuous 24-hr operations. Programmed runtimes are presented in Table 1 below.

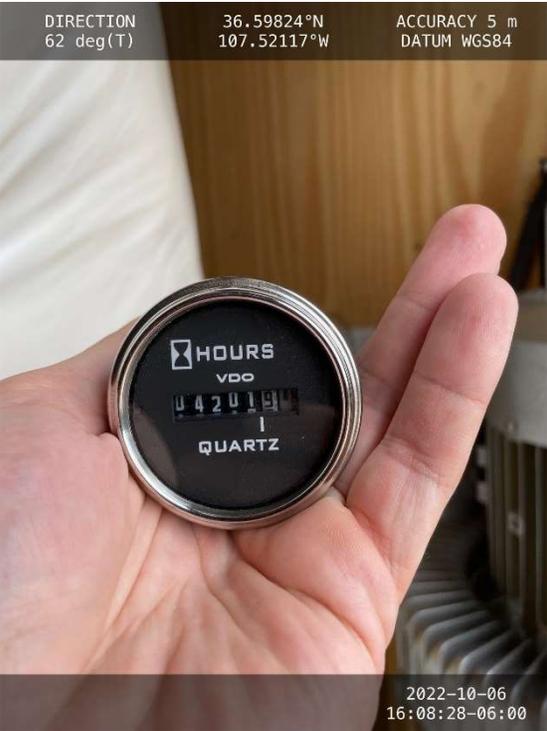
<b>Photo No.:</b> 1	<div style="background-color: #333; color: white; padding: 2px; font-size: 0.8em;">             DIRECTION 62 deg(T)      36.59824°N      ACCURACY 5 m              107.52117°W      DATUM WGS84           </div>

<div style="background-color: #333; color: white; padding: 2px; font-size: 0.8em; text-align: right;">             2022-10-06              16:08:28-06:00           </div>
<b>Direction:</b> N/A	
<b>Comments:</b> View of hour meter on 10/06/22.

An hour meter reading was not recorded during the 12/19/22 O&M event; therefore, the hour meter reading from 01/10/23 was used to calculate system runtime in 4Q22. System runtime between the last reading of 3Q22 (09/19/22) and 01/10/23 was 2,633 hours; the available hours during this period were 2,689. Therefore, yielding a runtime percentage (%) of 97.9 for 4Q22. Photographs of relevant meter readings are documented in the attached Photographic Log.

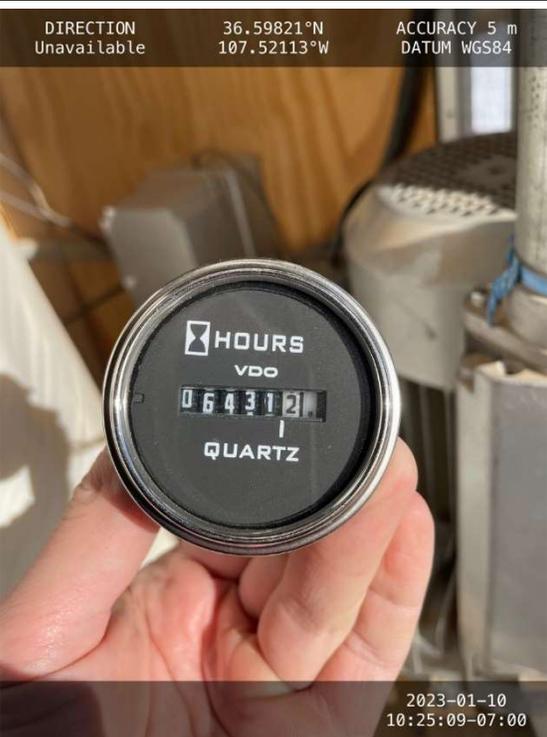
<b>Photo No.:</b> 2	<div style="background-color: #333; color: white; padding: 2px; font-size: 0.8em;">             DIRECTION Unavailable      36.59821°N      ACCURACY 5 m              107.52113°W      DATUM WGS84           </div>

<div style="background-color: #333; color: white; padding: 2px; font-size: 0.8em; text-align: right;">             2023-01-10              10:25:09-07:00           </div>
<b>Direction:</b> N/A	
<b>Comments:</b> View of hour meter on 01/10/23.
