LT Environmental, Inc.

February 11, 2019

**RE: Closure Request
 JRU 55 Battery
 Remediation Permit Number 2RP-3863
 Eddy County, New Mexico**

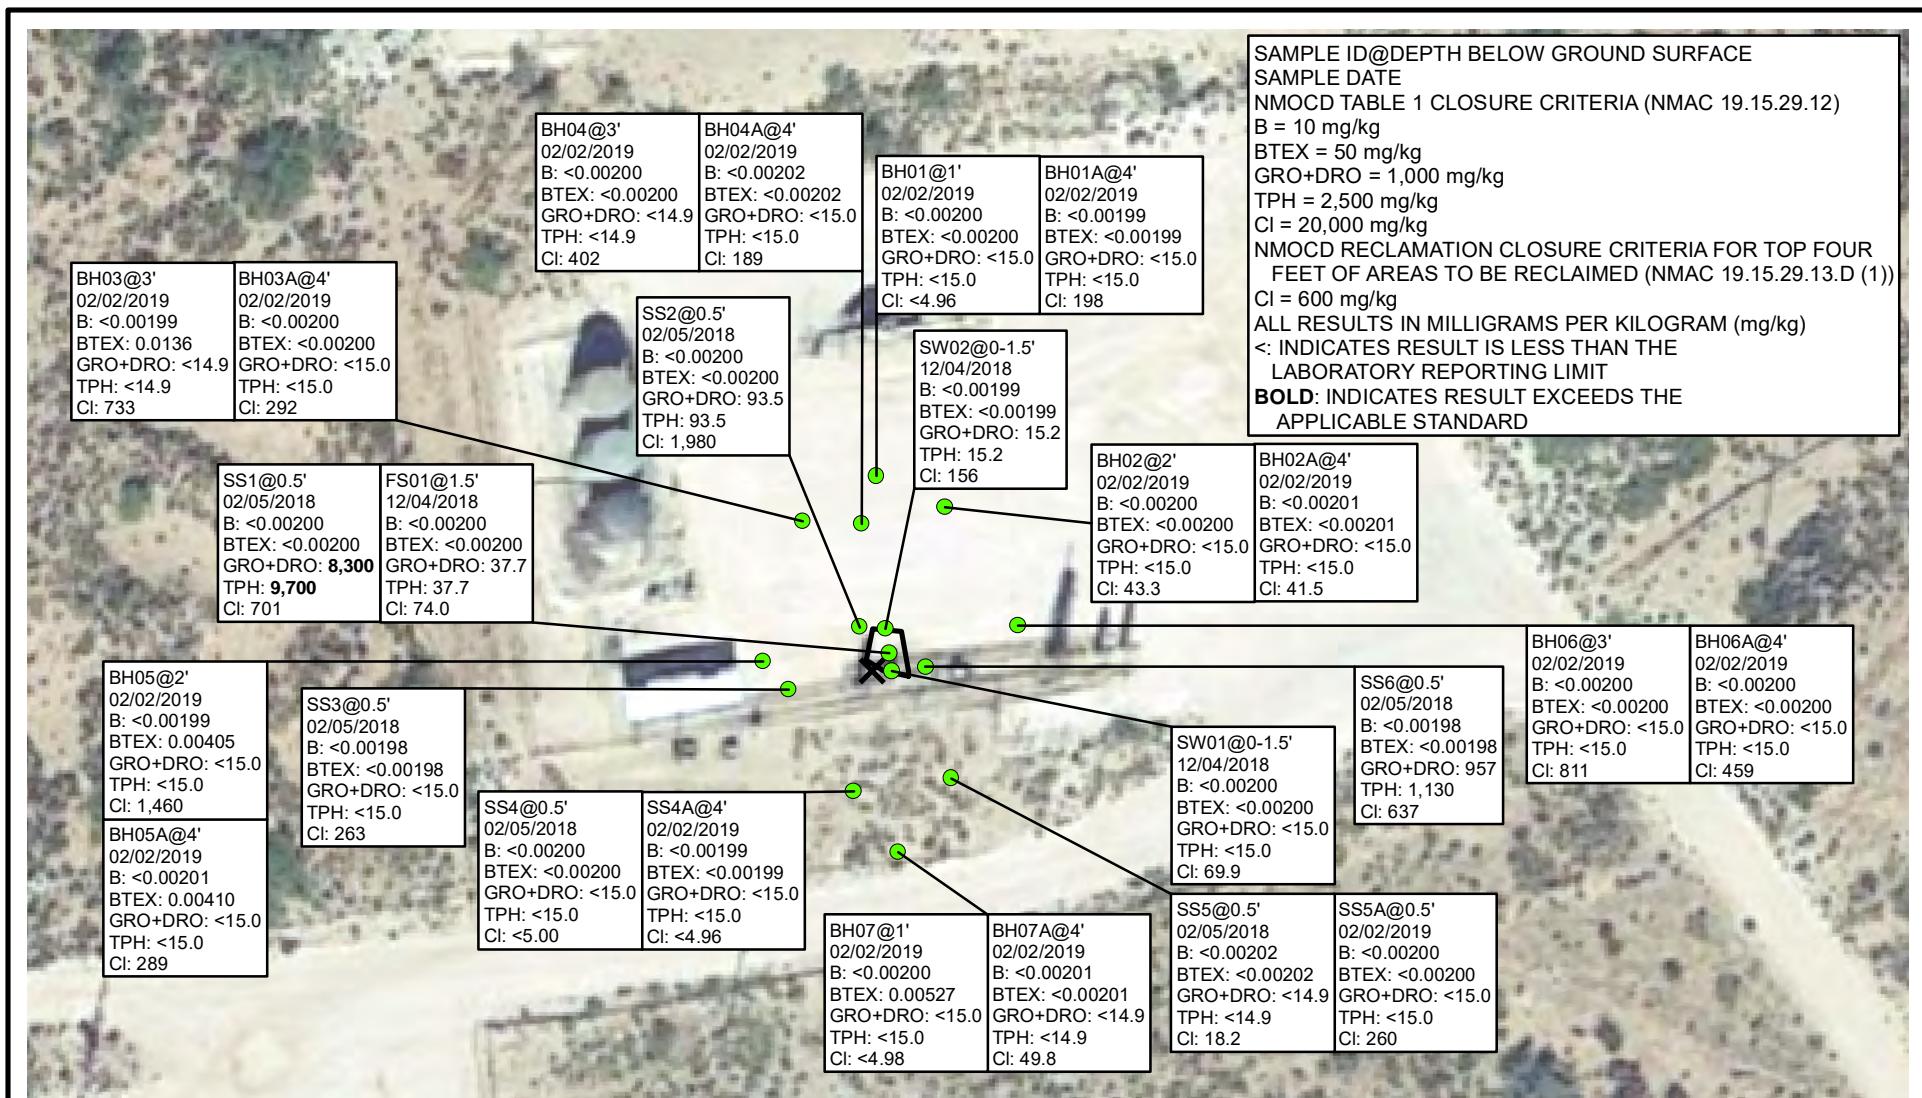
The excavation measured approximately 142 square feet and was completed to a depth of 1.5 feet bgs (Figure 2). Approximately eight cubic yards of impacted soil were removed via hydro-vacuum from the excavation and properly disposed of at the R360 Landfill in Hobbs, New Mexico.

LTE returned to the Site on February 2, 2019, to collect site characterization samples using a hand auger. Discrete soil samples BH01 through BH07, BH01A through BH07A, SS4A, and SS5A were collected between 1 foot and 4 feet bgs (Figure 2).

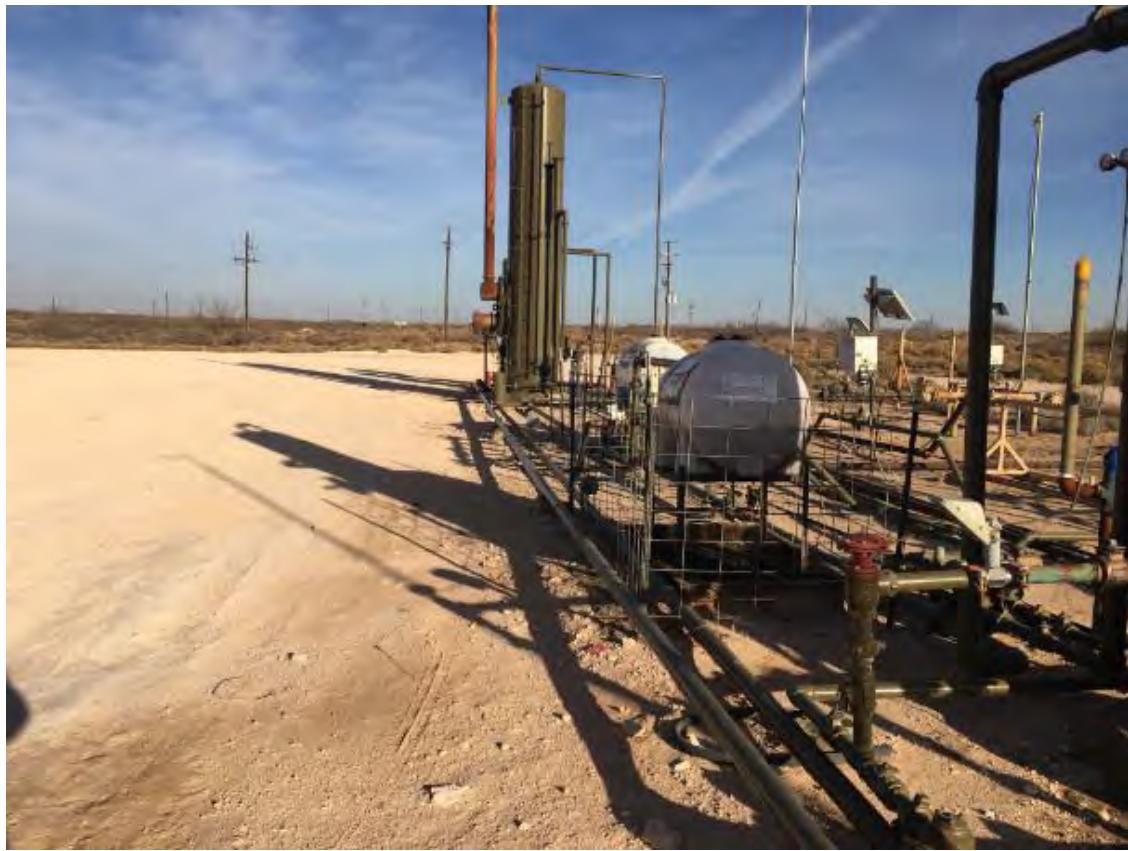
View south of processing equipment.

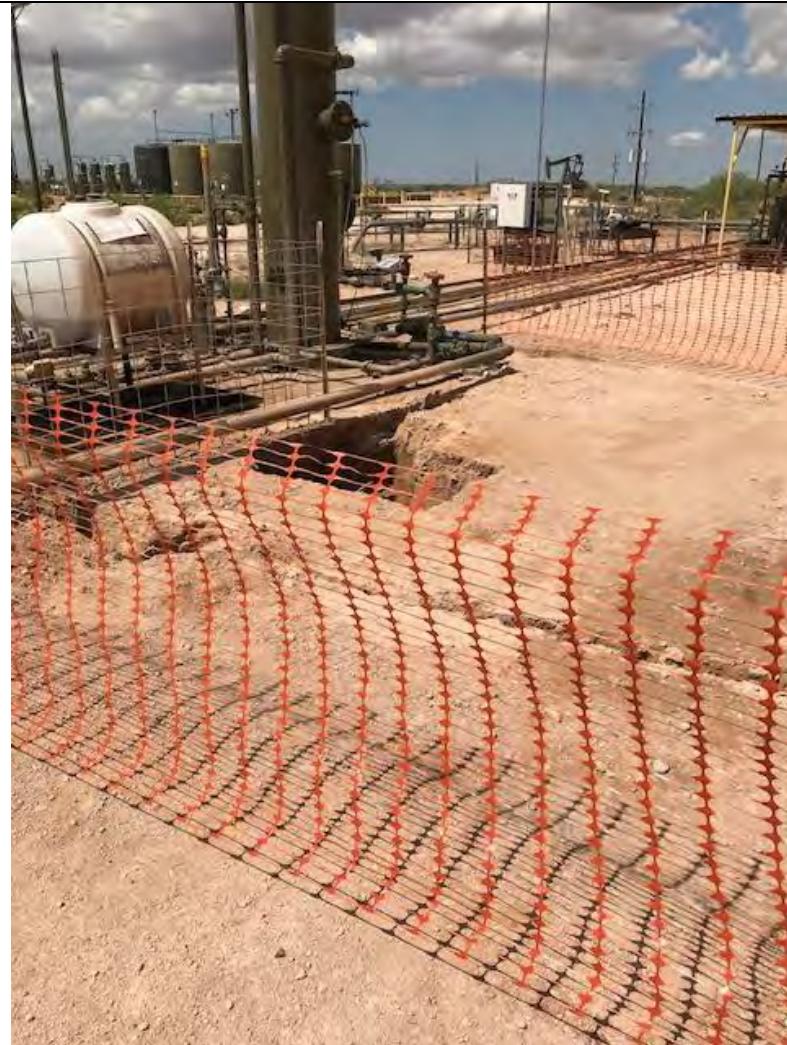
Fenced excavation near processing equipment.
