**RE: Closure Request
Poker Lake Unit Pierce Canyon 17 Federal 1H Battery
Remediation Permit Number 2RP-4656
Eddy County, New Mexico**

LT Environmental, Inc. (LTE), on behalf of XTO Energy, Inc. (XTO), presents the following report detailing soil sampling activities at the Poker Lake Unit Pierce Canyon 17 Federal 1H Battery (Site) in Unit P, Section 17, Township 25 South, Range 30 East, Eddy County, New Mexico (Figure 1). The purpose of the soil sampling activities was to assess impacts to soil after 11 barrels (bbls) of produced water were released at the Site.

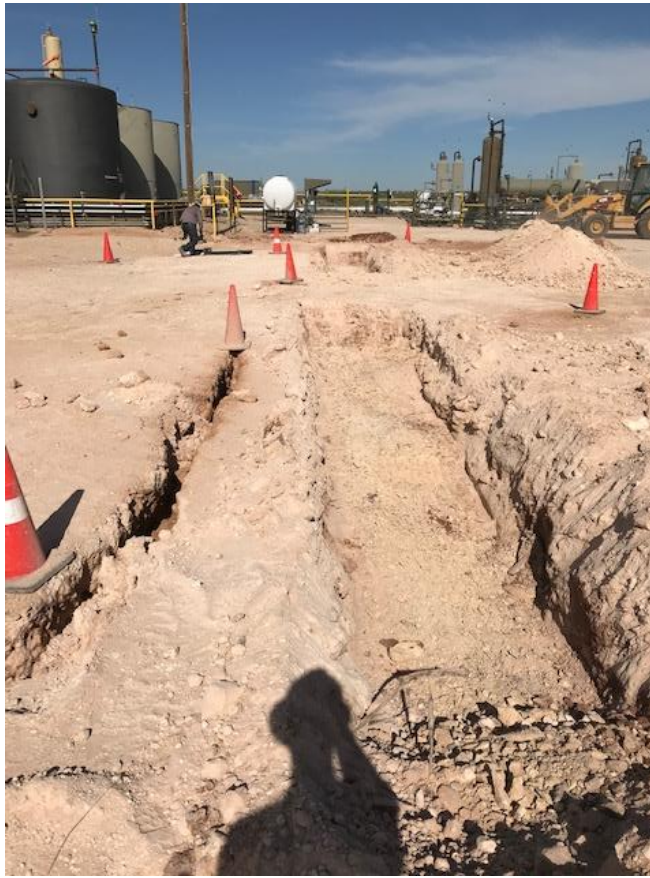
View east of realese area and excavation boundary.

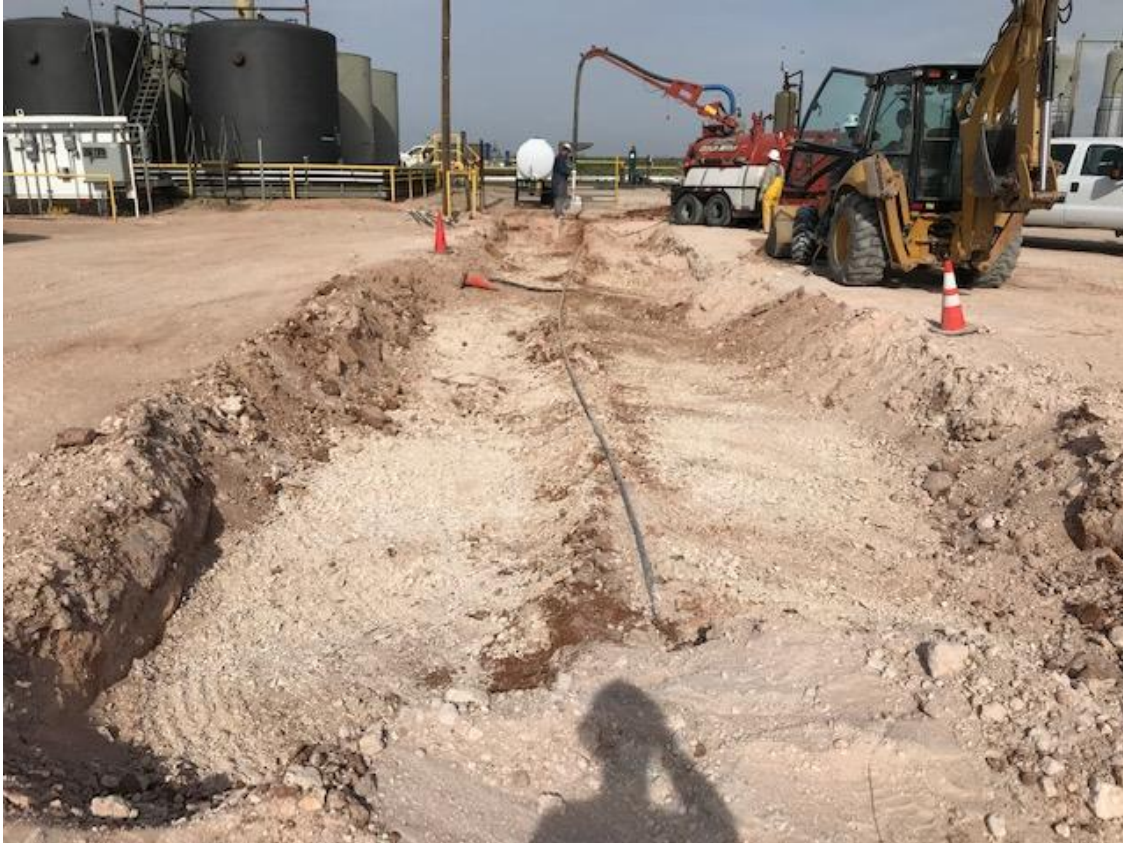
View east of the release area and excavation boundary.

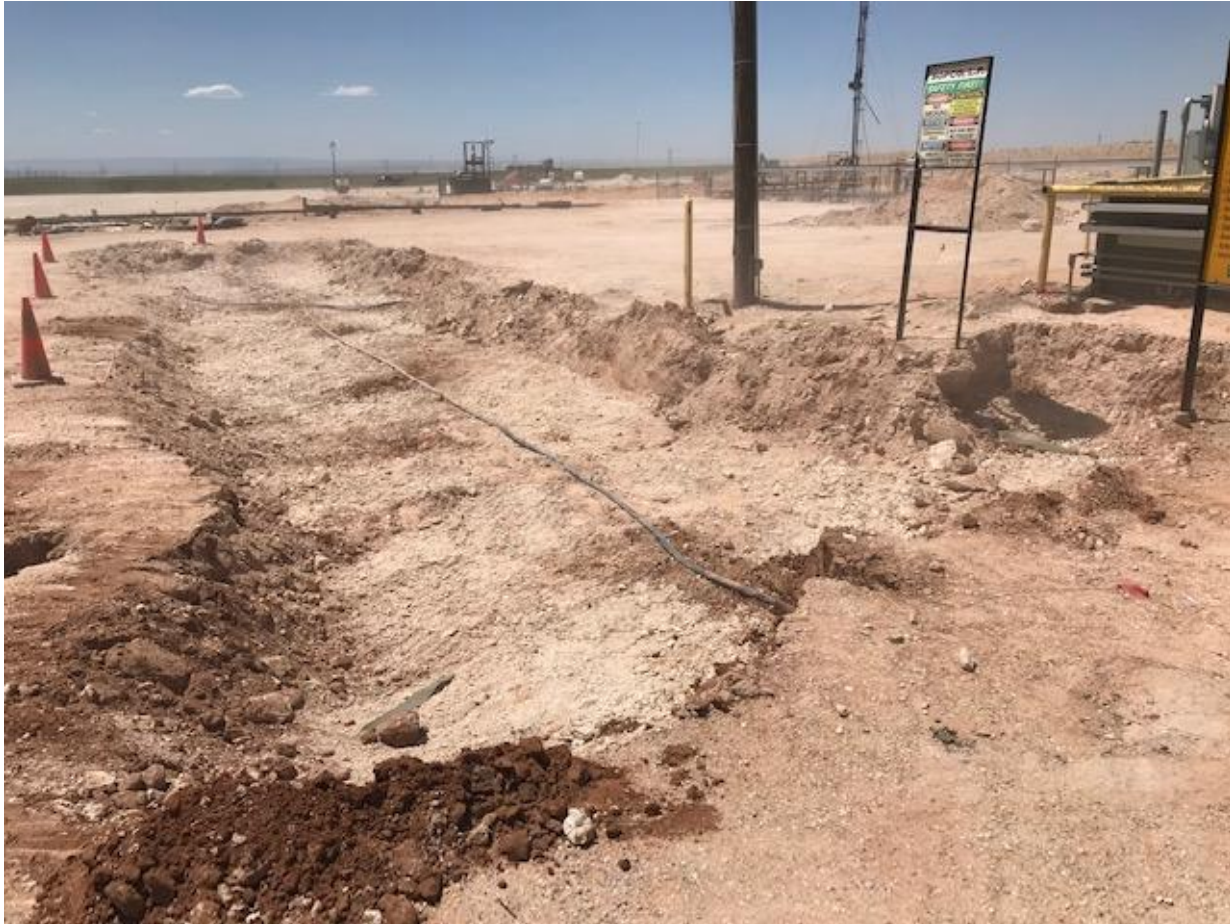
View west of release area and excavation boundary.
