Mr. Bradford Billings  
New Mexico Oil Conservation Division  
1220 South St. Francis Drive, #3  
Santa Fe, New Mexico 87505**RE: Closure Request  
Hat Mesa 32 State 001  
Remediation Permit Number 1RP-3715  
Lea County, New Mexico**

LT Environmental, Inc. (LTE), on behalf of XTO Energy, Inc. (XTO), presents the following report detailing excavation of impacted soil and confirmation soil sampling activities at the Hat Mesa 32 State 001 (Site) located in Unit D, Section 32, Township 20 South, Range 33 East, in Lea County, New Mexico (Figure 1). The purpose of the soil sampling and excavation activities was to address impacts to soil after a nipple on the chemical injection line check valve failed, causing the release of 5 barrels (bbls) of oil onto the surface of the well pad. The release was discovered on June 26, 2015. A vacuum truck was used to recover approximately 3 bbls of oil, and a backhoe was used to scrape the saturated soil for disposal.

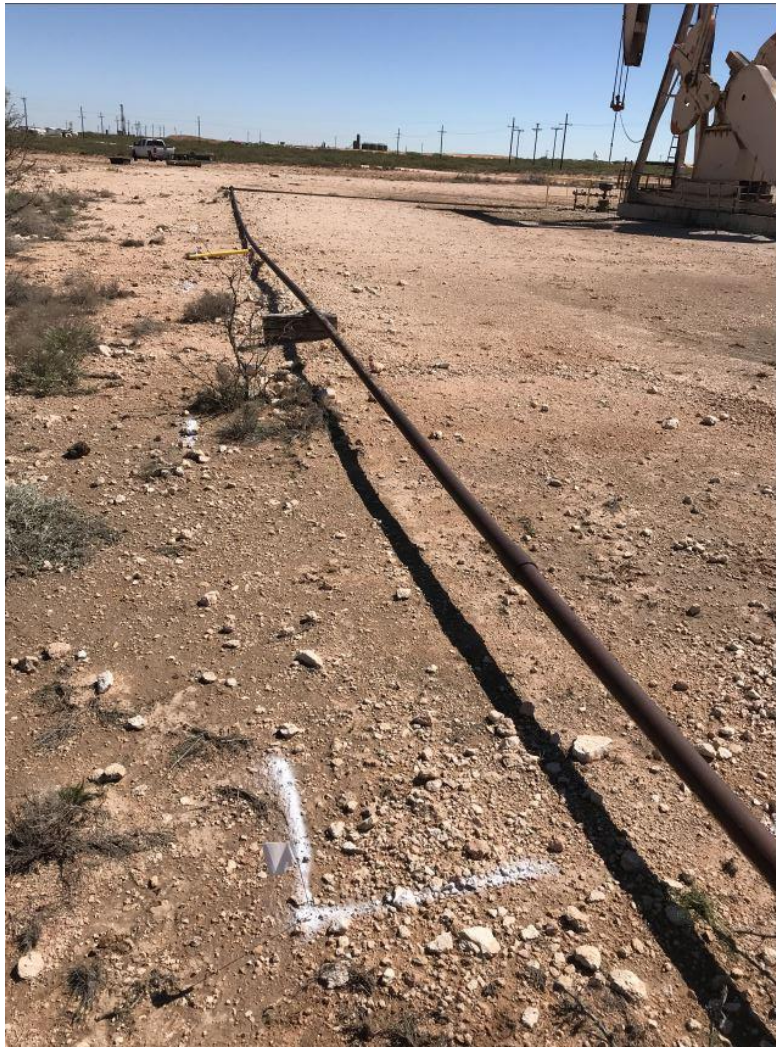
**View of release area prior to excavation.**

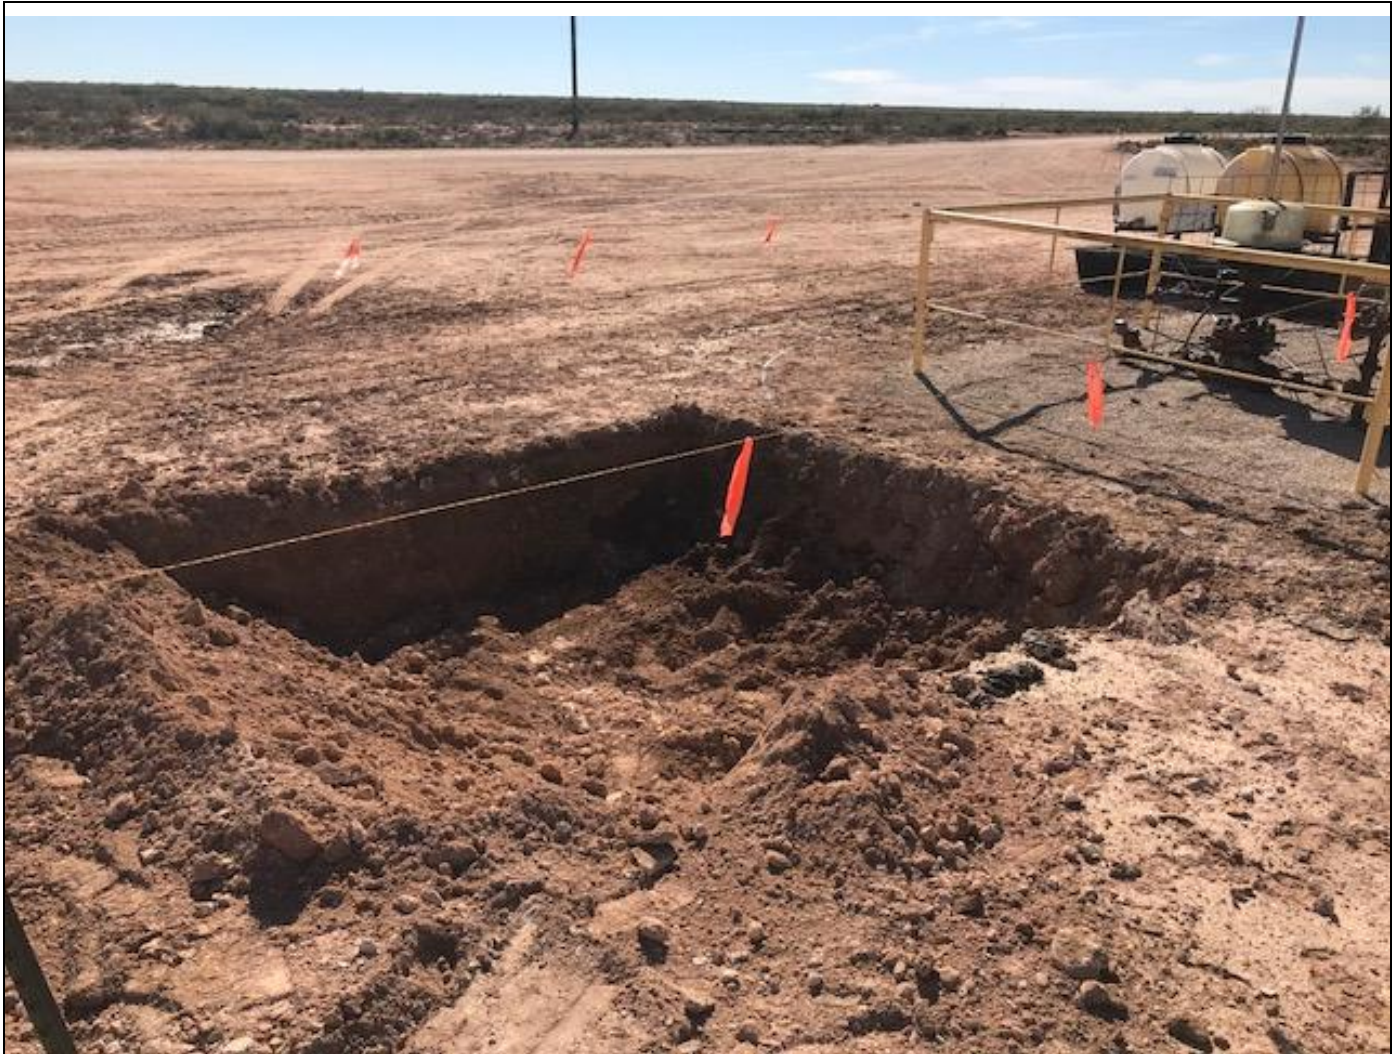
**Southeast facing view of the smaller excavation.**

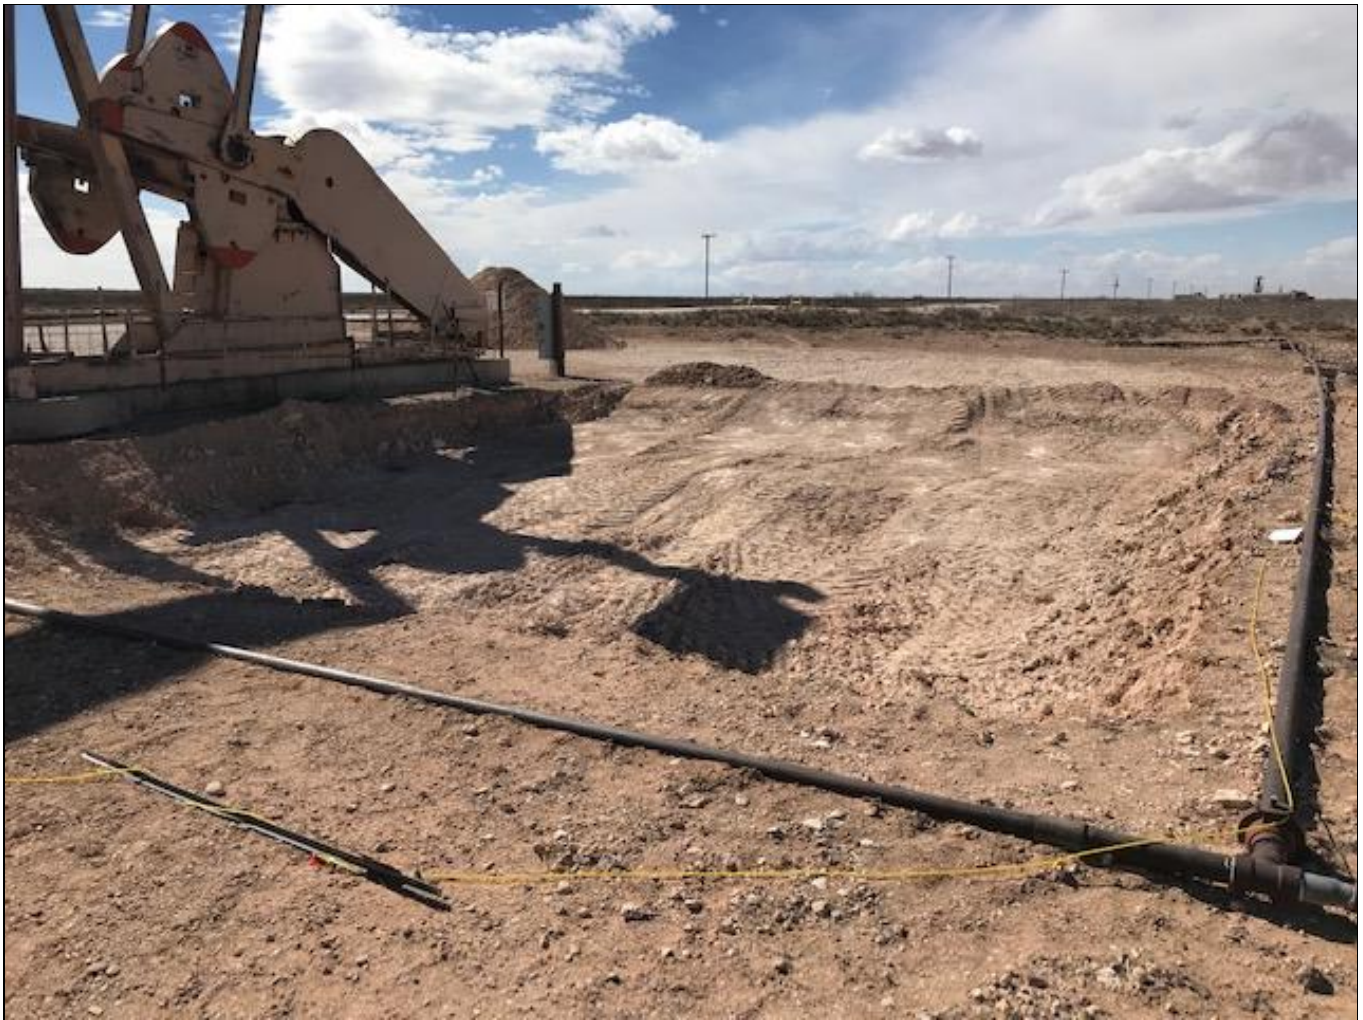
**West facing view of the larger excavation.**
