**Re: Site Assessment, Liner Inspection, and Closure Report
 Loco Hills SWD 35 #2
 API No. 30-015-37268
 GPS: Latitude 32.7860909 Longitude -103.9436874
 UL "N", Sec. 35, T17S, R30E
 Eddy County, NM
 NMOCD Ref. No. NRM2033528219**

Paragon Environmental, LLC (Paragon) has been contracted by Spur Energy Partners (Spur) to perform a site assessment, conduct a liner inspection, and write a closure report for the release site known as the Loco Hills SWD 35 #2. Details of the release are summarized below:

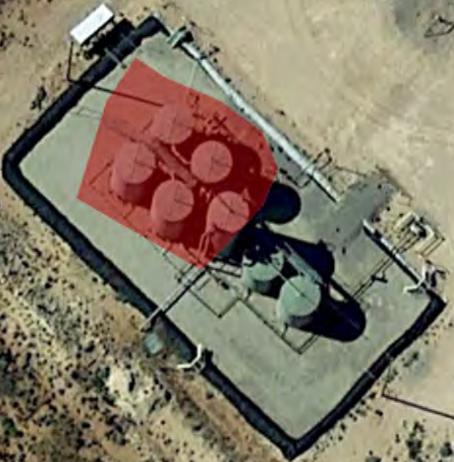
Loco Hills SWD 35 #2
API 30-015-37268
Eddy County, NM
Site Map

Legend
Spill Area

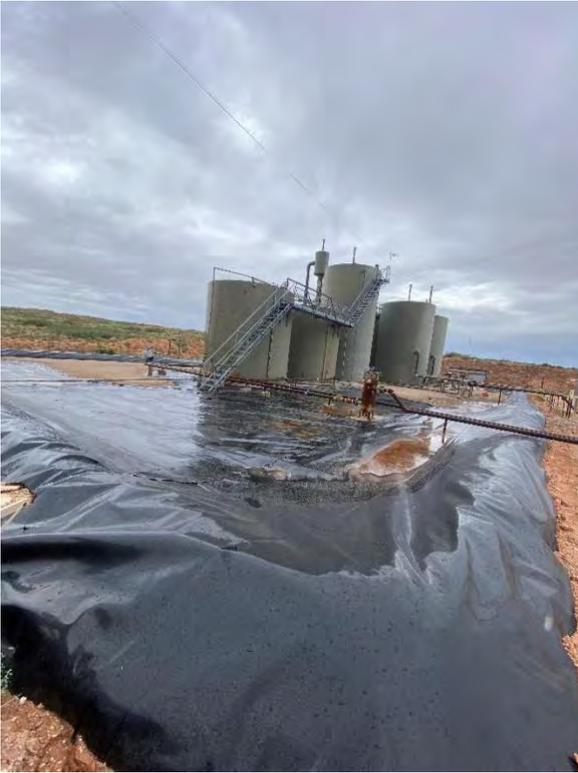
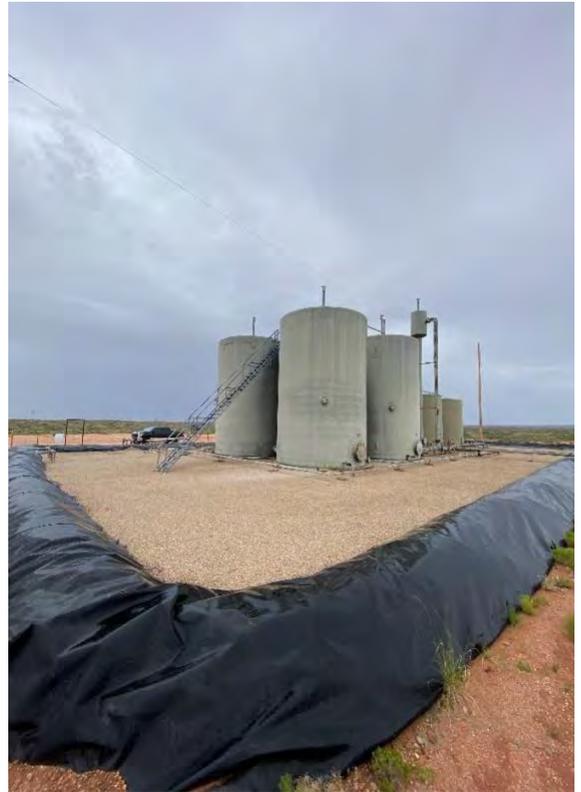
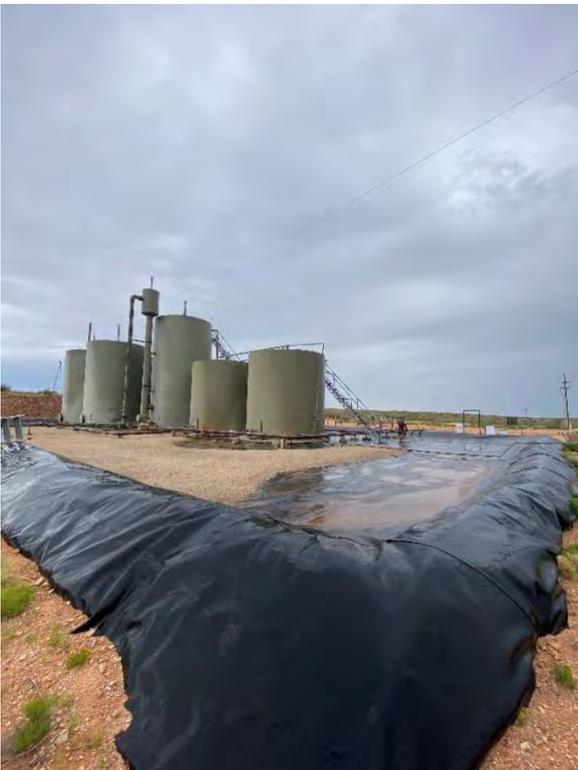
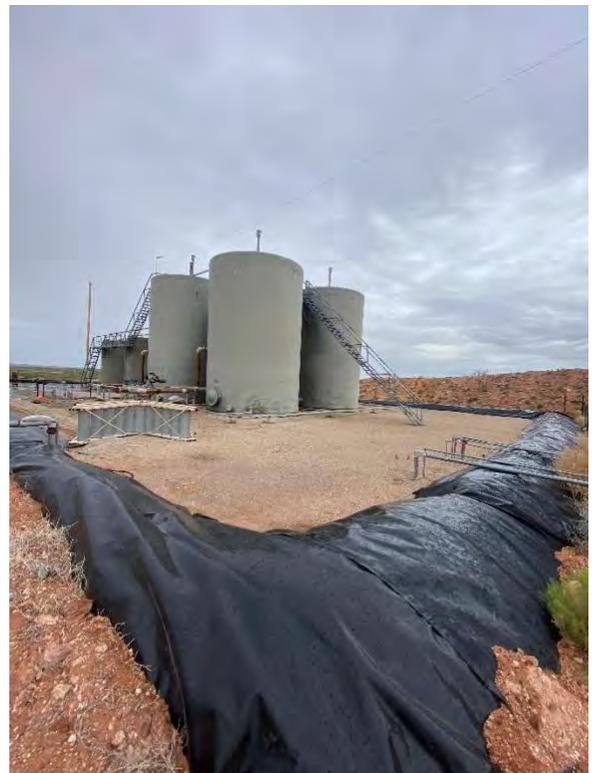
Liner Inspection

Because the spill had already been cleaned, we moved to closure by conducting a liner inspection. On August 3, 2022, an email was sent to the OCD advising that we would be conducting a liner inspection on August 6, 2020. The liner inspection found no evidence that the liner had been breached, no damages were found, and the liner inspection passed.

Visualization	Yes	No	Comments
Is there a tear in the liner?		x	
Are there holes in the liner?		x	
Is the liner retaining any fluids?		x	
Does the liner have integrity to contain a leak?	x
