I Release Notification

Site Name: Riddle Gas Com A #1R	Site Type: Well Site
Date Release Discovered: 8/25/2022	API# (if applicable) 30-045-31138

On August 25, 2022, approximately 13 barrels of condensate and 3 barrels of produced water were released from an above ground storage tank at the Riddle Gas Com A #1R wellsite (30-045-31138) S09, T27N, R09W, Unit G. The release was due to corrosion around the manway door of the tank. The release was discovered at 1:00 PM MST on August 25, 2022 and was reported to NMOCD on 9/1/2022.

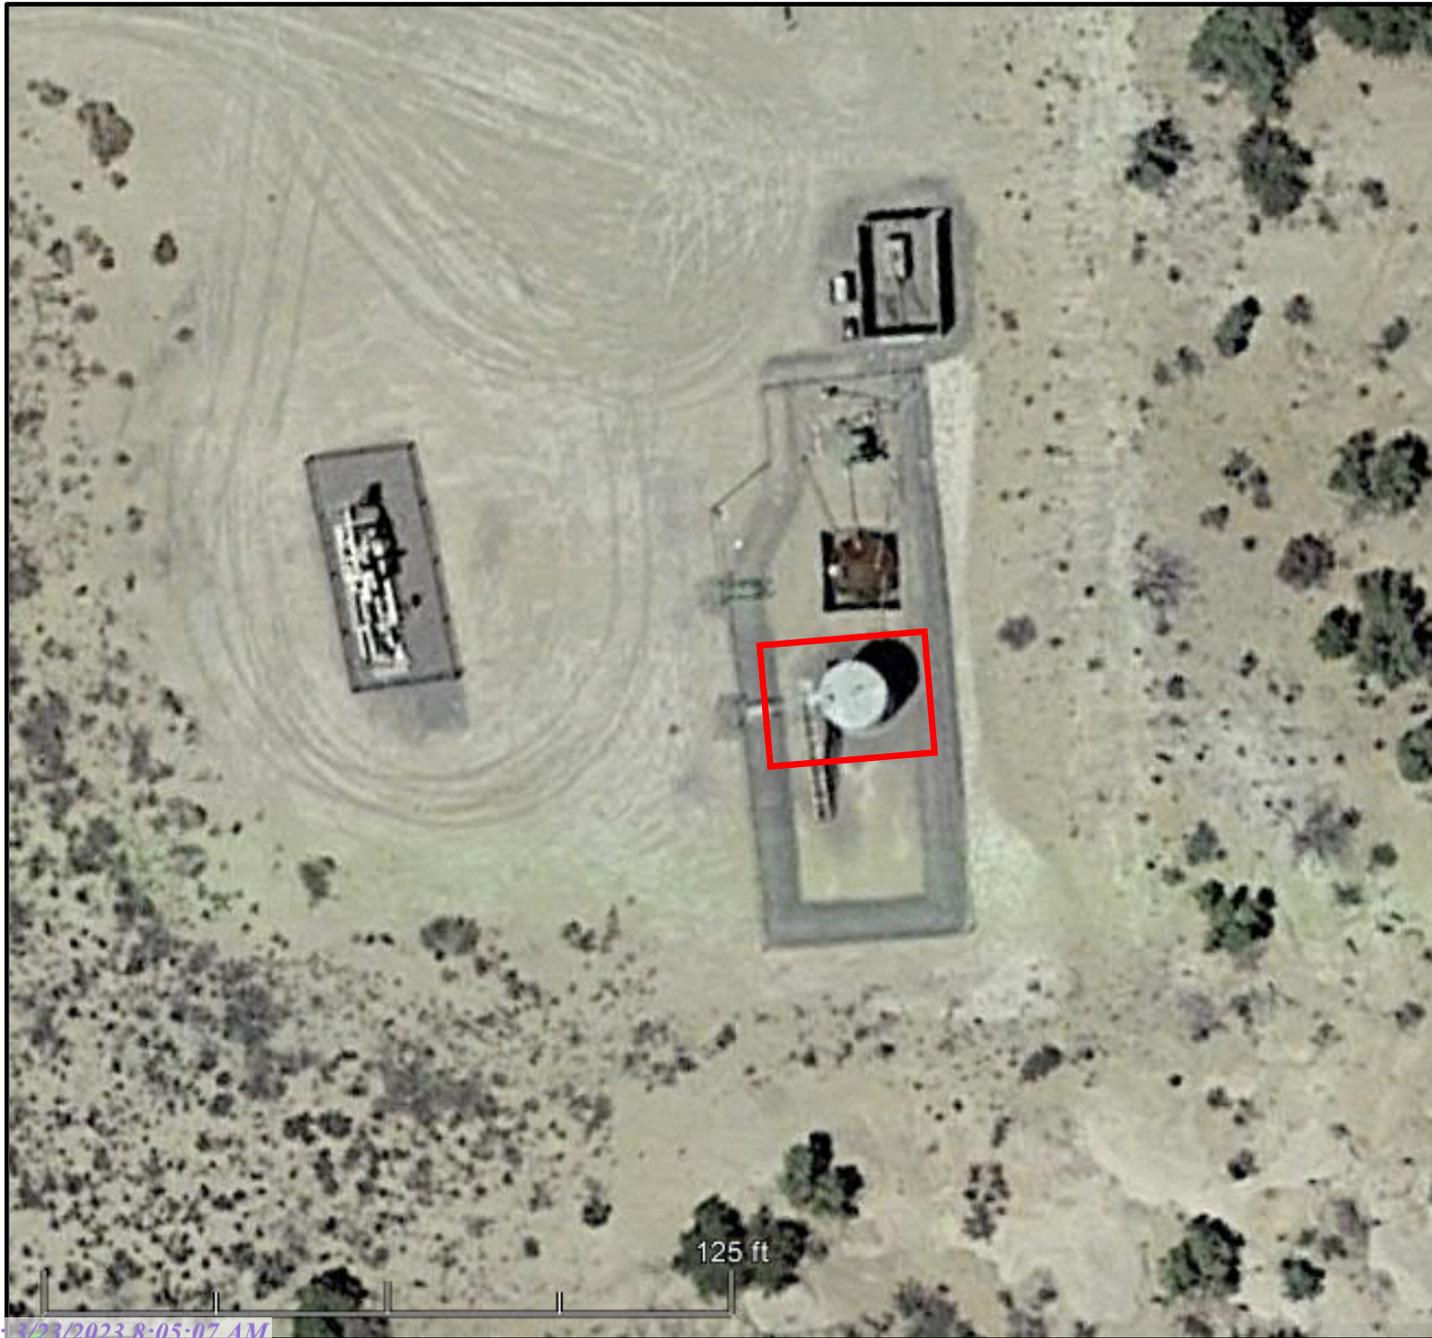
Release Area

The operator conducting daily checks discovered corrosion around the man way door. The release remained inside the berm. No fluids were recovered. There was no immediate danger to the public and no fire occurred as a result of the release. The well was shut in and the tank drained for inspection and repair prior to being put back into service.

Impacted soil was removed and transported offsite for disposal. Six (6) 5-point composite samples were collected from the excavated area on December 27, 2022. One additional 5-point composite sample was collected from the south sidewall on March 8, 2023. Analytical results from this sampling event were below NMOCD action criteria noted in NMAC 19.15.29 Table 1. Sample diagram and analytical results are included in this summary report.

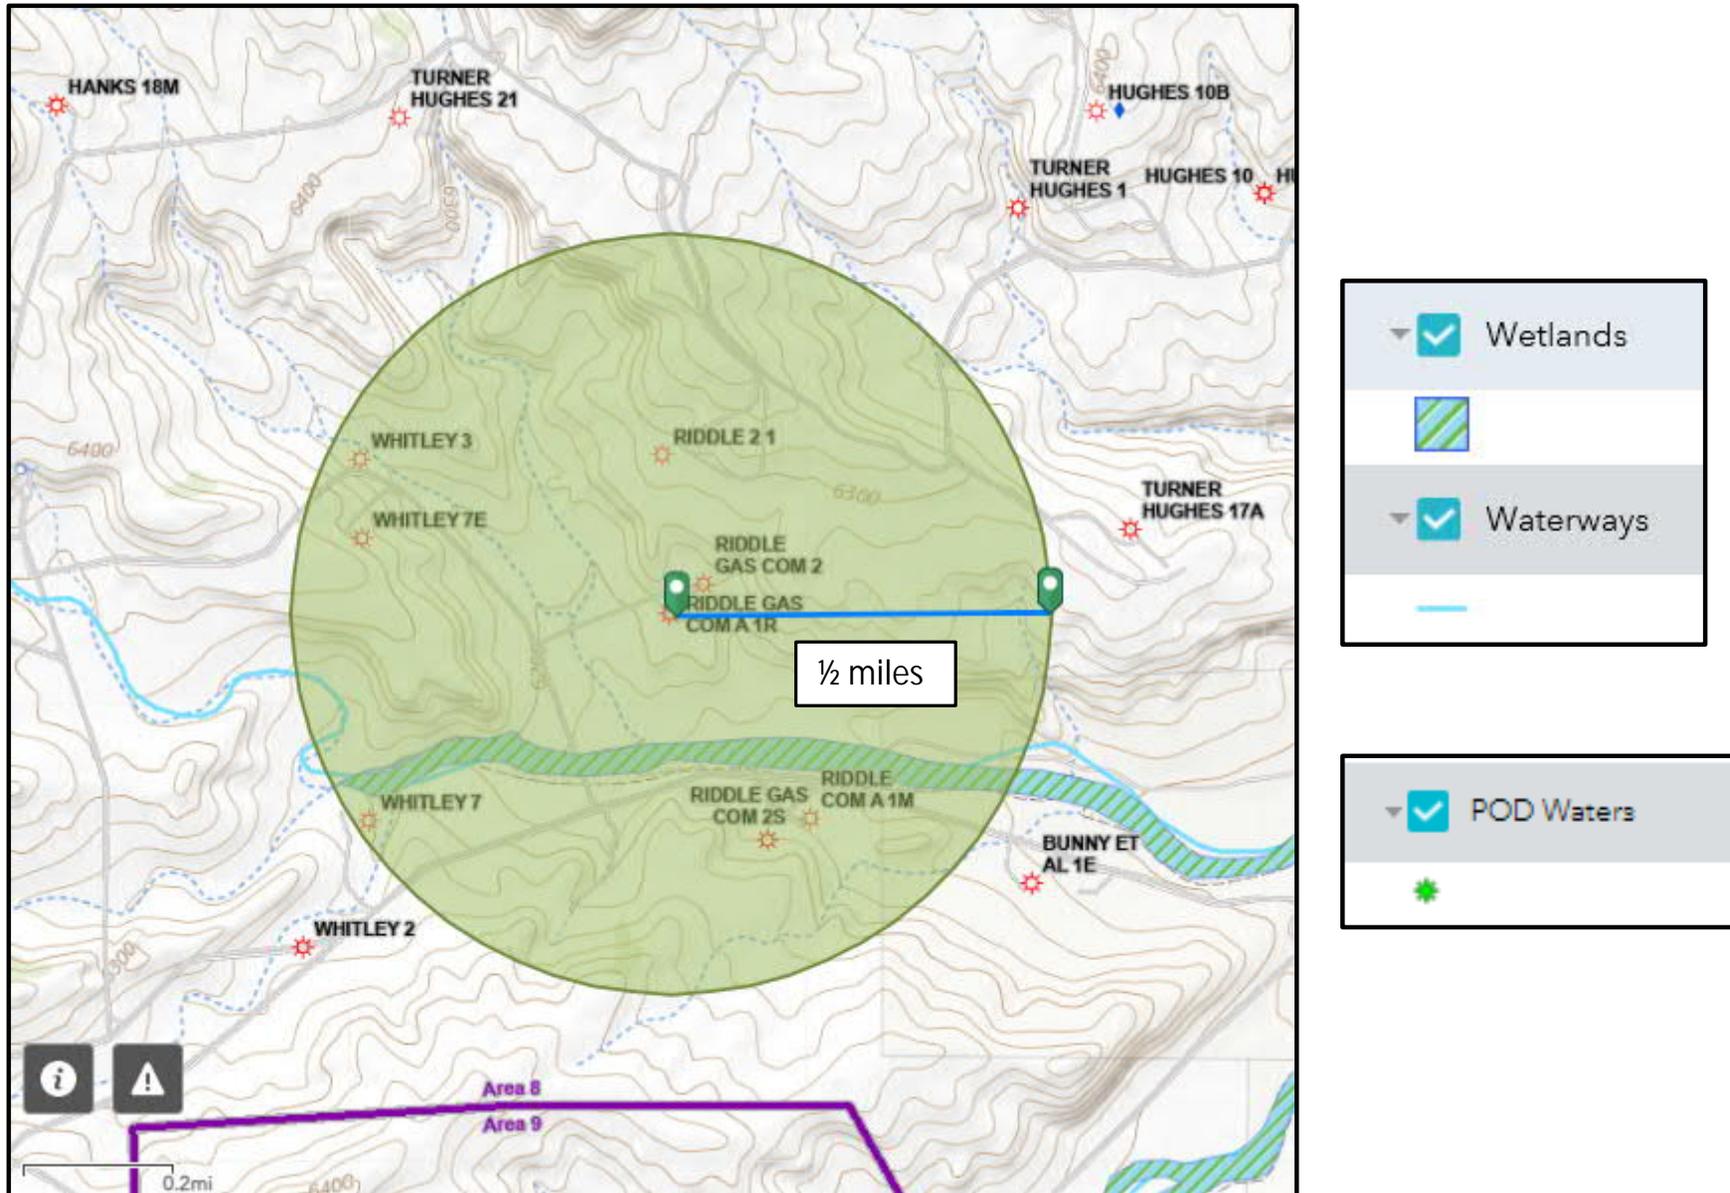
Determination of water sources and significant watercourses within ½ mile of the lateral extent of the release

Note 1: Release point is not within 300 ft of a continuously flowing watercourse or other significant water course.

Note 2: The lateral extents of the release point are not shown to be within 300 feet of a mapped wetland.

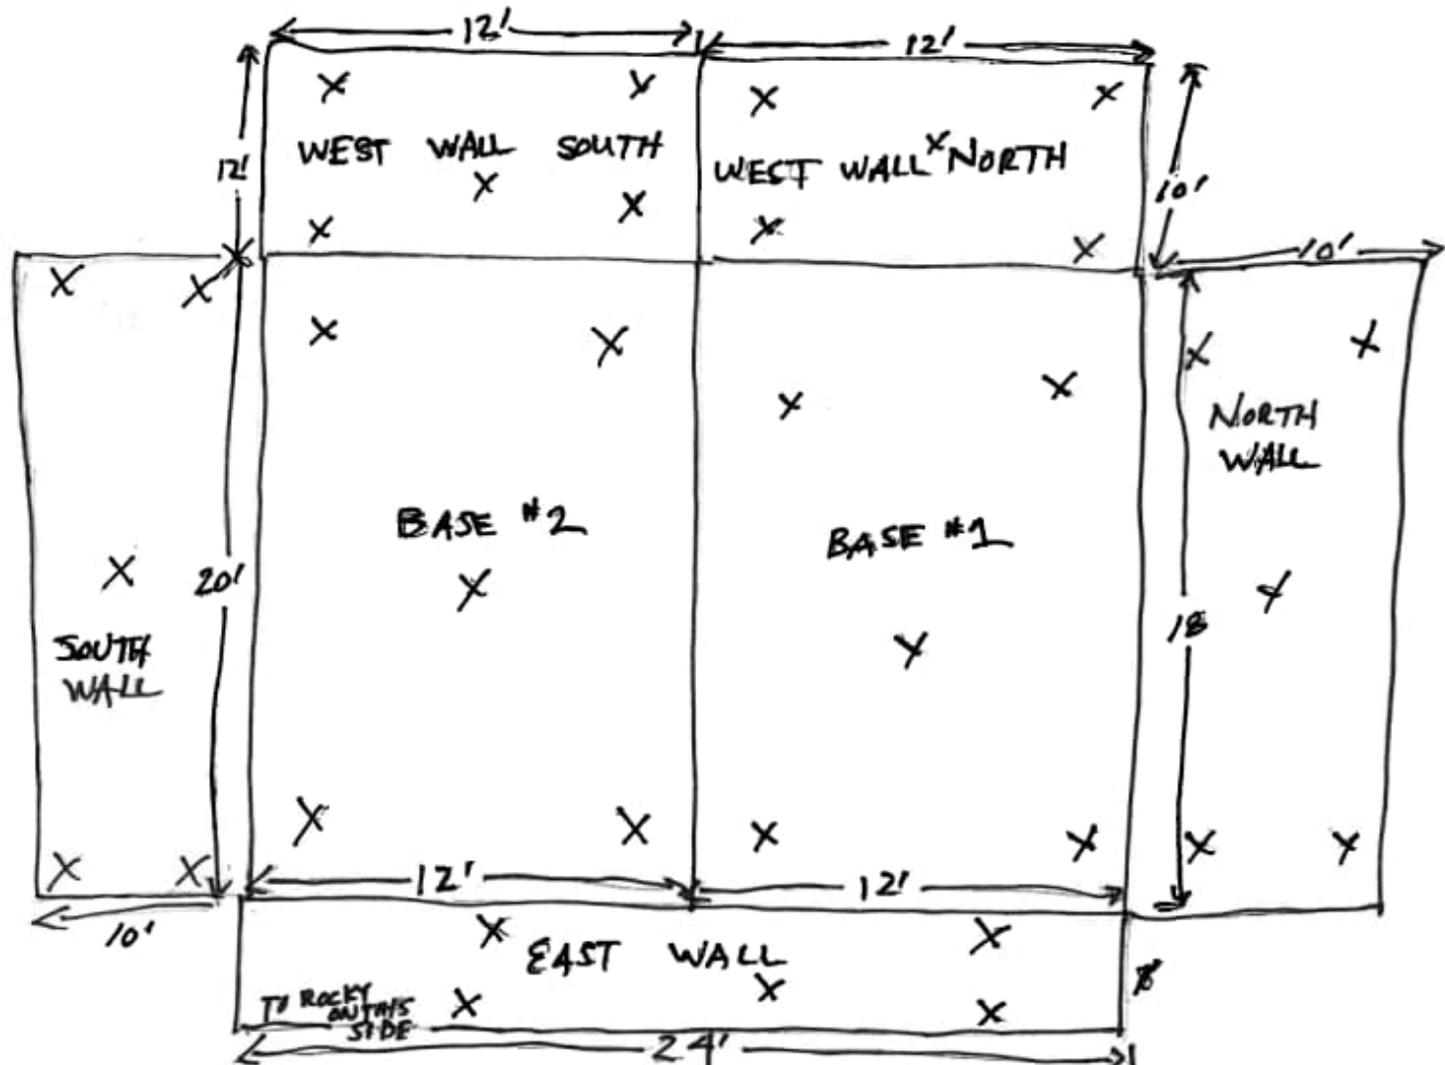
Field Sample Diagram

Confirmation samples were collected on 12/27/2022 and 3/8/2023 by Hilcorp personnel and all results were below NMOCD 19.15.29.12.D Table 1 closure criteria.

Pulled 2' of good over burden on this side.
