LT Environmental, Inc.

May 10, 2019

**RE: Deferral Request  
Hat Mesa 31-32 Tank Battery  
Remediation Permit Number 1RP-3143, 1RP-3726, and 1RP-4072  
Lea County, New Mexico**

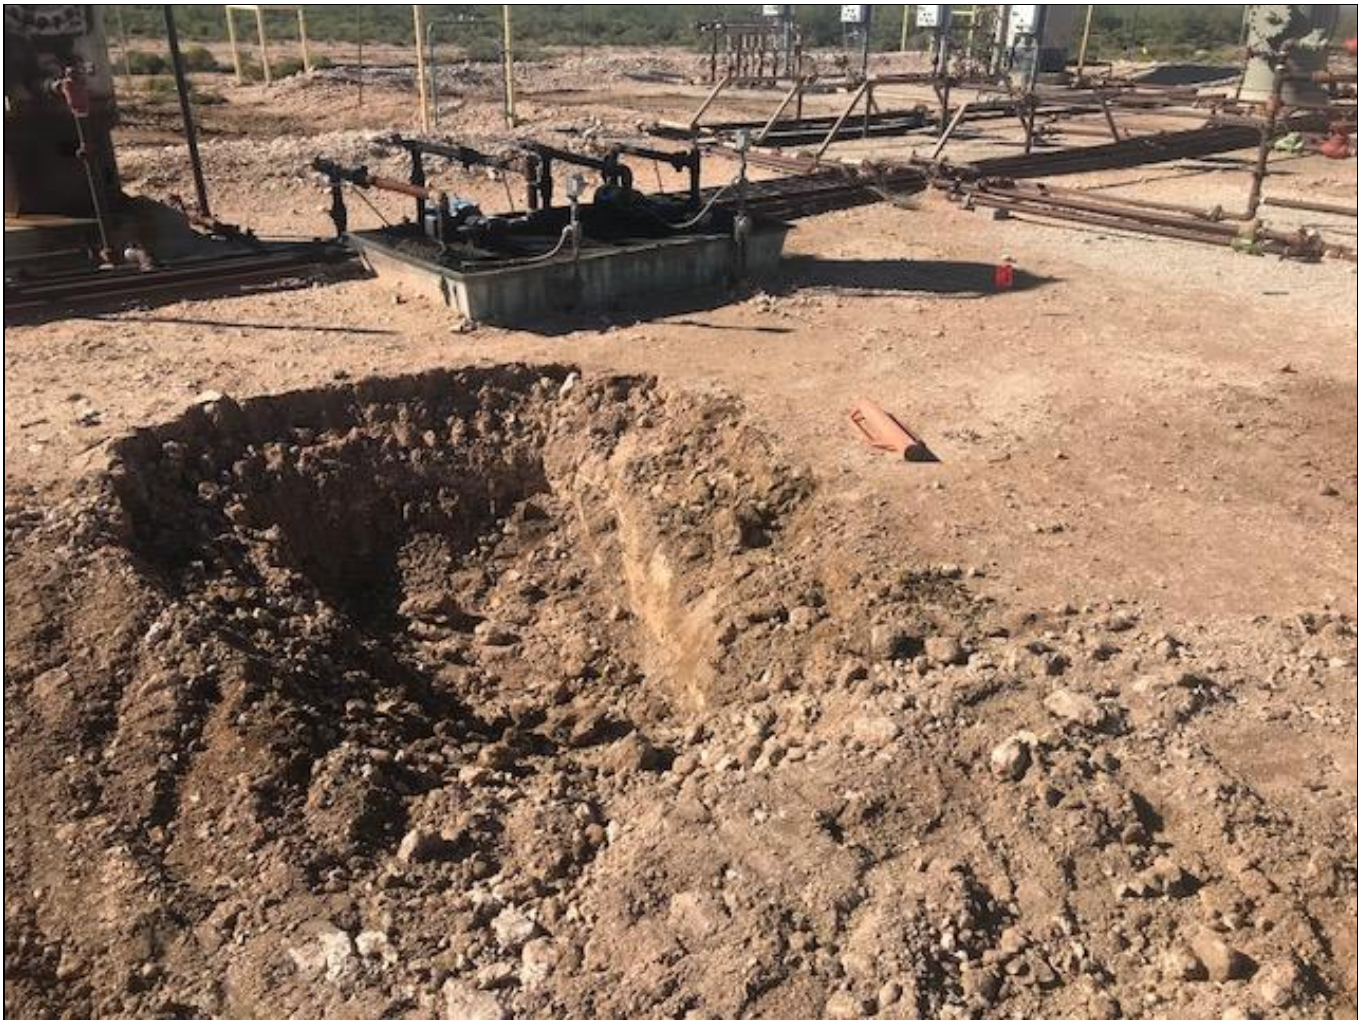
±1.50 TI-0LYE y2WUK of the northern excavation
