**Subject: Closure Letter Report  
ConocoPhillips  
1RP-5062  
EVGSAU Satellite #3 Trunk Line Release  
PLSS Unit Letter H, Section 32, Township 17 South, and Range 35 East  
Lea County, New Mexico**

**EVGSAU SATELLITE #3 TRUNKLINE RELEASE  
SITE LOCATION MAP**

**ATTACHMENT C**  
**Photographic Documentation**

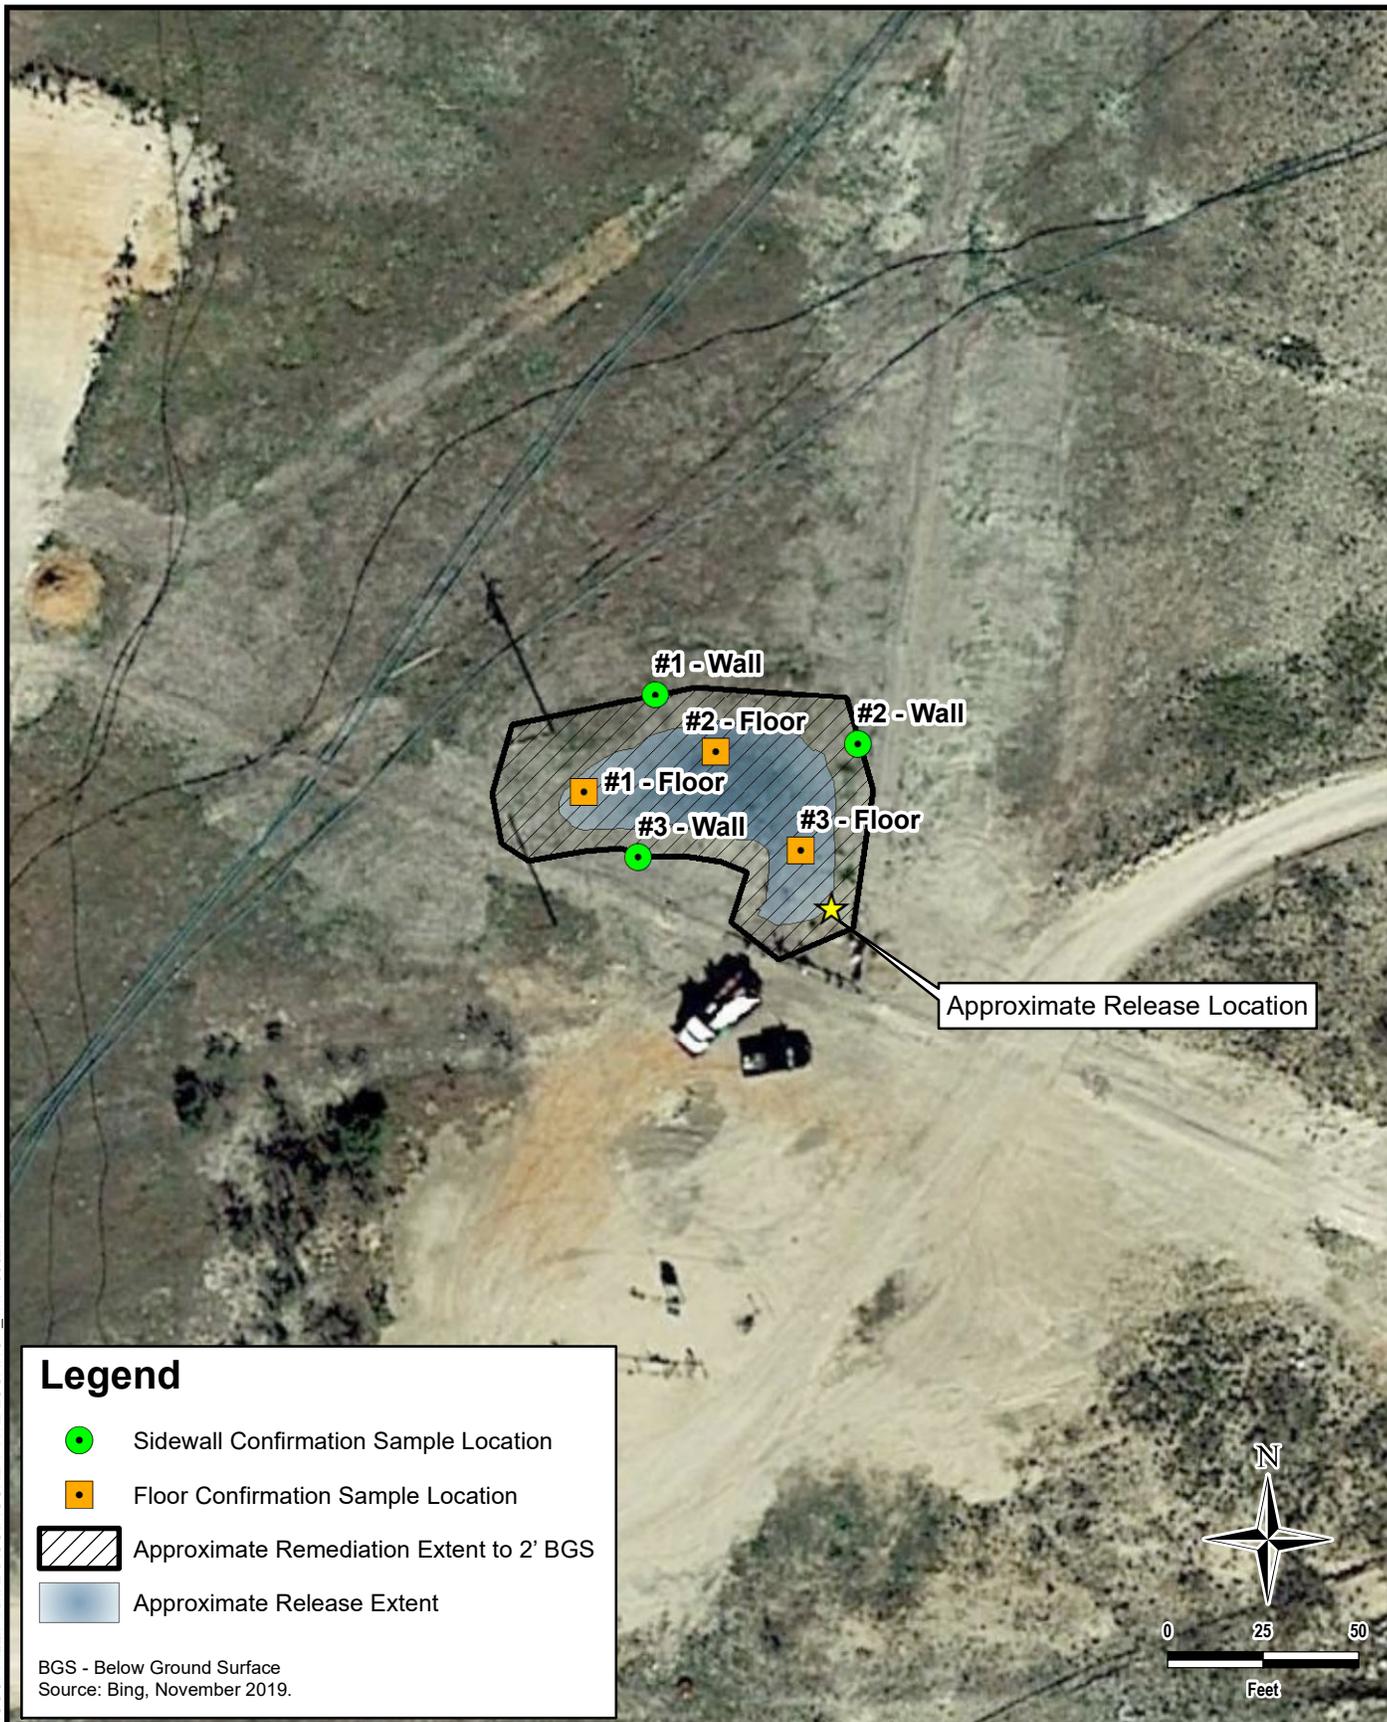
Figure No.

- Sidewall Confirmation Sample Location
- Floor Confirmation Sample Location
- Approximate Remediation Extent to 2' BGS
- Approximate Release Extent

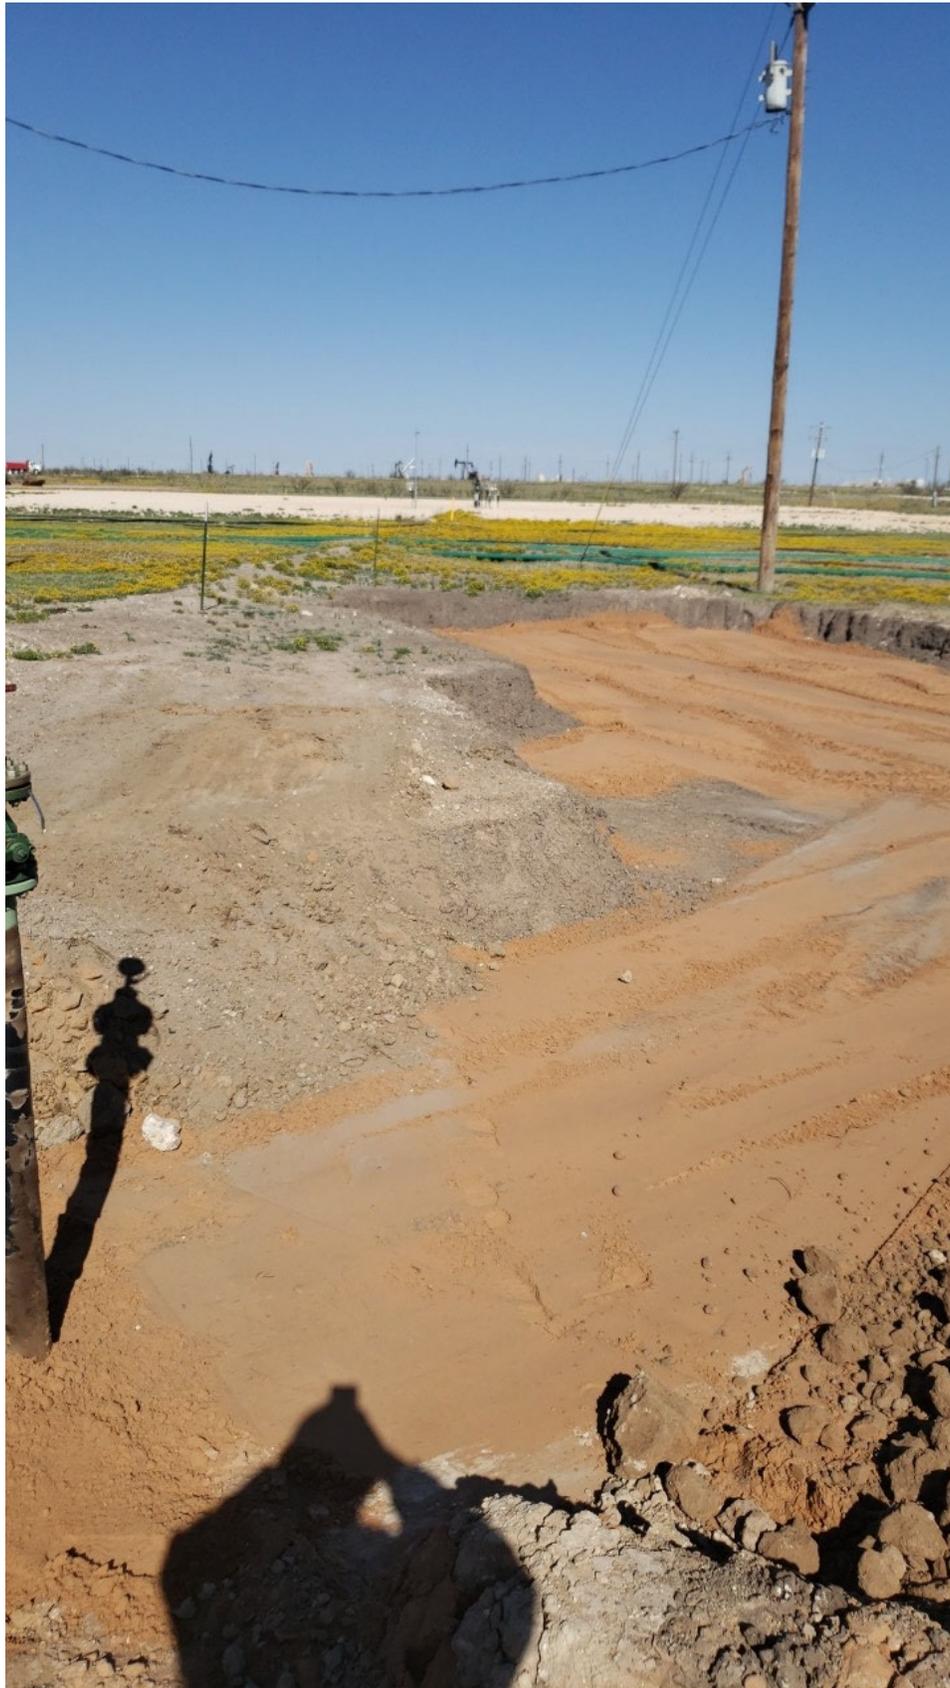
TETRA TECH, INC. PROJECT NO. 212C-MD-02152	DESCRIPTION	View facing east of excavation area.	1
	SITE NAME	EVGSAU Satellite 3 Trunk Line Release	04/17/2019

In accordance with 19.15.29.8. B. (4) NMAC that states "the responsible party may commence remediation immediately after discovery of a release", ConocoPhillips elected to begin remediation of the impacted area in April 2019. Remedial activities included excavating the visibly impacted soils. The visible footprint of the release was excavated to approximately 2 ft below ground surface (bgs). Photographic documentation of the remedial activities is included in Attachment C, photos 1 and 2.

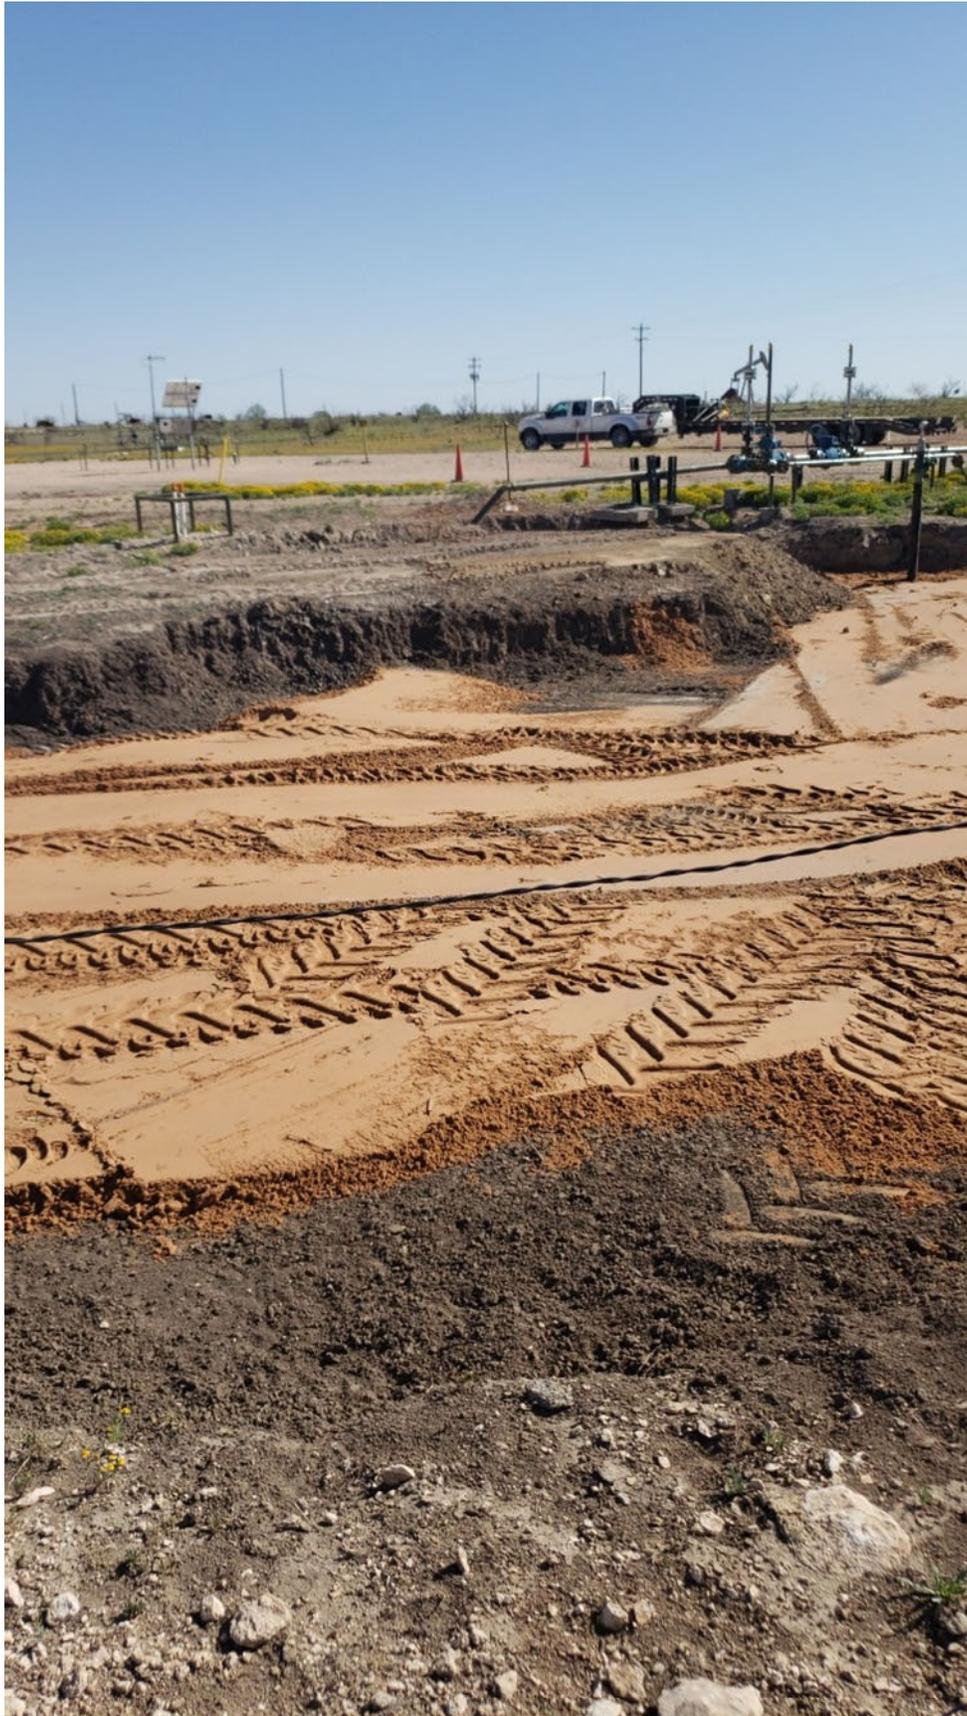
TETRA TECH, INC. PROJECT NO. 212C-MD-02152	DESCRIPTION	View facing south of excavation area.	2
	SITE NAME	EVGSAU Satellite 3 Trunk Line Release	04/17/2019

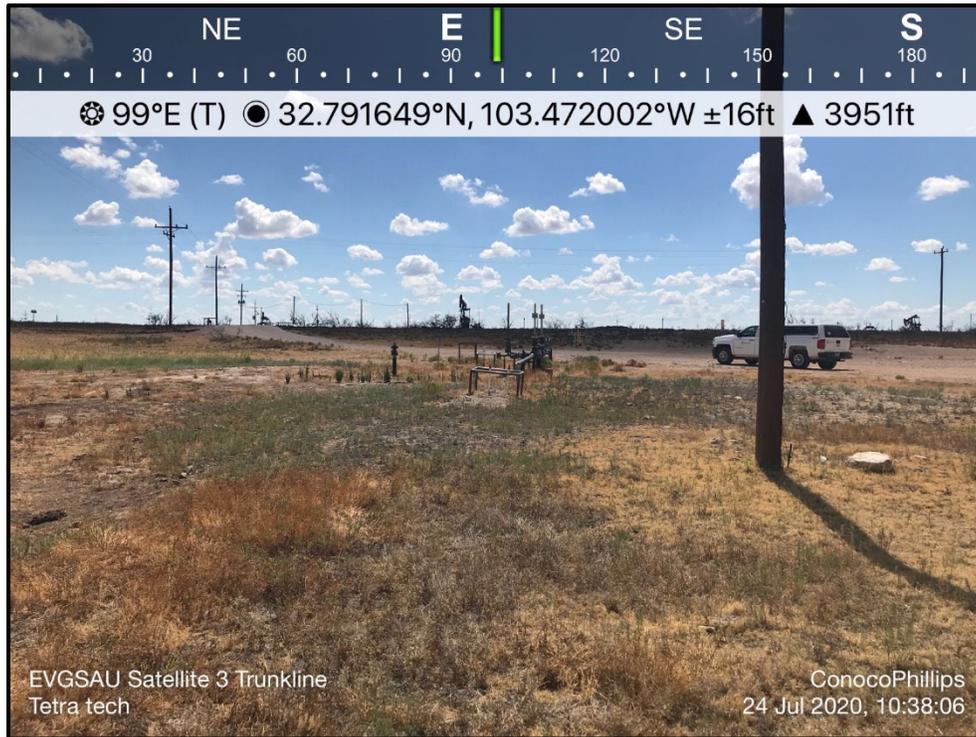
TETRA TECH, INC. PROJECT NO. 212C-MD-02152	DESCRIPTION	View facing east of release area.	3
	SITE NAME	EVGSAU Satellite 3 Trunk Line Release	7/24/2020

From review of recent aerial photography and the visual Site inspection, it appears that the formerly impacted surface areas were restored to the conditions that existed prior to the release in accordance with 19.15.29.13 NMAC (Attachment C). The lease road areas remain unvegetated by design, as they are needed for production operations.

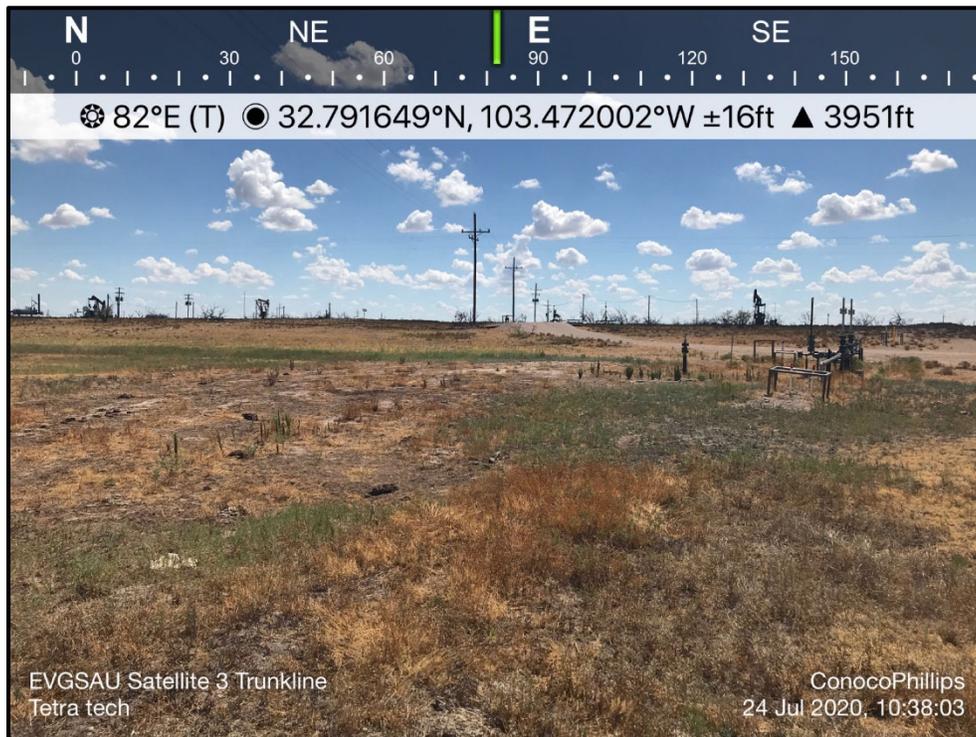
TETRA TECH, INC. PROJECT NO. 212C-MD-02152	DESCRIPTION	View facing east of release area.	4
	SITE NAME	EVGSAU Satellite 3 Trunk Line Release	7/24/2020

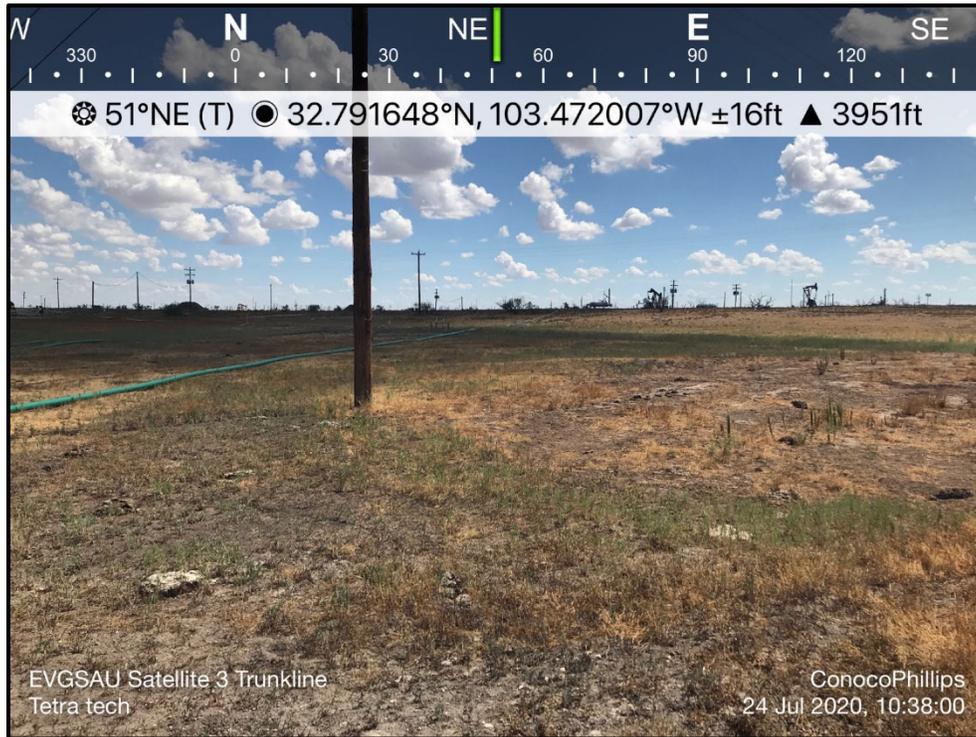
TETRA TECH, INC. PROJECT NO. 212C-MD-02152	DESCRIPTION	View facing northeast of release area.	5
	SITE NAME	EVGSAU Satellite 3 Trunk Line Release	7/24/2020

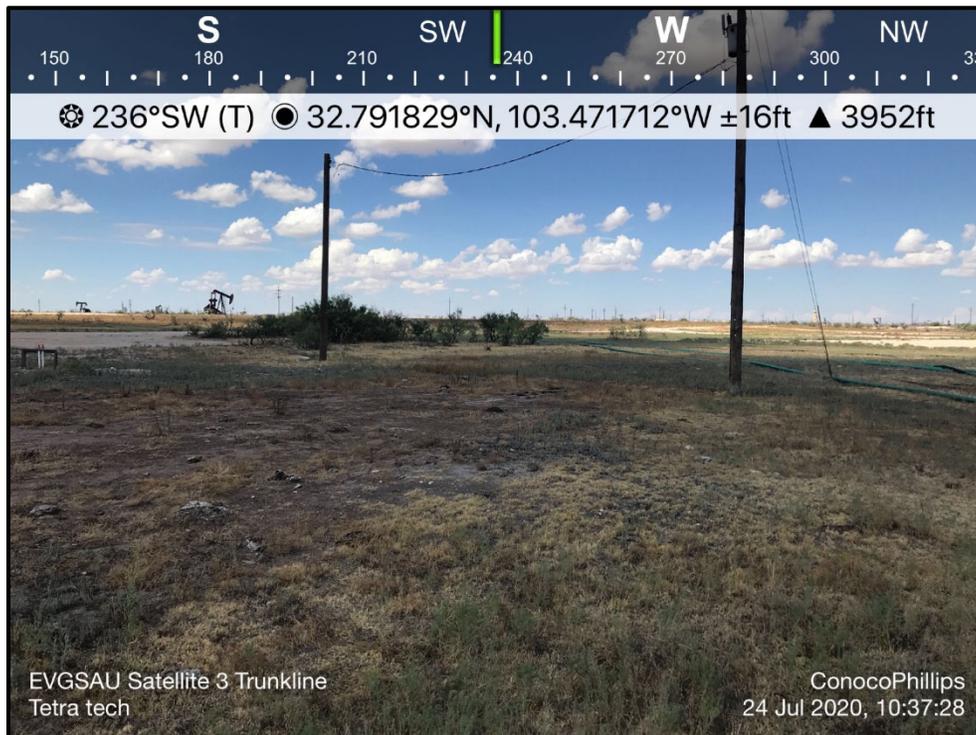
TETRA TECH, INC. PROJECT NO. 212C-MD-02152	DESCRIPTION	View facing southwest of release area.	6
	SITE NAME	EVGSAU Satellite 3 Trunk Line Release	7/24/2020

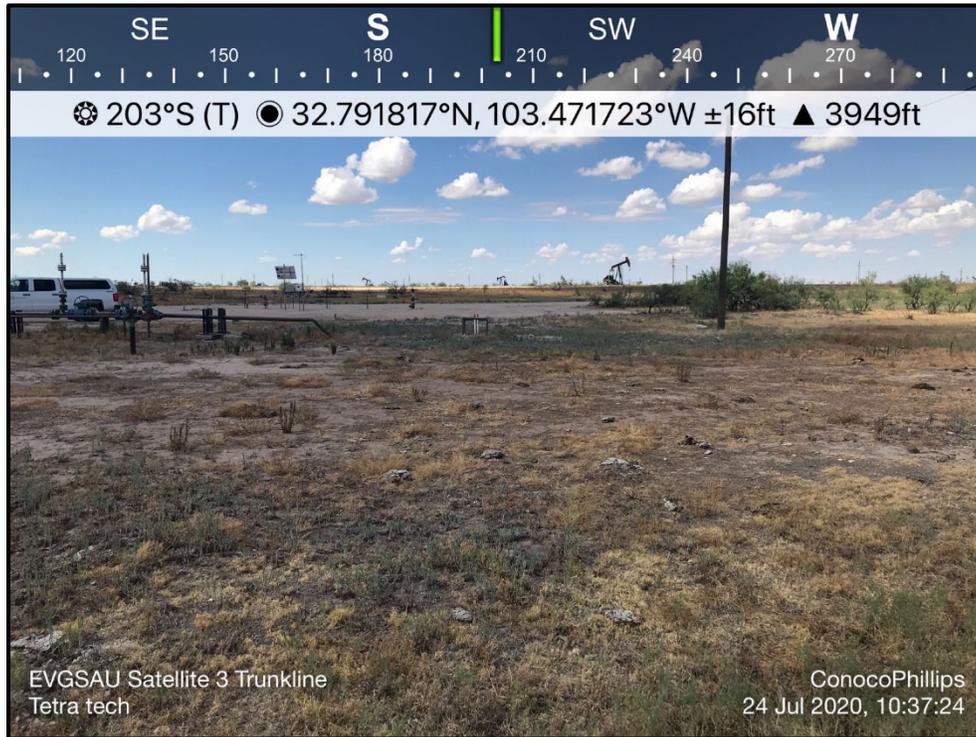
TETRA TECH, INC. PROJECT NO. 212C-MD-02152	DESCRIPTION	View facing south of release area.	7
	SITE NAME	EVGSAU Satellite 3 Trunk Line Release	7/24/2020

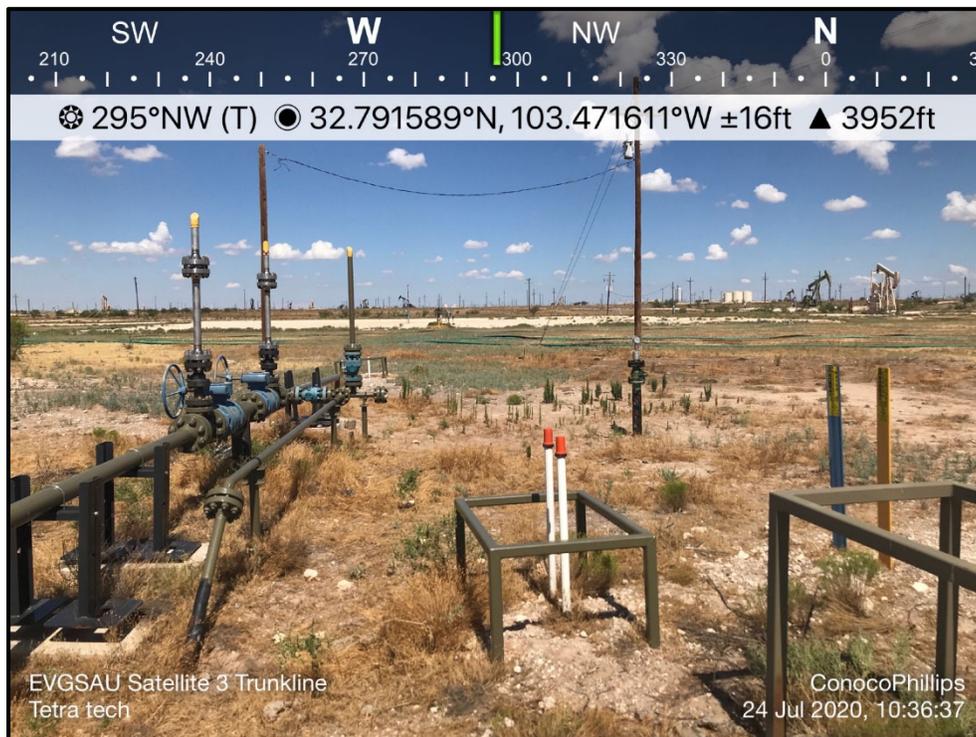
TETRA TECH, INC. PROJECT NO. 212C-MD-02152	DESCRIPTION	View facing west of above ground piping at release area.	8
	SITE NAME	EVGSAU Satellite 3 Trunk Line Release	7/24/2020
