**SITE CHARACTERIZATION UPDATE AND PROPOSED
REMEDATION PLAN**

**FEDERAL CM COM #1 (WELLHEAD AREA)
UNIT M, SECTION 12, TOWNSHIP 19S, RANGE 24E
EDDY COUNTY, NEW MEXICO
32.67054, -104.54807
RANGER REFERENCE NO. 5375**

**EOG RESOURCES, INC.
ARTESIA DIVISION
105 S 4TH STREET
ARTESIA, NEW MEXICO 88210**

**RANGER ENVIRONMENTAL SERVICES, LLC
P.O. BOX 201179
AUSTIN, TEXAS 78720**

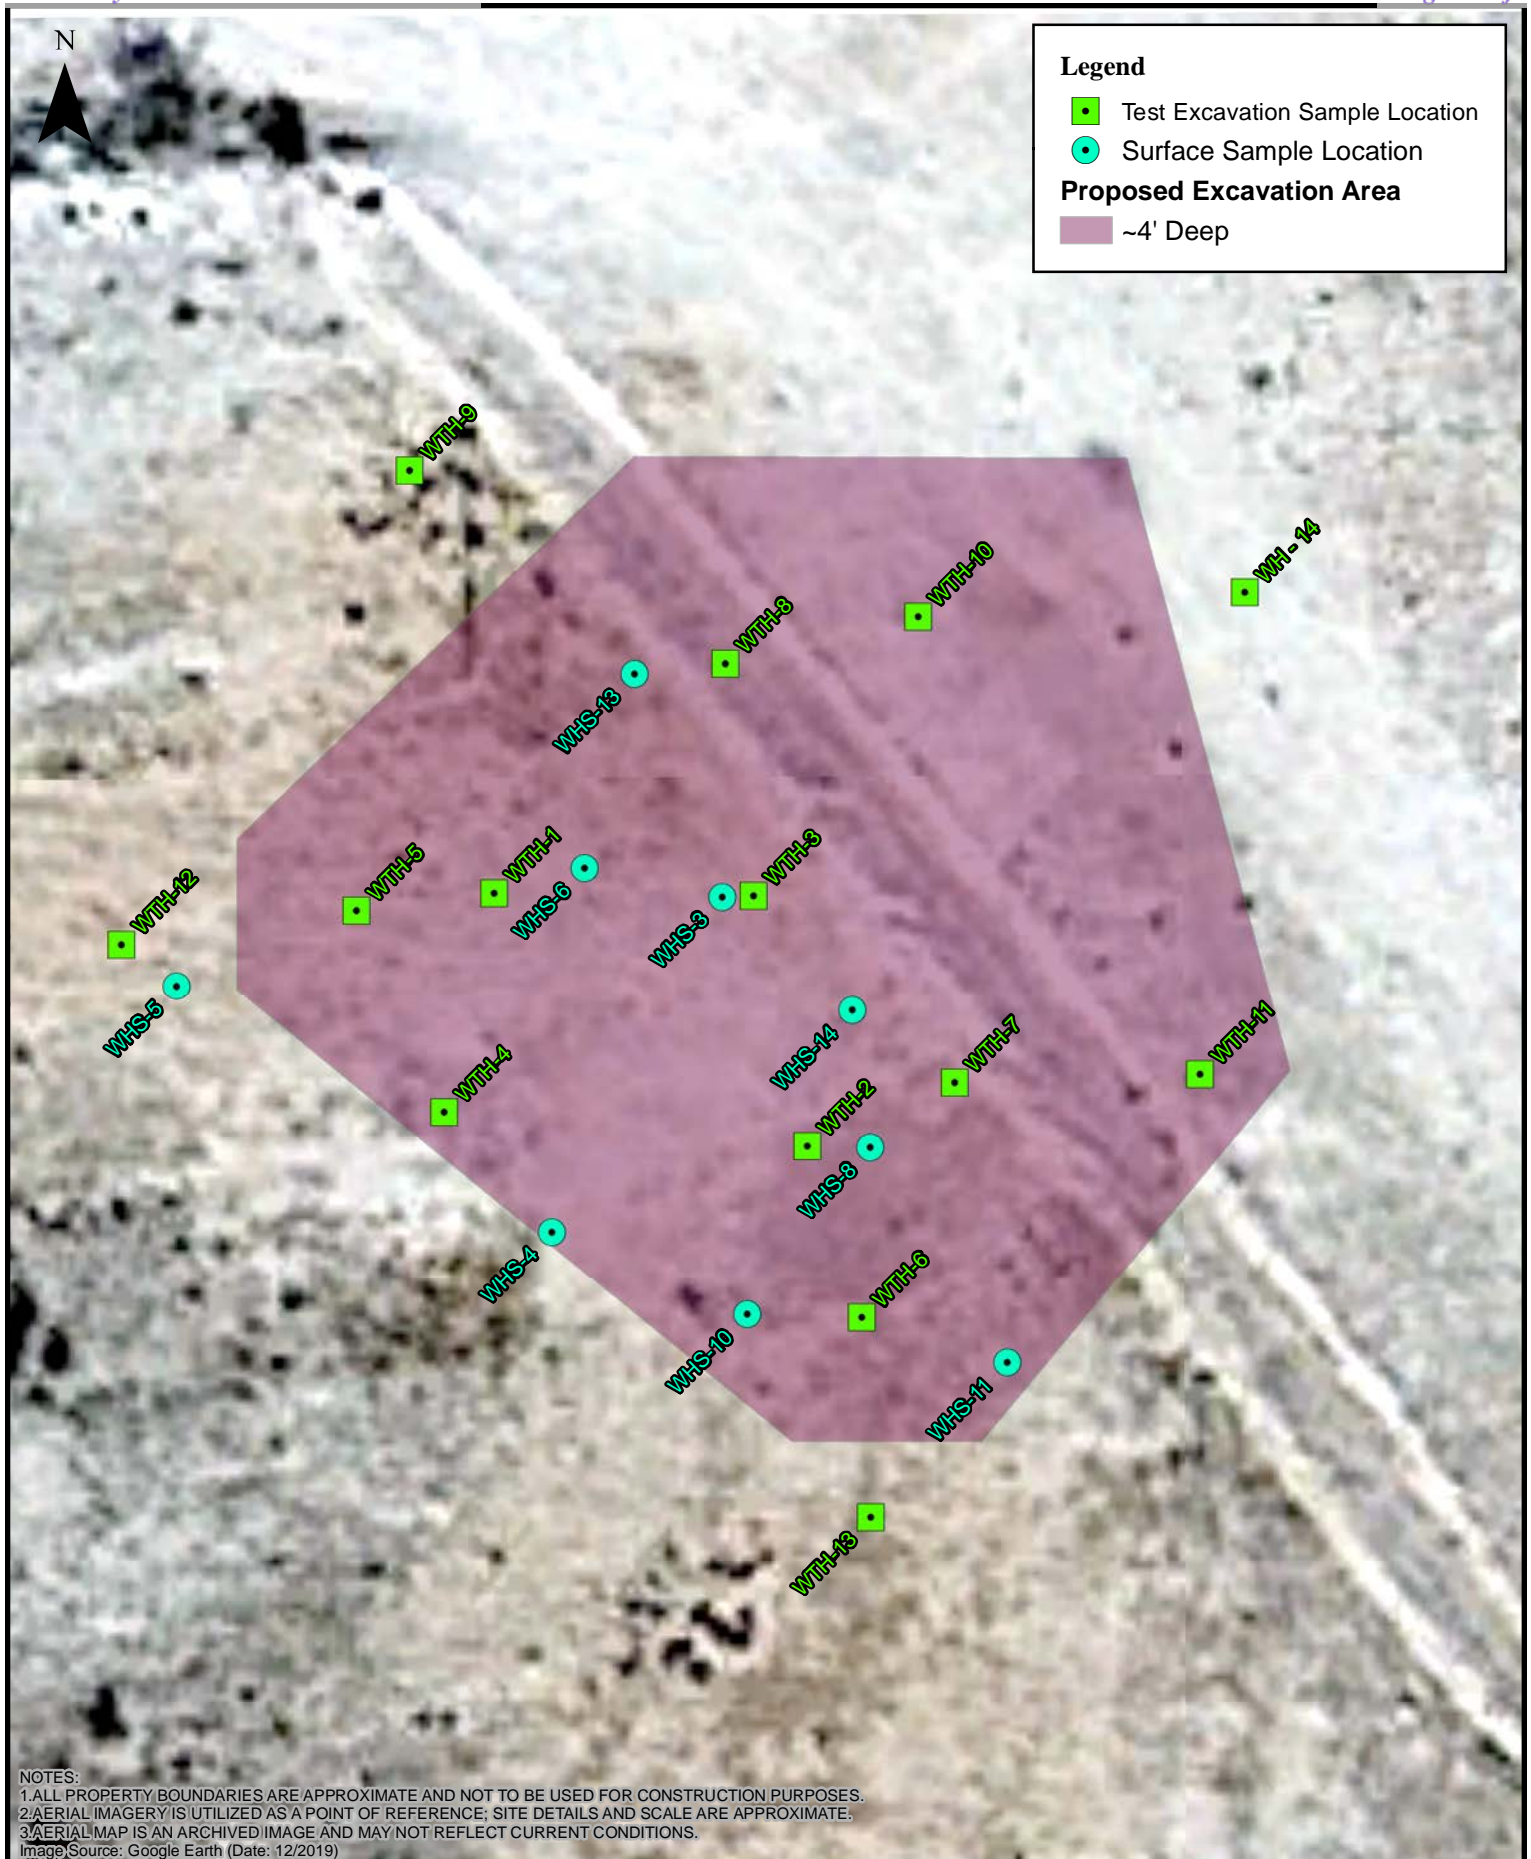
Proposed Excavation Area Map

The proposed excavation will be irregular in shape and have maximum dimensions of approximately 67 feet by 65 feet and will be completed to anticipated depths of approximately four feet bgs. A *Proposed Excavation Area Map* is attached which illustrates the proposed excavation boundaries and depths. It is anticipated that approximately 600 cubic yards of material will be generated during the site remediation process. The excavated material will be transported off-site for disposal at an approved disposal facility.

To address the elevated soil concentrations at the Site, soil removal operations are proposed. The proposed excavation activities at the Site are based upon the cumulative Site soil analytical and field screening data.

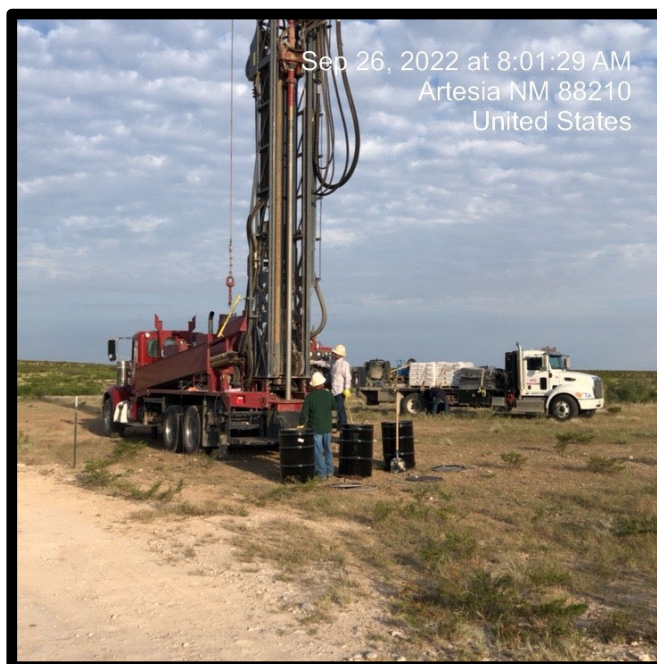
PHOTOGRAPH NO. 1 – A view of the soil boring/temporary well “SB-1” installation process. The view is towards the northwest.

In September 2022, Ranger representatives and HCI Drilling installed and gauged a soil boring/temporary monitor well ("SB-1") in order to obtain site-specific depth-to-groundwater information. The temporary monitor well was installed on September 26, 2022 at approximate GPS coordinates 32.66546743, -104.55115675, located within a half-mile radius of the Site. The soil boring was drilled to a depth of approximately 108 feet bgs utilizing air rotary drilling techniques and a two-inch diameter temporary monitor well was installed. The monitor well was allowed to equilibrate for 72 hours and was then gauged with a Heron Instruments electronic water level meter on September 29, 2022. The temporary monitor well was found to be dry, thus confirming that the area depth-to-groundwater is greater than 100 feet bgs. Upon completion of the depth-to-groundwater investigation activities, the temporary monitor well was properly plugged and abandoned.

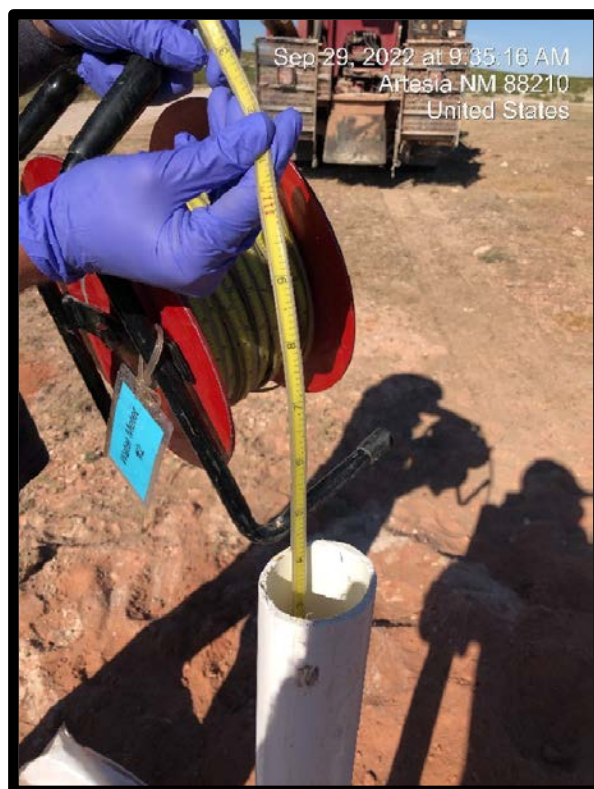
PHOTOGRAPH NO. 2 – A view of the “SB-1” gauging activities on September 29, 2022. The view is towards the west.

Based upon the results of the depth-to-groundwater investigation activities and the reviewed NMOSE information, the depth-to-groundwater in the area of the Site is confirmed to be greater than 100 feet bgs.
