**Vivian Battery
Remediation/Cleanup Work Plan
Section 30, T22S, R38E
Lea County, New Mexico**

**Chevron USA
P.O. Box 1949
Eunice, New Mexico 88231**

Vivian Battery Remediation/Cleanup Closure Report

**Section 30, T22S, R38E
Lea County, New Mexico**

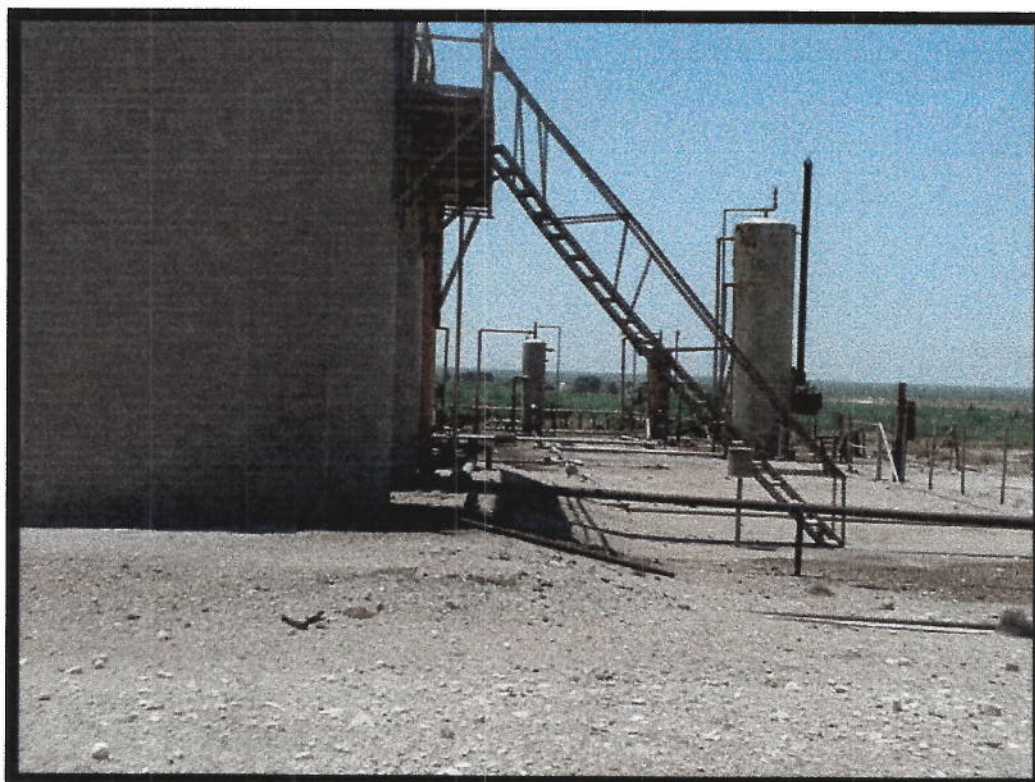
Photo #1 Before -South Pooling Area of Location East to West

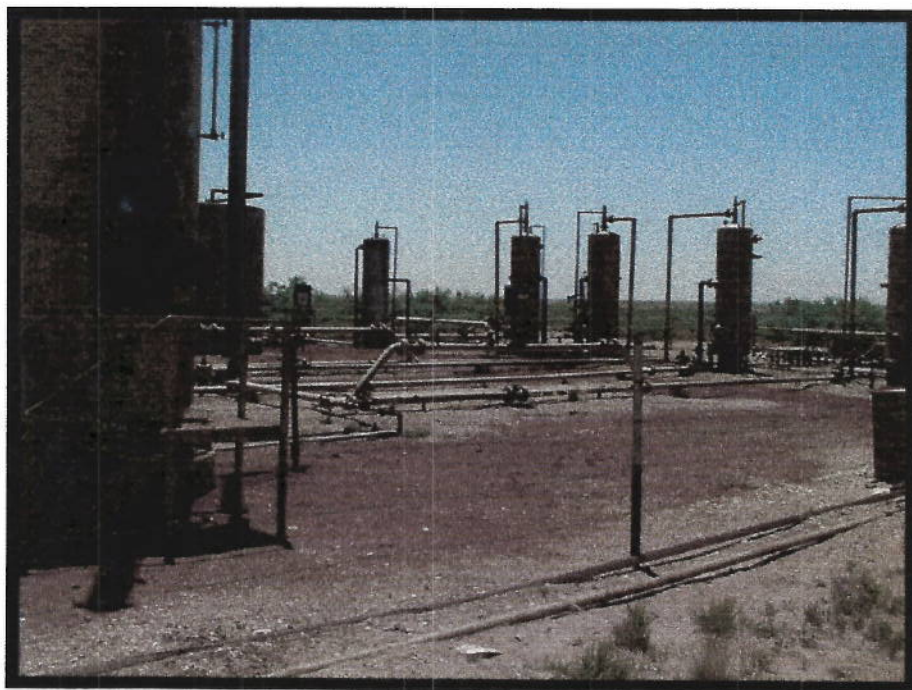
Phot #3 Before - Spill Area NE to SW Inside the Fence

Excavation inside the battery area began on June 6, 2000. As requested by Chevron, the contaminated soil was excavated to a depth of 18 inches. No field or laboratory analysis was conducted on the excavated soils or the soils left in place.

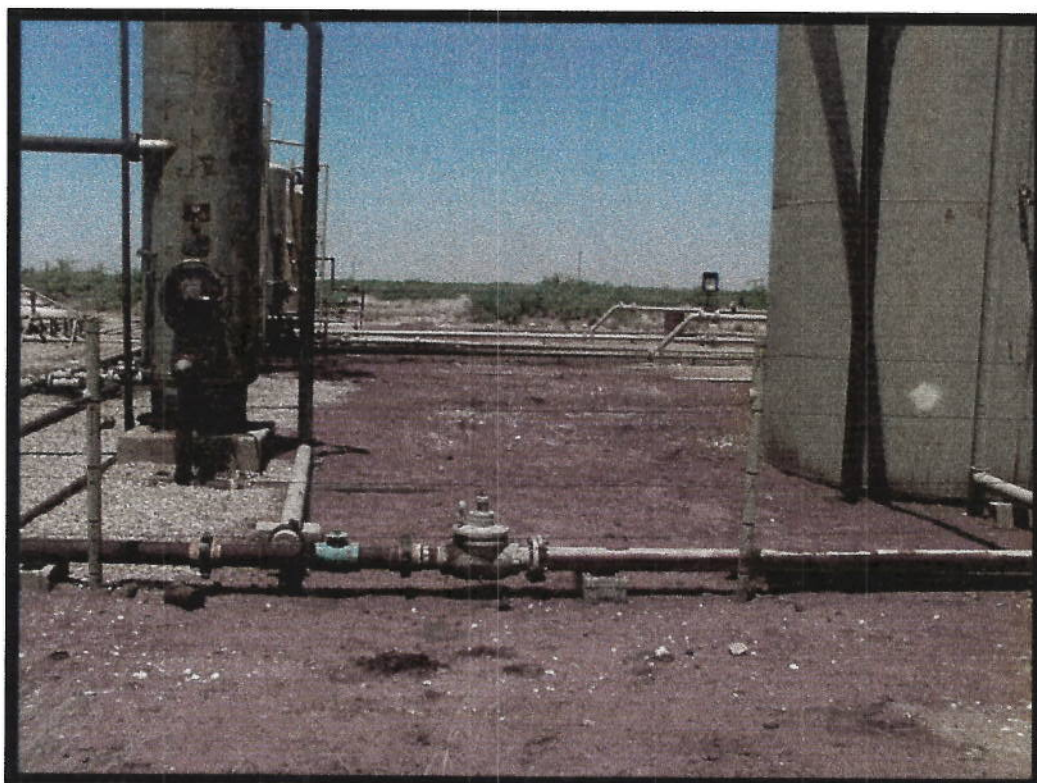
Photo #6 Before - Spill Area South to North Inside the Fence

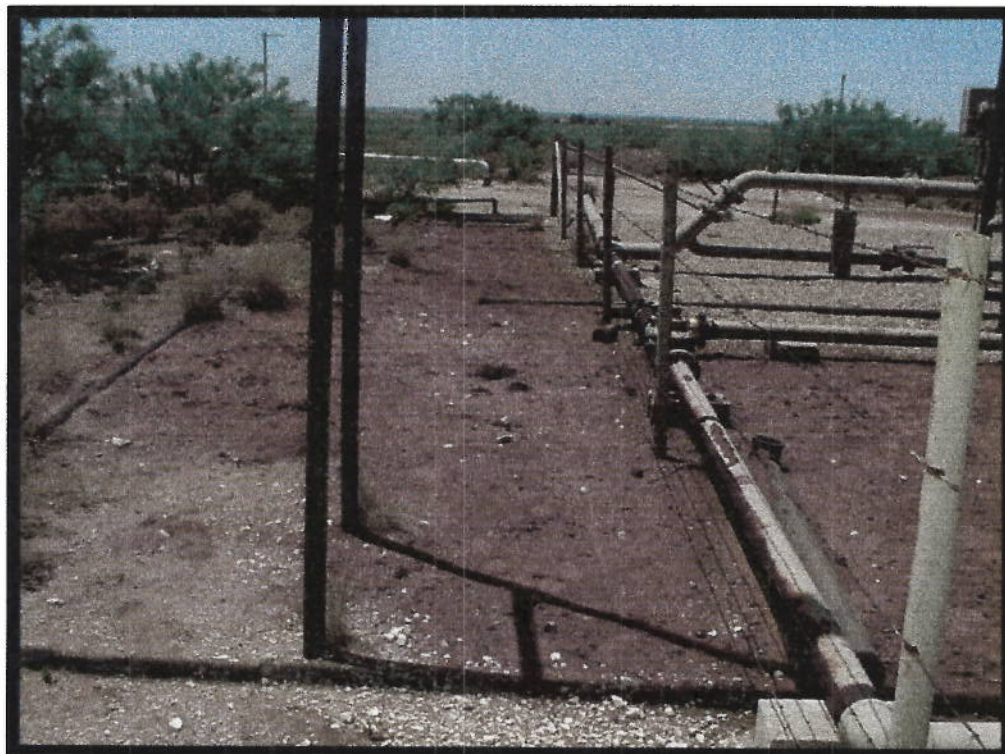
Photo #7 Before - Spill Area East to West Outside of Fence

From May 17 to May 23, 2000 SESI personnel excavated the stained area outside the battery fence. All soils excavated from this area, approximately 216 cubic yards, were transported to Sundance Services, an approved OCD disposal facility, in Eunice, New Mexico. (Exhibit C)

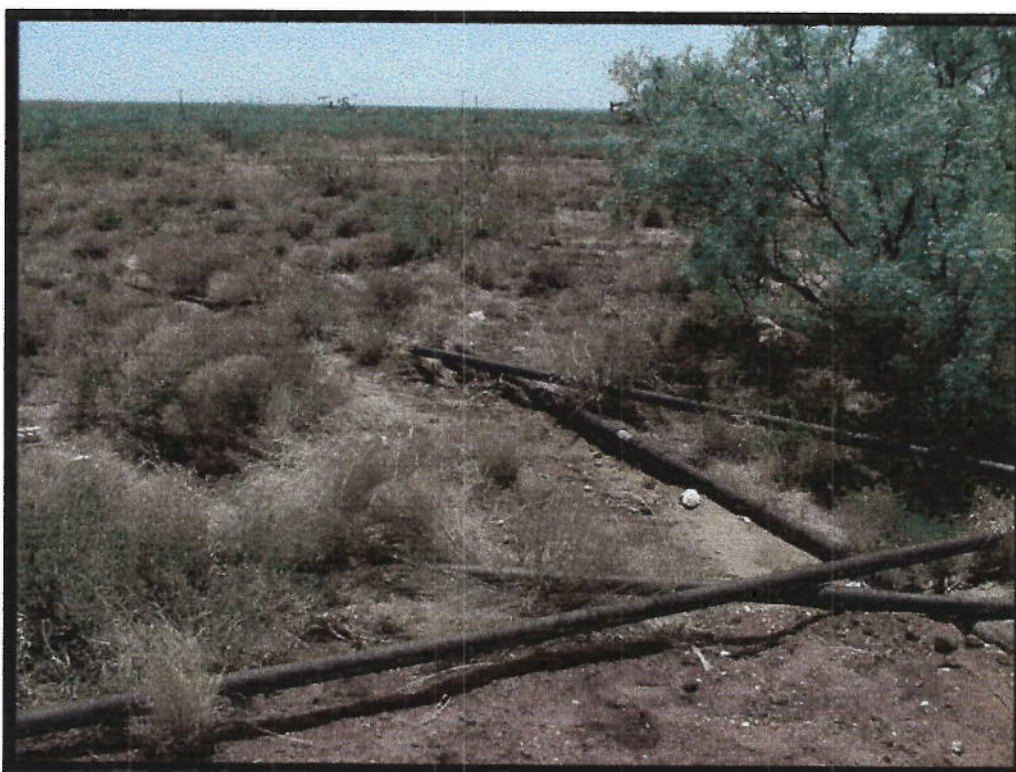
Photo #8 - Before Spill Area Runoff North to South Outside of Fence

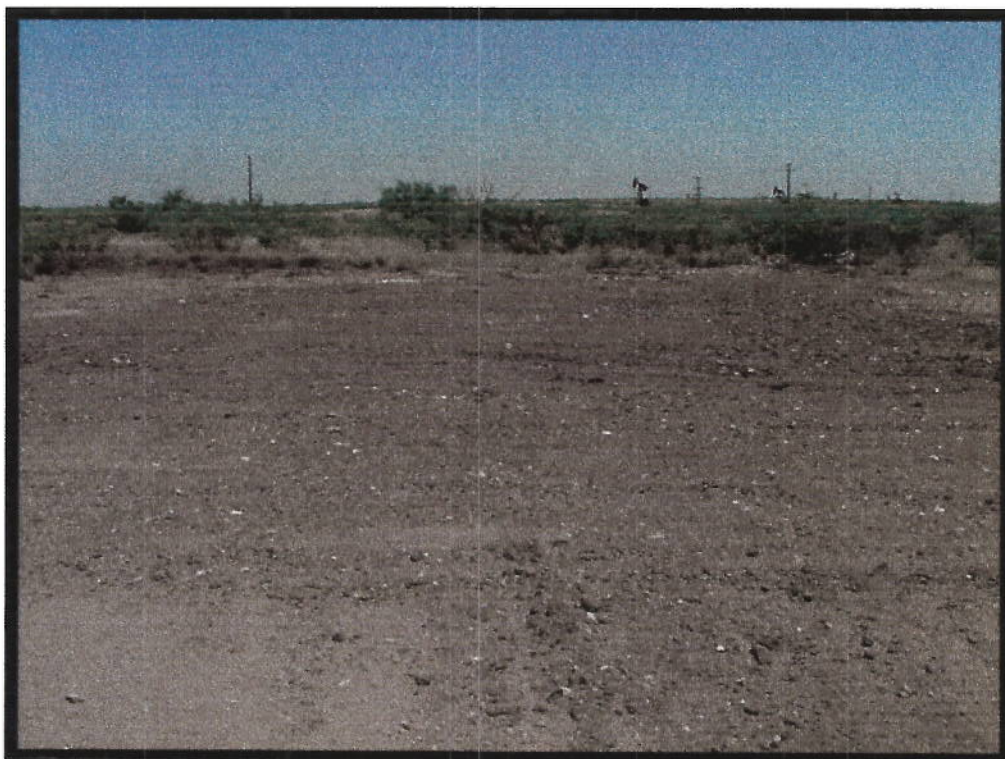
Photo #9 Before - Spill Area Far South Pool West to East Outside of Fence

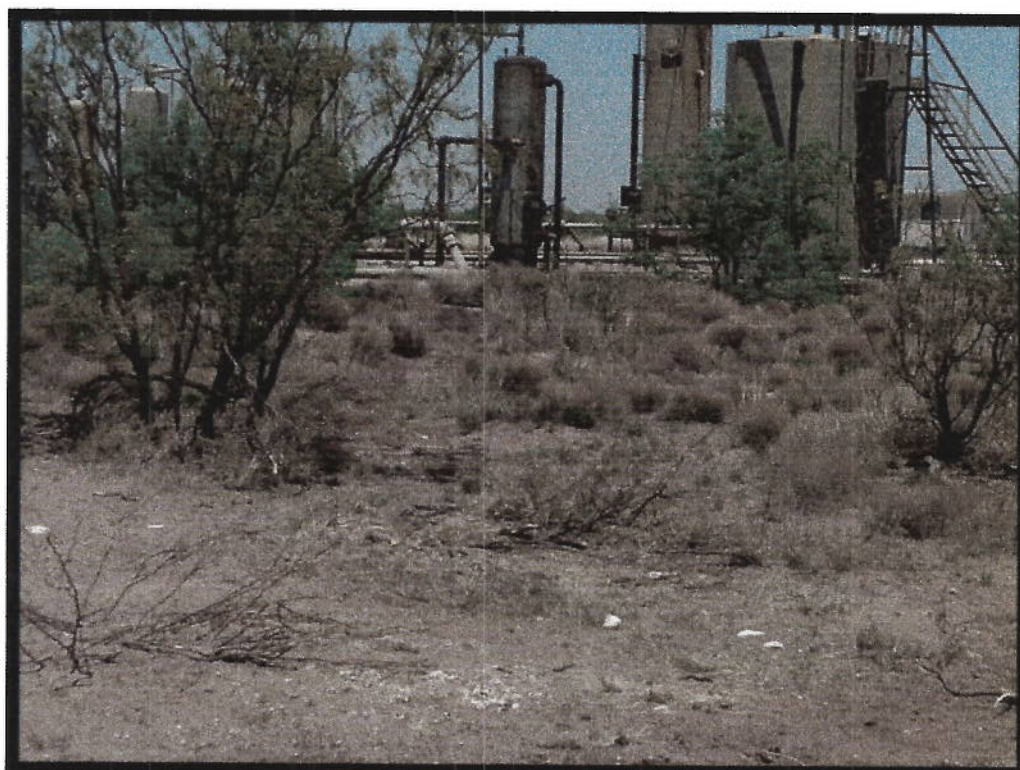
Photo #10 Before - Spill Area South to North Outside of Fence

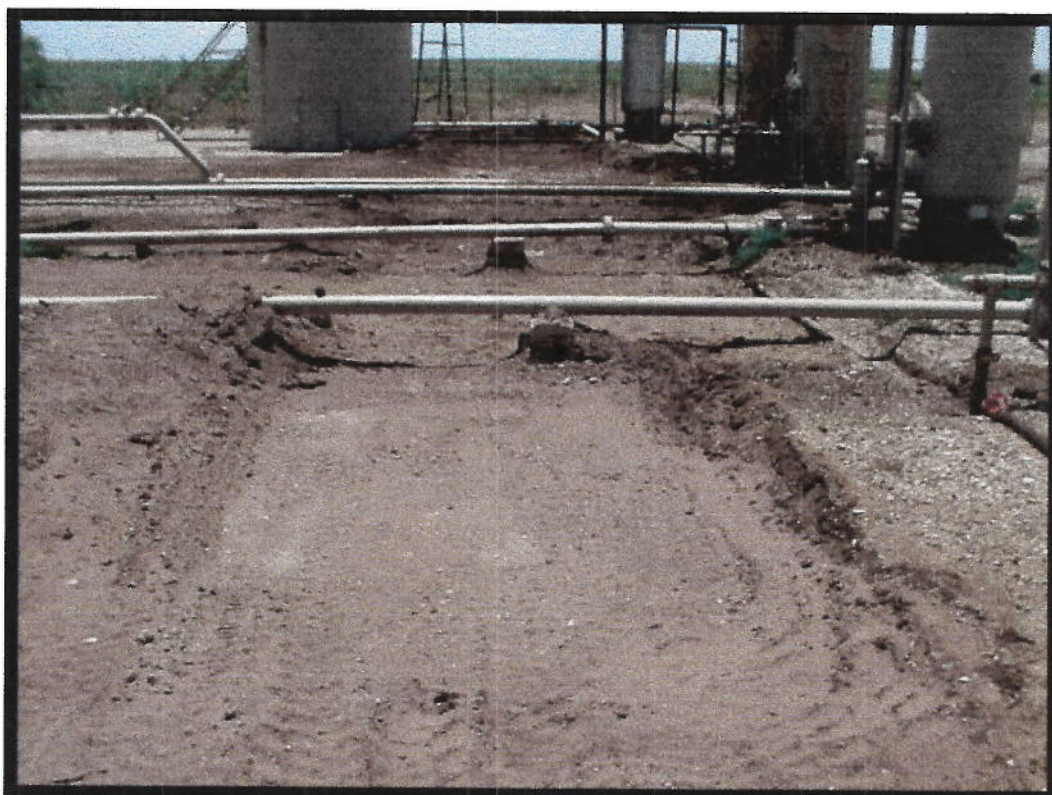
Laboratory analysis showed the samples were above the approved limit. On May 25, 2000 an additional three yards were removed. On June 19, 2000, composite samples were taken from sides and bottom of the excavation and transported under chain of custody to Cardinal Laboratories for analysis. (Exhibit E) The results of the analysis are as follows:

Photo # 14 During - Bottom Hole Facing South

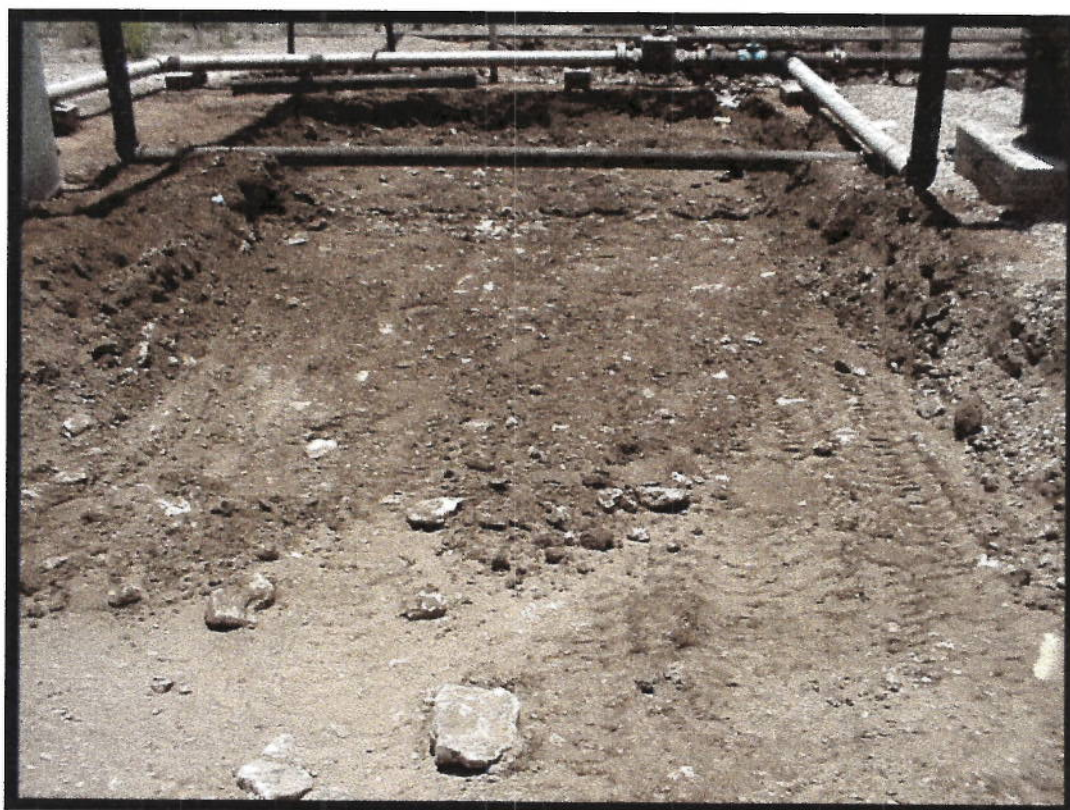
Photo #16 During - Bottom Hole Facing West

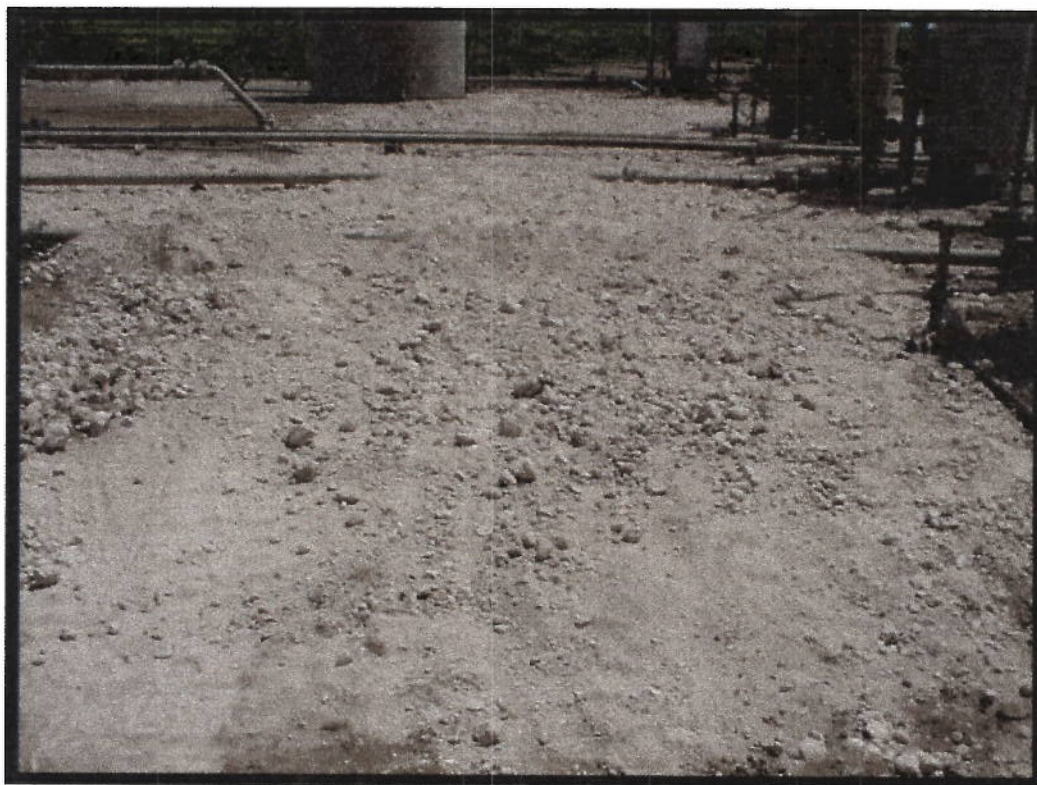
Photo #21 After - Facing South Inside Fenced Area

A total of 294 cubic yards of contaminated material was taken to Sundance Services for proper disposal. On July 7, 2000 the excavated area inside the fence was backfilled with approximately 66 cubic yards of caliche. On July 10, 2000 the excavated outside the fence was backfilled with approximately 138 cubic yards of topsoil.

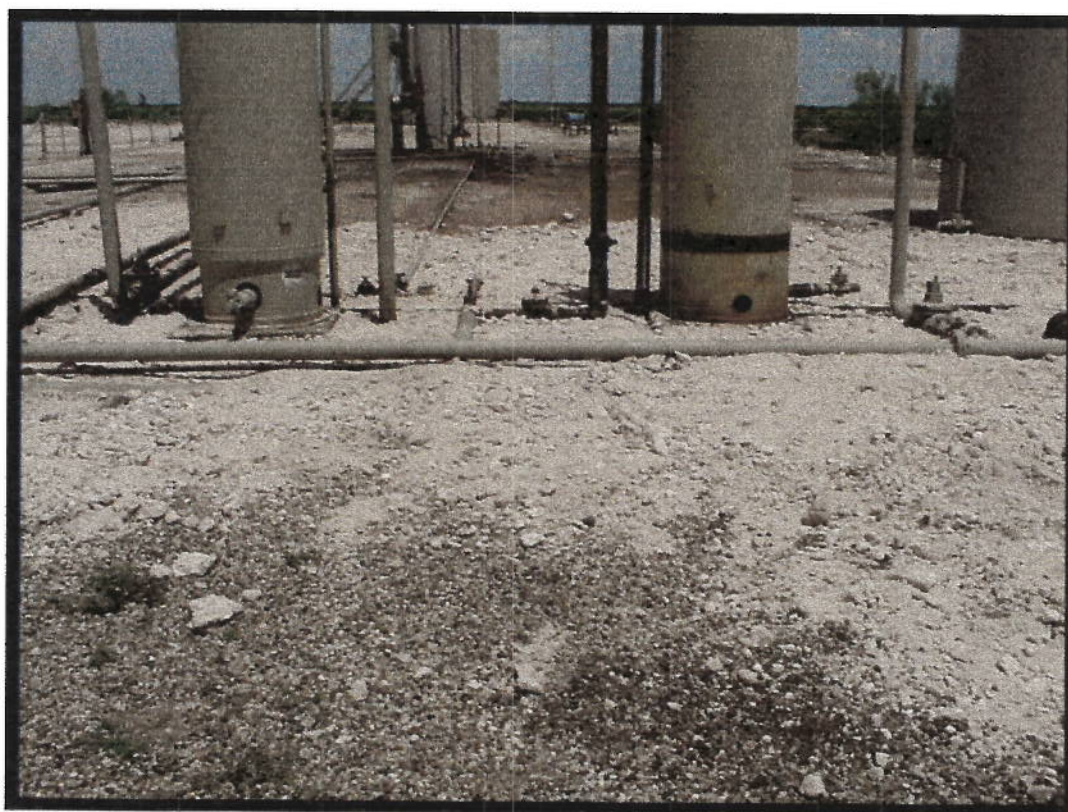
Photo #22 After - Facing East Inside Fenced Area

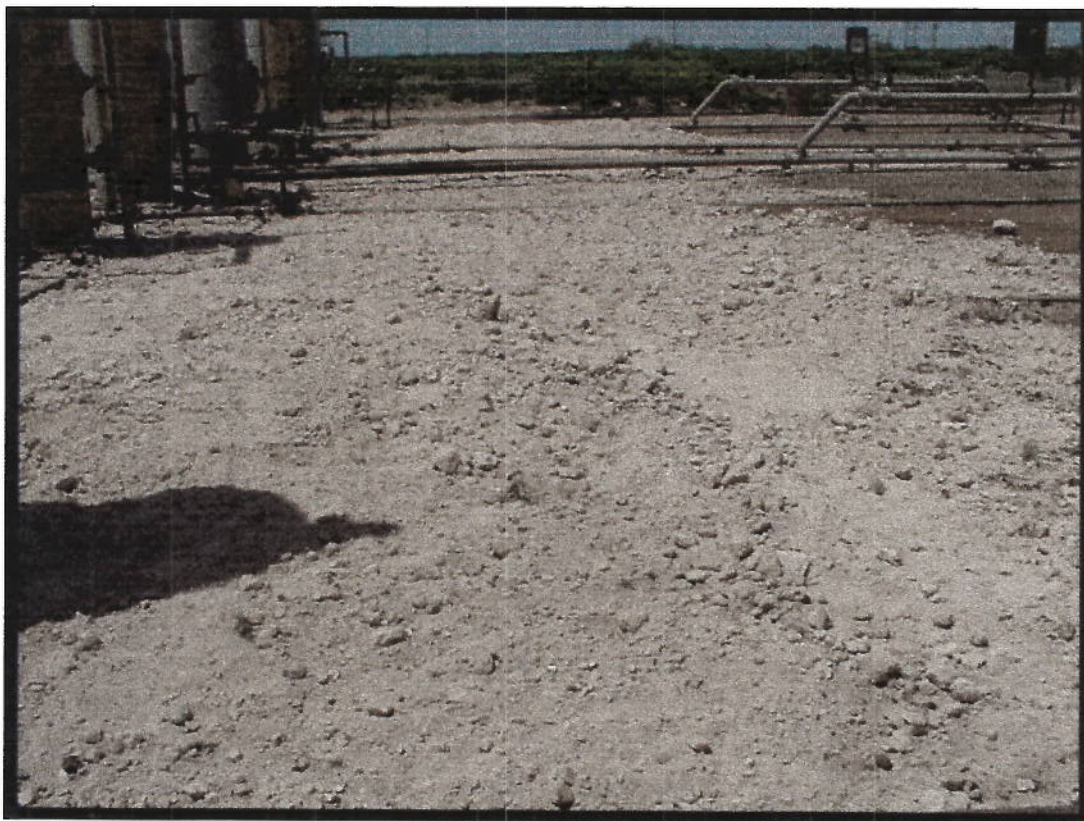
Photo #23 After - Facing North Inside Fenced Area

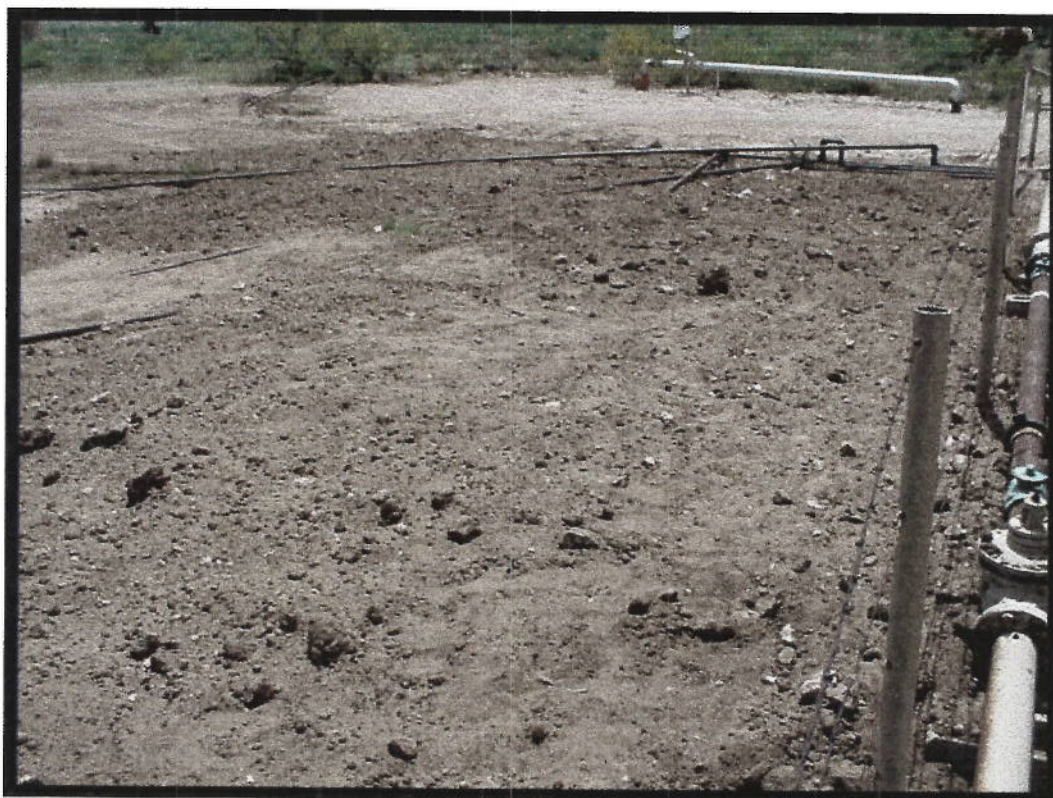
Photo #24 After - Facing SW Outside Fenced Area

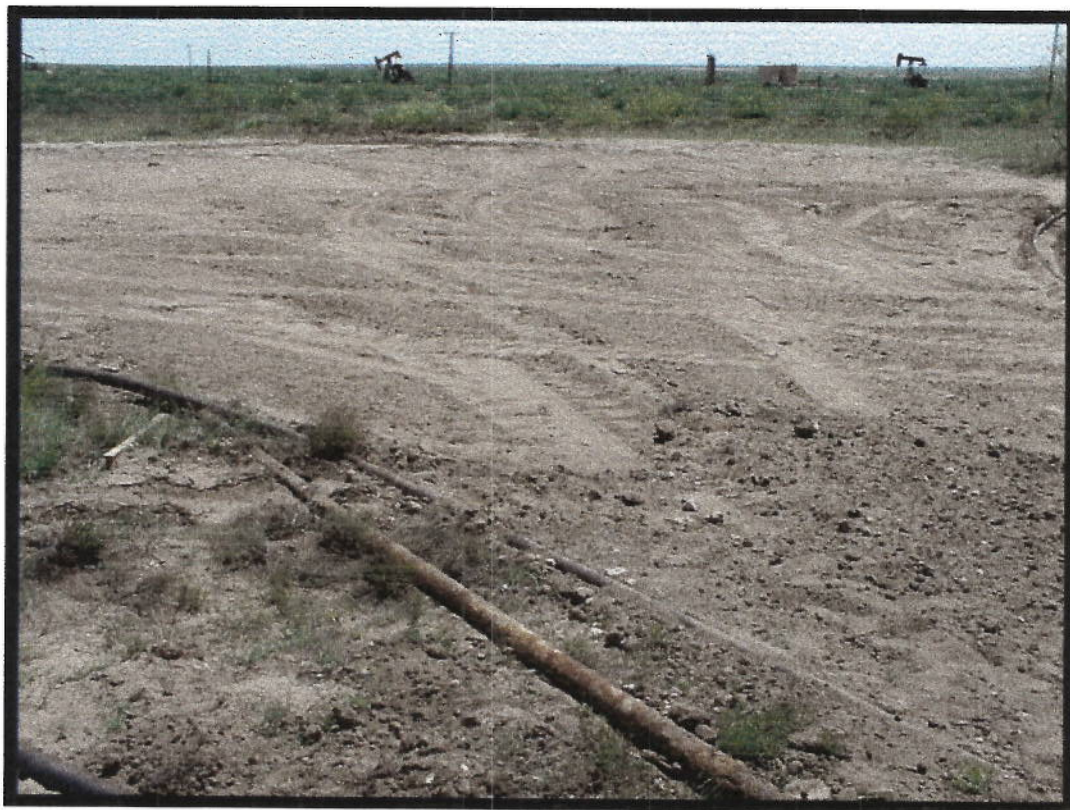
Photo #25 After - Facing South Outside Fenced Area

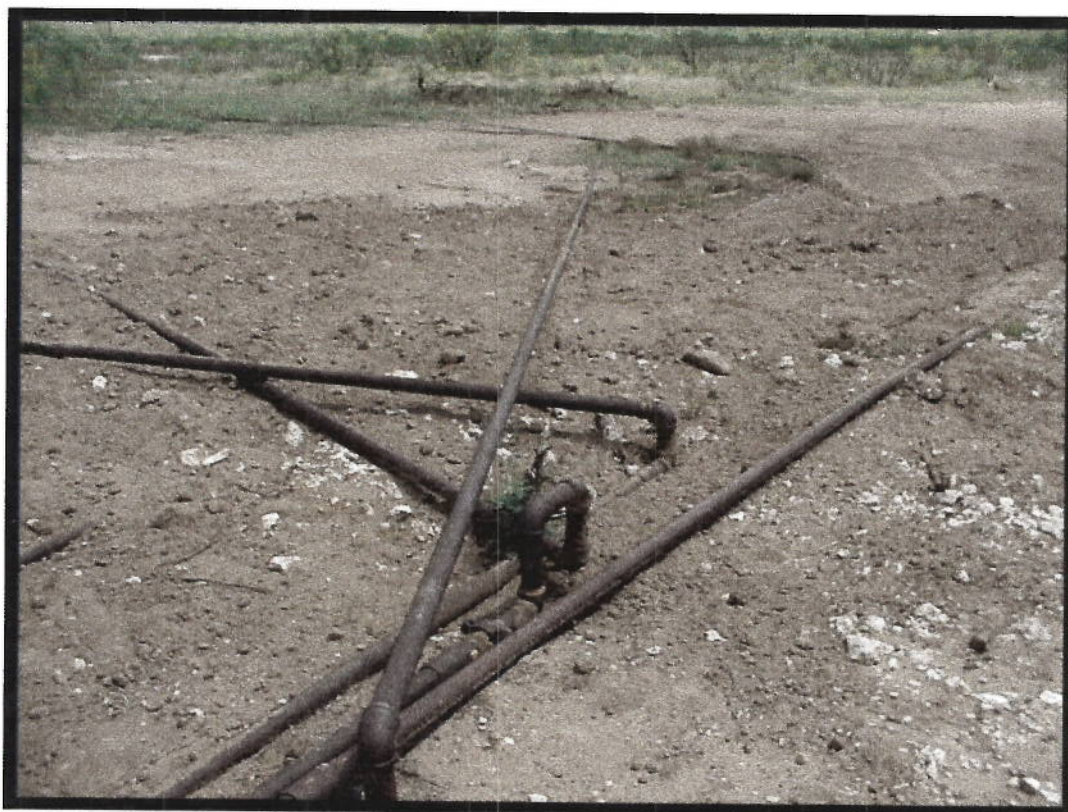
Photo #26 After - Facing East Outside Fenced Area
