# Remediation Summary & Variance Request

## H.L. Brown Operating, LLC Federal G #001

Roosevelt County, New Mexico  
Unit Letter "D", Section 3, Township 8 South, Range 37 East  
Latitude 33.6546570 North, Longitude 103.146285 West  
NMOCD Reference No. nAPP2227233275

### Etech Environmental & Safety Solutions, Inc.

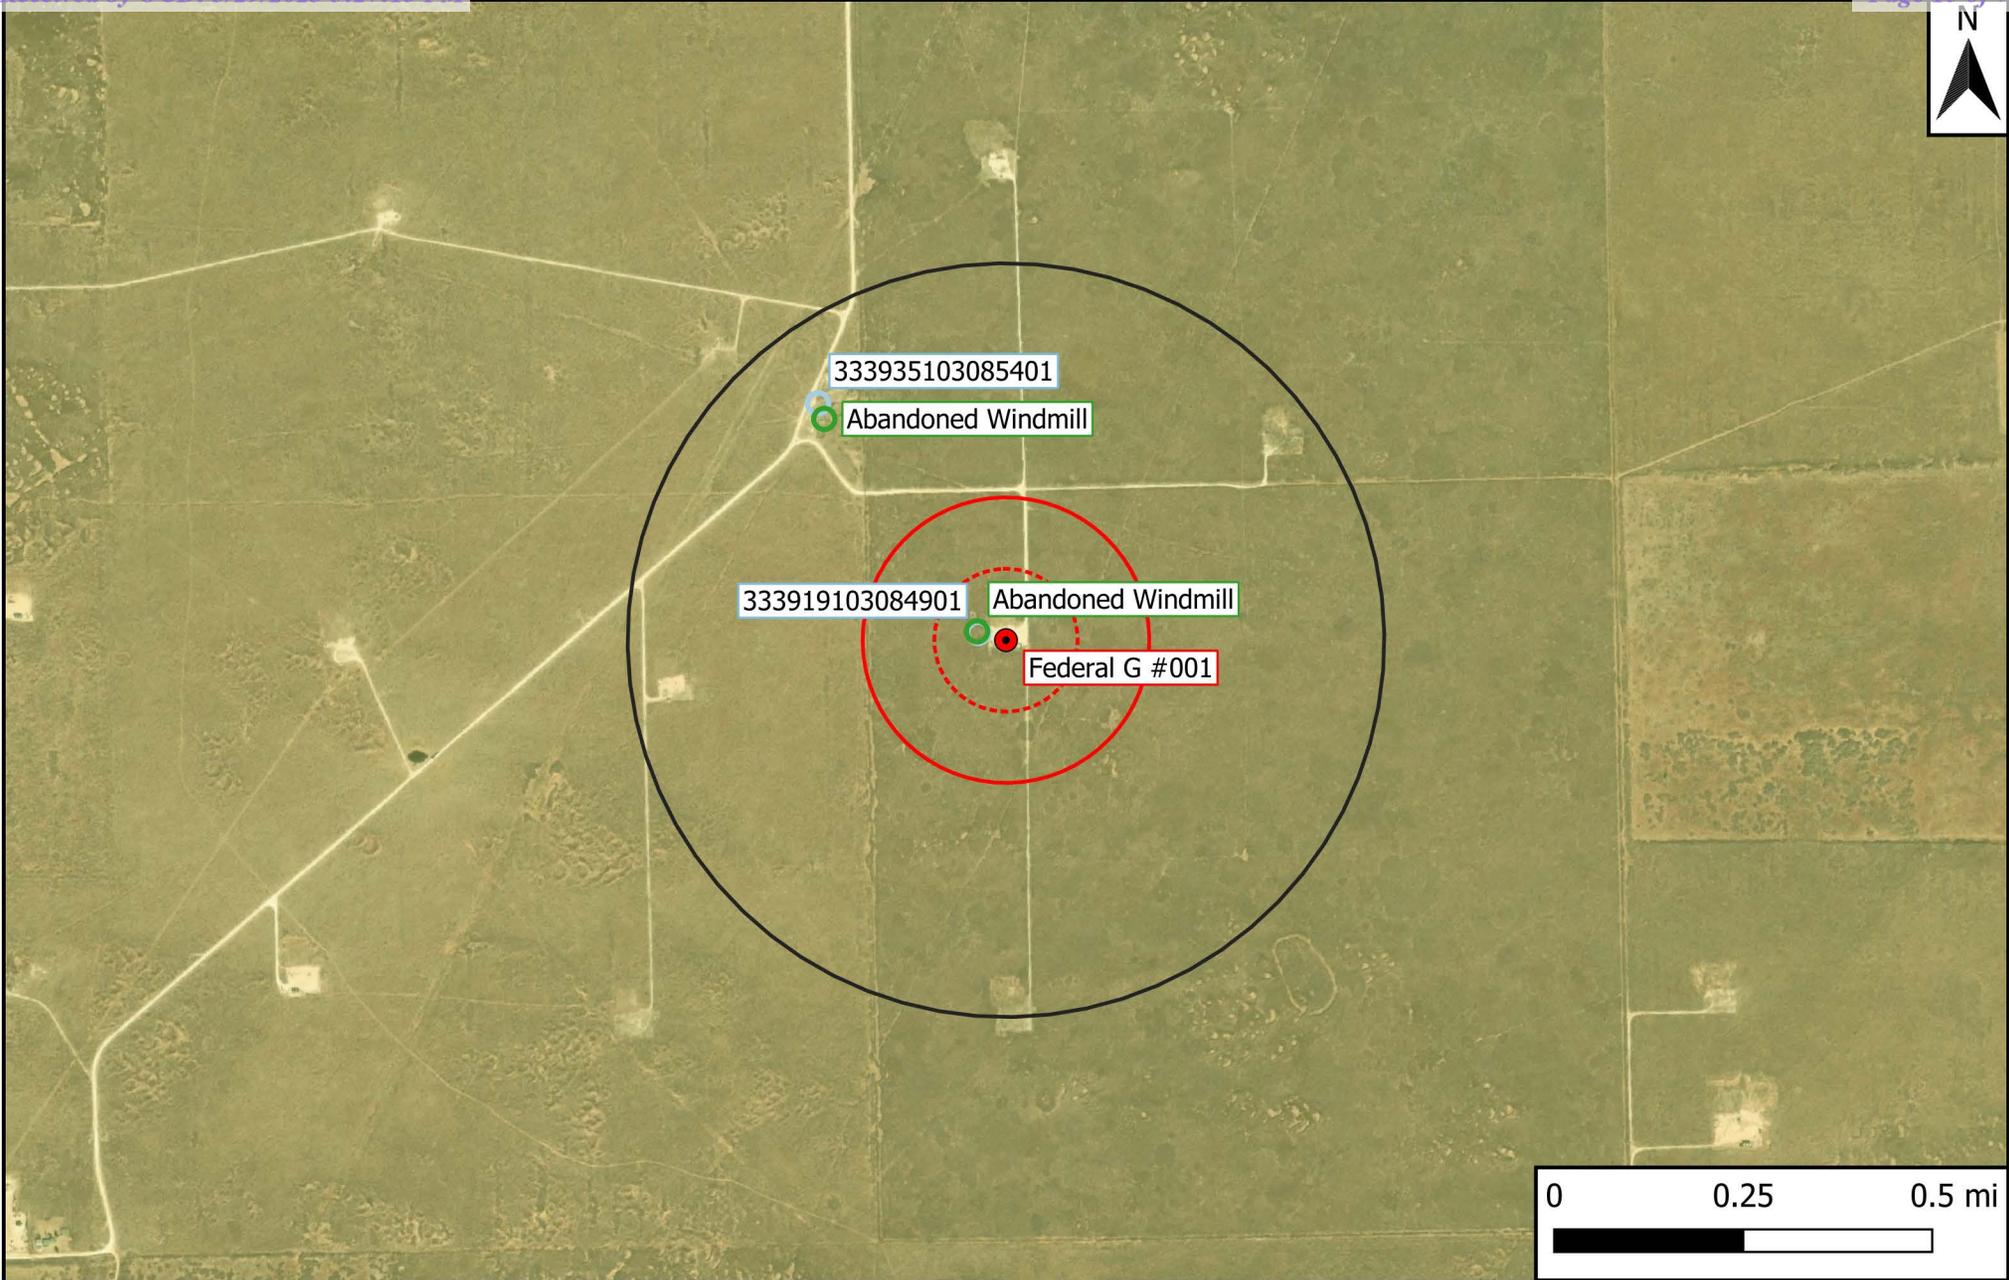
## Figure 2 Site Characterization Map

Legend		
Site Location	1% Annual Flood Chance	500-Ft Radius
Well - NMOSE	Emergent/Forested Wetlands	1,000-Ft Radius
Well - USGS	Freshwater Pond/Lake	0.5-Mi Radius
Well - Exploratory/Monitor	Karst Potential (Low/Med./High)	Municipal Boundary
Potash Mine Workings	Riverine

**Figure 2**  
 Site Characterization Map  
 H.L. Brown Operating, LLC  
 Federal G #001  
 GPS: 33.654657, -103.146285  
 Roosevelt County

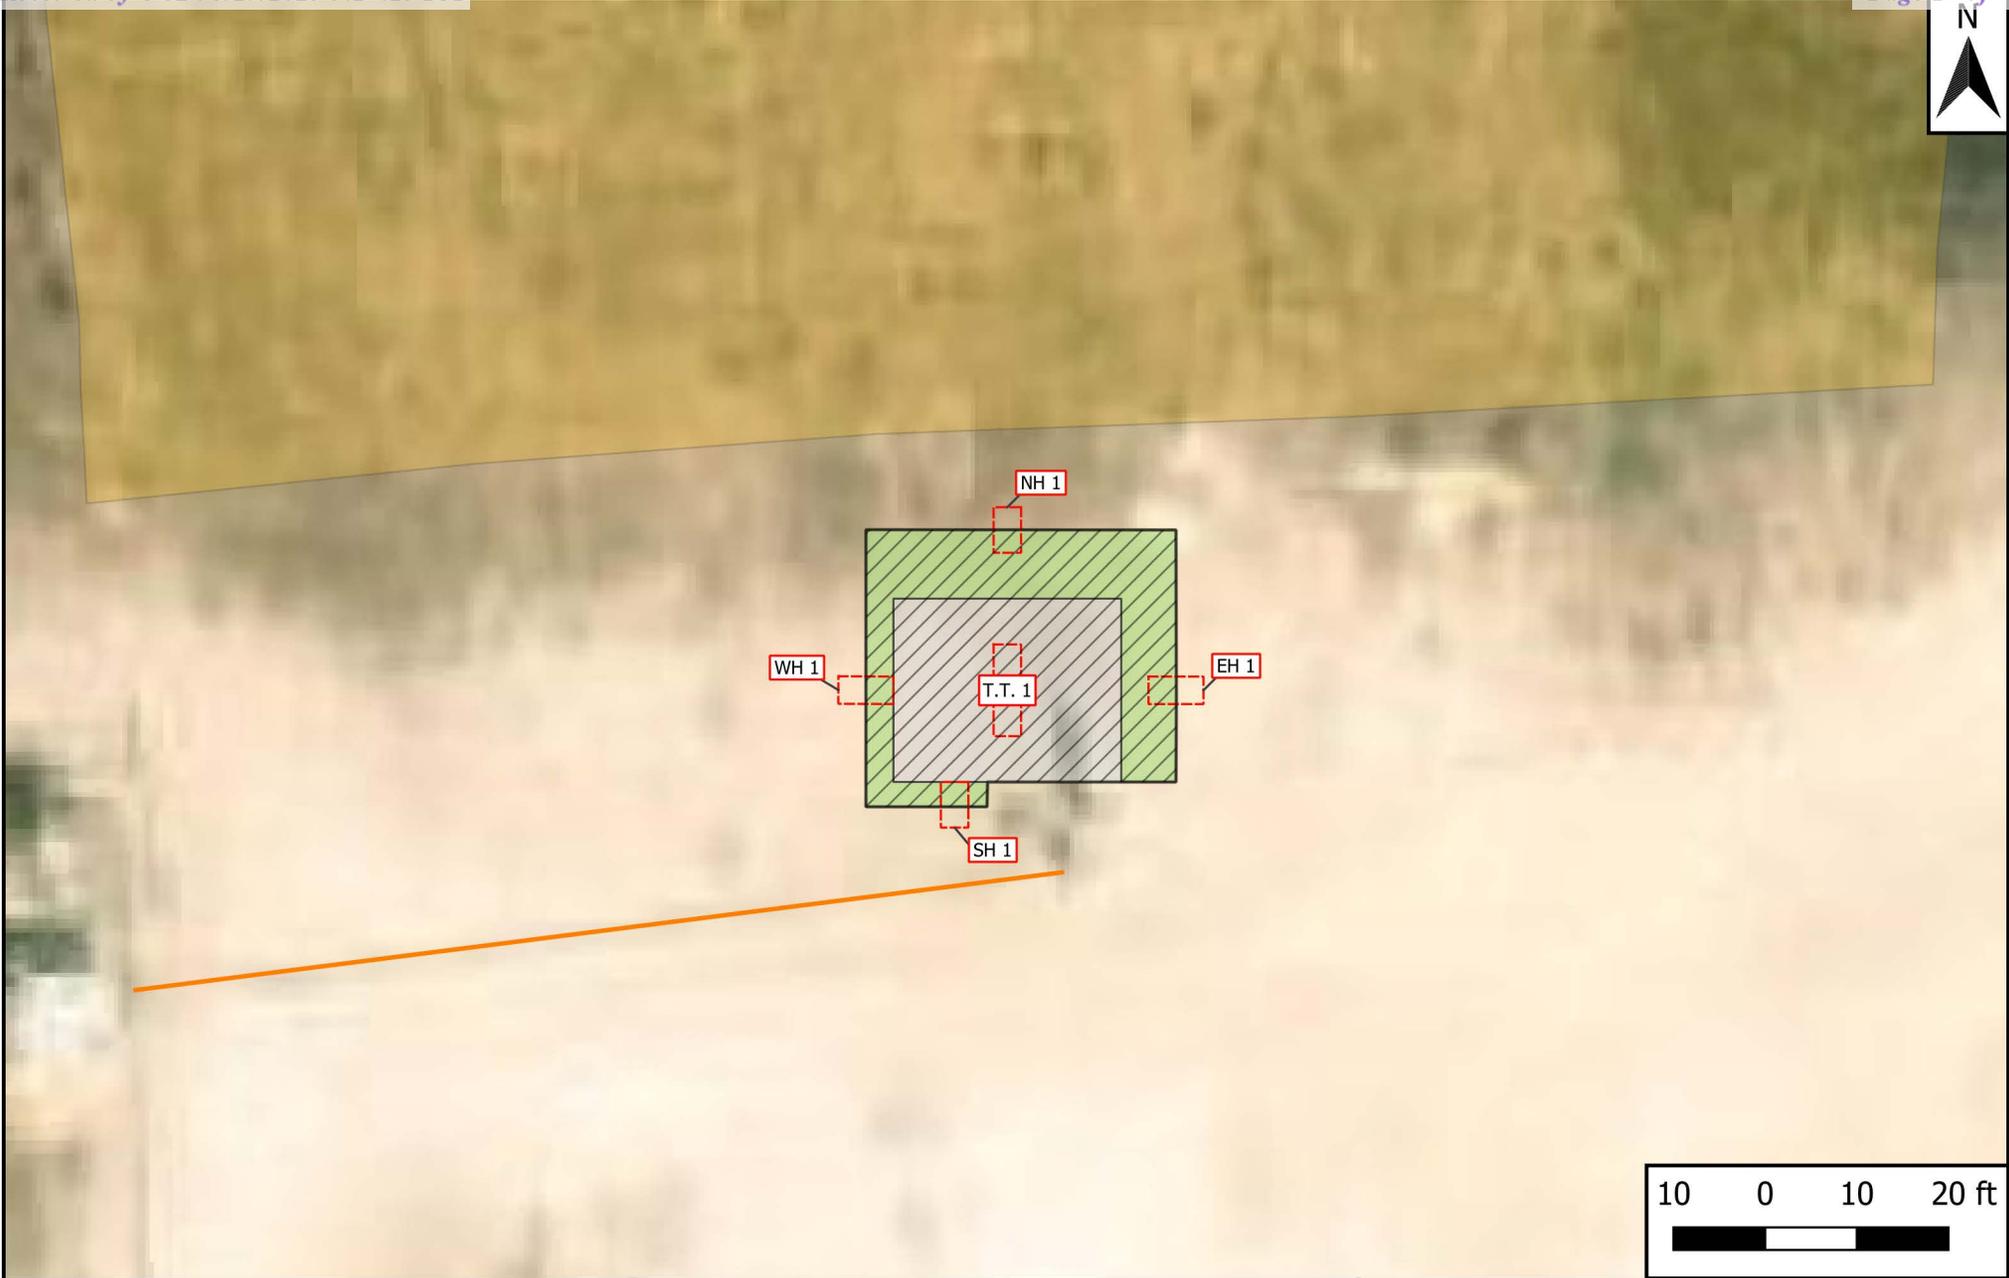
## **Figure 3 Site & Sample Location Map**

Legend	
	Proposed Excavation
	Proposed Liner
	Test Pit (≈18' bgs)
	Test Trench
	Historical Reserve Pit
	Pipeline

**Figure 3**  
 Site & Sample Location Map  
 H.L. Brown Operating, LLC  
 Federal G #001  
 GPS: 33.654657, -103.146285  
 Roosevelt County

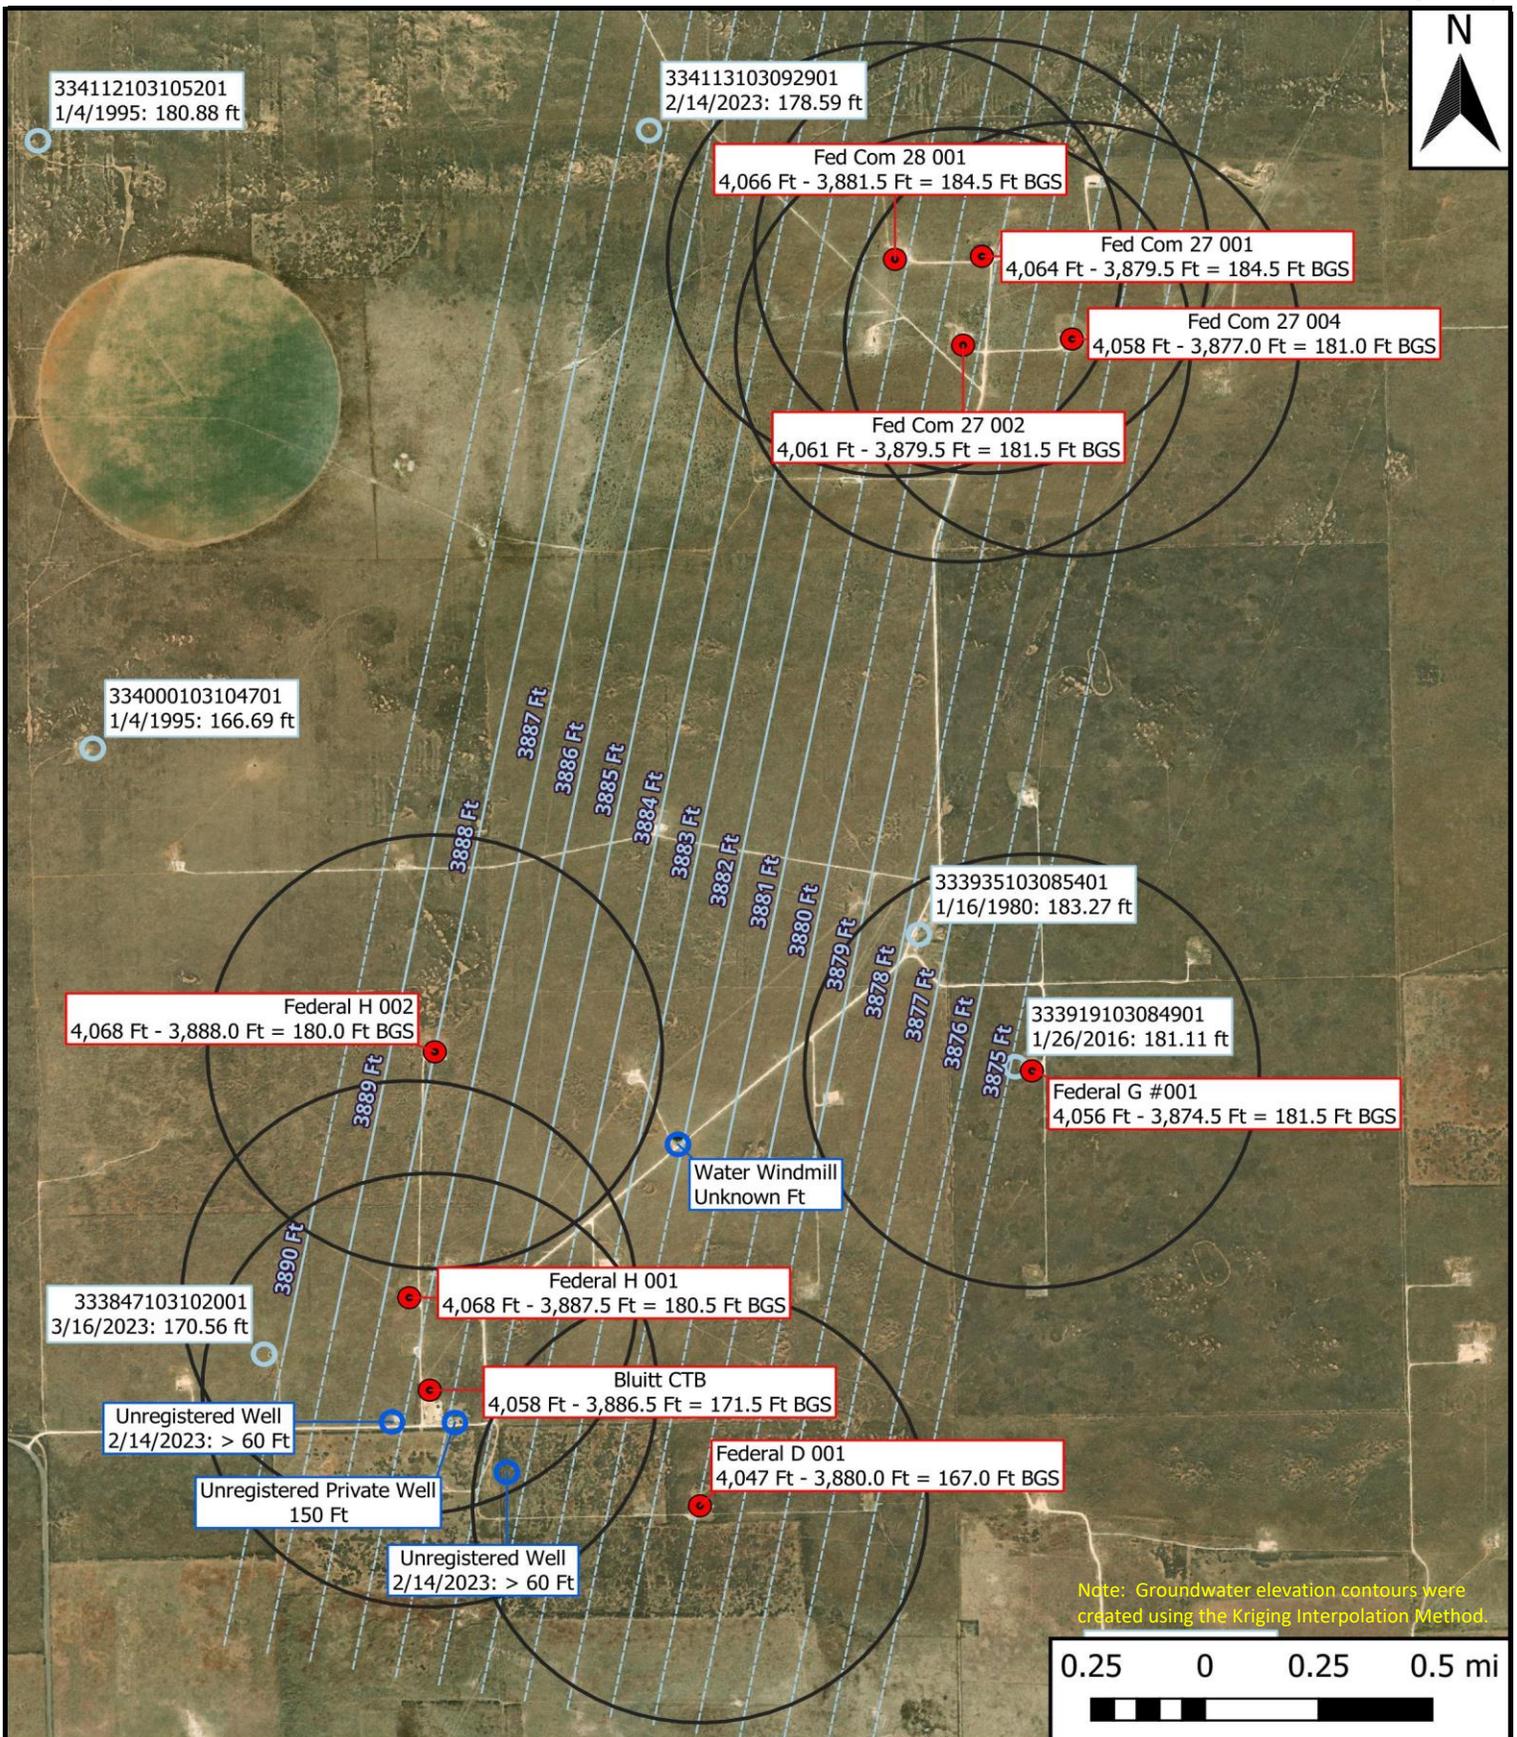
**HL Brown Sites**  
 Inferred Depth to Groundwater Map  
 H.L. Brown Operating, LLC

- Site Location
- Half Mile Radius
- Well - USGS
- Well - Other
- Groundwater Contours (Ft MSL)
- Extended Groundwater Contours

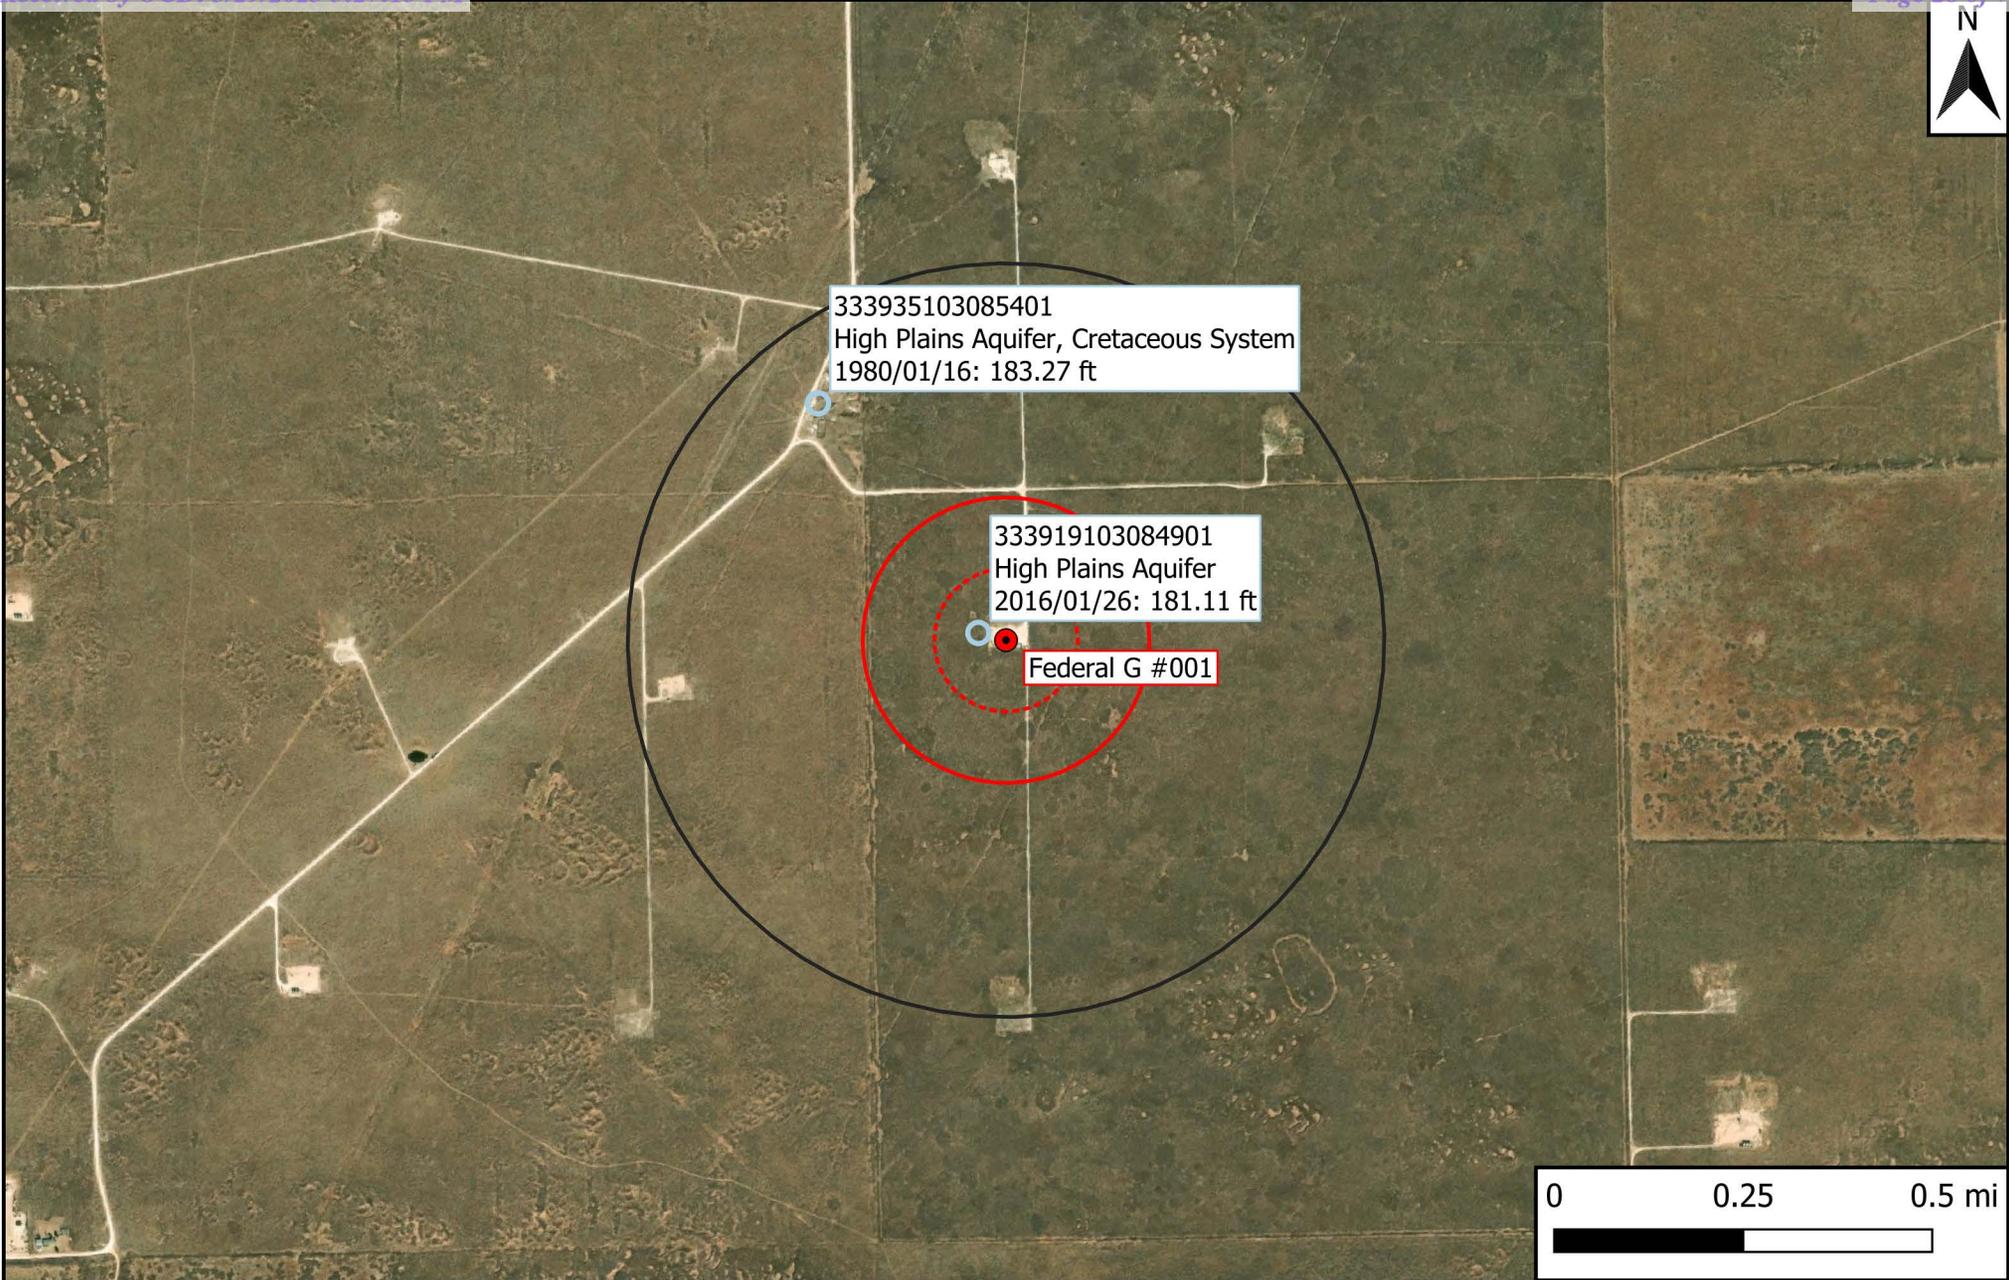
**Figure 4**  
 USGS Well Proximity Map  
 H.L. Brown Operating, LLC  
 Federal G #001  
 GPS: 33.654657, -103.146285  
 Roosevelt County

- Legend
- Site Location
  - Well - USGS
  - ⊞ 500-Ft Radius
  - ⊞ 1,000-Ft Radius
  - ⊞ 0.5-Mi Radius

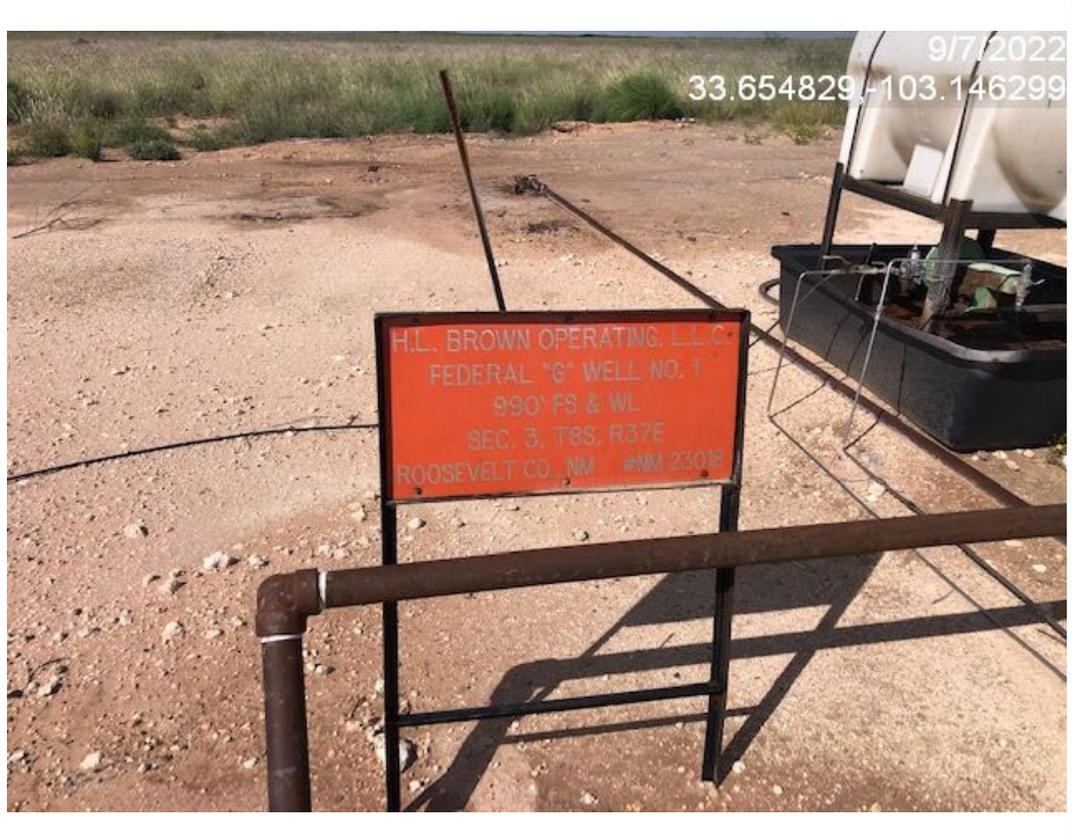
<b>Photo Number:</b> 1

<p>9/7/2022 33.654829,-103.146299</p>
<b>Photo Direction:</b> North-Northeast	
<b>Photo Description:</b>  View of the affected area.

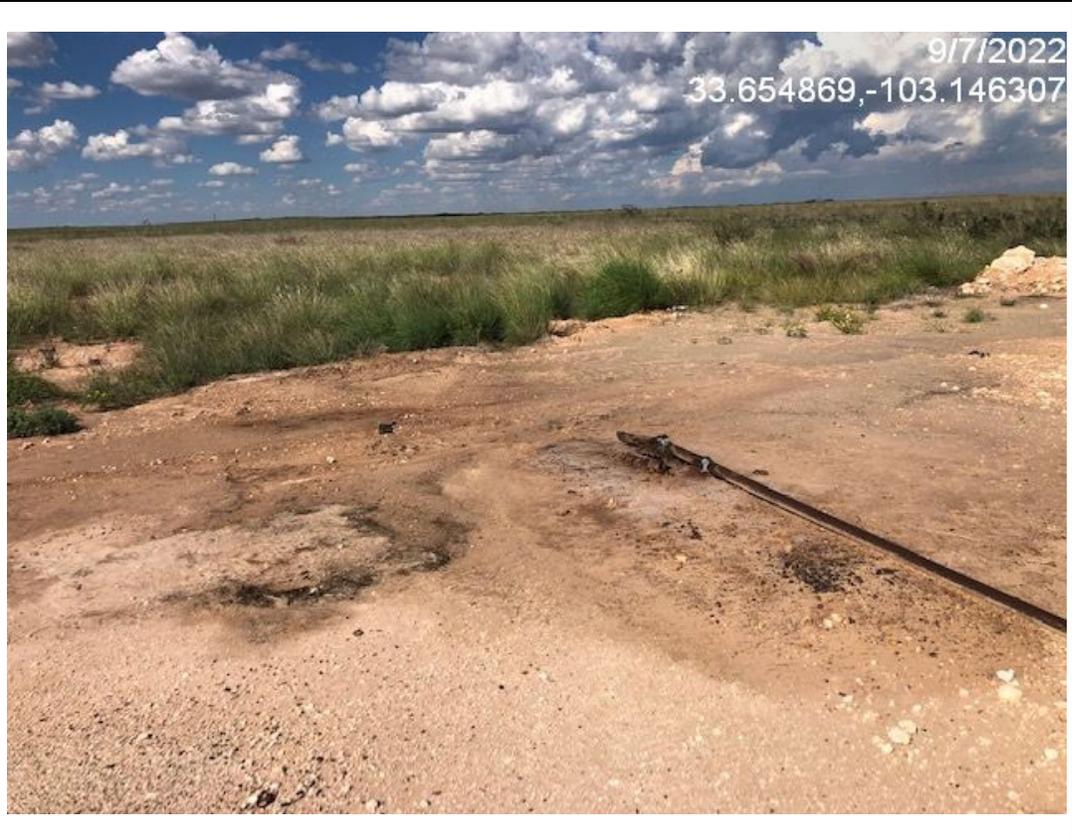
<b>Photo Number:</b> 2

<p>9/7/2022 33.654869,-103.146307</p>
<b>Photo Direction:</b> Northeast	
<b>Photo Description:</b>  View of the affected area.

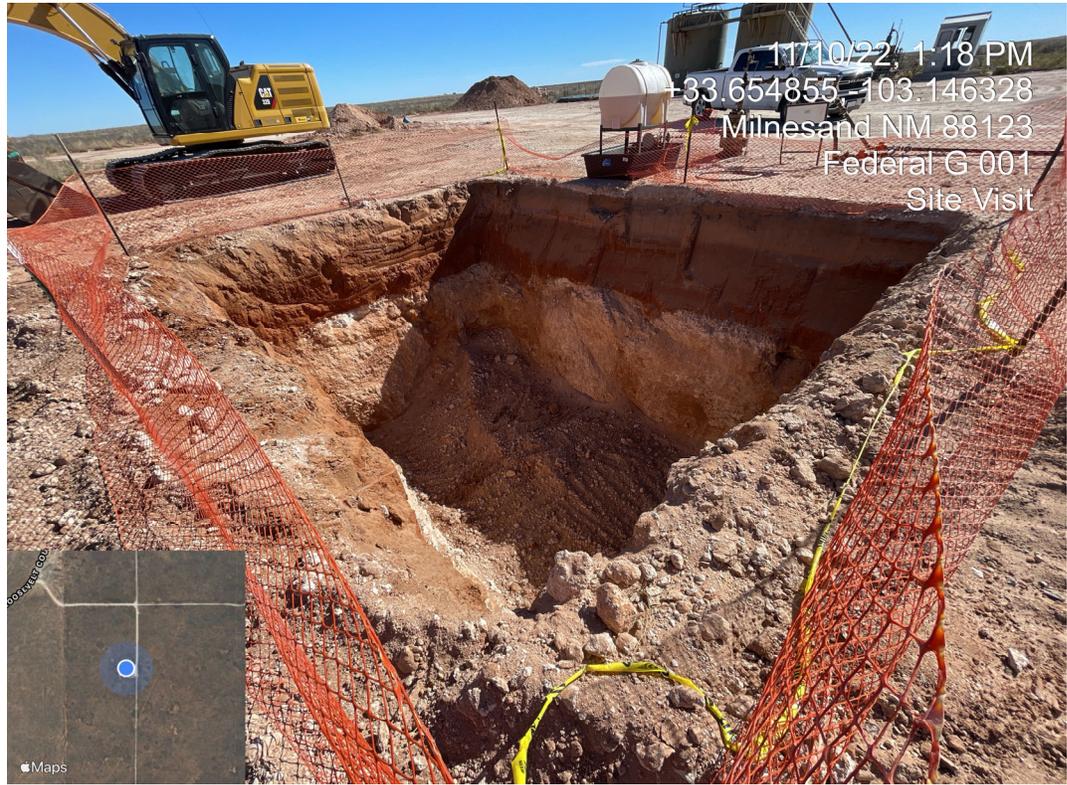
<b>Photo Number:</b> 3

<b>Photo Direction:</b> Southwest	
<b>Photo Description:</b>  View of the excavated area & test pit/trench.

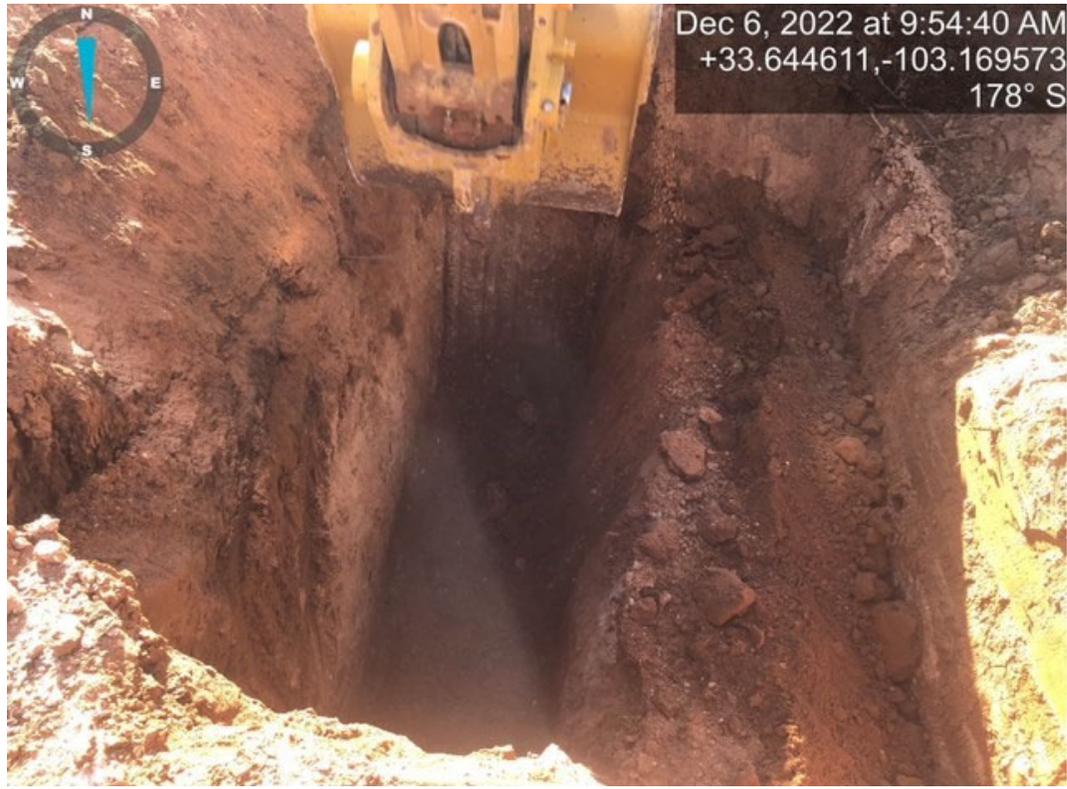
<b>Photo Number:</b> 4

<b>Photo Direction:</b> South	
<b>Photo Description:</b>  View of the advancement of test trench T.T. 1.

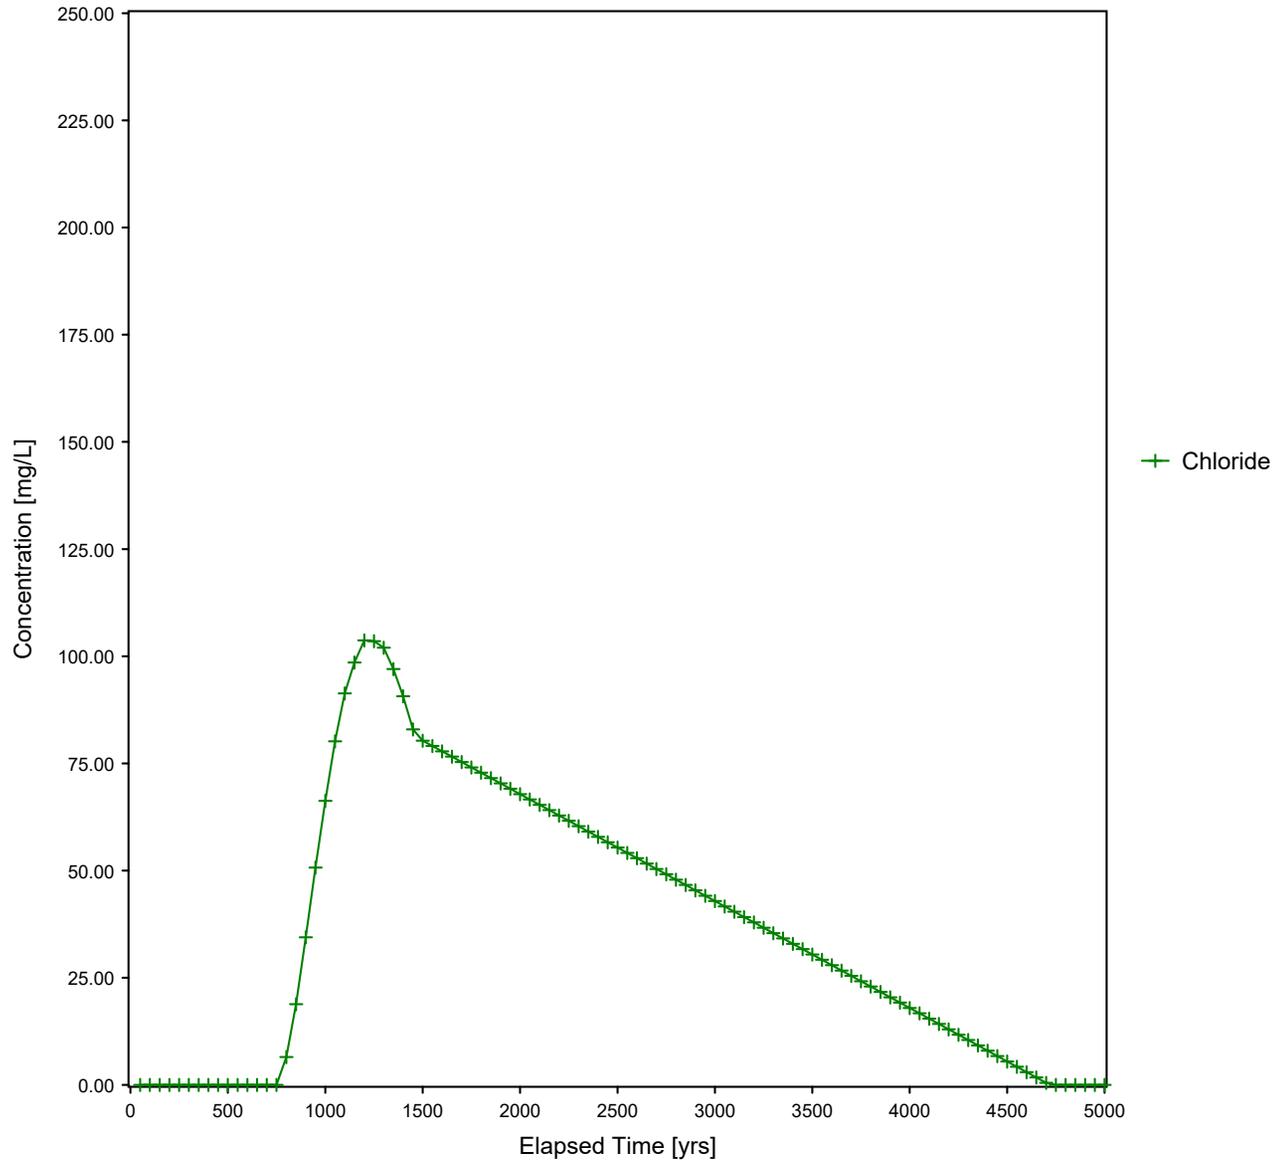
### Chloride Concentration At The Receptor Well (with Liner) H.L. Brown Operating, LLC Federal G #001

Option Chosen Saturated and unsaturated zone models  
Run was DETERMIN  
Infiltration Specified By User: 7.620E-03 m/yr  
Run was transient  
Well Times: Find Maximum Concentration  
Reject runs if Y coordinate outside plume  
Reject runs if Z coordinate outside plume  
Gaussian source used in saturated zone model

VARIABLE NAME	UNITS	DISTRIBUTION	PARAMETERS		LIMITS	
			MEAN	STD DEV	MIN	MAX
Infiltration rate	m/yr	CONSTANT	0.762E-02	-999.	-999.	-999.
Area of waste disposal unit	m <sup>2</sup>	CONSTANT	90.0	-999.	-999.	-999.
Duration of pulse	yr	DERIVED	0.100E-08	-999.	-999.	-999.
Spread of contaminant source	m	DERIVED	-999.	-999.	-999.	-999.
Recharge rate	m/yr	CONSTANT	0.000	-999.	-999.	-999.
Source decay constant	1/yr	CONSTANT	0.250E-01	0.000	0.000	0.000
Initial concentration at landfill	mg/l	CONSTANT	0.119E+05	-999.	-999.	-999.

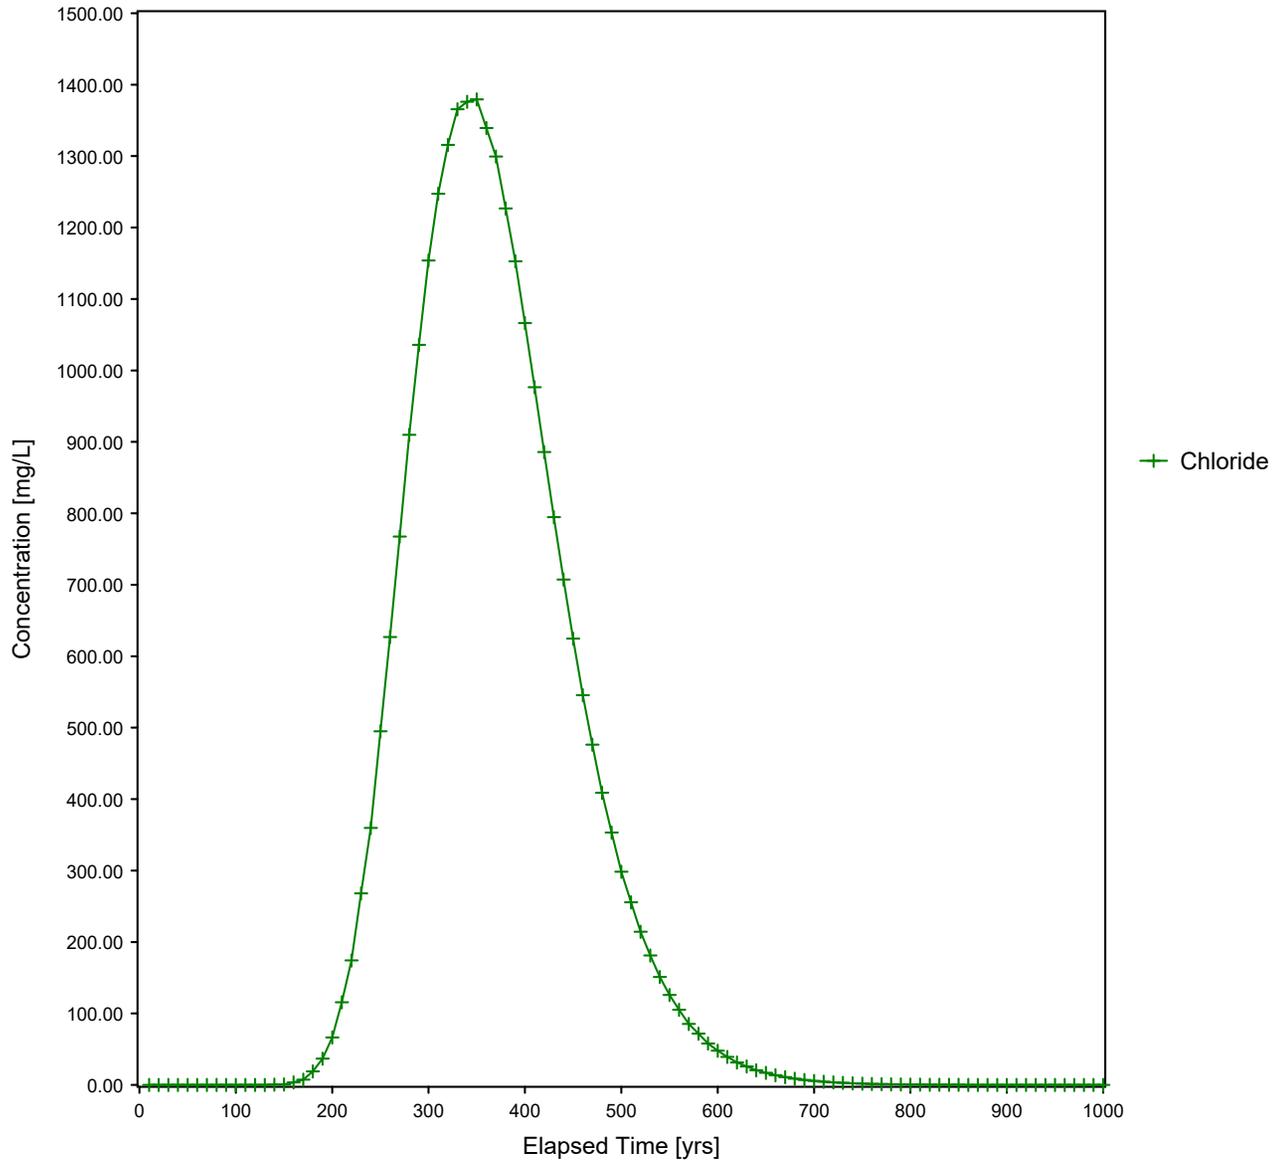
### Chloride Concentration At The Receptor Well (No Liner)

Option Chosen Saturated and unsaturated zone models  
Run was DETERMIN  
Infiltration Specified By User: 3.048E-02 m/yr  
Run was transient  
Well Times: Find Maximum Concentration  
Reject runs if Y coordinate outside plume  
Reject runs if Z coordinate outside plume  
Gaussian source used in saturated zone model

VARIABLE NAME	UNITS	DISTRIBUTION	PARAMETERS		LIMITS	
			MEAN	STD DEV	MIN	MAX
Infiltration rate	m/yr	CONSTANT	0.305E-01	-999.	-999.	-999.
Area of waste disposal unit	m^2	CONSTANT	90.0	-999.	-999.	-999.
Duration of pulse	yr	DERIVED	0.100E-08	-999.	-999.	-999.
Spread of contaminant source	m	DERIVED	-999.	-999.	-999.	-999.
Recharge rate	m/yr	CONSTANT	0.000	-999.	-999.	-999.
Source decay constant	1/yr	CONSTANT	0.250E-01	0.000	0.000	0.000
Initial concentration at landfill	mg/l	CONSTANT	0.119E+05	-999.	-999.	-999.
Length scale of facility	m	DERIVED	-999.	-999.	-999.	-999.
Width scale of facility	m	DERIVED	-999.	-999.	-999.	-999.
Near field dilution		DERIVED	1.00	0.000	0.000	1.00
