## Amended Remediation Summary and Soil Closure Request

### **H.L. Brown Operating, LLC Federal H 001**

Roosevelt County, New Mexico  
Unit Letter A, Section 5, Township 8 South, Range 37 East  
Latitude 33.647455 North, Longitude 103.170203 West  
**NMOCD Reference No. nAPP2227233744**

**Etech Environmental & Safety Solutions, Inc.**  
2617 W. Marland  
Hobbs, New Mexico 88240

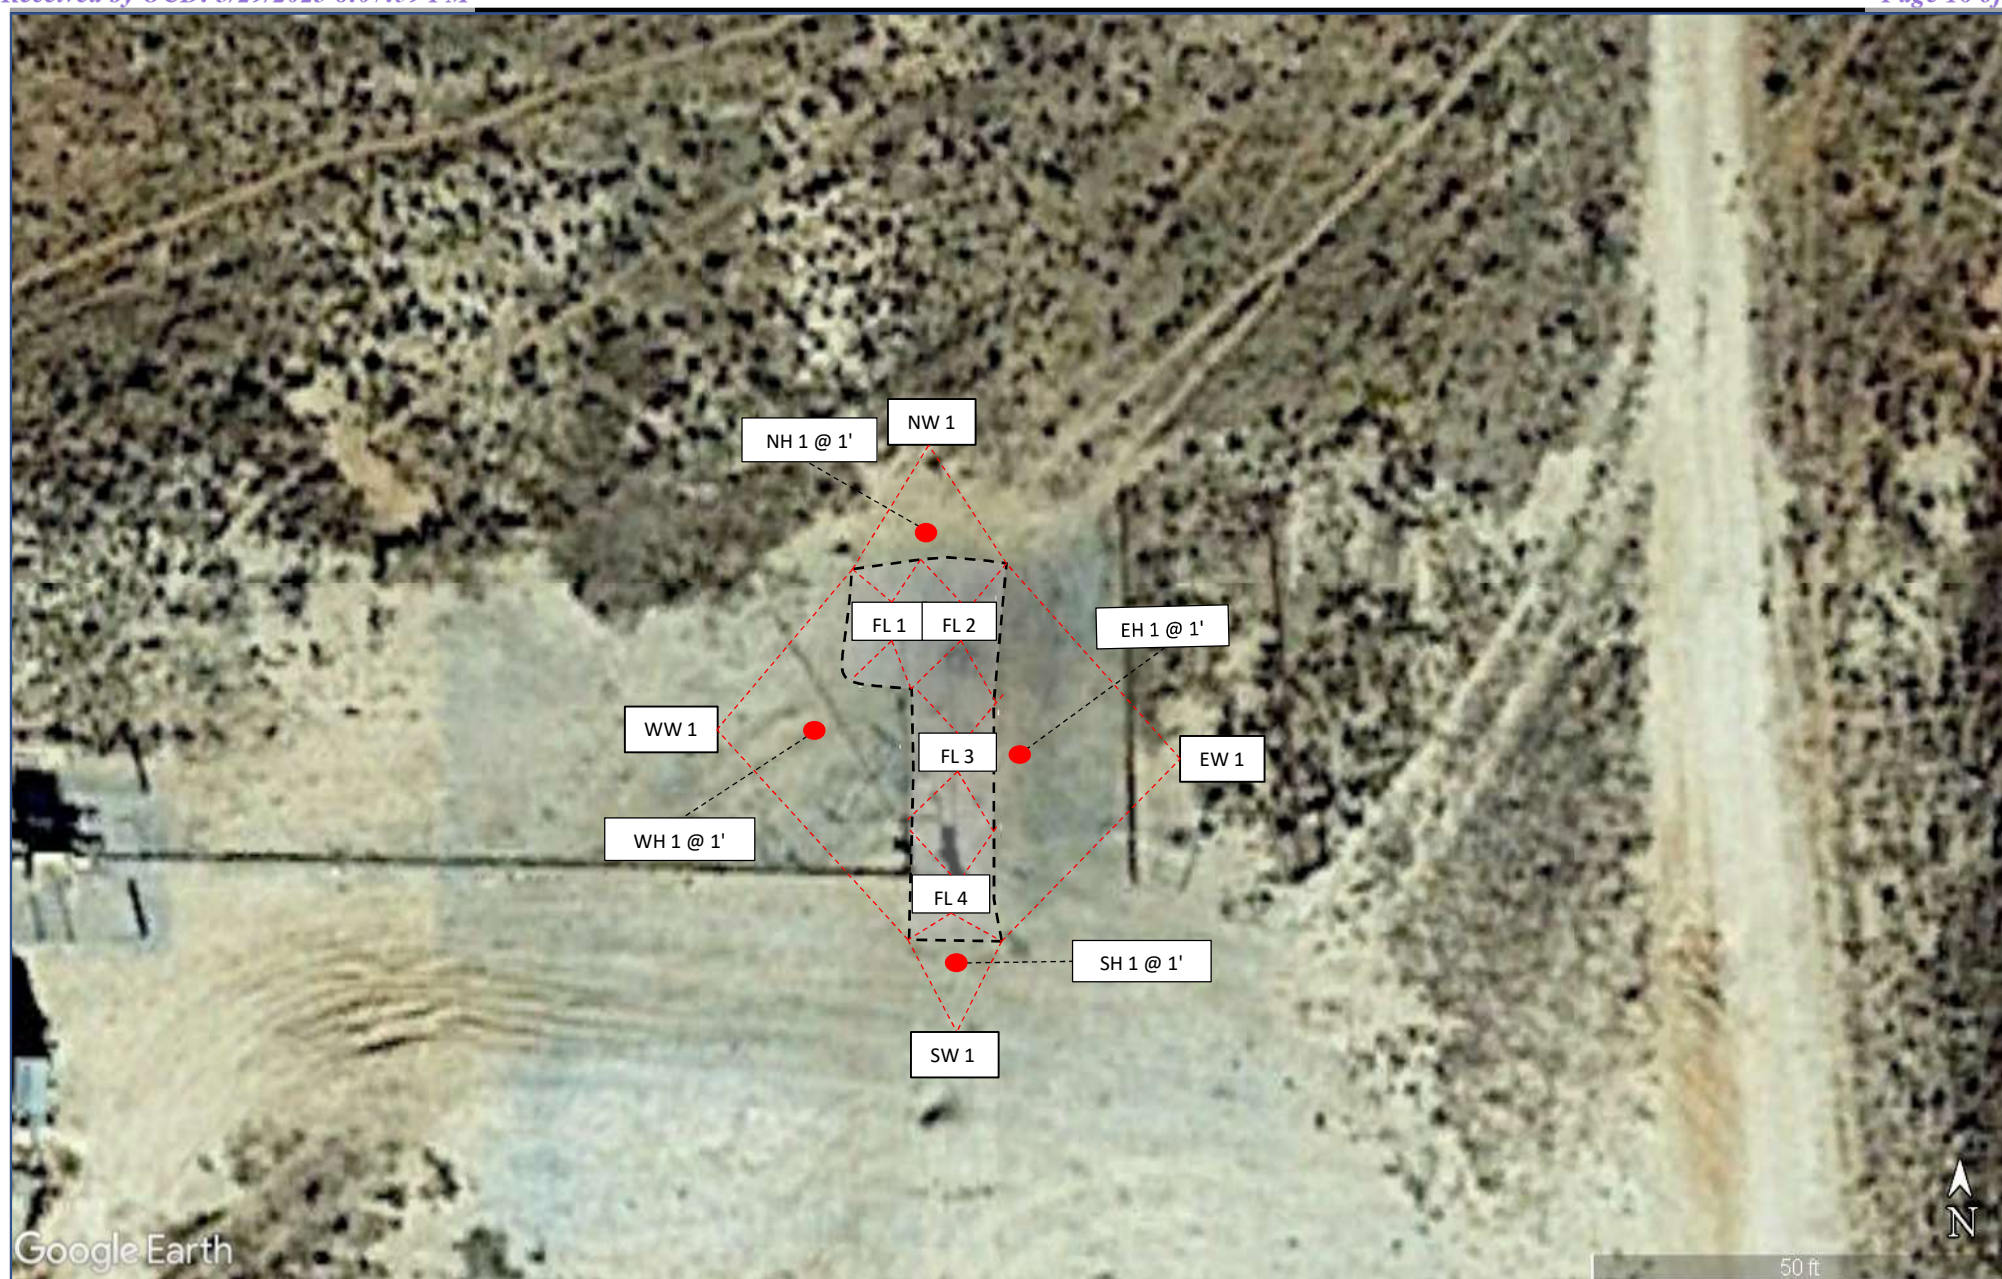
## **Figure 3**

Upon excavating impacted soil affected above the NMOCD Closure Criteria, Etech collected eight (8) confirmation soil samples (FL 1 @ 1', FL 2 @ 1', FL 3 @ 1', FL 4 @ 1', NW 1, EW 1, SW 1 and WW 1). The collected soil samples were submitted to a certified, commercial laboratory for analysis of BTEX, TPH, and chloride. Laboratory analytical results indicated BTEX, TPH, and chloride concentrations were below the NMOCD Closure Criteria in all of the submitted soil samples.

In addition, Etech collected four (4) horizontal delineation soil samples (NH 1 @ 1', EH 1 @ 1', SH 1 @ 1' and WH 1 @ 1') representative of each cardinal direction in an effort to further characterize the horizontal extent of the release. The collected soil samples were submitted to a certified, commercial laboratory for analysis of TPH and chloride. Laboratory analytical results indicated TPH, and chloride concentrations were below the NMOCD Closure Criteria and NMOCD Reclamation Standards in all of the submitted soil samples.

The final dimensions of the excavated area were approximately thirty-seven (37) feet in length, and ranged from eleven (11) to nineteen (19) feet in width and one (1) foot in depth. During the course of remediation activities, approximately sixty (60) cubic yards of impacted soil were transported to an NMOCD-approved surface waste facility for disposal.

### **Site and Sample Location Map**

A site and sample location map is provided as Figure 3. A soil chemistry table is provided as Table 1. Field data and soil profile logs are provided as Appendix B. Laboratory analytical reports are provided as Appendix C. A photographic log of remediation activities is provided as Appendix D.
